CROFT 35 LONEMORE CROFTING TOWNSHIP.

CROFT35 LONEMORE TOWNSHIP

RUIN 1 ON CROFT 35 LONEMORE TOWNSHIP.

RUIN 2 ON CROFT 35 LONEMORE CROFTING TOWNSHIP..NG 78961 77555 GPS .ELEVATION 68M .FUNCTION HOUSE. SURVEYED 08-11-2008

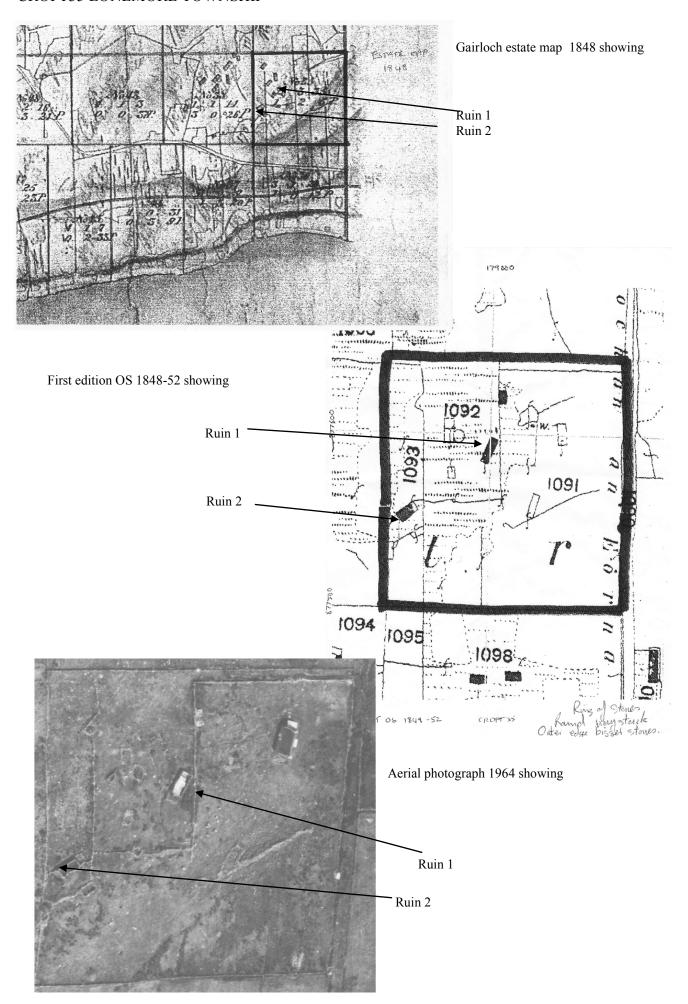
Ruins 1 and 2 are described separately as they are more substantial. The rest of the boulder walls, and footings are as marked on the plan with the walls up to 0.80m in height. Their function is unknown. However there are the outlines of what were according to local knowledge corn drying circles (S and W of ruin 1) where stones were placed around the corn stacks and ropes or nets attached to stop the corn from blowing away. There is also evidence of lazy beds where arable crops were grown (see photo)

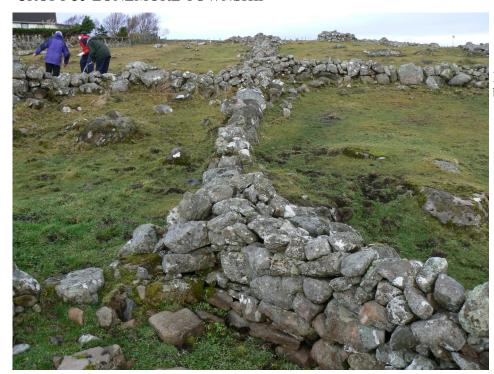
P1 showing some of the boulder walls on croft 35

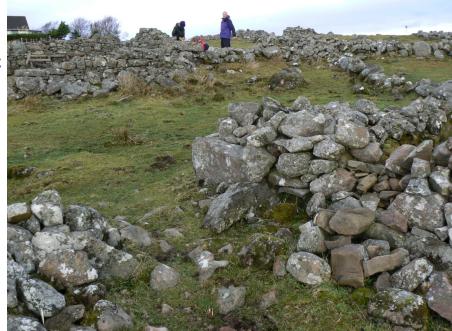
P2 showing footings and walls and the E end of ruin 2

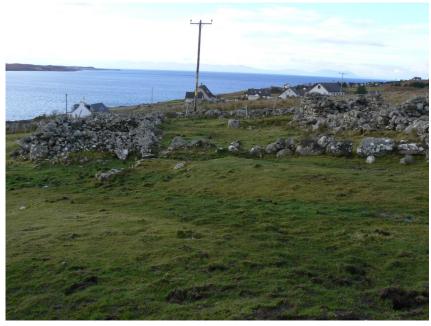
P4 showing ruin 2 and the ruin to the S of it with some walls and old lazy beds

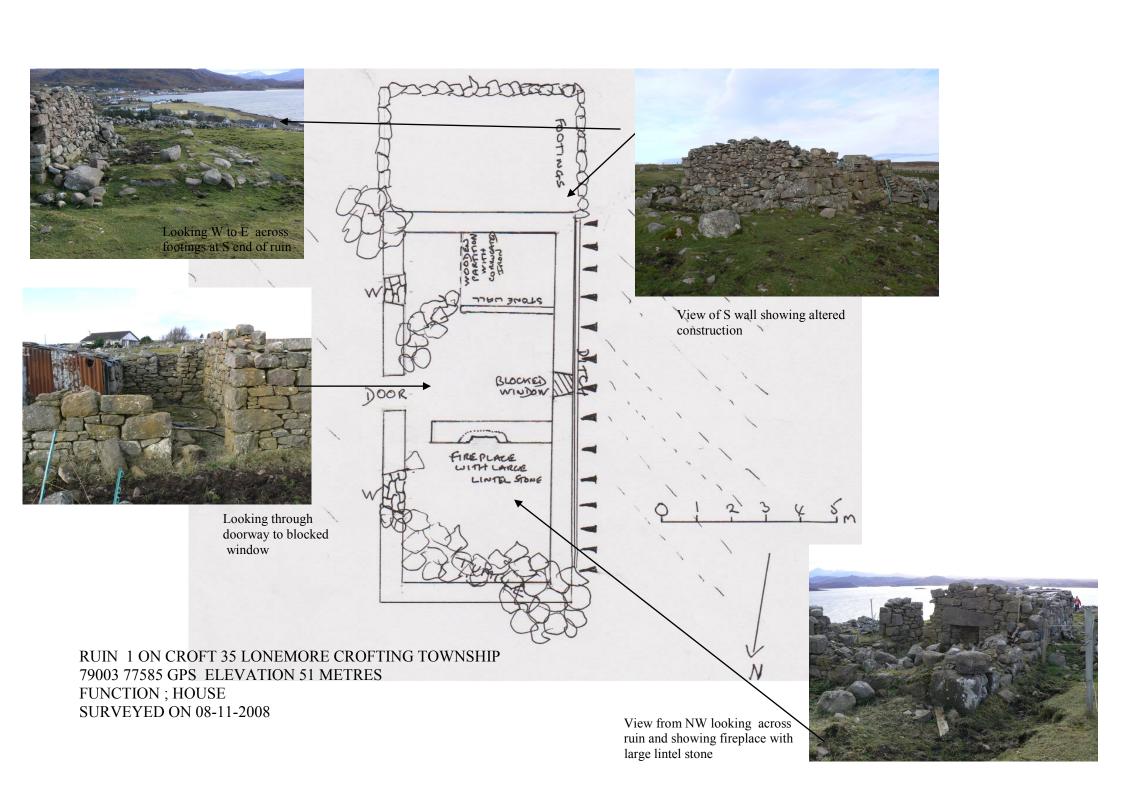
This substantial unroofed ruin is marked on the Gairloch estate map, and is shown as roofed on both the first and second editions of the OS maps.

It has a SE aspect with its gable end to the prevailing winds for shelter which is typical of the croft houses in Lonemore. The ground slopes gently from NW to SE both to the rear and front of the ruin and there has been a ditch dug to aid drainage to the rear of the building.

The external walls are built with dressed and selected stones that have been layered with the gaps filled with snecking and the interior of the wall construction with infill of smaller stones. There is a lot of tumble as marked on the scale drawing and the S wall appears to have been rebuilt in a rougher manner at a later date. Inside the ruin at this point is a shed so this was probably done at the same time as the shed was constructed.

On the E wall there is evidence of two windows and a doorway, and on the W wall a filled in window. There are two interior walls: one is part of the shed made within the S end of the ruin, and the other, a dividing wall that contained the fireplace, chimney and a very large lintel stone which is 1.4m in length and 0.5m in height.

To the S of the ruin are the footings of another structure. These are broken down making it difficult to define a definite edge.

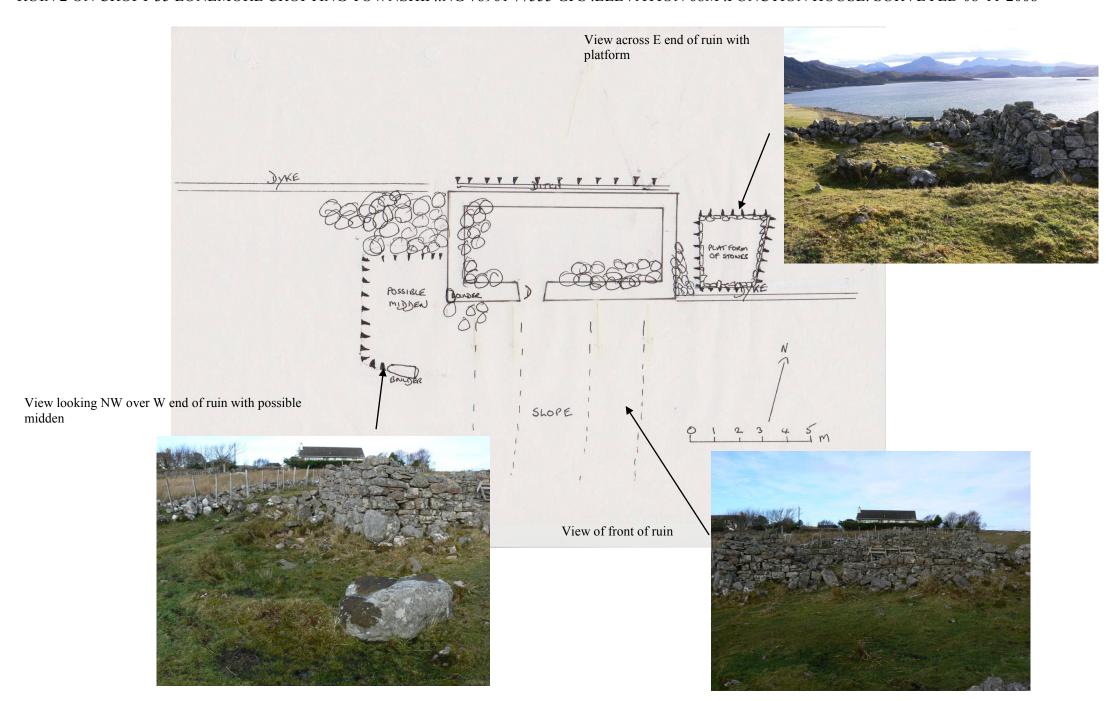
This unroofed ruin has a S aspect on a slope overlooking Loch Gairloch. It is marked on the Gairloch estate map and is shown as roofed on both the first and second editions of the OS maps. It is part of the group of cottars houses where population was concentrated before the crofts were made.

The walls are made with selected stones, some large boulders at the base, with snecking and infill. They average 0.60 m in thickness, and have a maximum height of 1.91m. There is a lot of tumble around the ruin. There is an opening in the S wall with a fallen lintel which is a doorway. No evidence of windows can be seen in the remaining walls.

To the rear of the ruin is a ditch to help with drainage, and at the W end a possible midden. At the E end of the ruin is a raised platform of stones which is probably the remains of another building, function unknown.
