## **CROFT 49 LONEMORE CROFTING TOWNSHIP**

### **RUINS ON CROFT 49 LONEMORE TOWNSHIP**

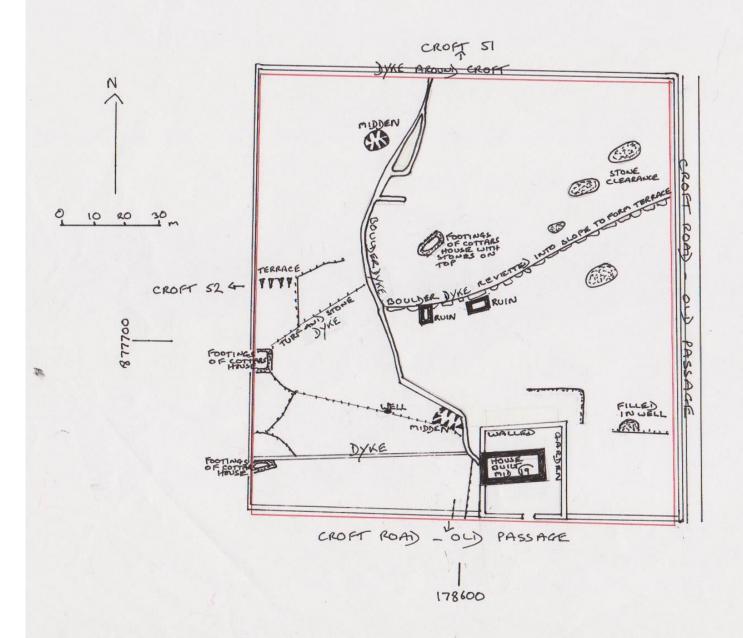
This croft is given an acreage of 4.5 on the estate map. It is on a slope and fairly well drained except in the SE corner where there is a filled in well. (78656 77768). There is another well at (78574 77678) which still has a structure and contains water (see picture)

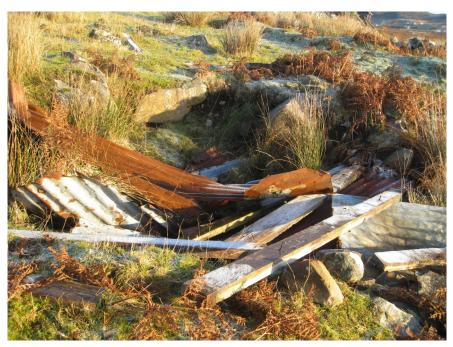
POSSIBLE MIDDEN

This was a well worked croft as is evident from all the remaining stone dykes and footings of turf and stone dykes. There are also two circular hollows which may have been middens. (see plan)

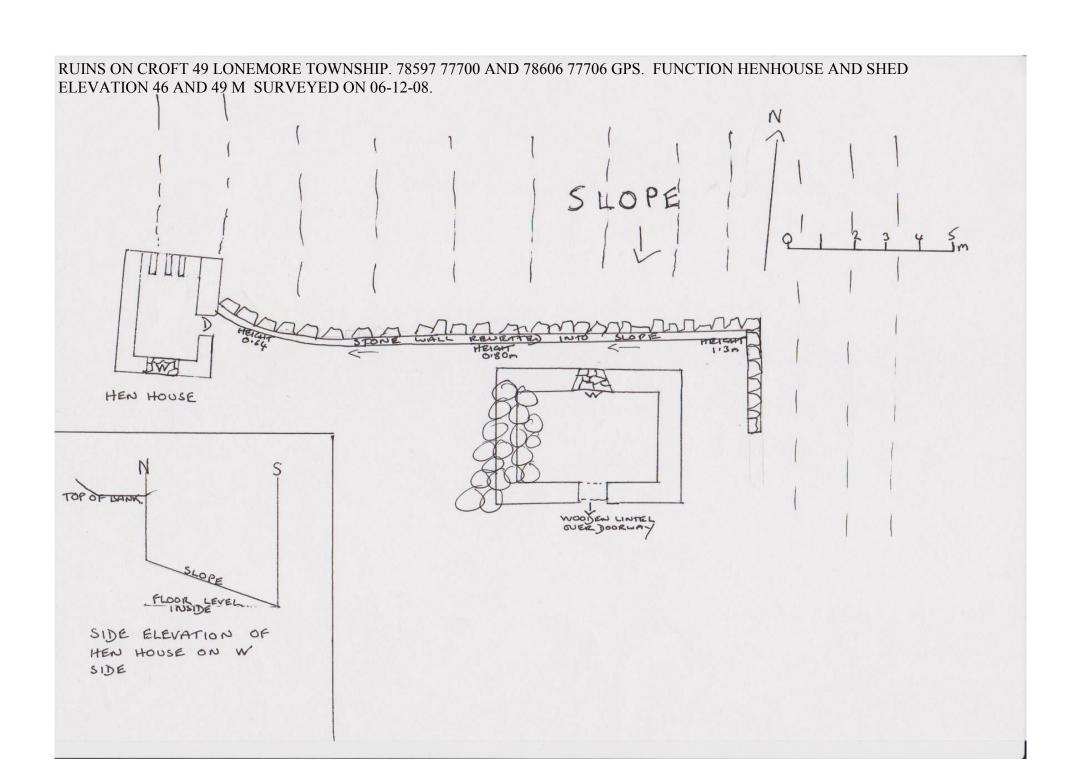
On the croft there are several footings of older, small cottars houses which have been covered with field clearance stones. There are also some piles of stone clearance. Two ruins below the stone dyke that runs NE to SW are described in separate descriptions. The larger of these is shown as roofed on both the first and second OS, with the other unmarked on any OS. The dyke is also shown on the OS maps.

A stone house built in the mid 19th century, that is surrounded by a walled garden is still occupied. On the first and second OS there is a building just N of this but it is on the wrong axis so it must have been demolished, and another built.

These are all shown on the plan.

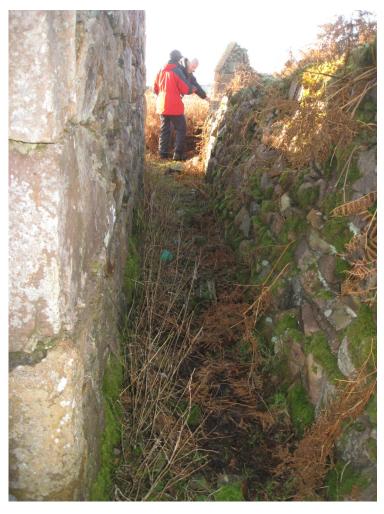
THE RETAINING WALL BEHIND THE SHED WITH THE HENHOUSE IN THE BACK-GROUND.

The wall ranges in height from 1.3m to 0.64m, sloping towards the henhouse. It is made of small boulders and selected stones and is shown on both the first and second OS maps.

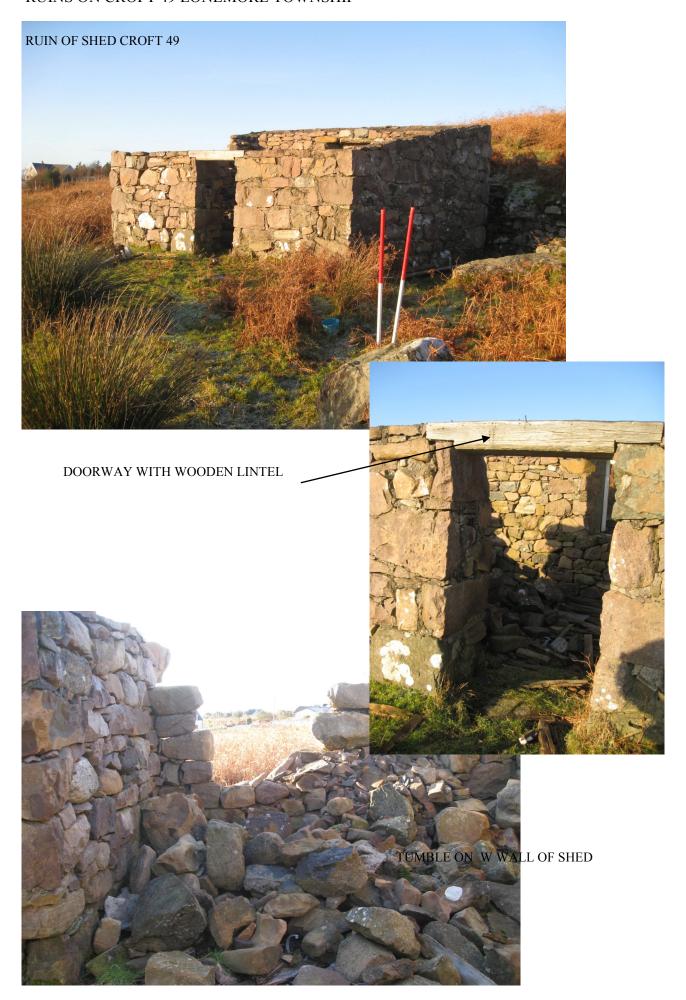
# RUINS ON CROFT 49 LONEMORE TOWNSHIP

The E ruin was known to have been a shed where walking sticks were made .It is well made of dressed stone that has been layered, with snecking, and has been partially harled. The walls are 0.60m thick and up to 2.30m high on the N wall .There is a doorway on the S wall with a wooden lintel ,and a window in the N. wall facing onto the stone wall. The shed is unroofed but must have had a flat roof as the walls slope from N to S (see picture), with no gables. It is still in very sound condition except for the W wall which is broken down with a lot of tumble. This ruin is shown as roofed on both the first and second OS

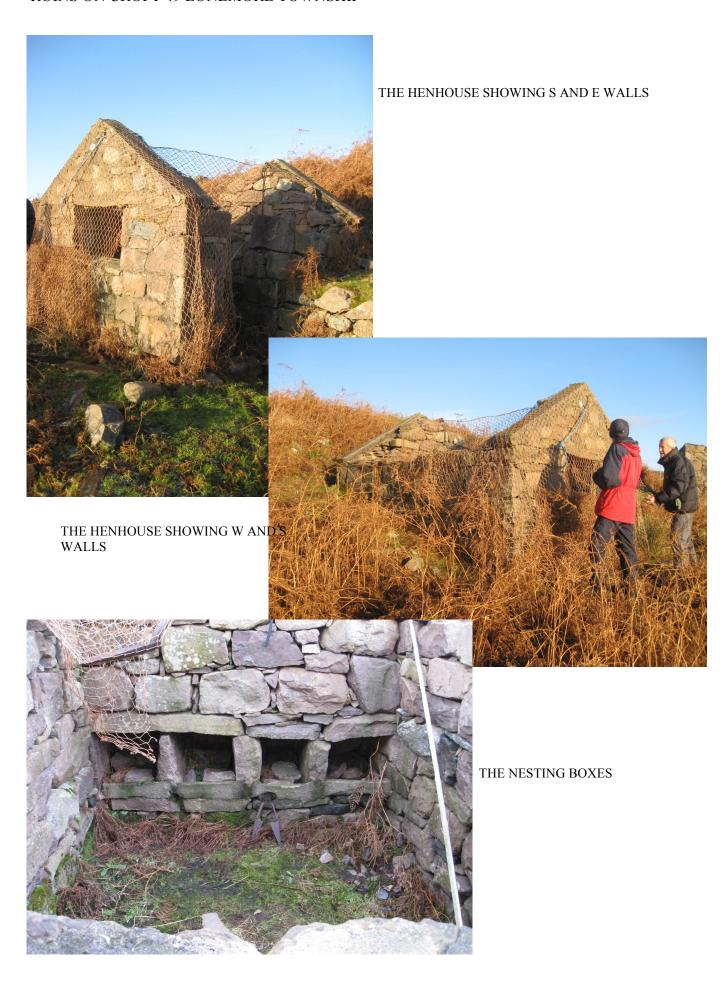
# RUINS ON CROFT 49 LONEMORE TOWNSHIP

The W ruin is a henhouse, unroofed, but still in very good condition with no tumble. It is made of dressed and selected stone with walls 0.50m thick .The height of the walls on the W and E walls is 1.40m and on the gable ends at N and S 2.22m. The henhouse is built into the natural slope, with part of the external sides of the W and N wall being covered by the bank. (picture) The 4 nesting boxes are situated in the structure of the rear N wall. (picture) They have a depth of 0.40m, a height of 0.30m, and are 0.60m off the floor. There is an entrance on the E wall ,and a window on the S wall This ruin is not shown on any OS map.
