CROFTS 50 AND 51 LONEMORE CROFTING TOWNSHIP

RUINS ON CROFT 51 LONEMORE CROFTING
TOWNSHIP NG 78472 77848 GPS
ELEVATION 65m
FUNCTION : HOUSE WITH ADJACENT
MIDDEN, ENCLOSURE AND SHED.
SURVEYED ON 05-11-08

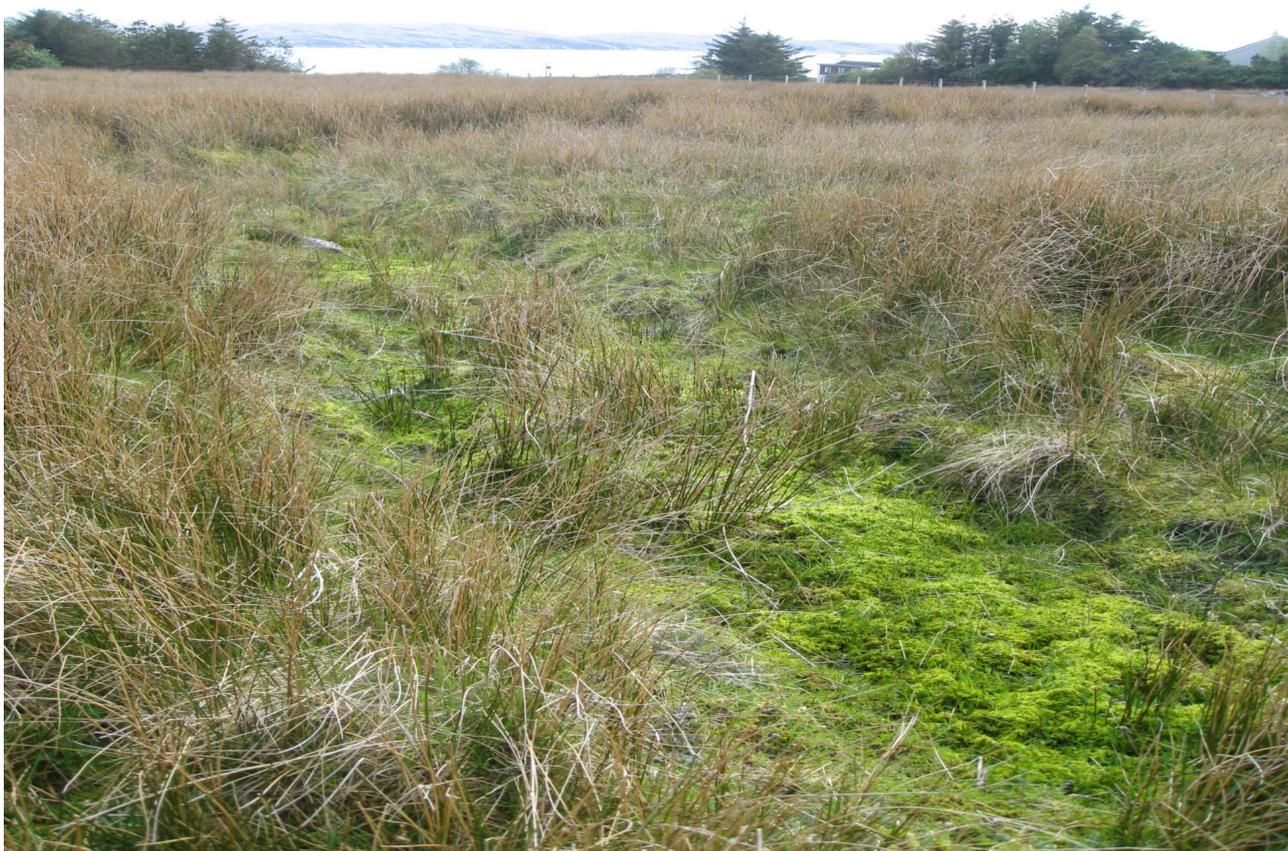
Crofts 50 and 51 are joined together without a boundary and have an acreage of 11 acres. The ground on croft 50 slopes gently to the SW and is fairly dry with grass and rushes. Croft 51 is boggy and is covered with rushes. A large drainage channel dissects this croft but is now uncleared resulting in poor drainage. (see picture)

DRAINAGE DITCH ON CROFT 51.

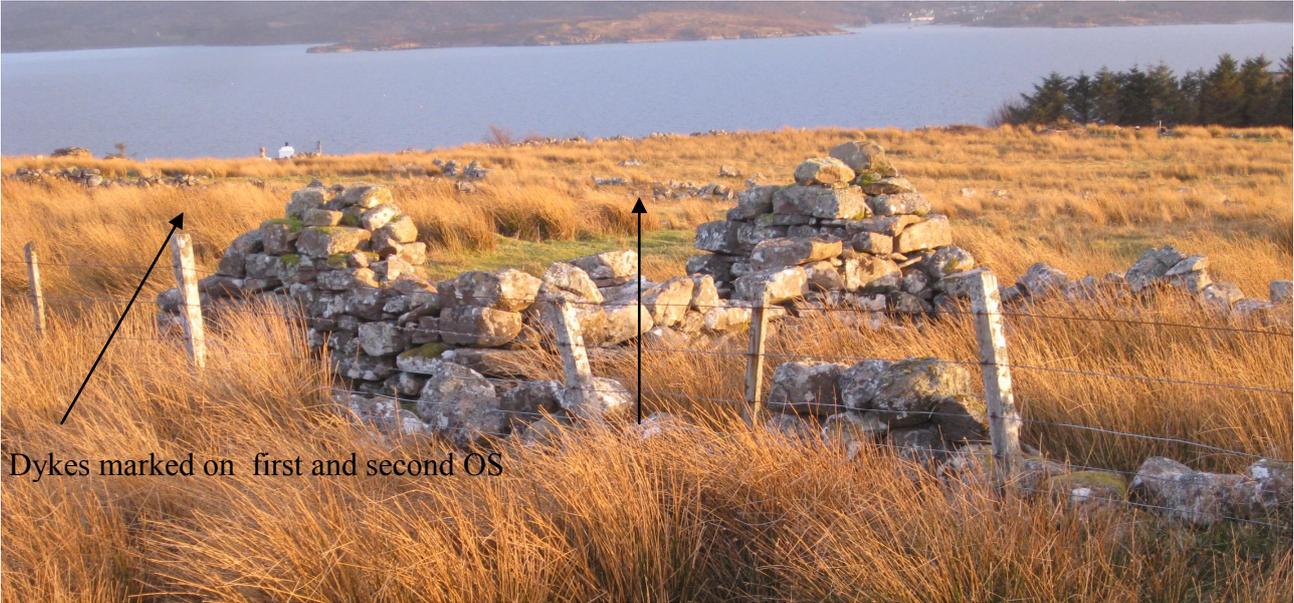
On both crofts there are several stone dykes and footings of turf and stone dykes as shown on the plan. It is noted that the dykes running W and S of the ruins are marked on the first OS. (see picture) The township head dyke runs along the N edge of the crofts. (see picture)

Dykes marked on first and second OS

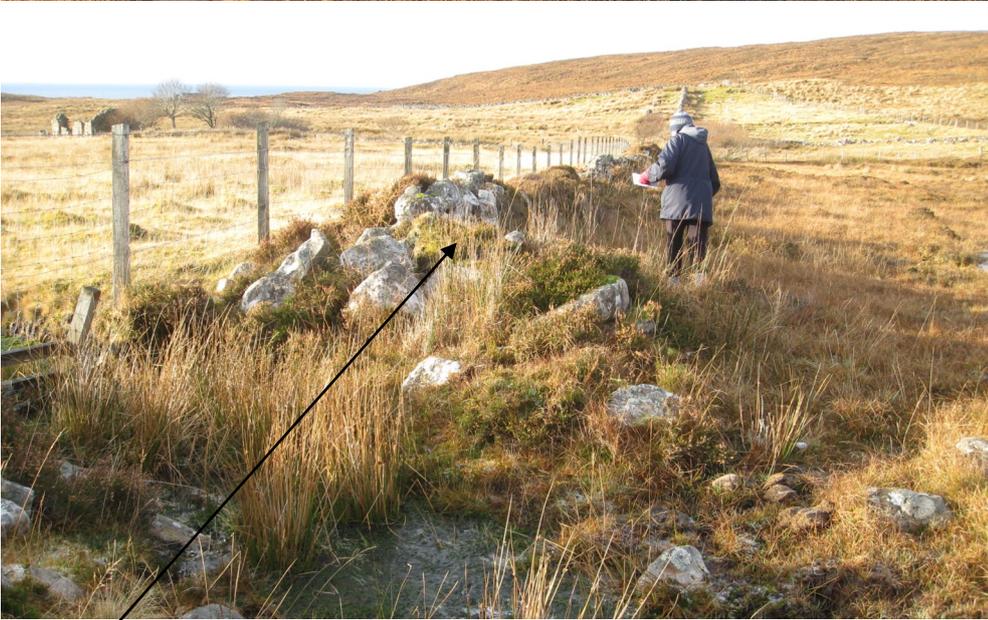
Head dyke running along N boundary of crofts

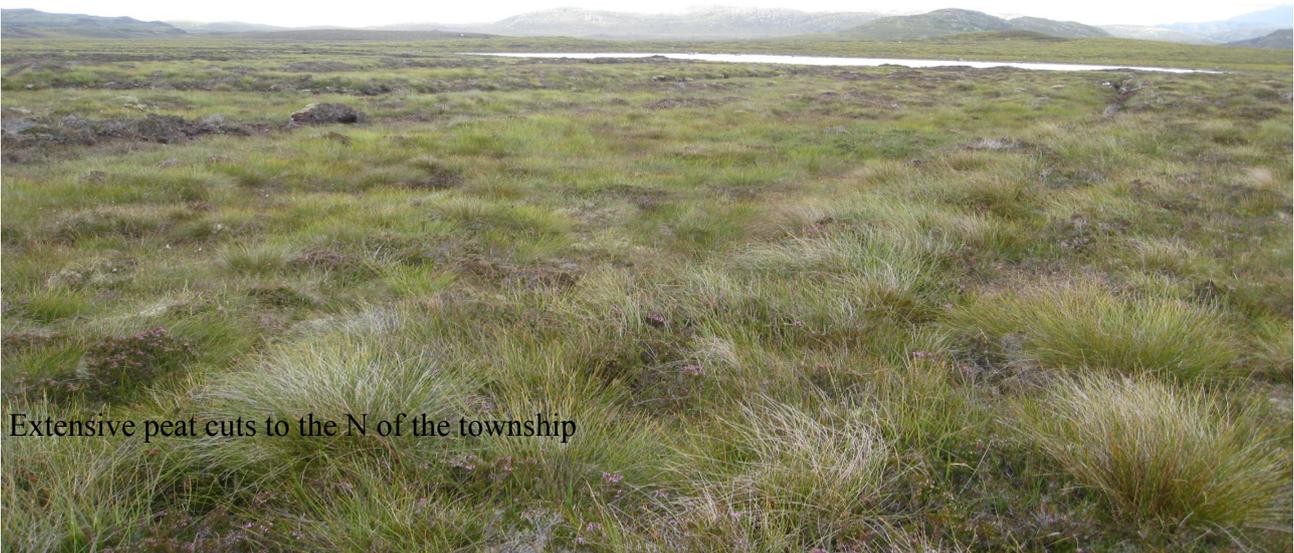
Along the E boundary of the crofts is an old passage, now a track which continues up on to the common grazing to extensive peatcuts where the whole village cut peats (see picture)

Extensive peat cuts to the N of the township

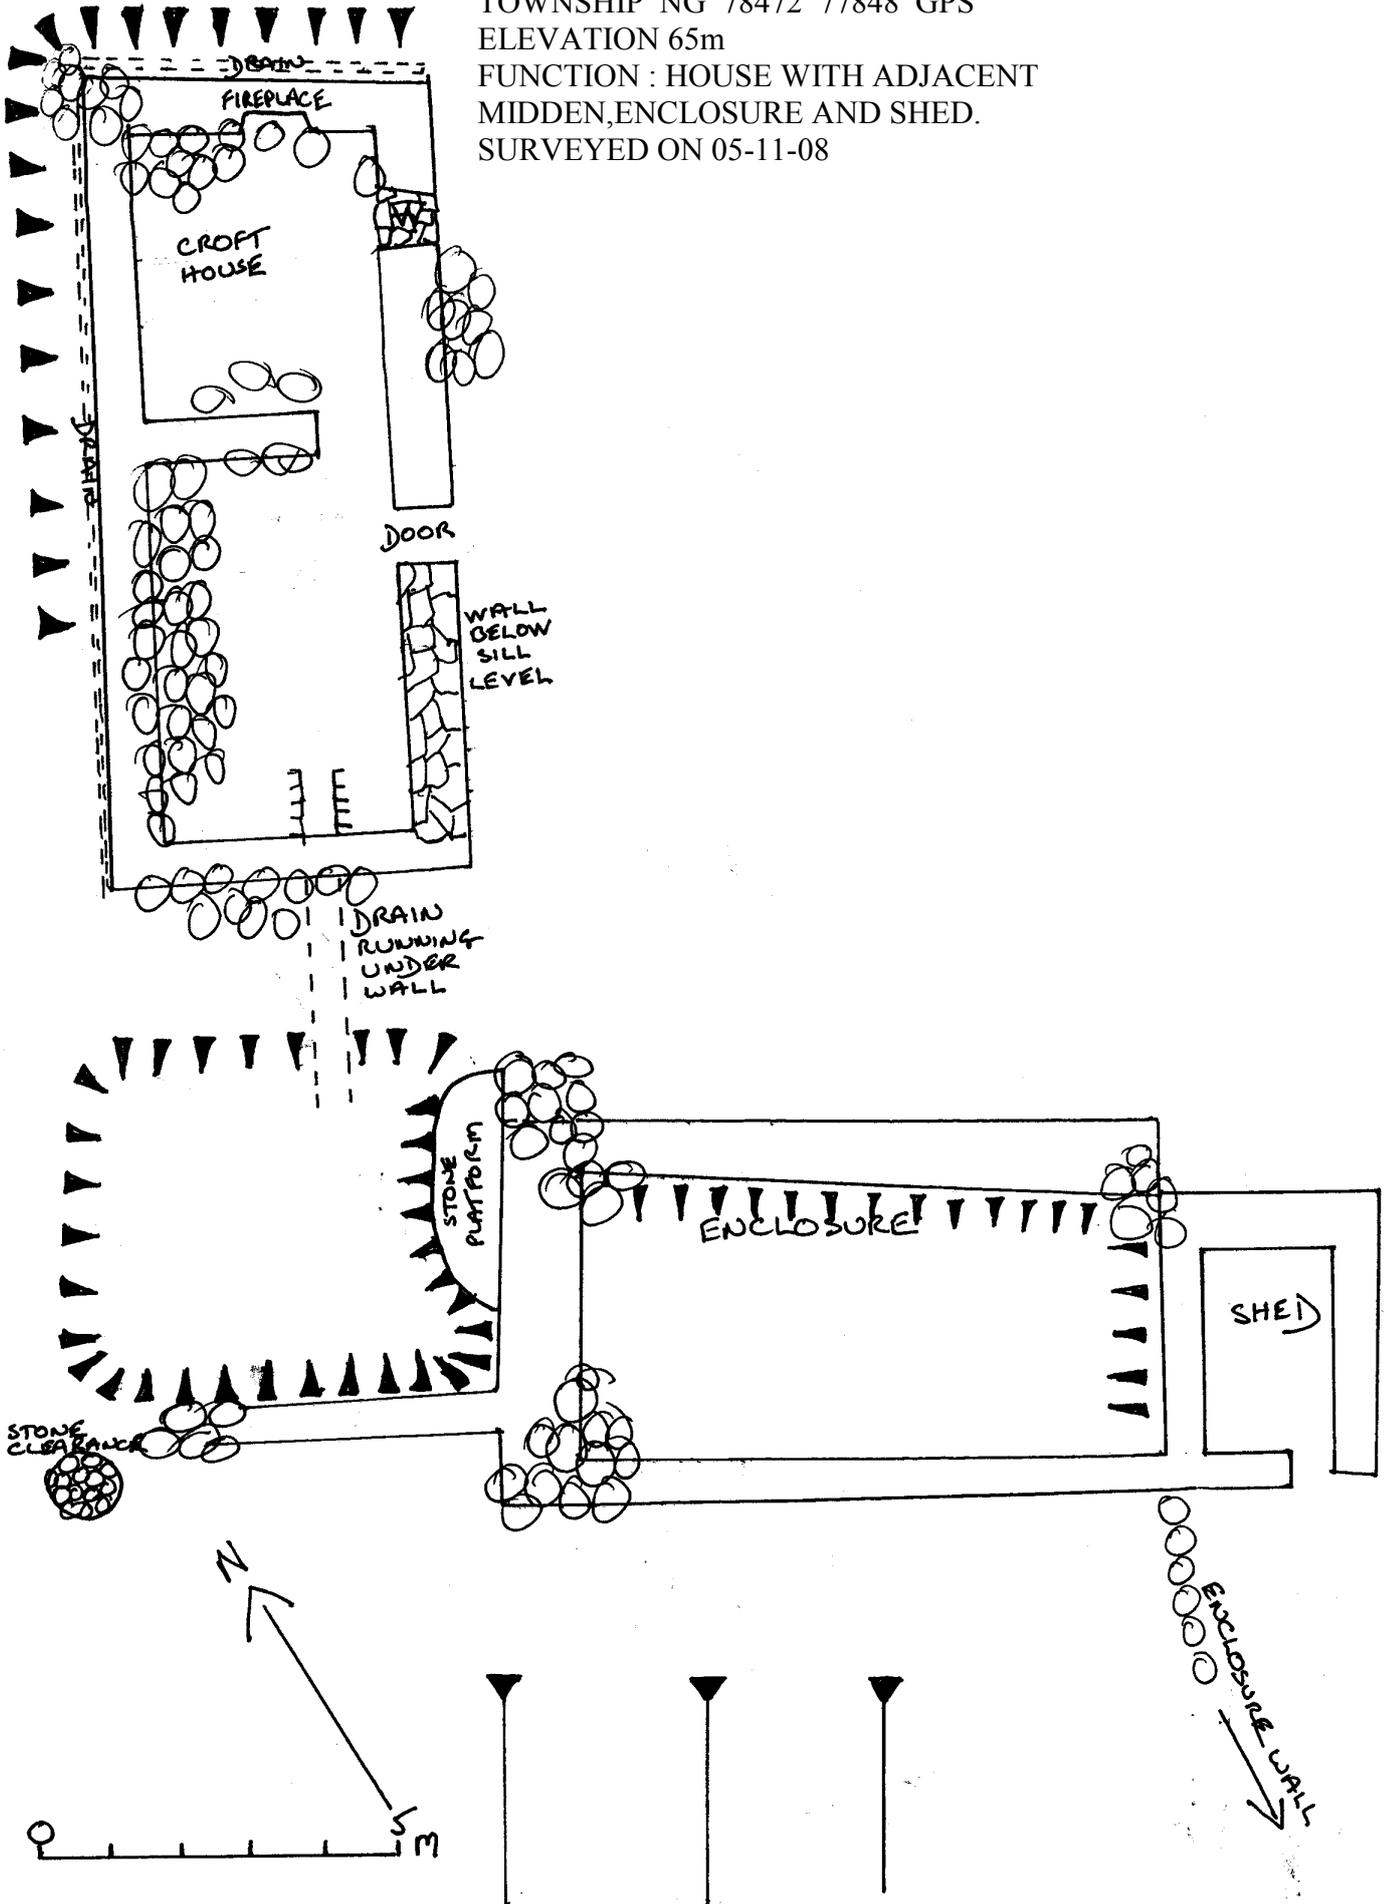
In the S section of the interior there is a drain that extends under the external wall running into the adjacent midden. (see scale drawing)

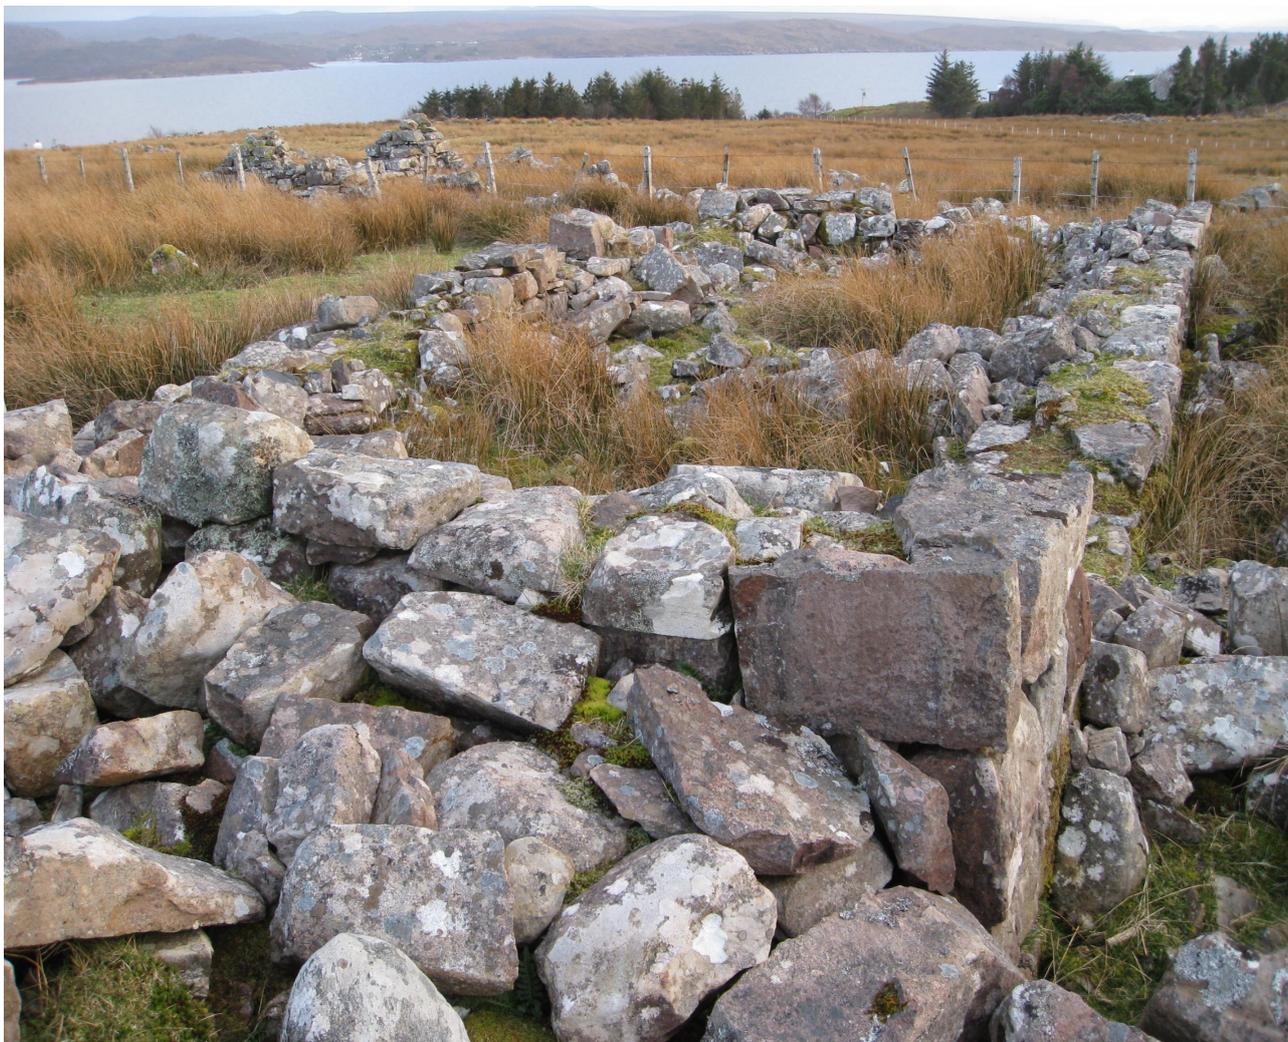
LOOKING S OVER THE CROFT HOUSE TOWARDS THE ENCLOSURE AND SHED

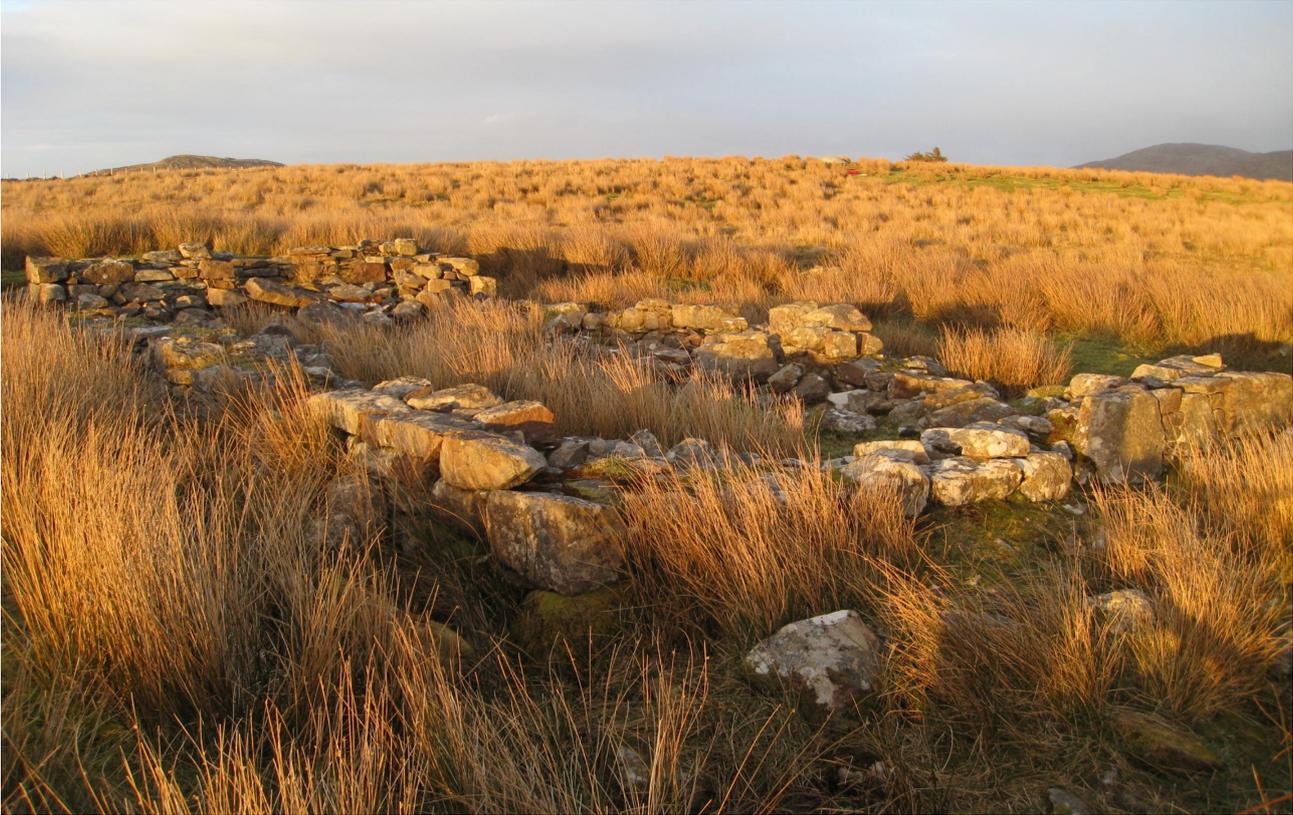
The croft house is unroofed and in a ruinous state with a lot of the walls in a tumbled down condition. It can be seen that the walls were well made with selected and dressed stone with some snecking and infill in the centre of the wall construction. The walls now range in height from 0.10 to 1.46m with a width of 0.60m.

VIEW OF HOUSE RUIN FROM THE SW

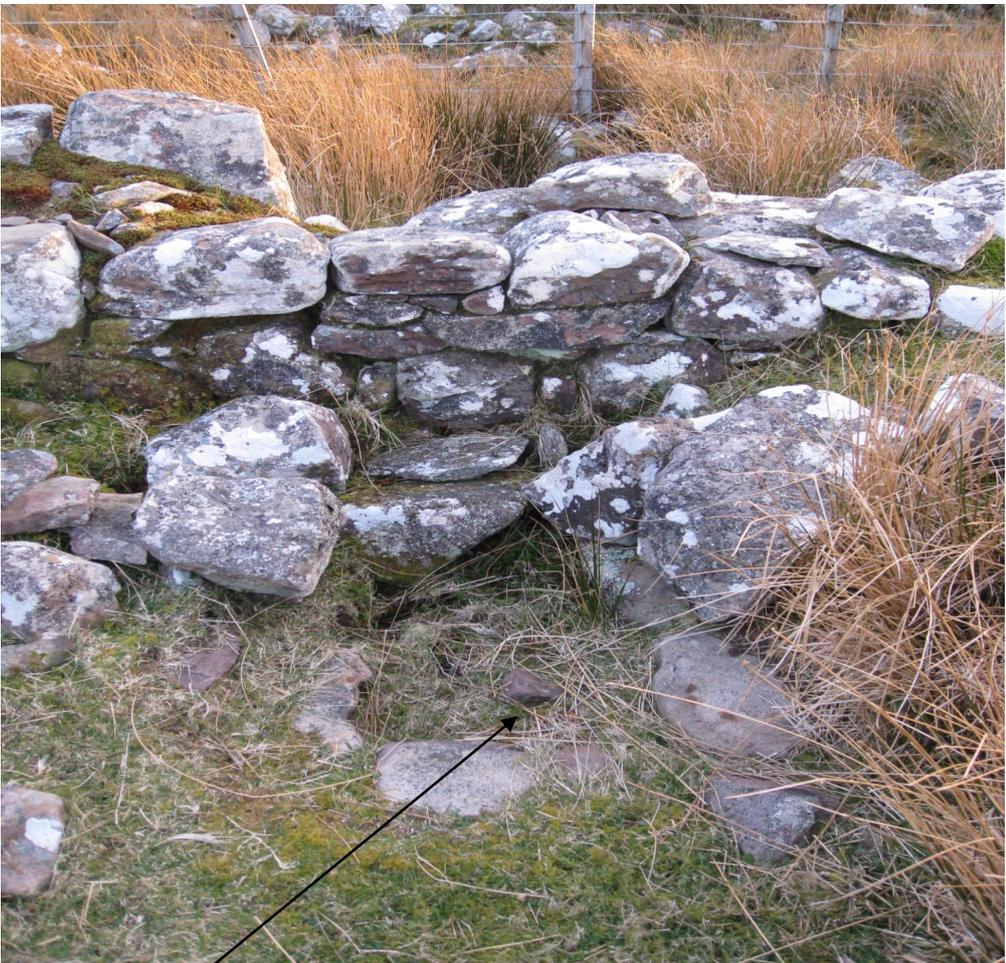
DETAIL OF DRAIN RUNNING THROUGH TO MIDDEN

The drain from the house runs into a hollow with steep sides to a depth of 0.60m. On the E edge of this hollow is a stone platform 0.50m above the bottom of the hollow. This hollow was probably used as a midden and may have been on the site of an earlier building. It is surrounded on two sides by a rough boulder wall of varying thickness up to 0.5m and a height of 1m. To the SW is a pile of stone clearance.

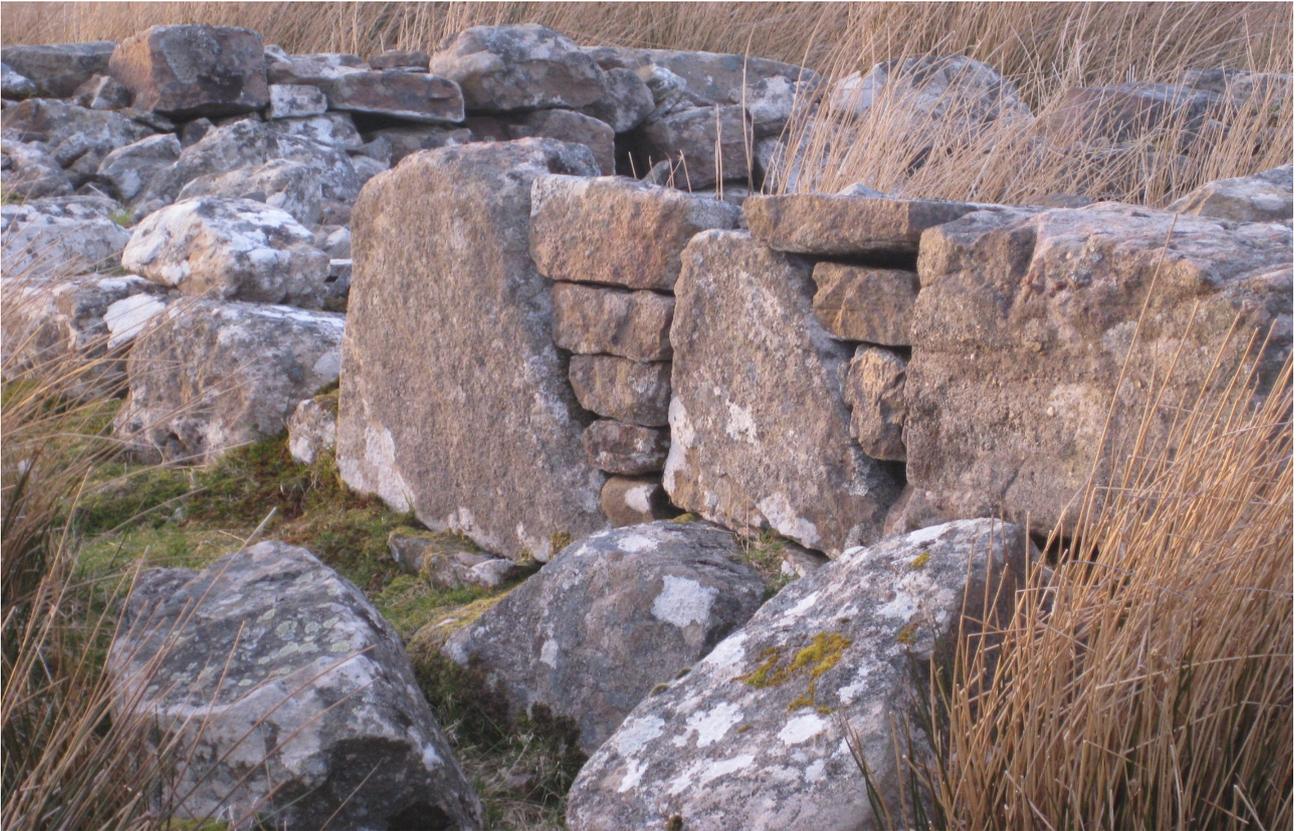
DETAIL OF STONEMWORK IN S WALL OF CROFT HOUSE

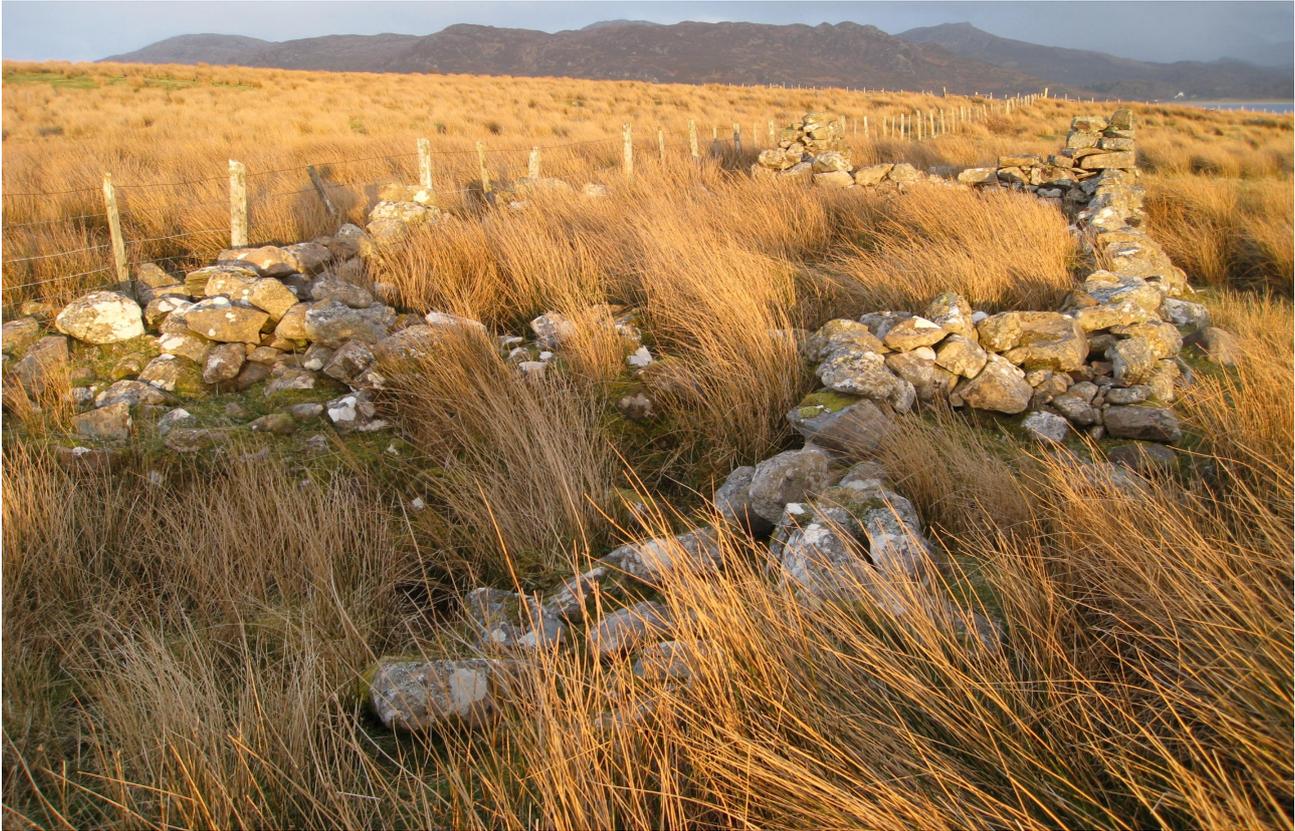
Joining on to this hollow is a stone enclosure with rough boulder walls of varying thickness up to 0.90m and 1.25m in height.

LOOKING FROM MIDDEN OVER ENCLOSURE TO SHED

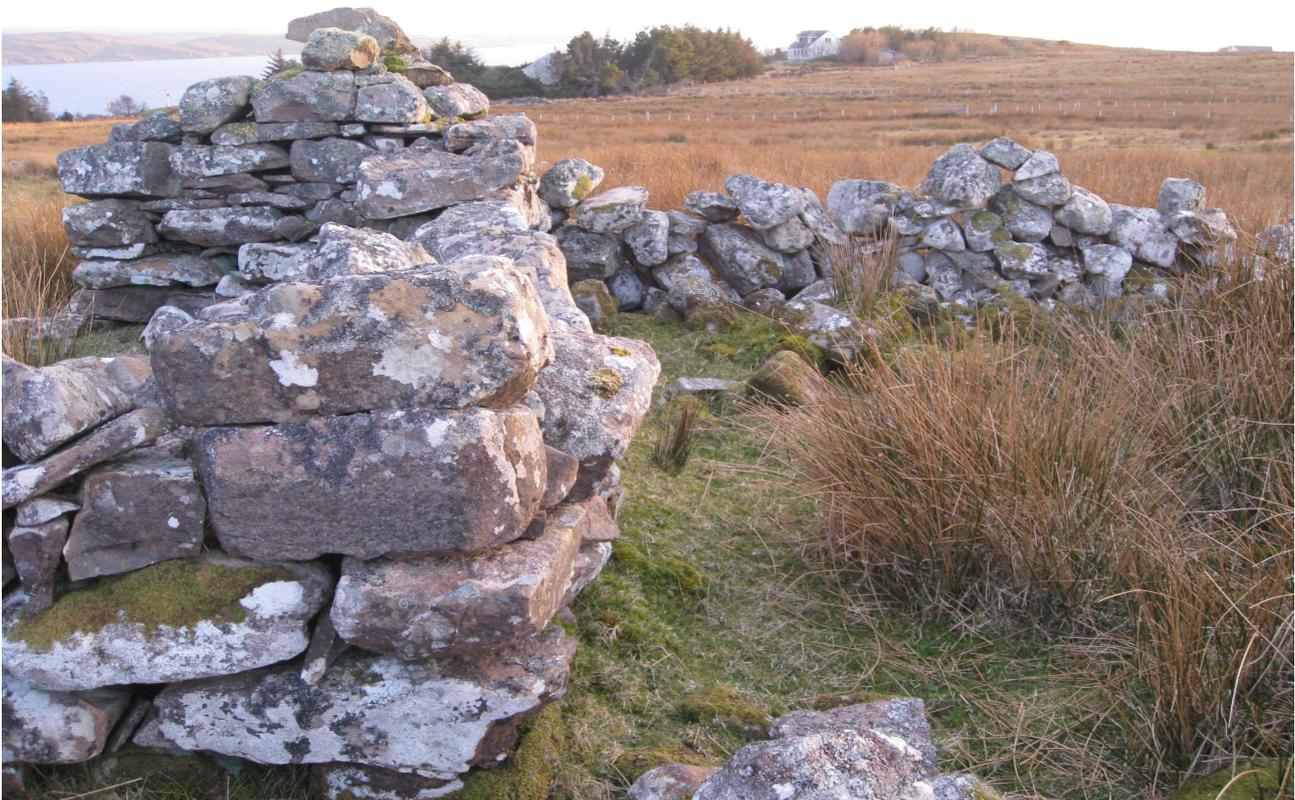
Joined to this enclosure at the E edge is a well constructed structure that was probably a storage shed. Its walls are made with dressed stone and range in height from 1.10 to 1.50m. There are two intact gable walls on the N and S walls and the walls are up to 0.70m thick. There is a visible entrance but no windows.

SHED WALL SHOWING DRESSED STONE WITH ADJOINING ENCLOSURE WALL MADE OF BOULDERS
