CROFT 54 LONEMORE TOWNSHIP.

LOWER RUIN CROFT 54 LONEMORE GAIRLOCH. NG 78488 77487 GPS
 ELEVATION 29 METRES
 SURVEYED ON 12-11-08
 BUILDING FUNCTION POSSIBLE BYRE

UPPER RUIN CROFT 54 LONEMORE GAIRLOCH.NG 78462 77487 GPS
 ELEVATION 31 METRES
 SURVEYED ON 12-11-08
 BUILDING FUNCTION HOUSE WITH BYRE /SHED ATTACHED

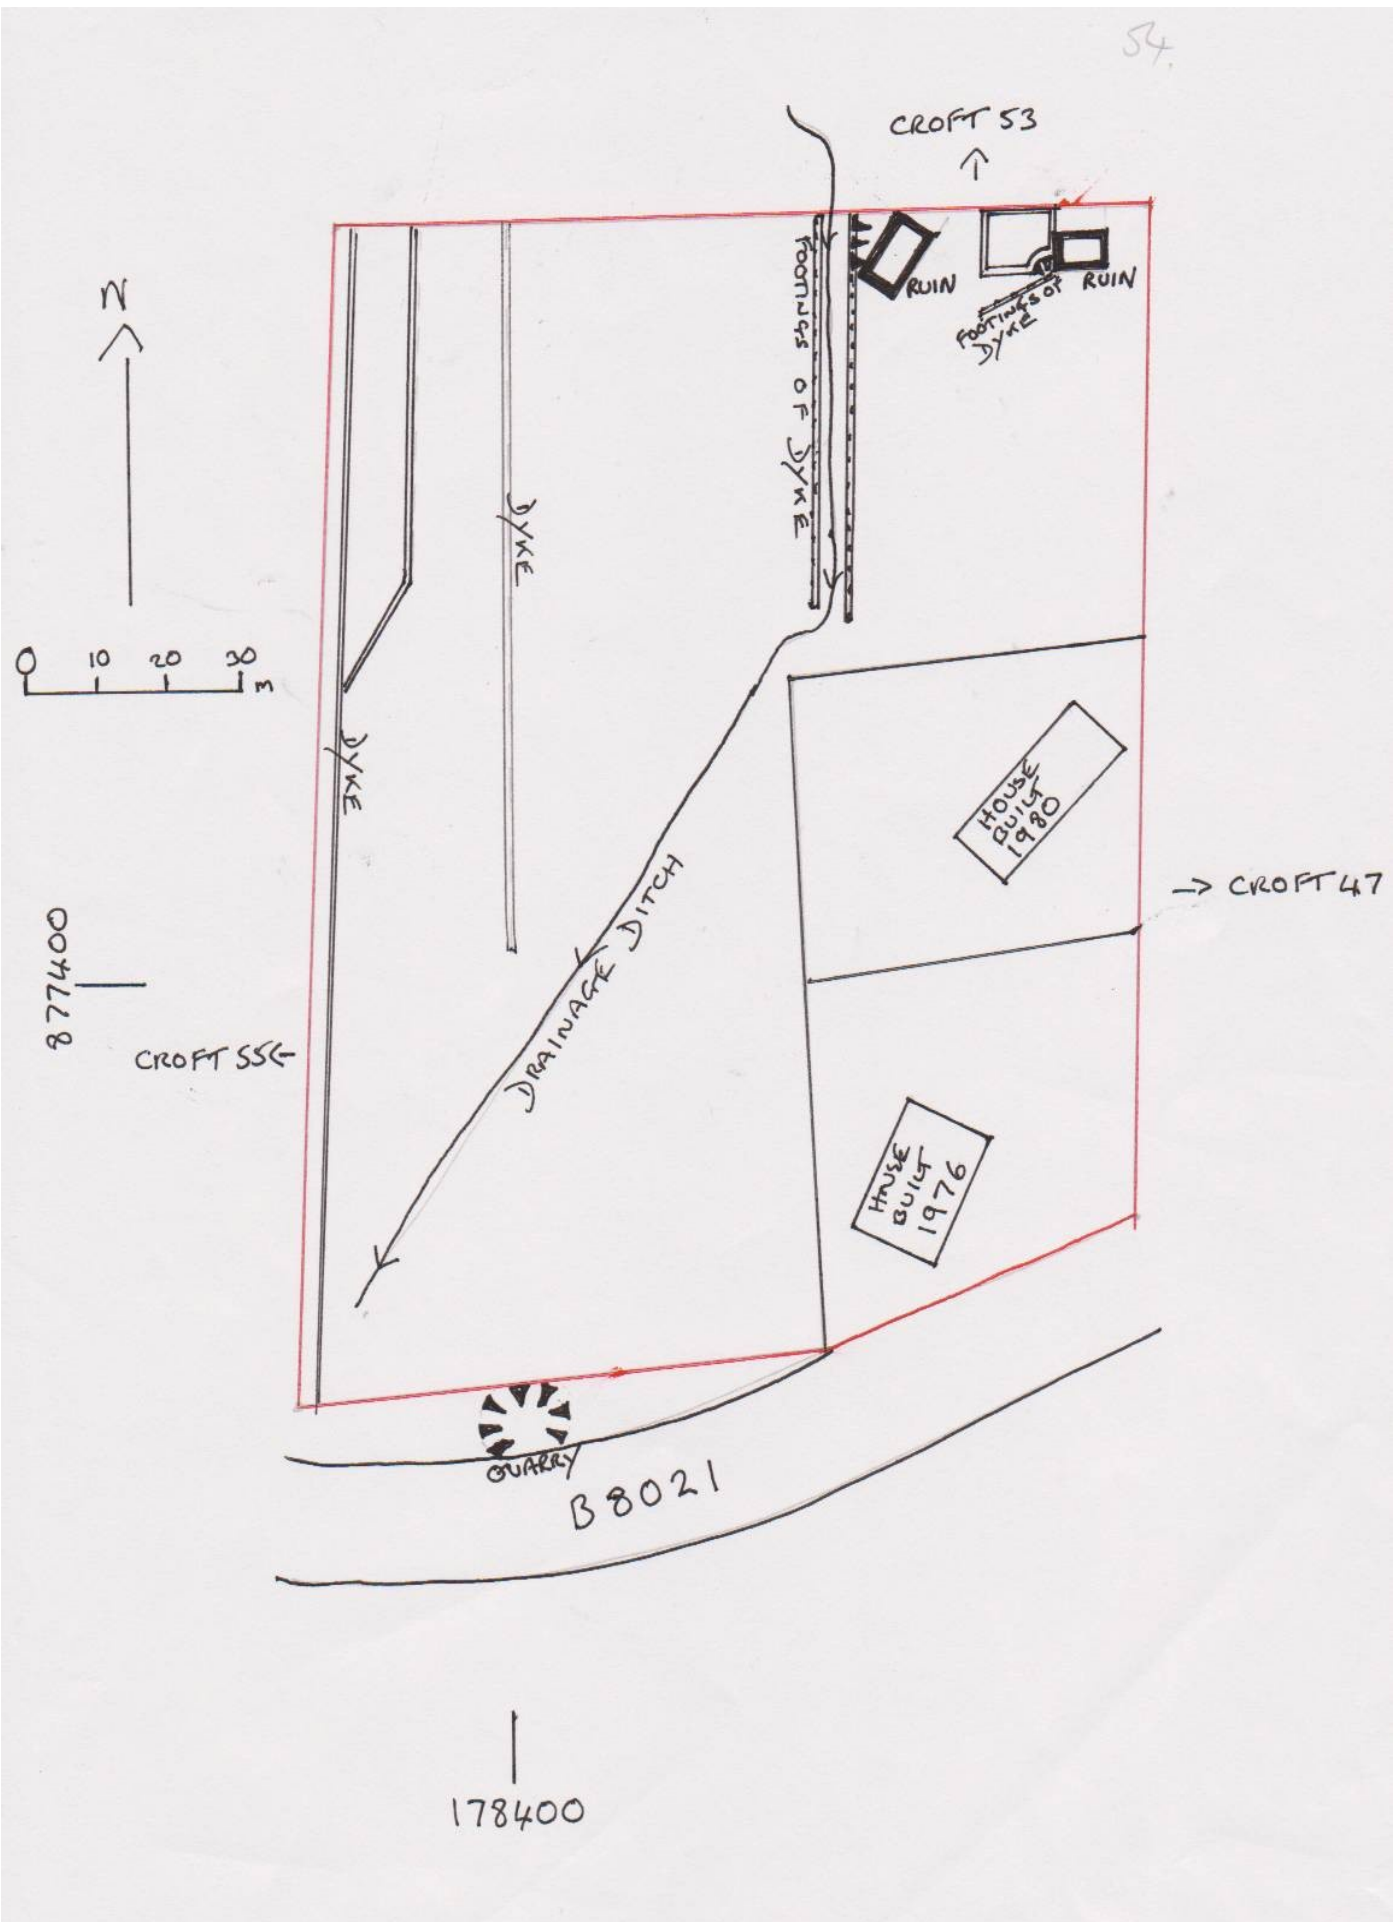
54.

Croft 54 is shown as having 3.75 acres on the estate map. Apart from the area taken up by the gardens of the new houses built in 1976 and 1980 (see plan), it is mainly grass used for grazing sheep. A large drainage ditch crosses the croft to help keep it clear of bog.

There are several stone dykes and footings of others remaining (see plan)

In the NE corner of the croft are the ruins of two buildings and an enclosure shown on the first and second OS maps (see separate description).

On the S boundary of the croft runs the B8021, and there is a small quarry or borrow pit that was used to provide hardcore for the road construction.

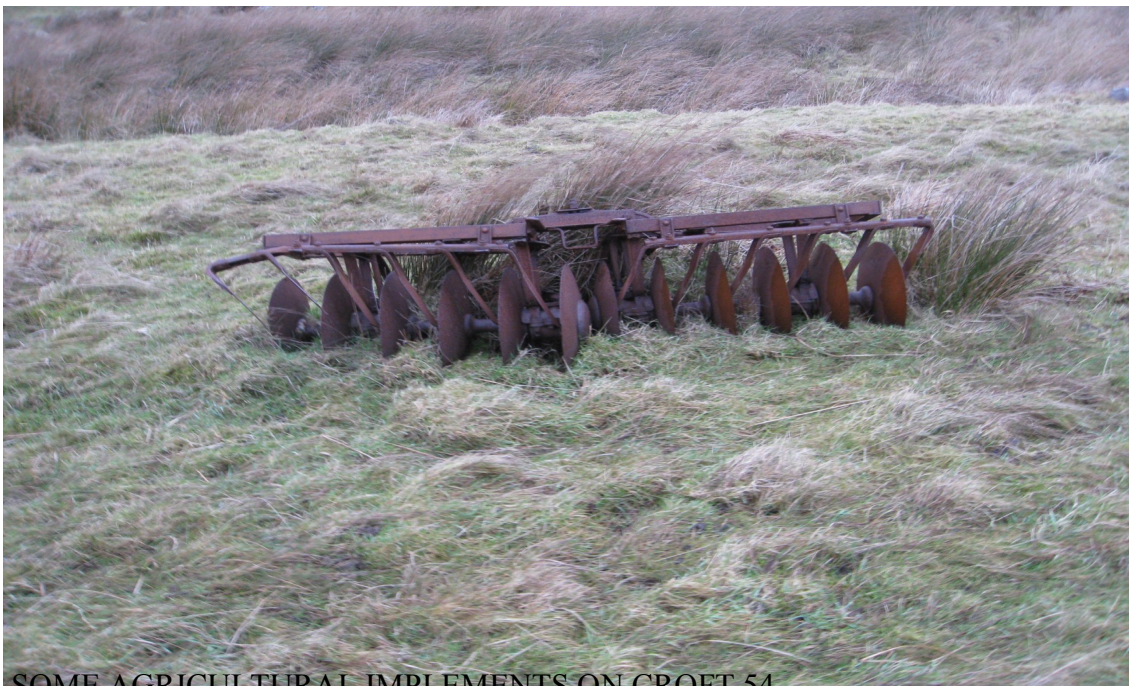
SOME AGRICULTURAL IMPLEMENTS ON CROFT 54

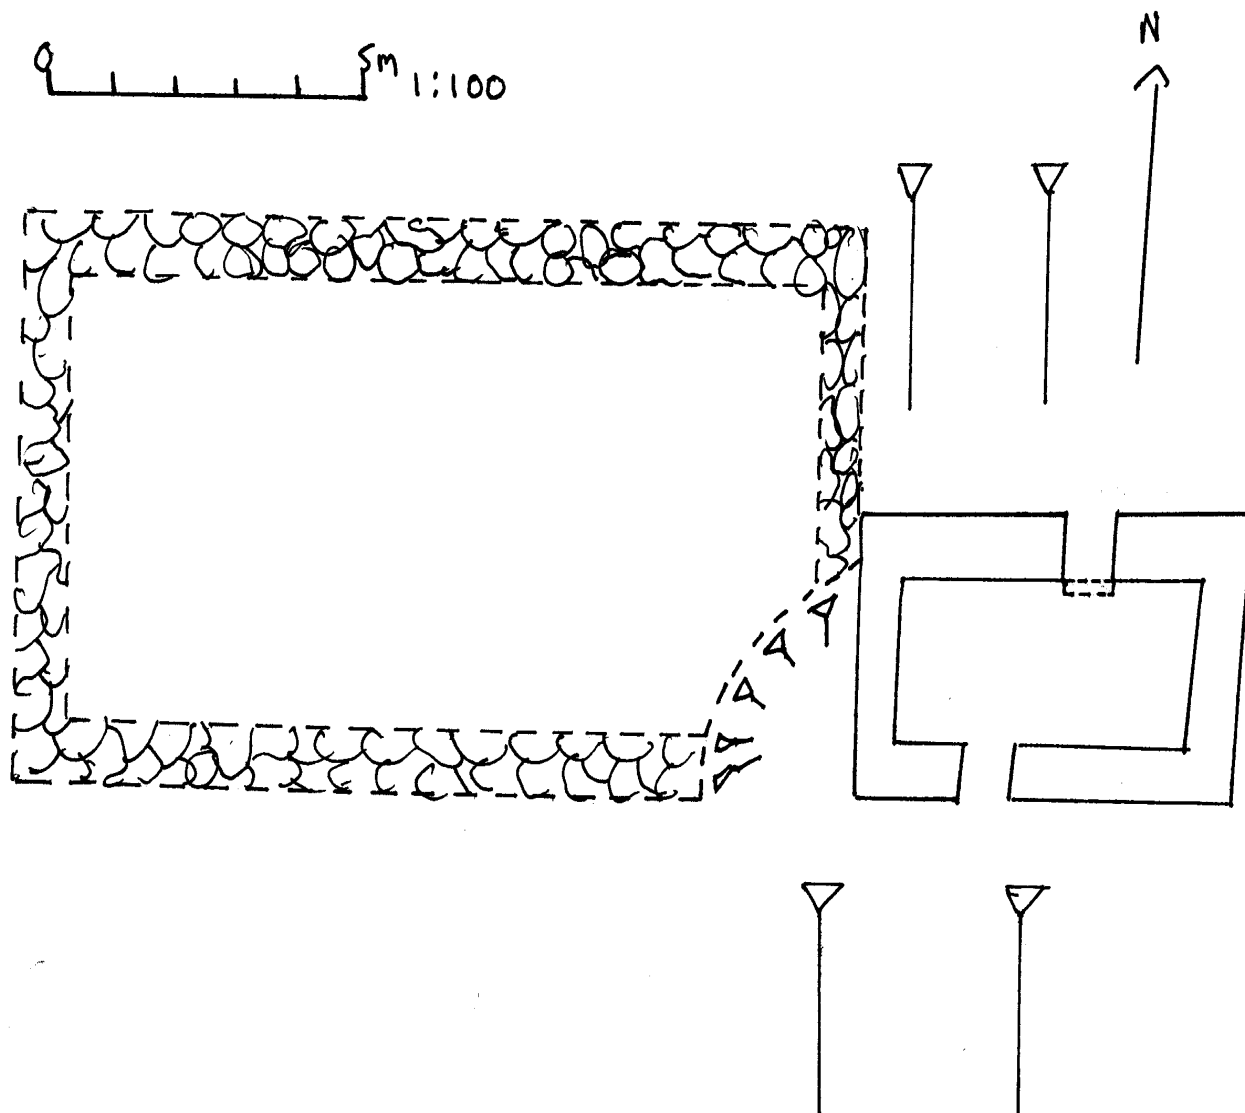
Unroofed ruin shown as unroofed on both 1st and 2nd OS

It has a southerly aspect on a gentle N to S slope.

The walls consist of boulders with a few selected stones and range in height from 0.60 to 1.75 m. There is little tumble and on the rear wall the thickness is still 1m.

No evidence of any windows but 2 doorways on the N. and S walls. The S. doorway has its lintel in place at a height of 1.45m. And the N. doorway has a step just inside the wall.

The ground is lower inside the ruin than on the ground outside indicating possible mucking out of a byre.

To the west of the ruin and attached is a boulder wall enclosure with no definite entrance, but the wall is broken down and has been reconstructed in places It is 0.50m in height. In the SW corner of this enclosure is a semi circular hollow which could be a midden.

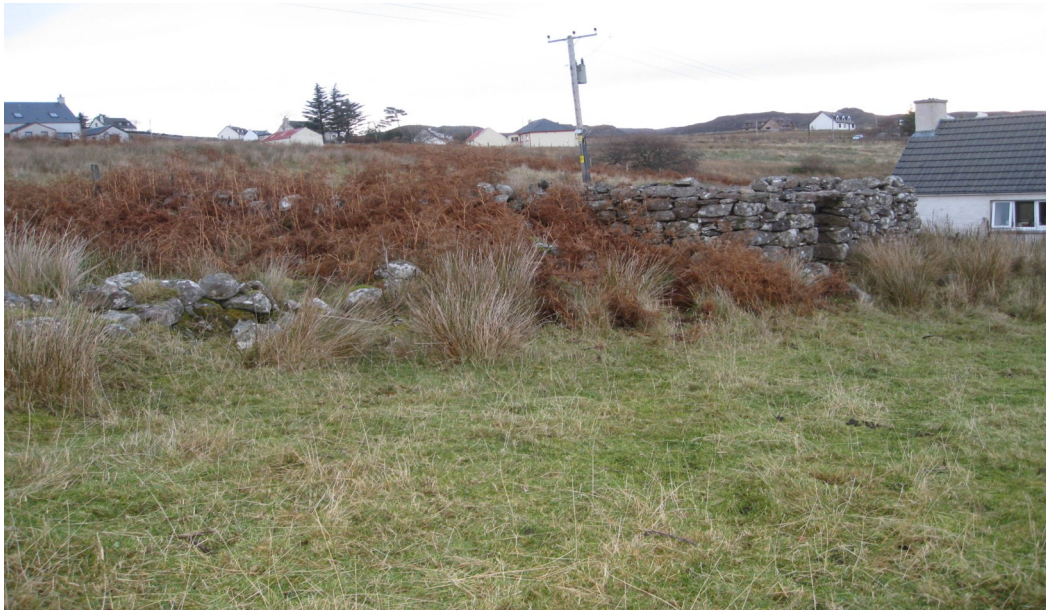
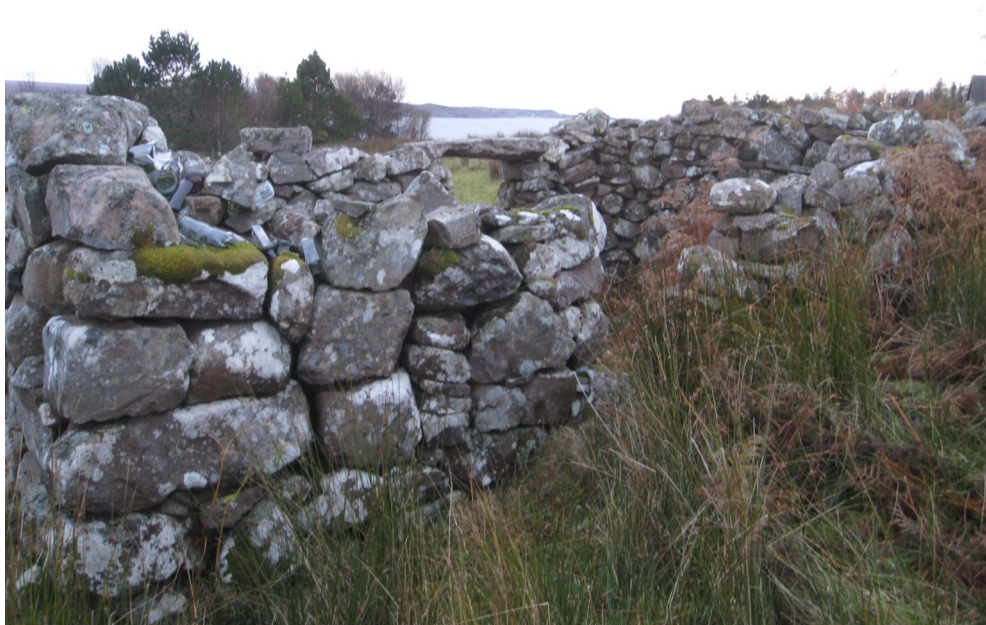
LOWER RUIN CROFT 54 LONEMORE GAIRLOCH. NG 78488 77487 GPS
SHOWING RUIN WITH ATTACHED ENCLOSURE AND TWO DOORWAYS

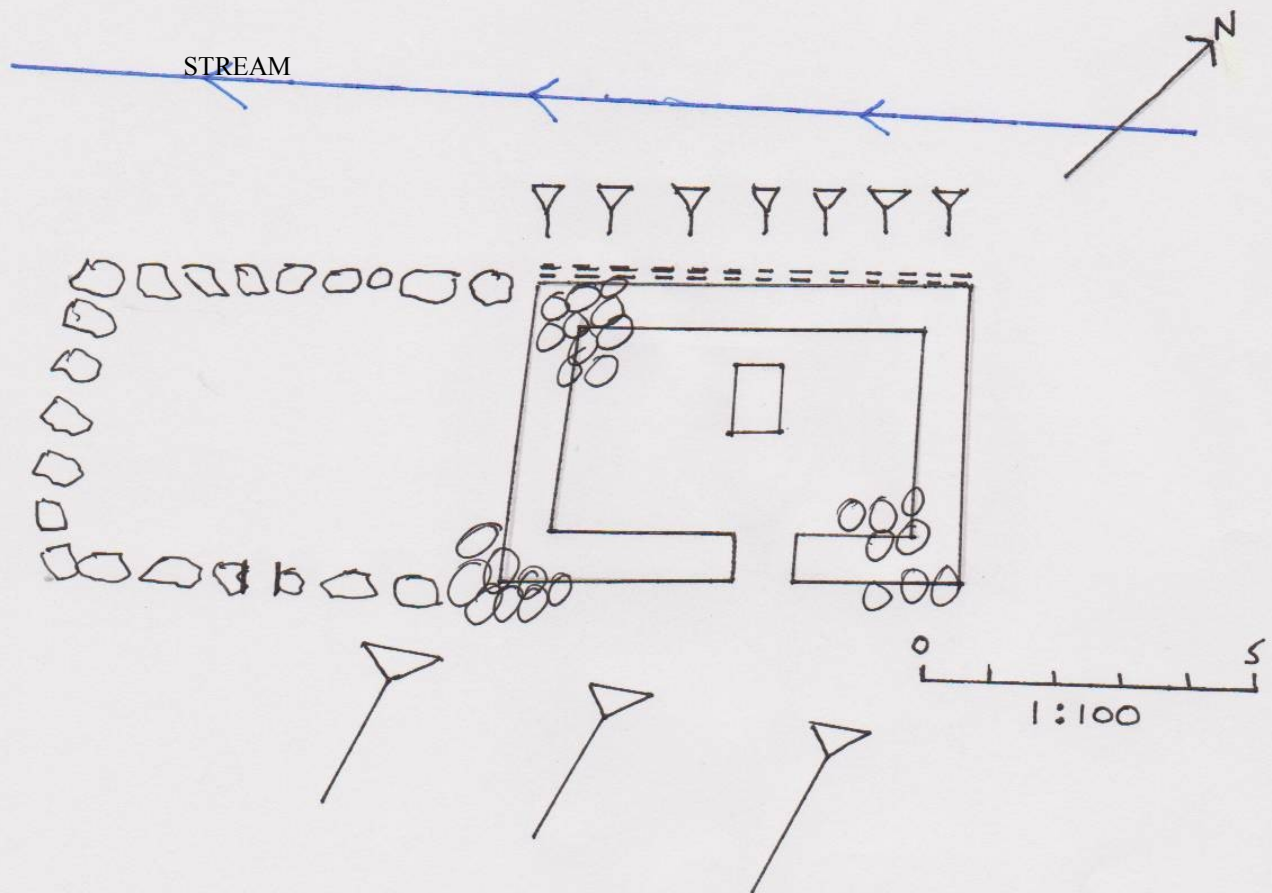
This unroofed ruin shown as roofed on both the 1st and 2nd edition os was known to have been a house before the family moved to croft 46.

The ruin has a southerly aspect which is typical of buildings in lonemore.

The basic outline of the building is shown although there are areas of tumble in 3 corners.the walls are constructed of chosen and dressed stone with some snecking and also infill in the center of the walls.the height varies from 2.59m(w.gable) to 0.50m and the most intact walls are 0.80m thick.

There was no visible evidence of a chimney or any windows but there is a doorway on the southeren wall with a large lintel still in place at a height of 1.55m.lying on the ground inside the ruin is another lintel which would indicate a window had existed.

The ground inside the ruin is at the same level as the ground outside.

Attached to the W edge of the ruin are visible footings of another building with a possible opening on the S side. Behind the N.wall of the ruin is a steep manmade slope leading to a ditch immediately behind the wall. Beyond this there is a stream at a distance of 2m.

The ground to the S. side of the ruin slopes gently to the S it is mainly grass and rushes and is still used for grazing sheep.

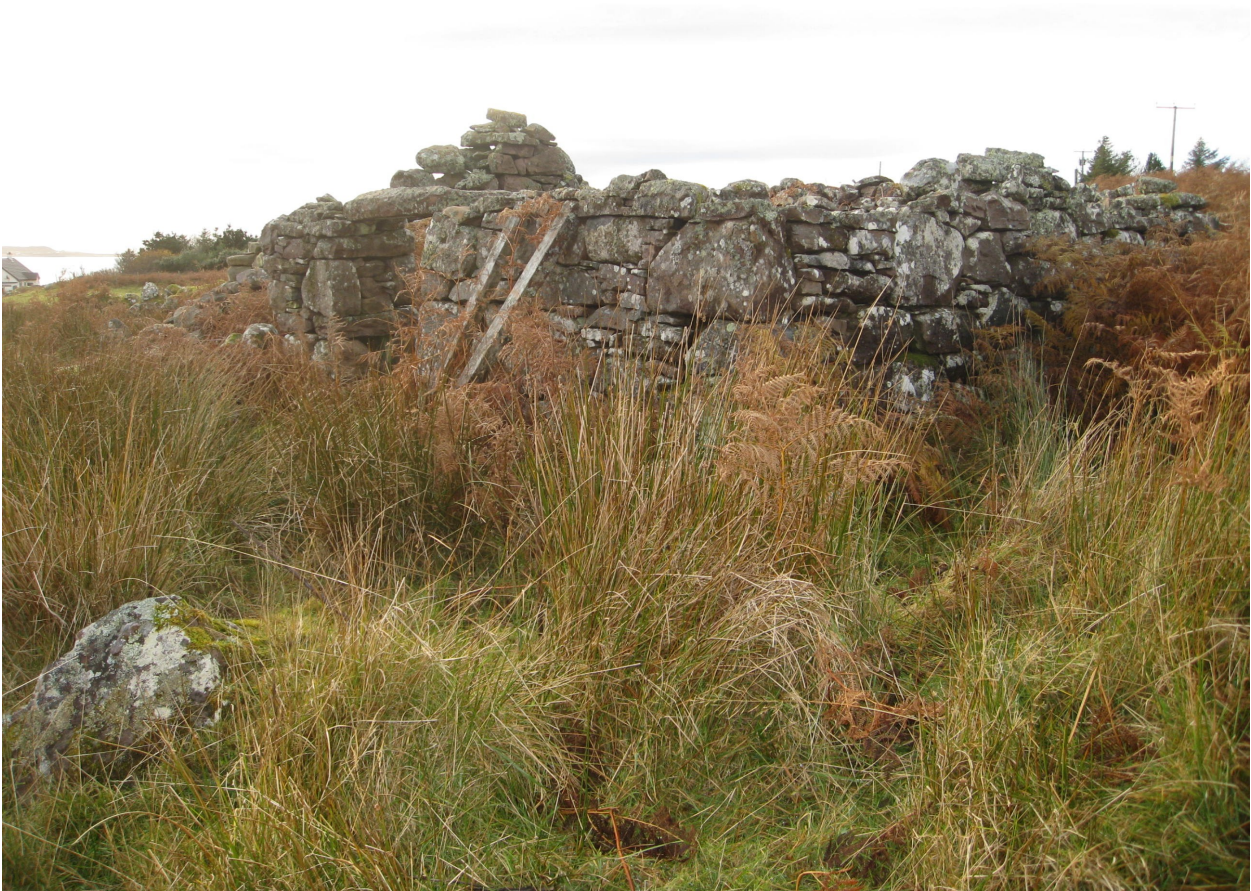
UPPER RUIN CROFT 54 LONEMORE GAIRLOCH. NG 78462 77487 GPS
SHOWING STONEMWORK AND LINTEL ABOVE DOORWAY.
