CROFT 57 LONEMORE CROFTING TOWNSHIP.

CROFT 57 LONEMORE TOWNSHIP.

RUIN ON CROFT 57 LONEMORE CROFTING TOWNSHIP. NG 78309 77587 GPS
ELEVATION 49M
SURVEYED ON 14-09-08 FUNCTION POSSIBLE BYRE/SHED.

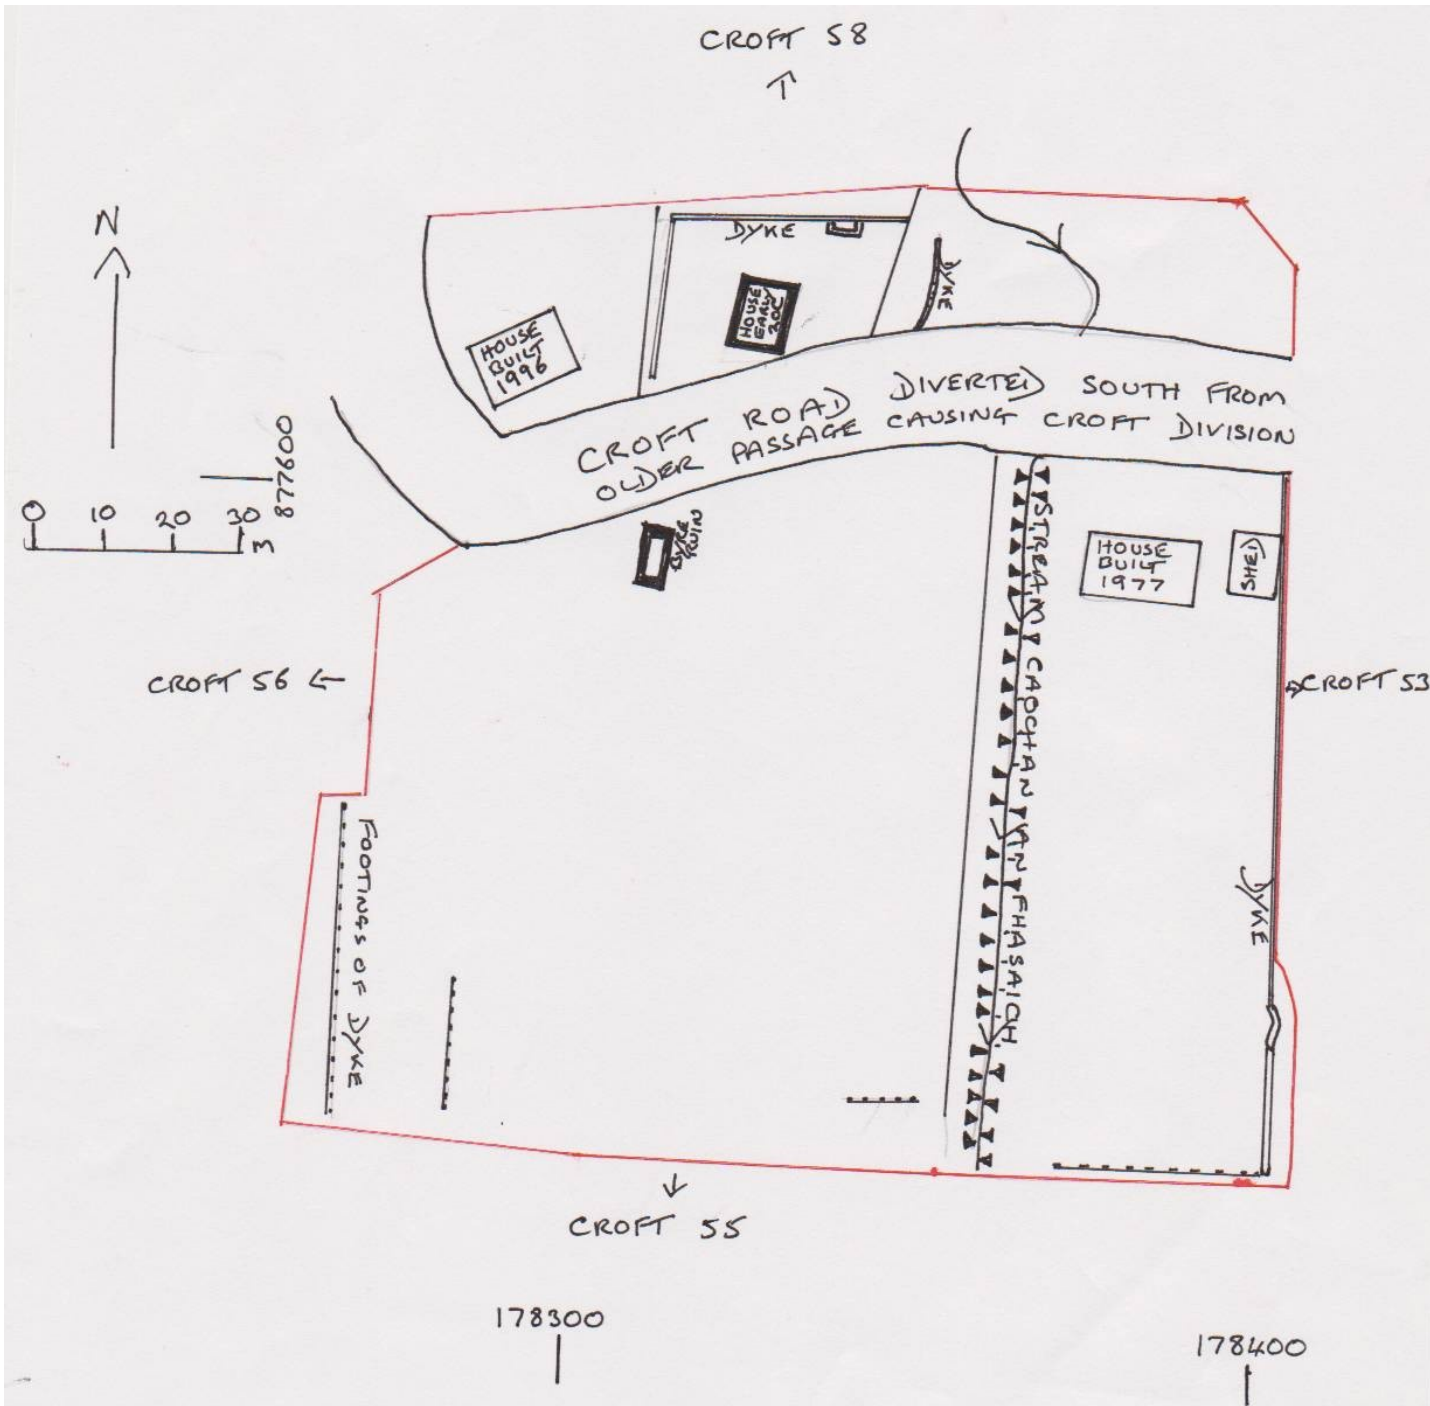
Croft 57 is given an acreage of 4.5 on the estate map. The croft is divided into two sections N and S by the croft road that was relocated S of the original passage to follow a track that had already developed. It is also divided by the stream Caochan an Fhasaich that flows N to S.

N of the road there are several remains of stone dykes (see Plan) and two houses built in the early twentieth century, and 1996.

S of the road there are footings of a few dykes and the stream is heavily banked with stones to prevent further erosion and flooding.

There is the ruin of a byre (see description) which is shown as roofed on the second OS at 78309 77587. No remains were found of the other byre on the W side of the croft and the building on the E side of the burn has disappeared under a house built in 1977.

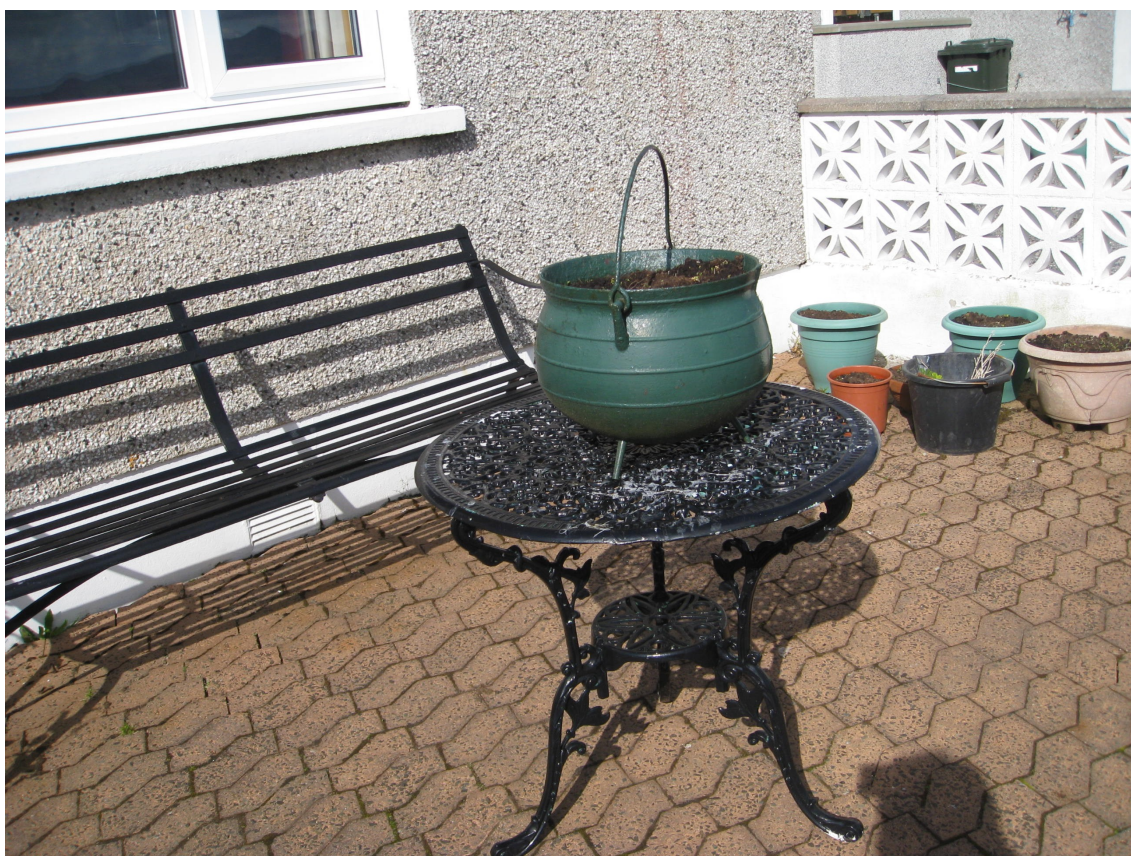
RECYCLED WASHING POT

Locally this area was known to have been used by the women of upper Lonemore to do their laundry, as it was sheltered and they could get their fires to heat the water in the pots, and there was a plentiful source of water. The current crofter remembers finding stone structures built on the stone embankments to light fires in, and has a few pots now used as flower containers (see picture)

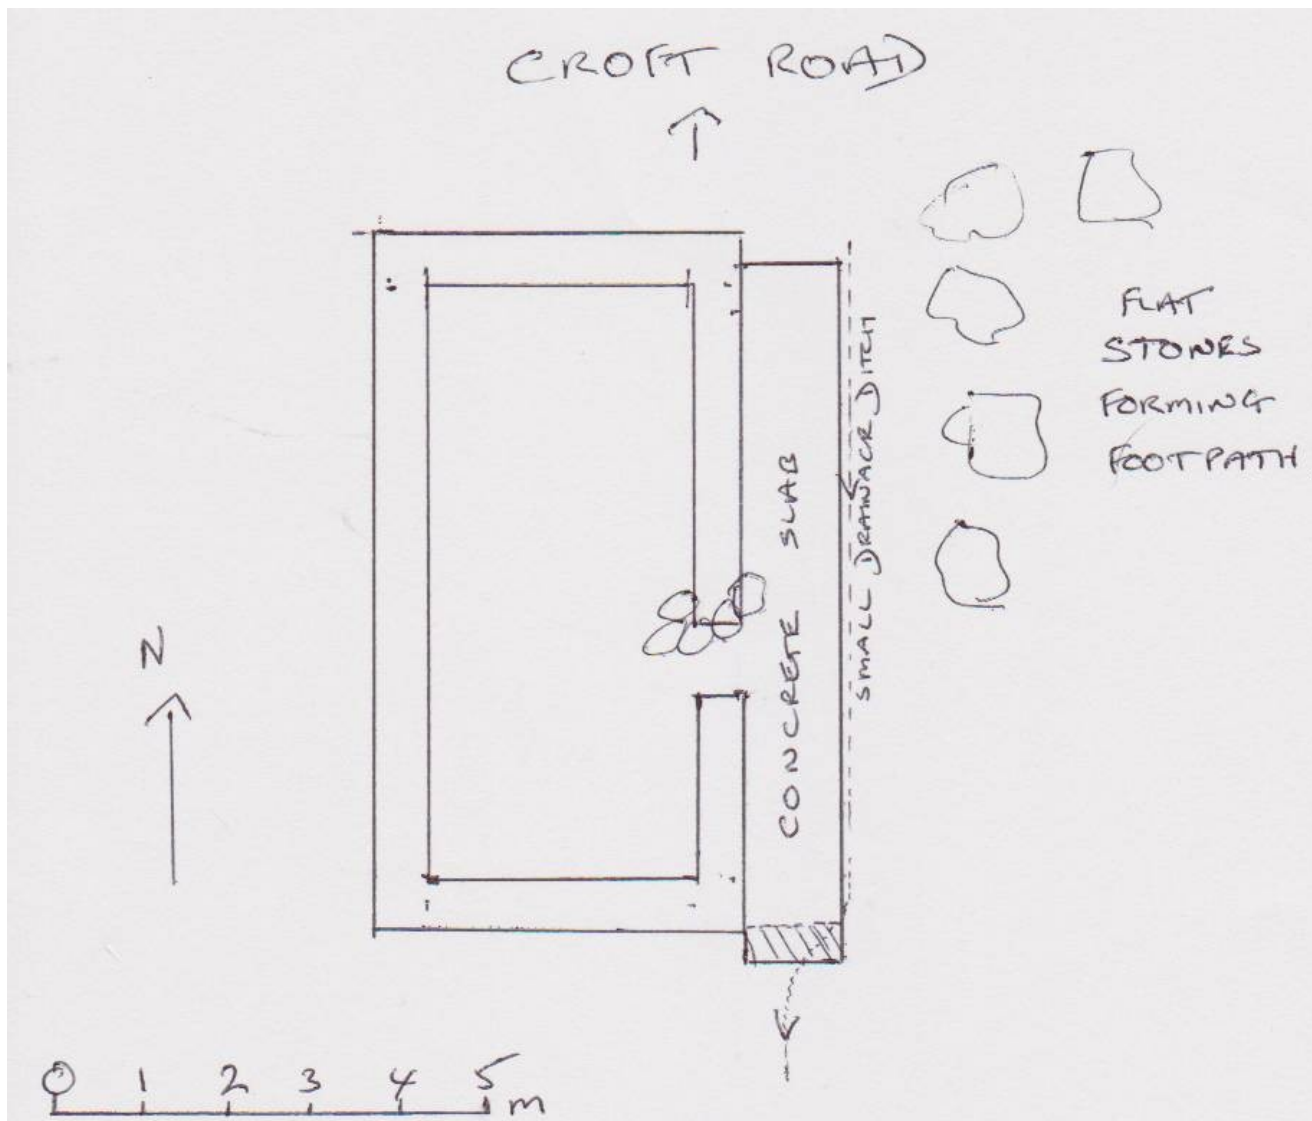
This unroofed ruin lies on a level area of ground adjacent to the croft road to the N. It is constructed of selected stones and boulders, and there seem to be additions of harled concrete blocks added at a later stage. It is marked on the first and second edition OS as roofed. To the front of the ruin there is an area of concrete and in front of that a small drainage ditch and some stepping stones. The ditch has a covering of flat stones at its S end. Today the ruin has a partial roof covering of corrugated iron which is held down by the use of large stones on top of the walls. The walls are up to 1.8m in height and have an average width of 0.6m. It is unused but the partial covering suggests some form of shelter for the sheep that sometimes graze on the W side of the croft.
