Plan of Croft 1 known as 'Lota Rodaidh Chaochail',
Port Henderson.
Centred on NGR NG 7457 7374

Croft 1, Port Henderson.

RUIN ON CROFT 1 PORT HENDERSON.74616 73753 GPS.ELEVATION 17m. SURVEYED ON 18-02-10. FUNCTION HOUSE WITH ADJOINING ENCLOSURE,KNOWN AS RODDY CEARCUILL'S HOUSE.

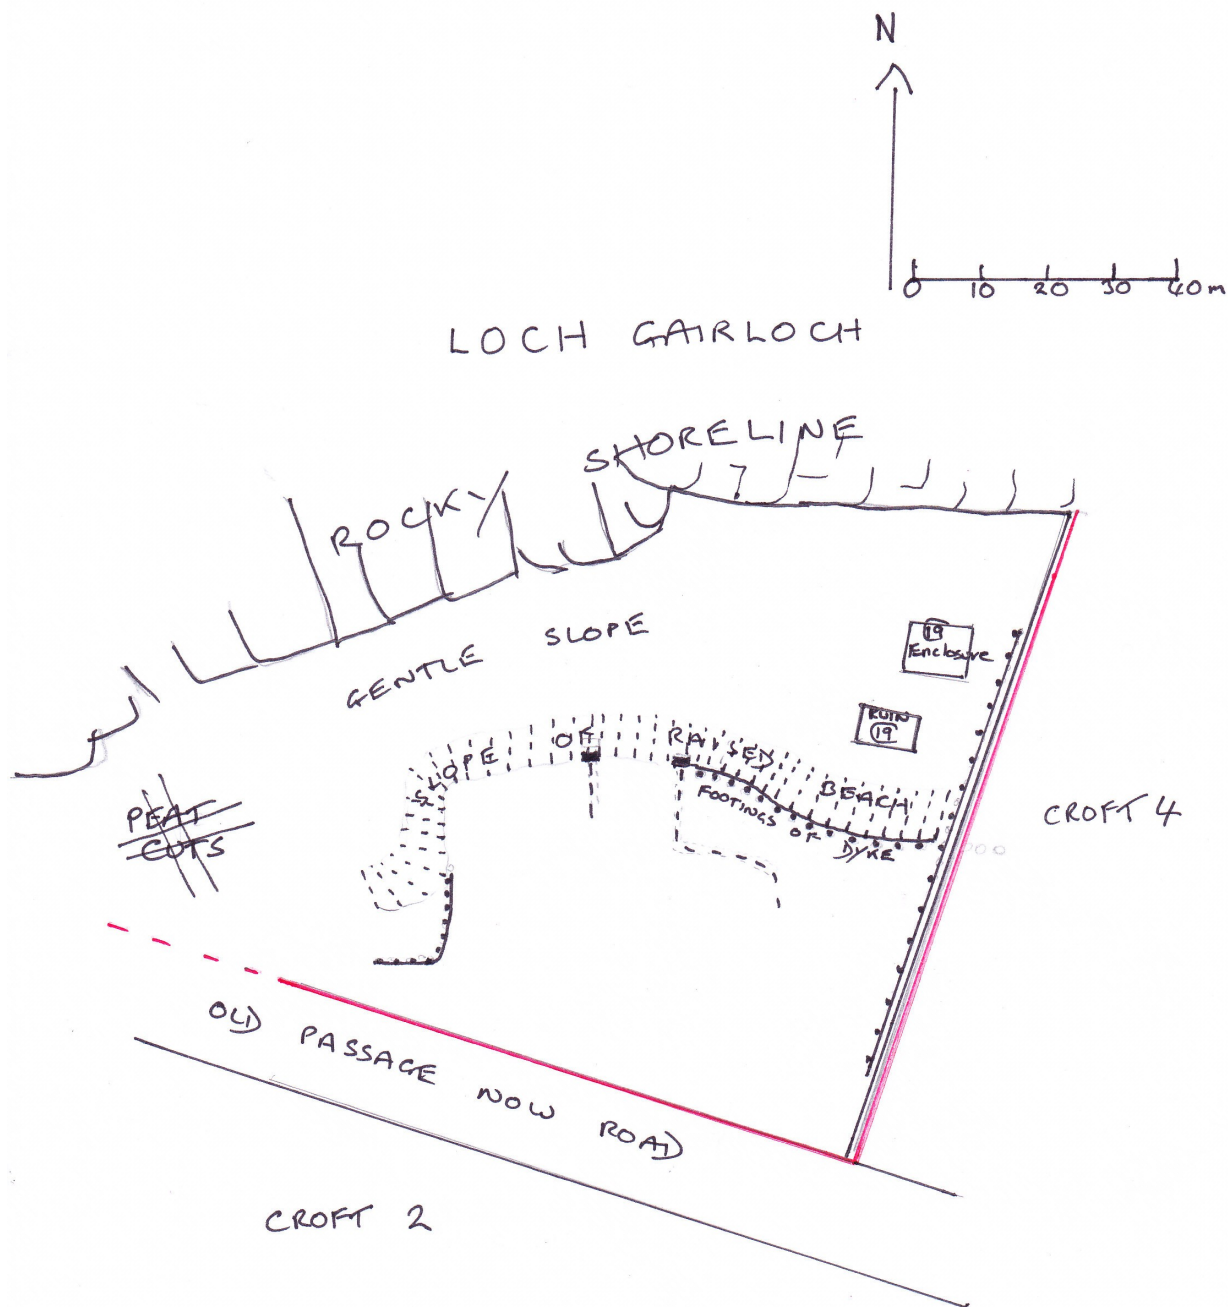
①

The ground on this croft situated at the W edge of the township slopes from S to N with the steep angle of a raised beach running from W to E across the centre. The estate map of 1845 gives an acreage of 1.5, but much of the land is of very poor quality.

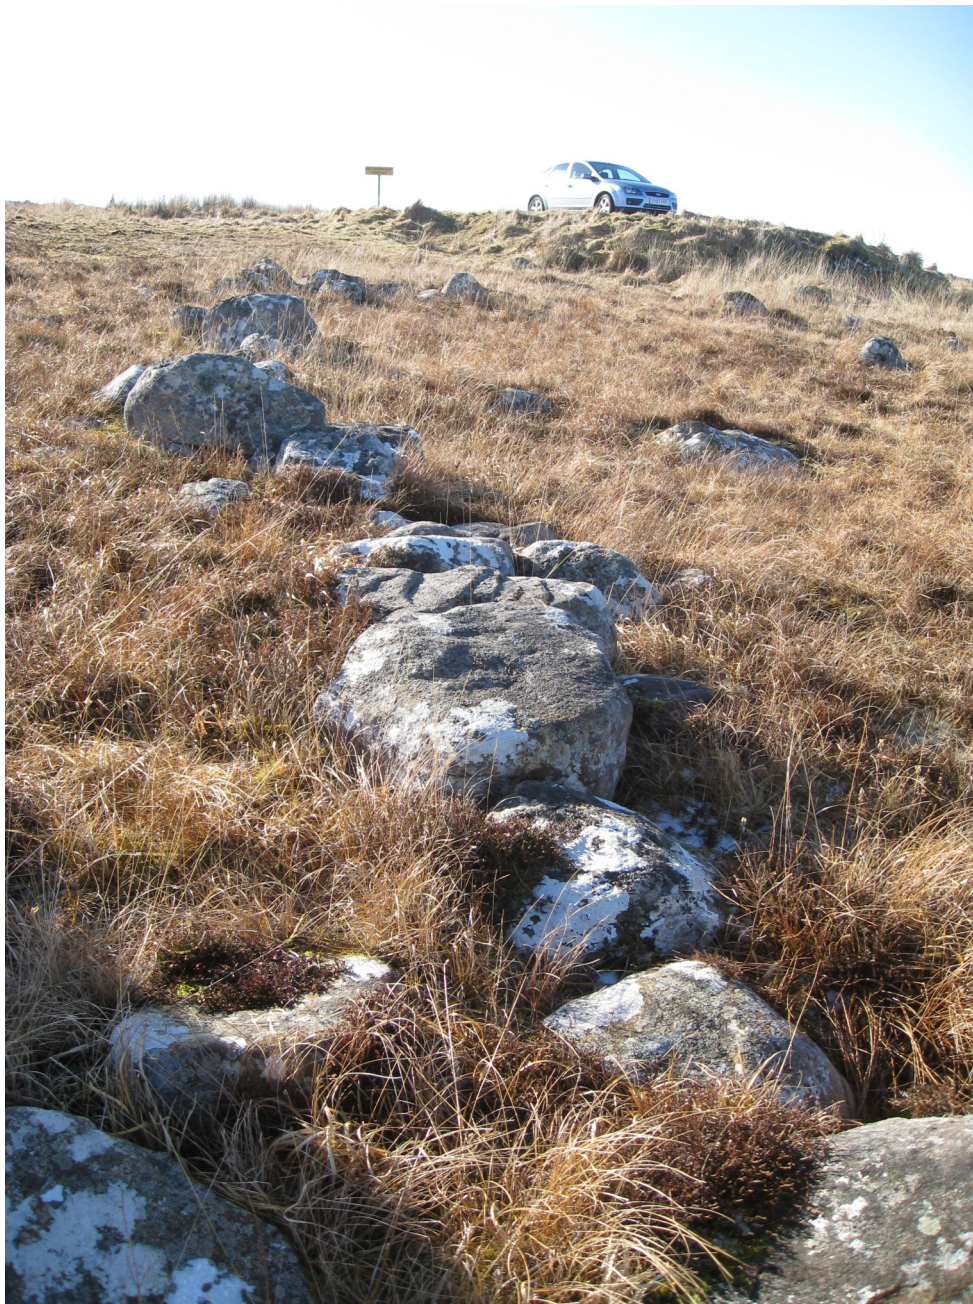
An attempt has been made in the past to cultivate some ground and there are several ruinous stone dykes as seen in picture, and a ruined house and enclosure at the base of the raised beach(see separate site description).

Ruinous stone dyke running down the slope on croft 1

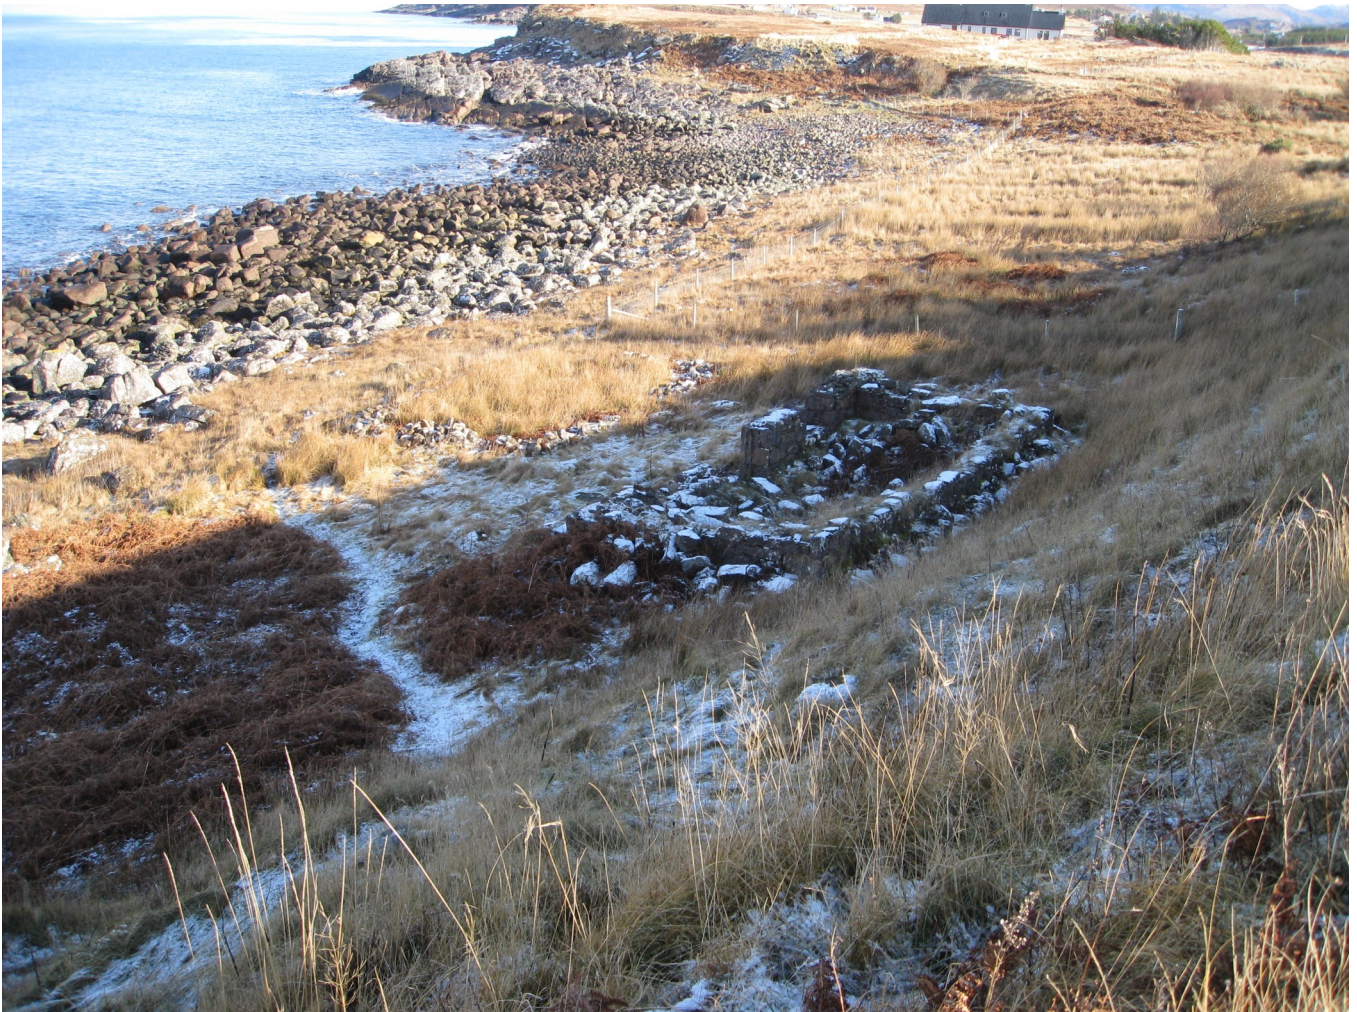
RUIN ON CROFT 1 SHOWING POSITION BY THE SEA, AT THE BASE OF THE SLOPE OF RAISED BEACH, WITH ADJOINING ENCLOSURE.

Today the ruin shows a well constructed house using chosen and dressed stone of local sandstone, arranged in layers with snecking as necessary. The floor is level with the exterior ground except on the N side where a step leads down to the ground sloping to the lochside.

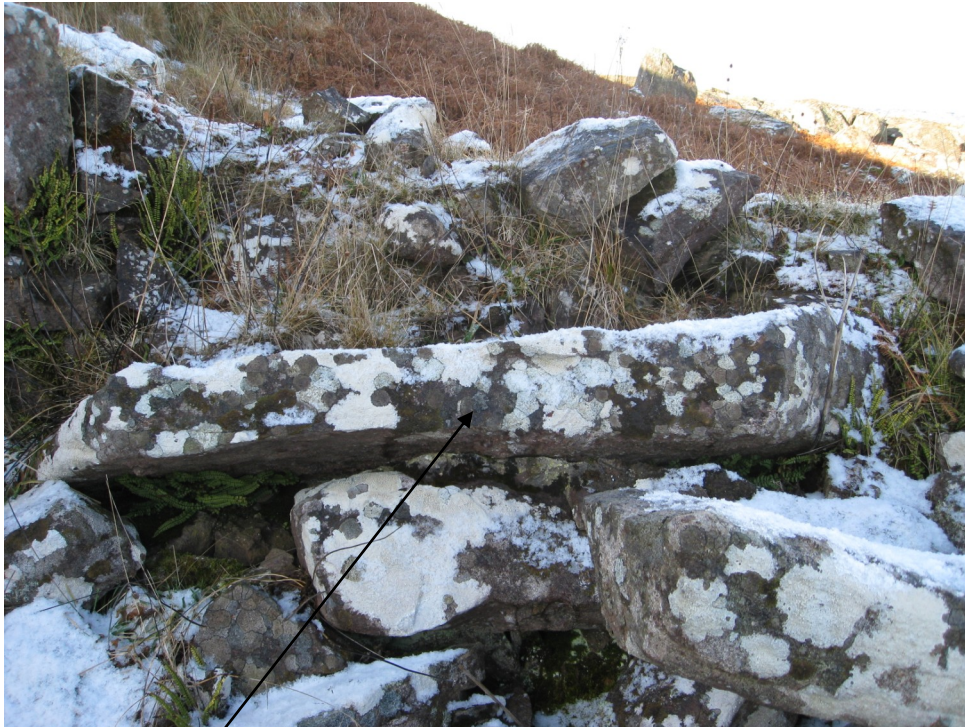
The walls are tumbled but remain at a height of 1.20m to 1.75m on the exterior and 0.60 m to 1.60m on the interior. A fireplace could be measured on the E gable wall but all that remains amongst the tumble on the W wall is a large lintel stone.

LINTEL STONE ON W SIDE

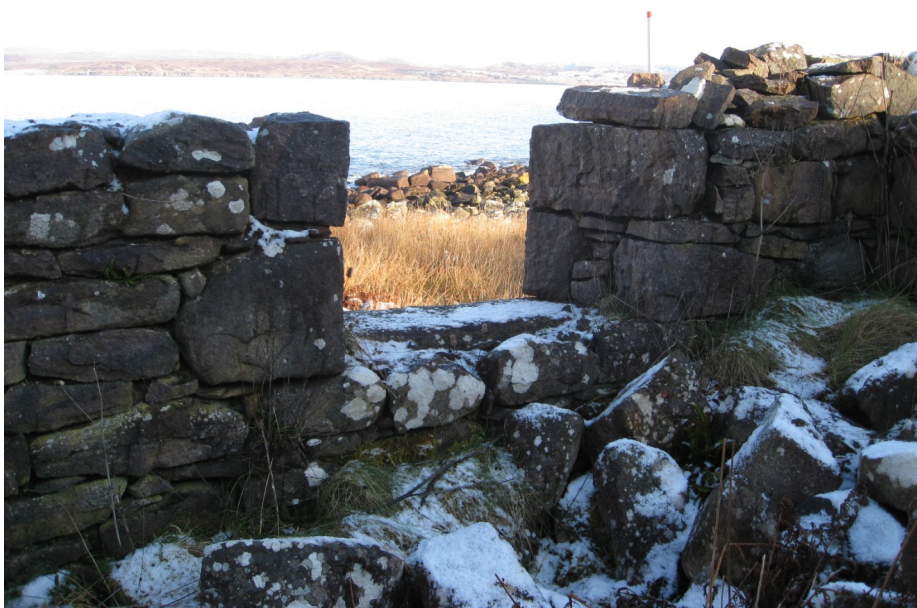
The walls have an average thickness of 0.60m all round the ruin. On the N side of the ruin there are two windows and a doorway. The windows show the typical local style of smaller outer size on the exterior wall face widening to the interior, therefore allowing light in while providing maximum shelter from the weather.

WINDOW ON N FACING SIDE OF HOUSE.

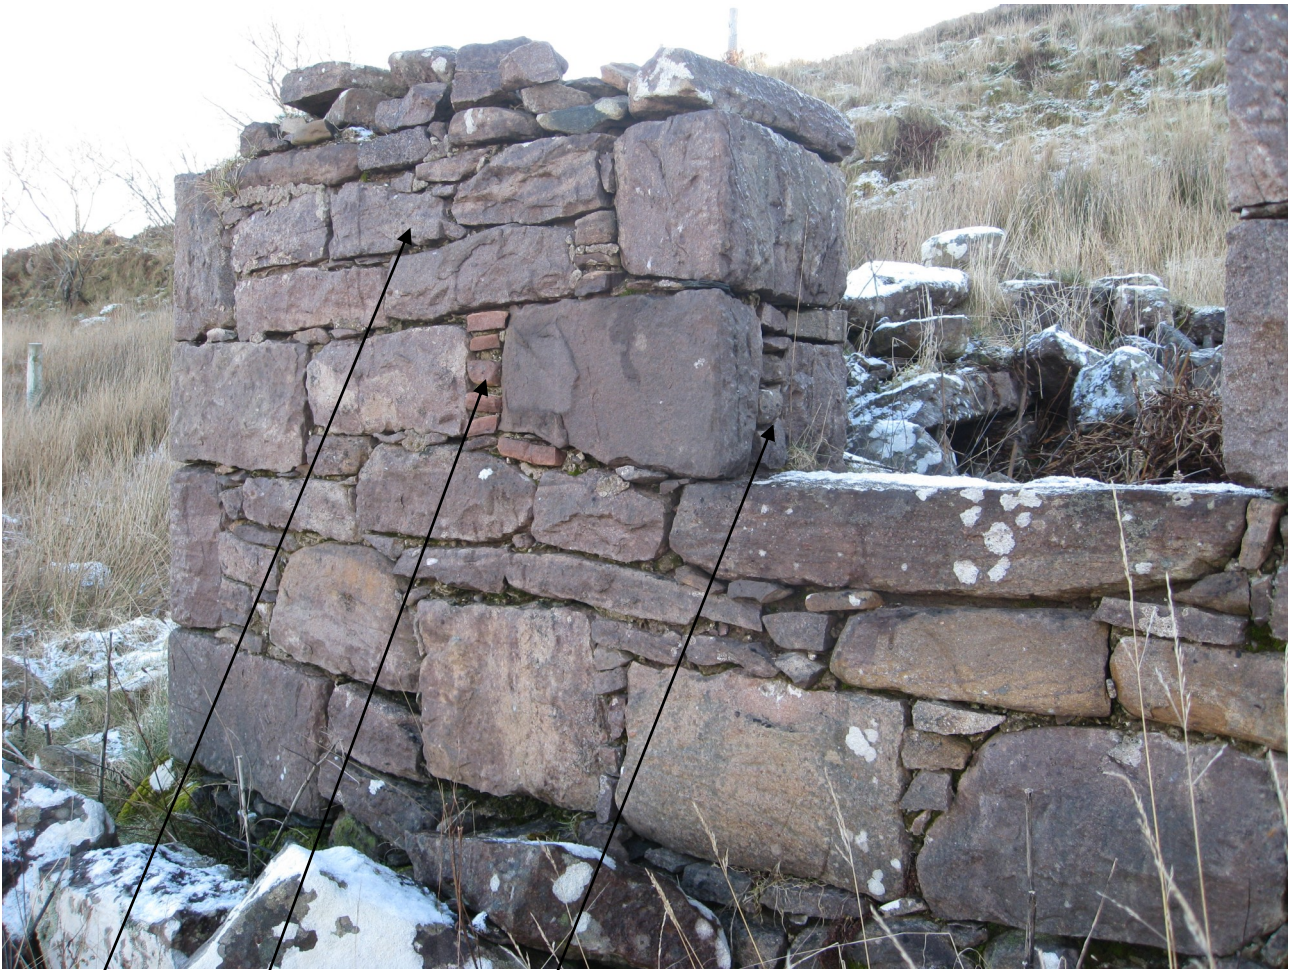
LAYERING SNECKING SLOPING SIDES OF WINDOWS

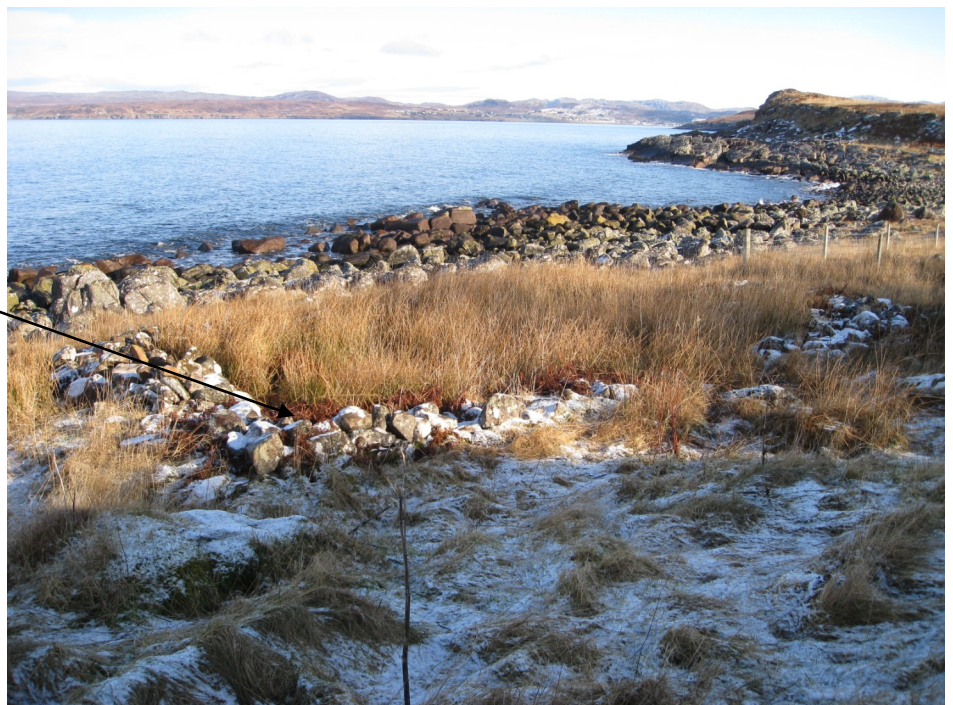
ENCLOSURE

The enclosure that is adjacent to the ruin has remaining walls standing from 0.10m to 0.40m with an average width of 0.4m. The walls are constructed with small rounded beach boulders.
