Inveravon Pictish Stones – Final Conservation Report

Inveravon Pictish Stones – Final Conservation Report:

Removal of Stones from South Wall of Inveravon Church, June 2011:

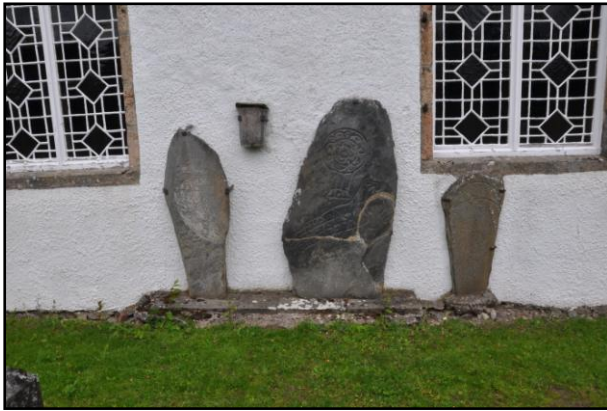
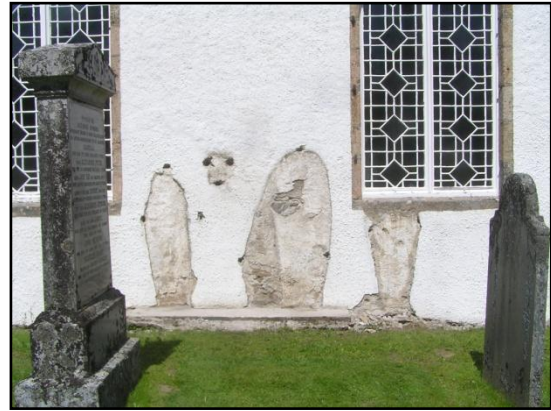
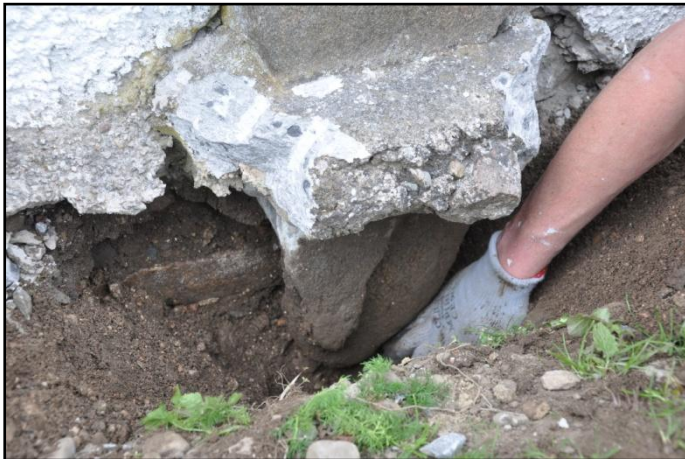
Initial photographic records were taken and the cement joints between the stones and the harled church wall carefully cut away with chisels. The concrete pads below the stones were investigated and cut away in the same manner. Two of the three larger stones were found to have been cut flat at the bottom for ease of display, having had their lower pointed base areas removed at a previous time, with only one stone, Inveravon Stone No.04, remaining intact; its pointed base being sunk into and hidden by the concrete base pad.

The stones were supported whilst their fixings were bent clear to allow safe removal of the stones; the fixings then being removed from the church wall by use of drills. The stones were individually crated for transport to our Edinburgh workshops.

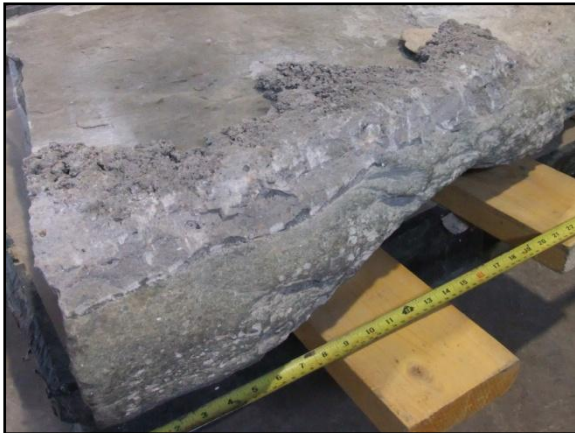
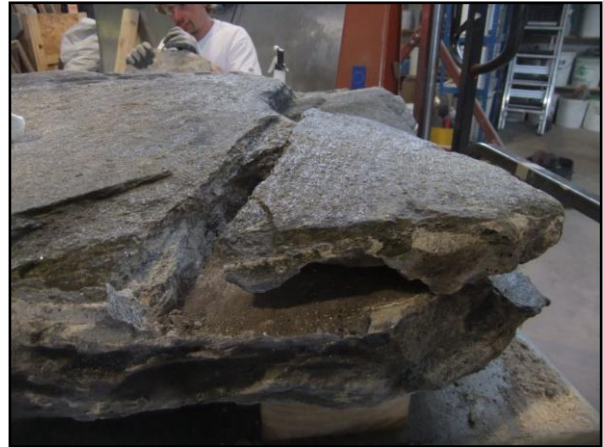
Workshop Conservation Treatment:

The remnants of concrete and cement were carefully removed from the stones with tungsten chisels and scalpels, with loose dirt and debris removed with non-metallic stencil brushes.

Stone No.03 had remnants of its previous repairs removed and the individual components of the stone along with the break joins cleaned.

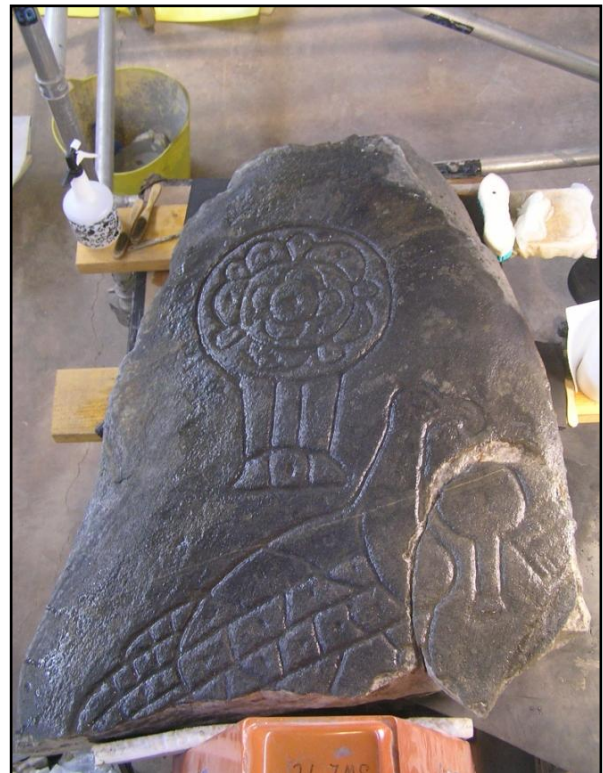
Further cleaning on all four stones was completed with wooden tools and stencil brushes followed by steam cleaning with a dental grade steam cleaner. The steam cleaning was found to bring out more definition in the carvings.

There was one previous fixing found in the top of Stone No.03; this being ferrous was removed with careful use of a core drill and the hole re-used during our siting of the stones.

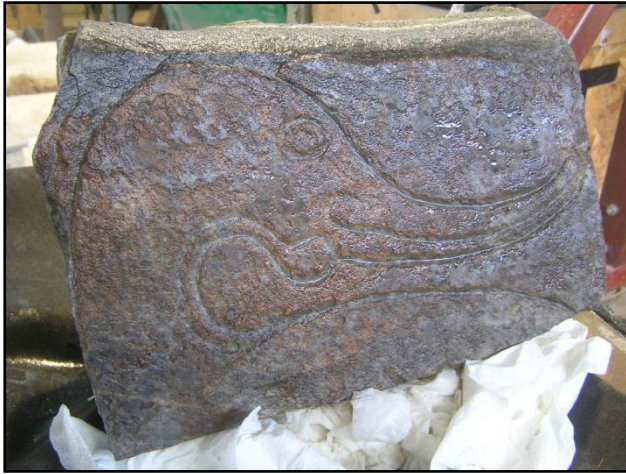
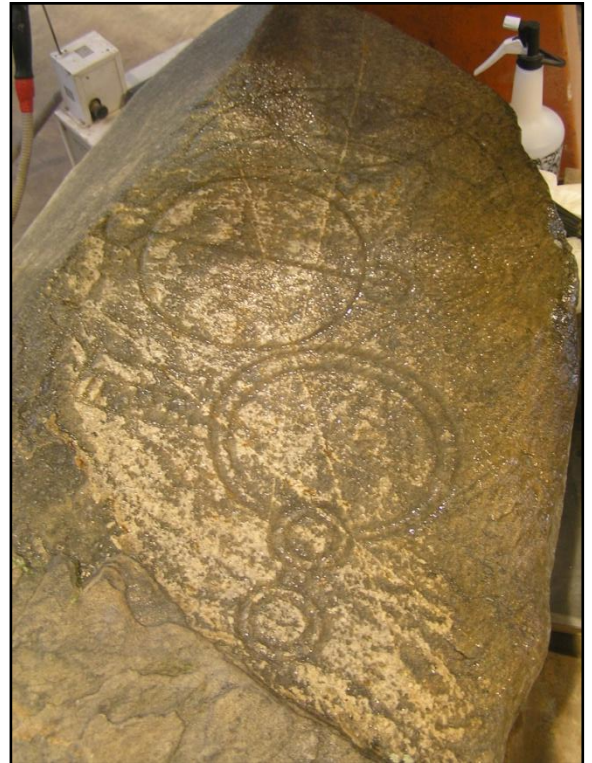
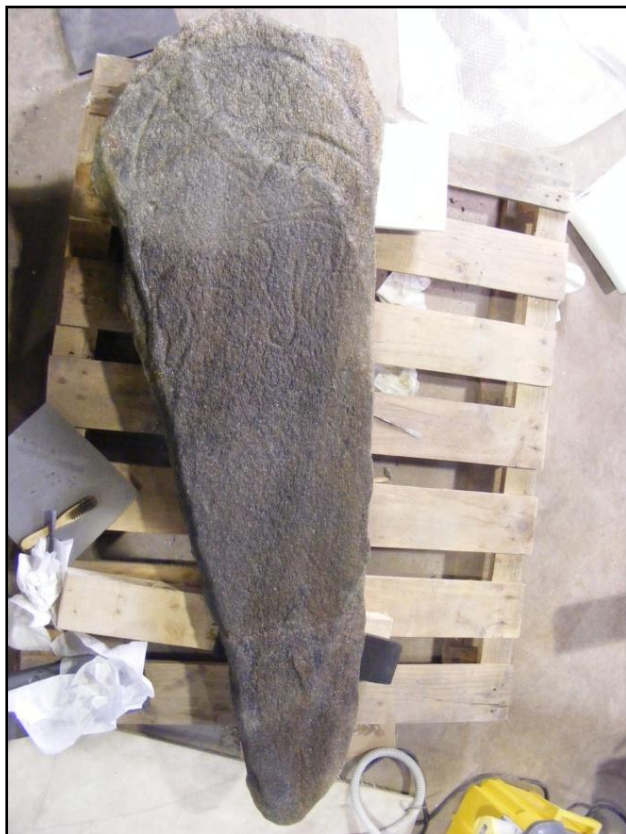
Workshop Conservation Treatment:

As the cleaning works progress,
the carvings become more
visible.

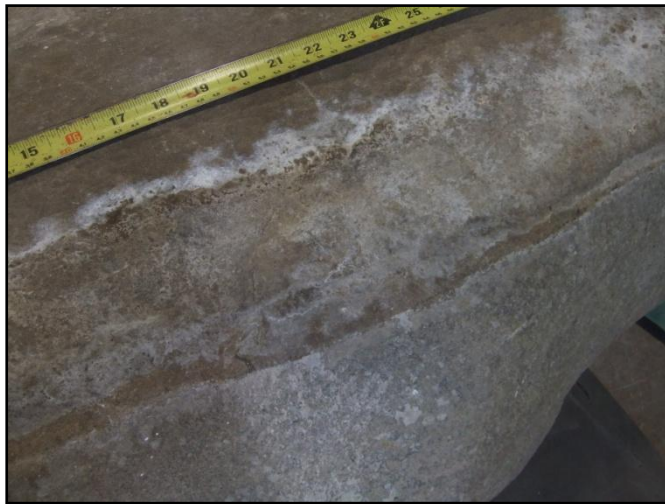
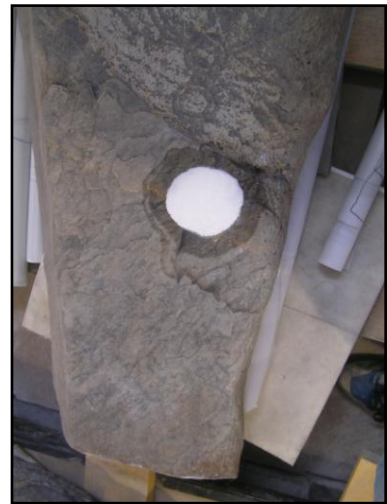
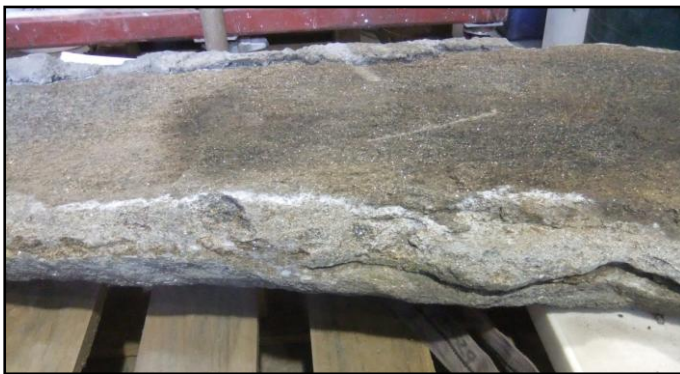
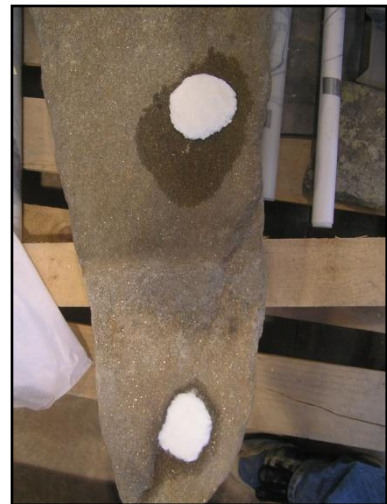
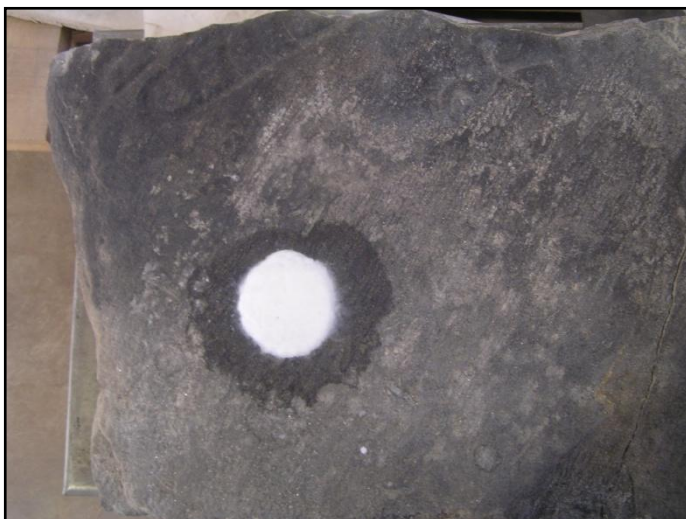
Workshop Conservation Treatment:

Following the removal of cement, environmental growth and general dirt and debris, all stone were cleaned with a dental grade steam cleaner. Salt tests were then completed to all stones. Although there was visible salt staining/ remnants of cement slurry in localised areas around the edges of where the cement had previously been, this was removed by the steam cleaning and our subsequent salt tests in various differing areas of all the stones showed very little to no salts present in our poultices, indicating that there were no salt issues remaining.

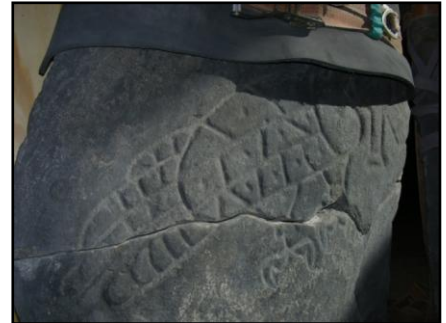
Fine fills to the fissures:

Once the stone surfaces were cleaned, the fine fissures were more visible, and they were carefully filled with Paraloid B72 in Acetone, and different coloured schist kindly sourced by Jonathan Swale from SNH that we ground down by hand.

The fills were completed to deter any future insect infestation, accumulation of dust and to protect the vulnerable edges of the laminations.

These fills were completed in particular to the backs and sides. The front fills to the large Pictish stone No 3 were the main fills carried out to the front of the stones

During conservation

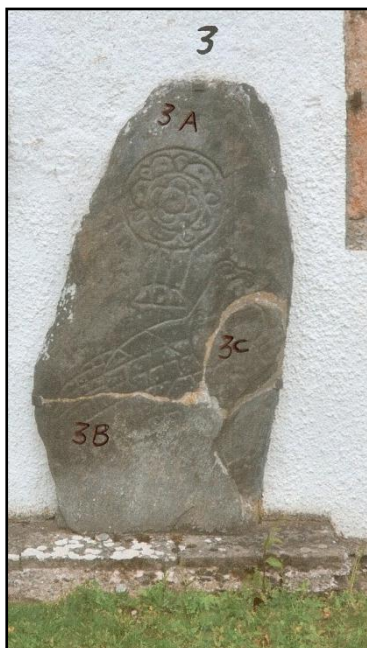
Pictish Stone no 3:

Before

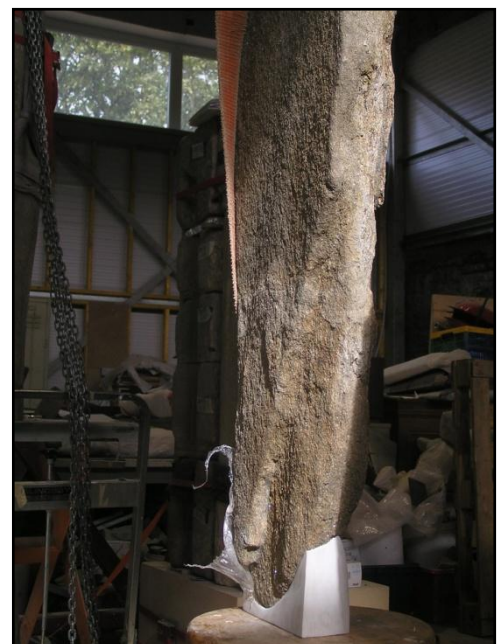
In workshop

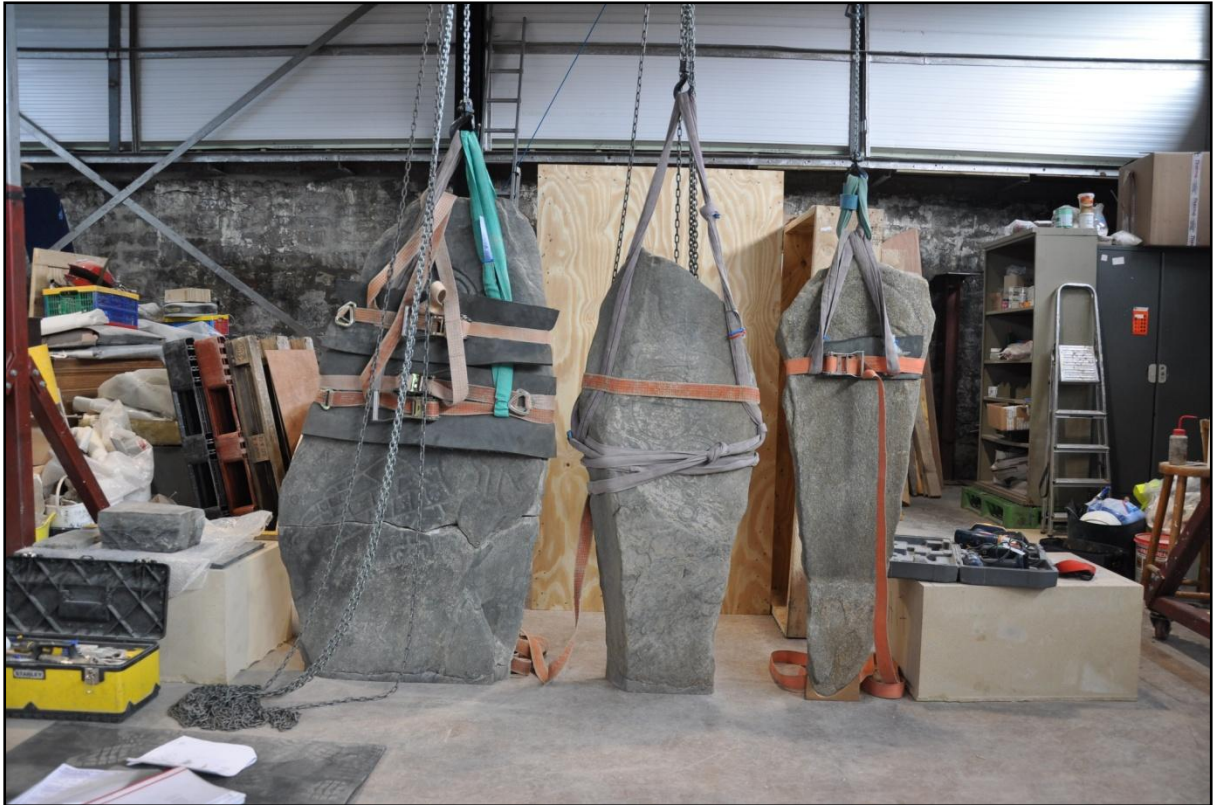
Resin Base Pads and Bronze Fixings:

Before returning the stones to site, resin base pads were made to safely support the stones along with bespoke bronze fixings. A dry run of the resin pads and bespoke bronze fixings designed with Niall Braidwood, was completed in our workshops.

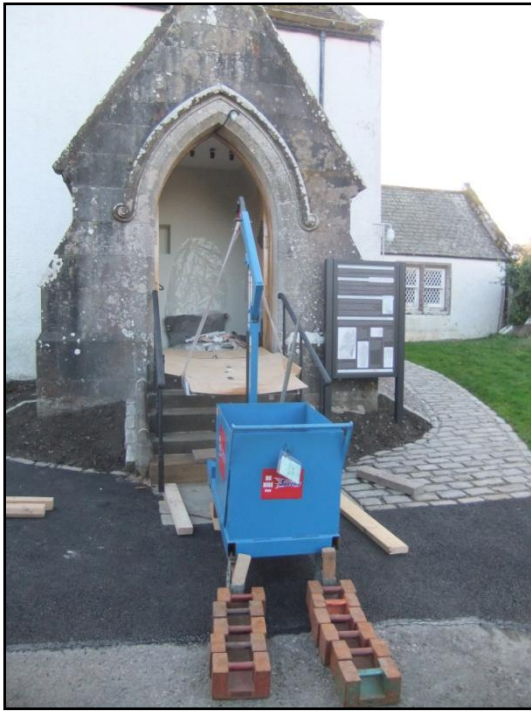
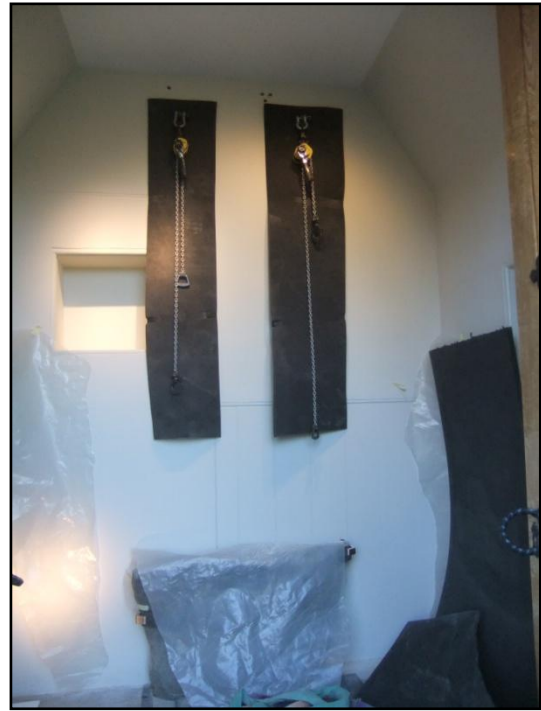
Re-Siting of the Stones in North Porch of Inveravon Church, November 2011:

The physical challenges of re-siting the heavy stones within the confined space of the North Porch were overcome by use of a counter balanced crane combined with eye bolts and chain blocks. Final positioning was agreed on site with the clients and the stones secured into the wall of the church with their phosphor bronze bracket fixings.

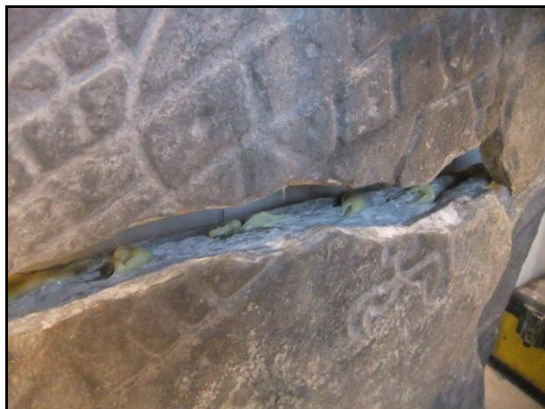
The component parts of Stone No.03 were secured together with polyester resin and fills completed using Paroloid B72 in acetone solution mixed with crushed schist stone, as described above.
