*Commissioned by Kerr Blyth Associates Ltd*

**Orroco Pier Hotel W Extension,  
South Queensferry  
Standing Building Recording**

**Survey Report: No. 1379**

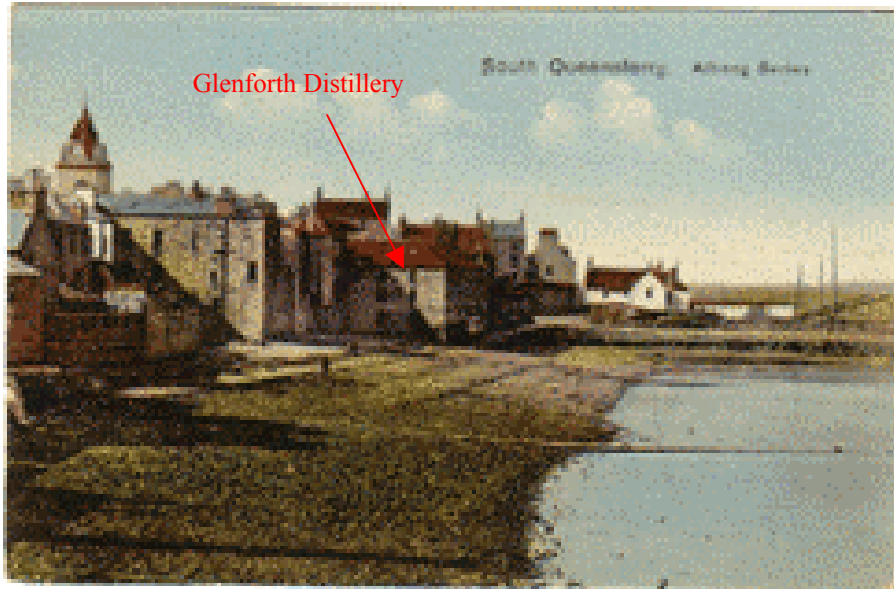
Plate 1 Historical postcard showing the position of the Glenforth Distillery.

- 3.3.1 Historical postcards (Plates 1 and 2) show the position of the distillery adjacent to the South Queensferry harbour. These are of architectural interest as the both show the distillery as a three-storey building with a continual sea wall at the base. This feature is partly still upstanding (Plate No.27)
- 3.3.2 An on-line database of Scottish distilleries records 1843 as the year of construction for the Glenforth Distillery, which contradicts the NMRS entry.
- 3.3.3 The New Statistical Account for 1834-45 mentions the following:

- 5.1 Plates 3 and 4 depict the east and north-facing elevations of the distillery building. The window remains (4 on Fig 3) on the west-facing elevation conform to the fenestration visible on Plate 1, which shows six square-headed windows present.

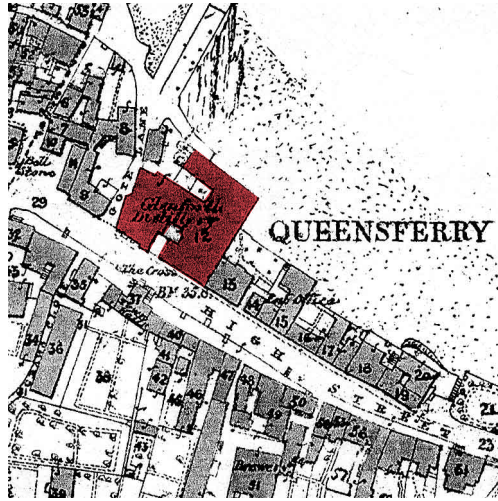
2a - 1st Edition Ordnance Survey map

- 3.2.1 Early map coverage predating the First Edition Ordnance Survey map of 1854 (Fig 2a) is at too small a scale to confirm the presence of any buildings predating the construction of the distillery. The First Edition map shows the position of the Glenforth Distillery with an irregular ground plan. The Second Edition Ordnance Survey map of 1890 (Fig 2b) shows a more regular layout and shows that the earlier gaps had been infilled. On this map, the distillery is depicted as ‘Malthouse’, implying that the distiller had gone out of use but was by this time malting grain for brewing. By the publication of the 1917 Third Edition map (Fig 2c) the buildings is depicted as ‘Malthouse (*disused*)’. On all three maps a small slipway is depicted on the north side of the building; this still survives today. Ordnance Survey maps published between 1947 to 2002 all show a gap where the distillery once stood.

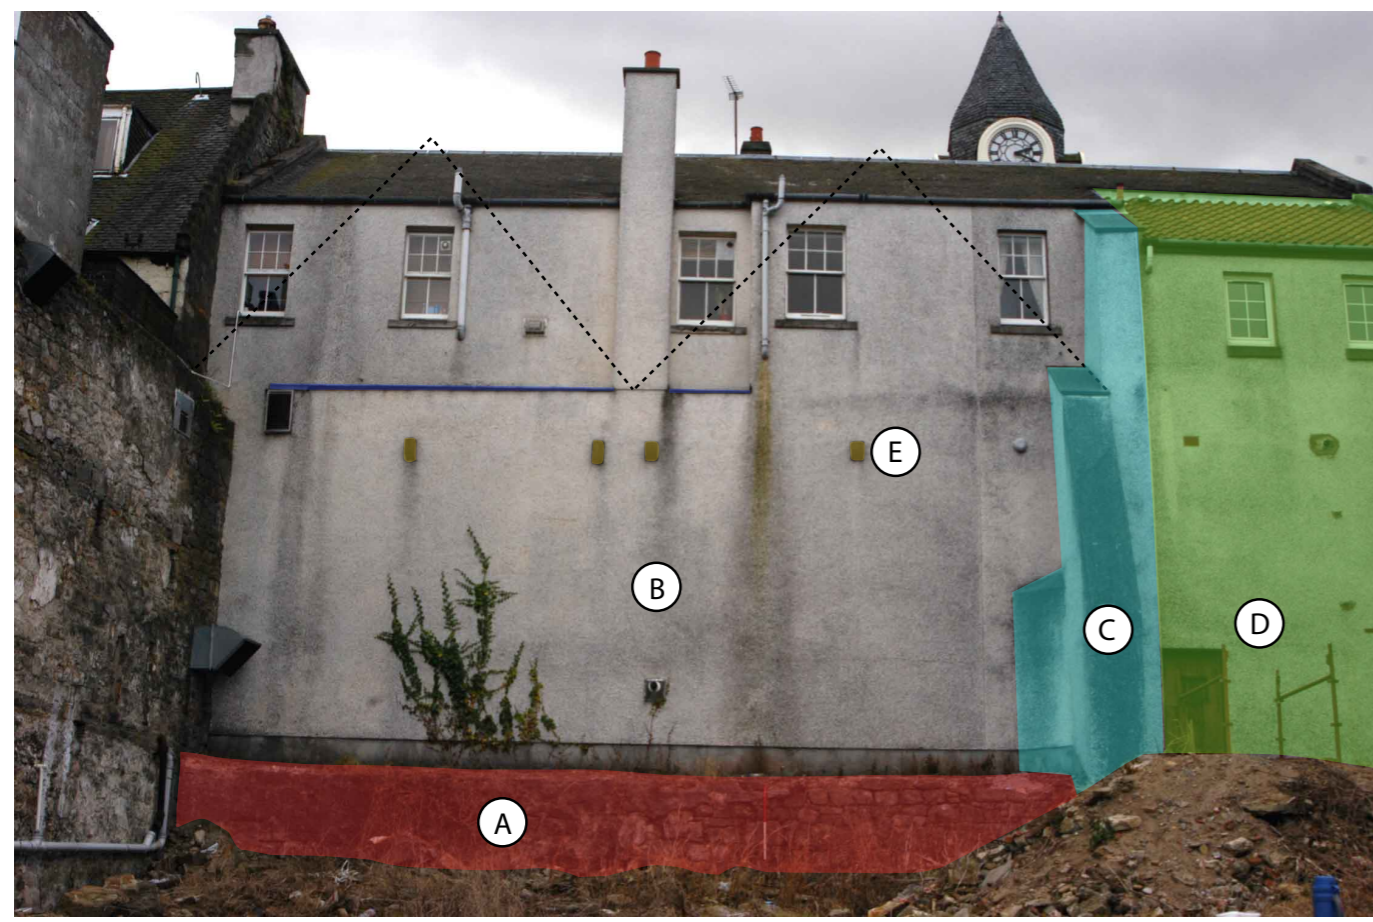
Fig 4a

4.3.1 At the base of the north-facing elevation is a retaining wall; this runs the length of the elevation and stands to a height of 1.7m (A). The north-facing elevation incorporates the rear wall (B) of a row of buildings fronting the High Street. The elevation is covered in wet-dash render, masking any significant structural details. A buttress (C) is present and this is possibly a partition wall contemporary with the distillery. Its stepped configuration strongly suggests that it has been created from a substantial partition wall. The west end of the elevation is of modern 20th-century construction (D). Also of interest is the position of corbels (E) which are on the same level as the west-facing elevation wall head. This suggests they may have supported tie-beams for the roof or the loft floor.

4.3.2 The north-facing elevation also includes the terminal end of the sea-wall (F) situated on the west side of the proposed development area. The existing portion of the sea-wall is 20.75m long and stands to a height of 4.4m.

- 5.2 The passage between the Harbour Hotel and the High Street shop front was in use during the lifetime of the distillery but was blocked in more recent times by the creation of a new extension to the row (Feature D on Fig 4a).

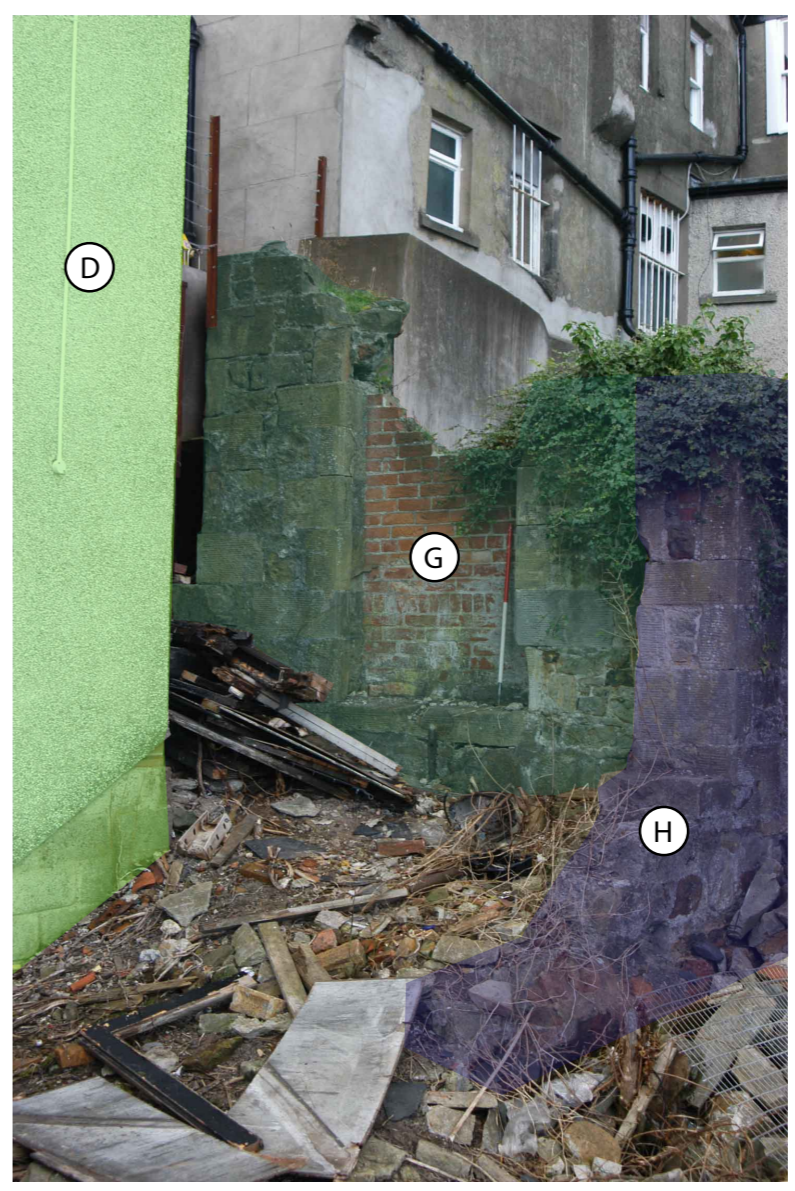
Fig 4c

4.4.1 The east facing elevation is variable in height with the highest remains surviving at the south-west corner of the site. Here the remains of a blocked doorway (G) are present along with a section of return wall (H). The door has been blocked with common brick and measures 2.5m high and c. 1.2m wide. The blocked door is flanked by ashlar sandstone surrounds with droved margins. The nature of the stonework shows that the door opened out into a passage or vennel which ran up to the High Street. This feature probably relates to a vennel shown on the Ordnance Survey map (Fig 2a-c.), that ran between the Harbour Hotel and the shops that fronted the High Street.

4.4.2 Further northwards the wall has been reduced in height and is largely overgrown. Visible below the adjoining public house car park is a section of

wall that abuts the interior north elevation of the sea wall (Plate 31). Below the revetment wall is an irregular assortment of large flagstones that have been crudely consolidated by concrete. The flagstones possibly represent the remains of the original ground floor level. The advantage of a flagstone floor is twofold. Firstly the floor would have been impervious to damp from seepage of sea water through the base of the sea wall and secondly stone would have been fireproof.

- 4.4.3 The northern end of this elevation also includes a section through the sea-wall (Plates 27-28). This feature appears to have been designed with three distinct types of material although it is clear that some attempt at consolidation has been attempted in the past. The base of the wall incorporates large blocks of sandstone up to 0.5m in length and 0.35m high. Above the foundation course is a second build including more regular blocks of sandstone with tightly mortared joints. Above this mid-section is the parapet which is slightly tapering with a moulded semi-circular string course. This feature runs the length of the wall and is designed to break the force of waves reducing the risk of overtopping during bad weather.
