Author	Author: Michael Cressey HND BA MSc PhD MifA FSA Scot
Illustrator	Illustrator: Leeanne Whitelaw BSc MAAIS
Editor	Sue Anderson BA MPhil PGDip MifA FSA Scot
Commissioned by	Commissioned by East Lothian Council
Date issued	January 2009
Version	Final
OASIS Reference	cfaarchal-55098
Planning Application No	08/00504/FUL
Grid Ref	NT 5168 7386

Report No. 1603
92-93 High Street, Haddington
Building Appraisal Report

- 0.1 A buildings appraisal was carried out at 92-93 High Street, Haddington in February 2009 on behalf of East Lothian Council. The building is situated at the west end of the High Street and is a Category B listed structure dating to the late 18th century. The building was last used as a jeweller's shop on the ground floor with domestic accommodation on the first and second floors.

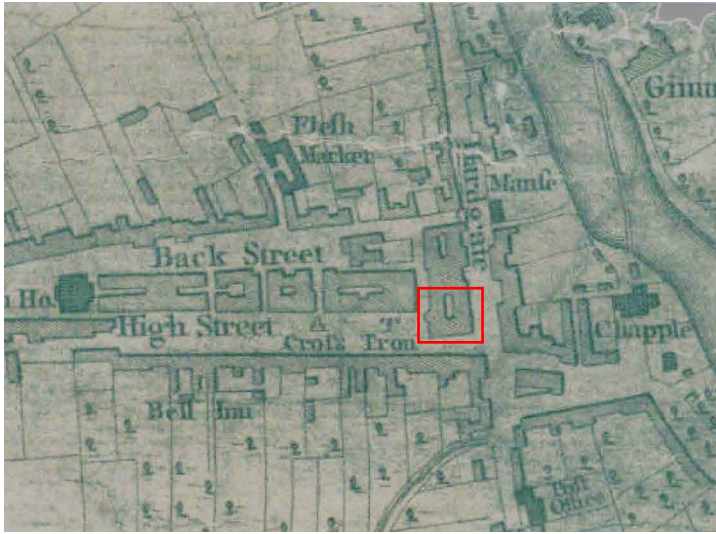
Fig 2a - Roy 1773

- 3.2.1 General Roy's Map of 1774-55 (Fig 2a) shows a block layout plan of two tenements with open courts in the middle on the site of what is now 92-93 High Street. External staircases fronting the High Street are also present suggesting that the High Street frontage was occupied as a separate dwelling to those at the rear.

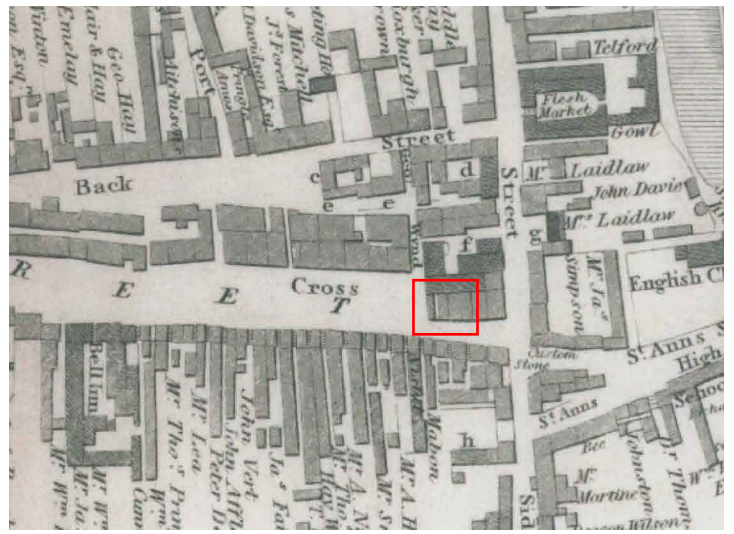
Fig 2b - Wood 1819

- 3.2.2 John Wood's Map of 1819 (Fig 2b) shows that there was a radical alteration from the 1773 building footprint. Now 92-93 High Street is represented by a series of smaller individual buildings forming discrete properties. This agglomeration of buildings persisted through to the middle of the 19th century. According to the 1853 Town Plan of Haddington (Fig 2c), the George Hotel had by then been extended southwards leaving a gap between it and the 92-93 High Street building. The Statutory List mentions that this new section was constructed in 1822. The gap between the buildings is still visible today. The 1893 Second Edition Ordnance Survey map (Fig 2d) shows the same detail as the 1853 map.

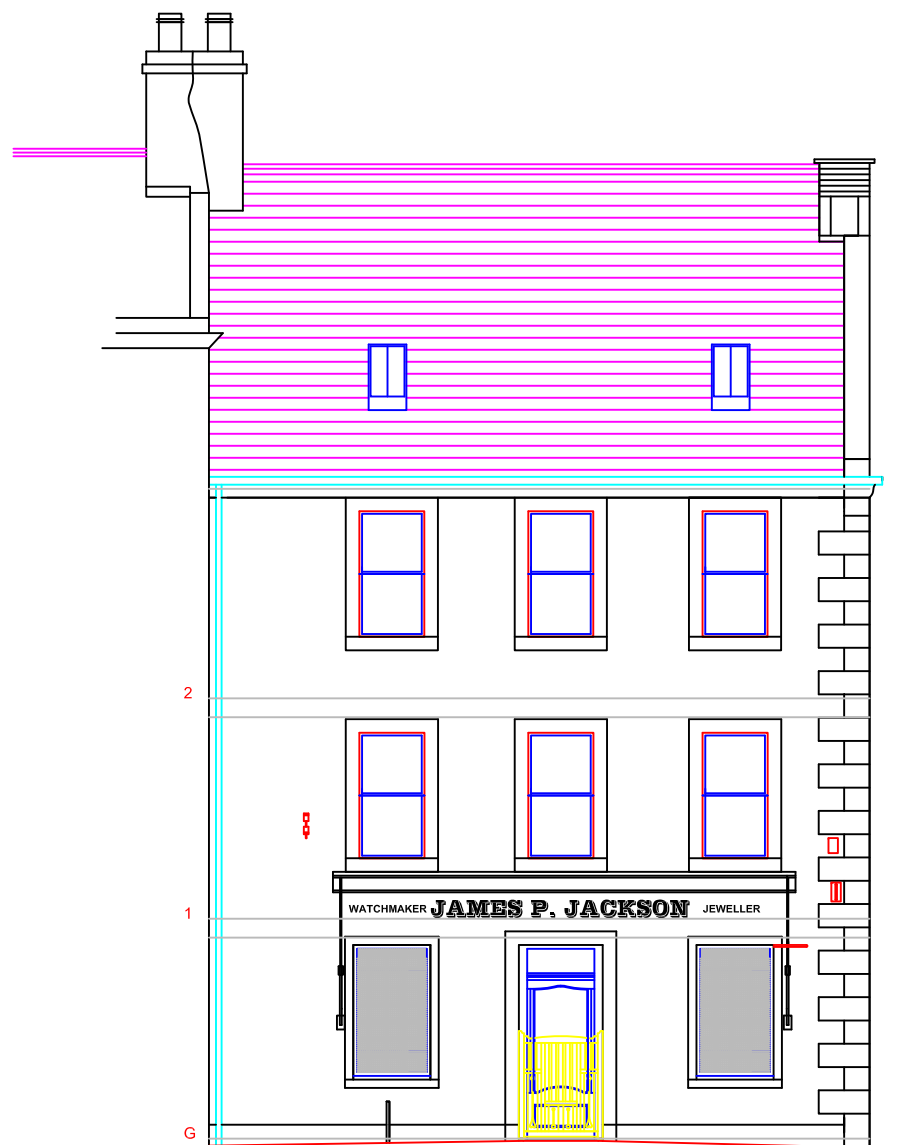
Fig 3a - WEST ELEVATION

- 4.2.1 The west-facing elevation measures 8.7m wide and 8.5m to the eaves line. The building is harled and painted with an ochre paint on the ground floor with a light buff on the upper floors. The fenestration includes three bays with a central door on the ground floor. The window surrounds have raised margins and are painted grey. The quoins on the south-west corner of the elevation are raised and also painted grey. Above the shop sign, showing *WATCHMAKER - JAMES P JACKSON – JEWELLER*, there is a shop front awning with metal stays. The ground floor windows have metal shutters and the door is gated. Above the door the glass light is inscribed *The Laboratory Established 1860*. The slate roof there are two cast-iron attic skylights. The skews are sandstone. The west-facing elevation adjoins the white-painted frontage of the George Hotel.

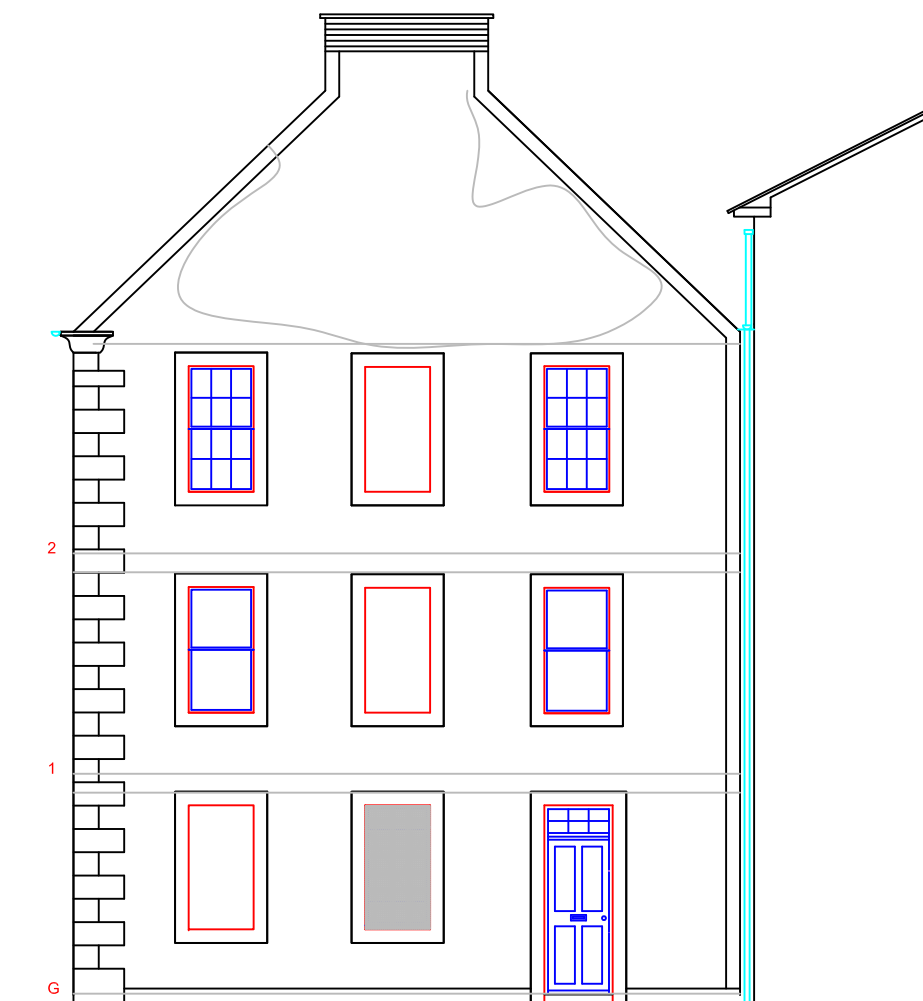
Fig 3b - SOUTH ELEVATION

- 4.2.2 The south-facing elevation measures 8.7m wide and 12.5m high to the base of the chimney stack. The fenestration is on three bays with raised margins. Three windows are blind (middle first and second, and ground floor left). The second floor windows are six-over-six sash and case with one-over-one sash and case windows on the floor below. The ground floor door is flanked on the left by a steel-shuttered window. The elevation is harled to the top of the 2nd storey window. Where the harling has been removed above this position, a regular-coursed conglomerate sandstone is exposed. The skews have been painted with the same grey as the shop-front dressings. The harling is also painted the same as the shop front. A gap of 200mm is present between the building and the George Hotel.

- 7.3 CFA understands that the exterior harling is to be removed. In the event that any earlier features are brought to light, their position should be recorded and photographed.

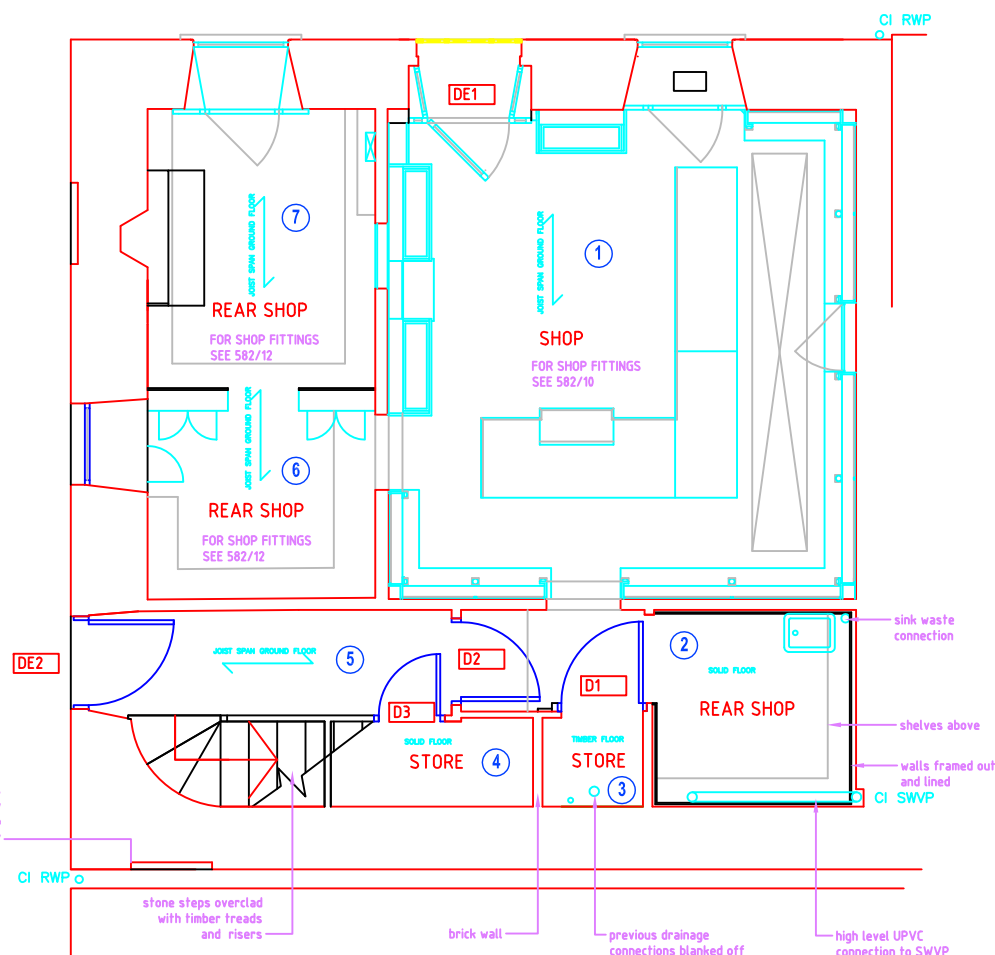
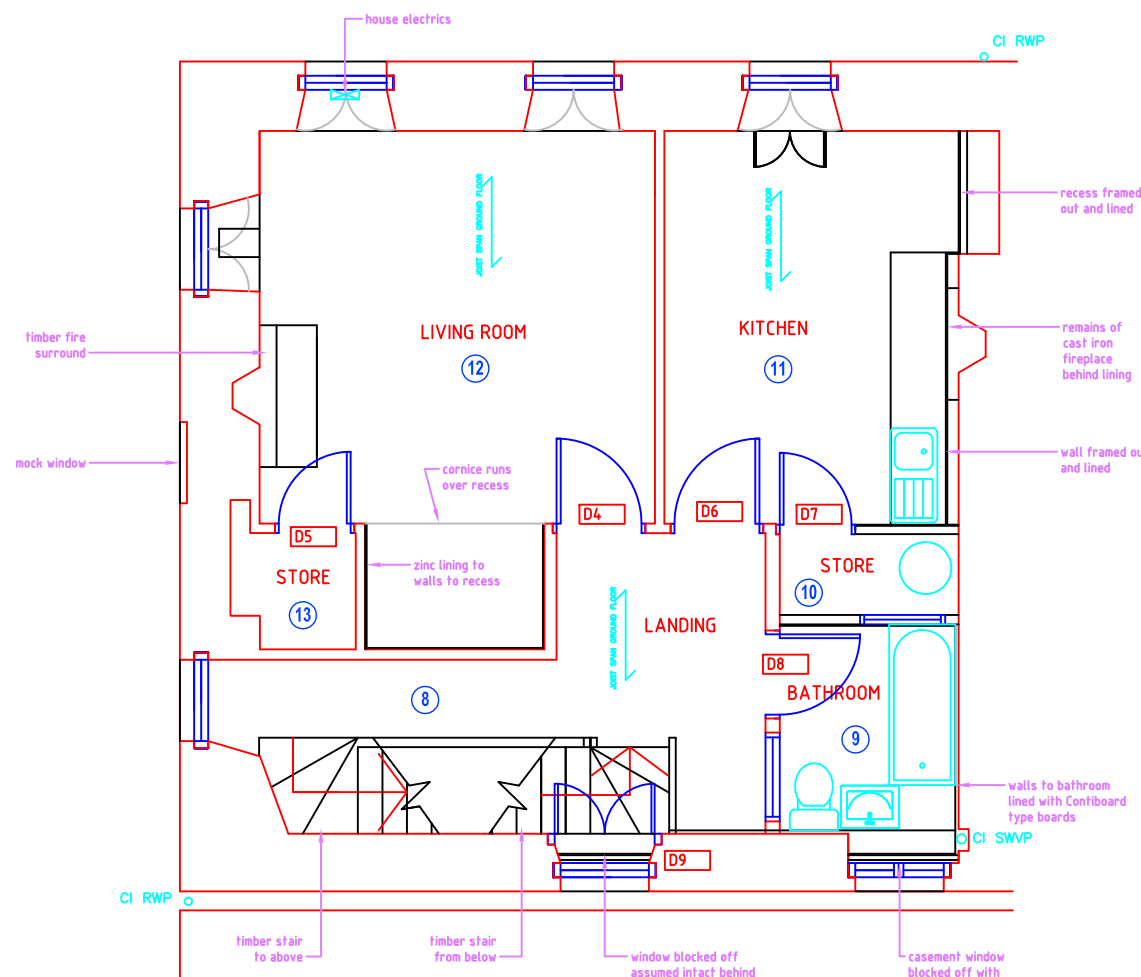
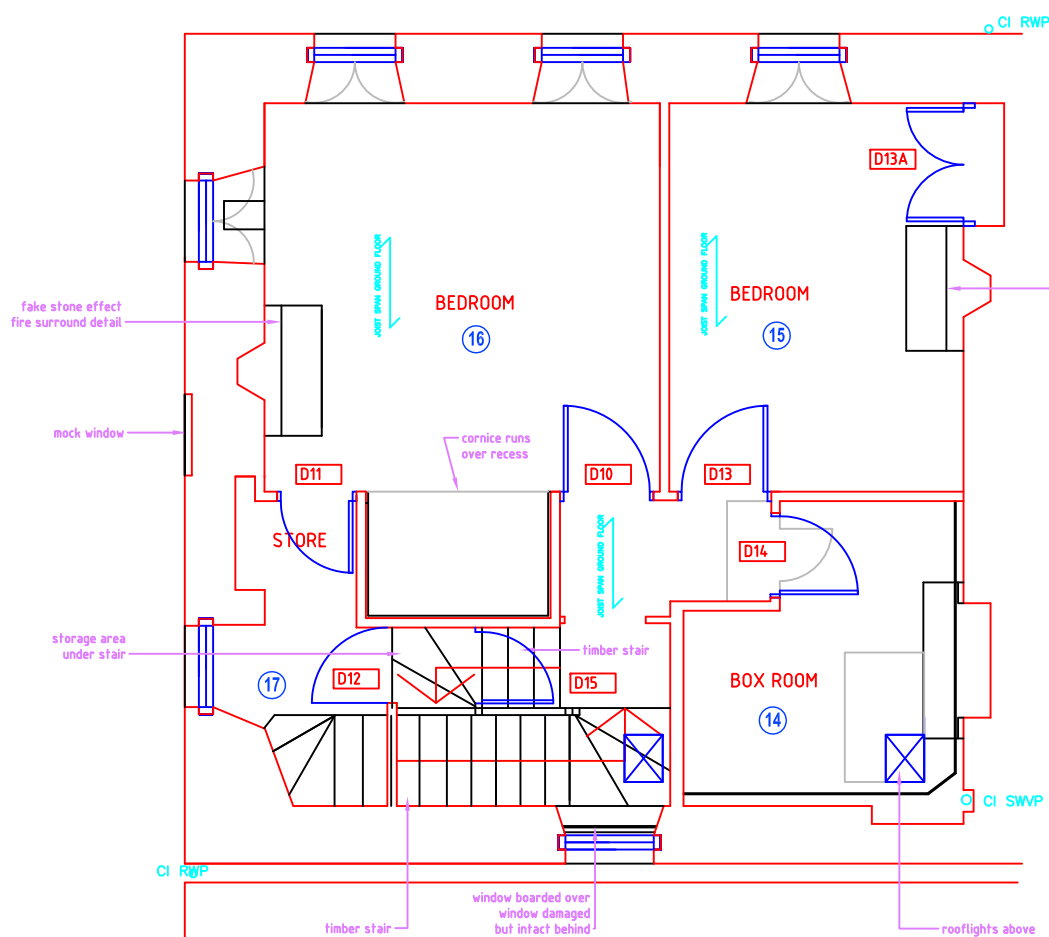
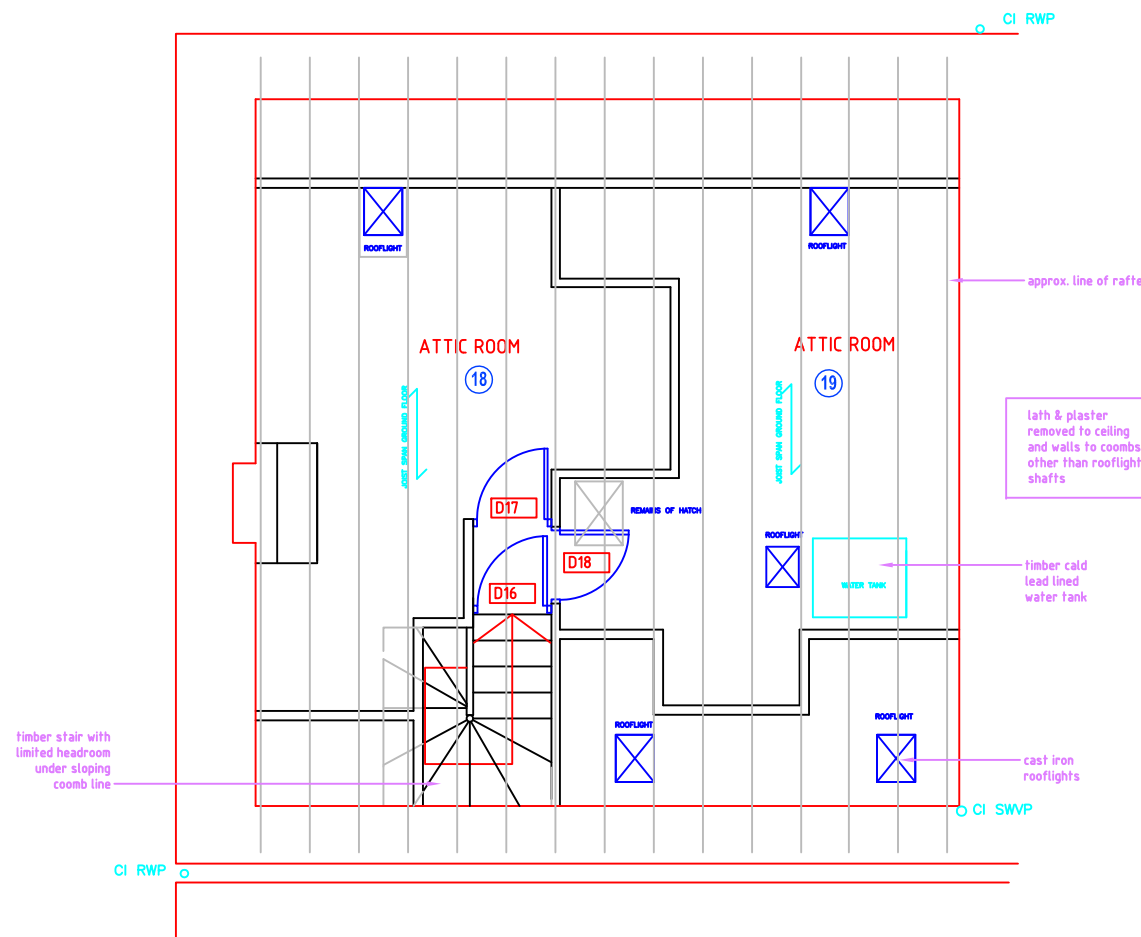
Title: Room Layout Plans

- 4.3.1 The building interiors are now described. The dimensions of the individual units are listed in Table 1. The name of each unit is as depicted on the architects plan (Fig 4).

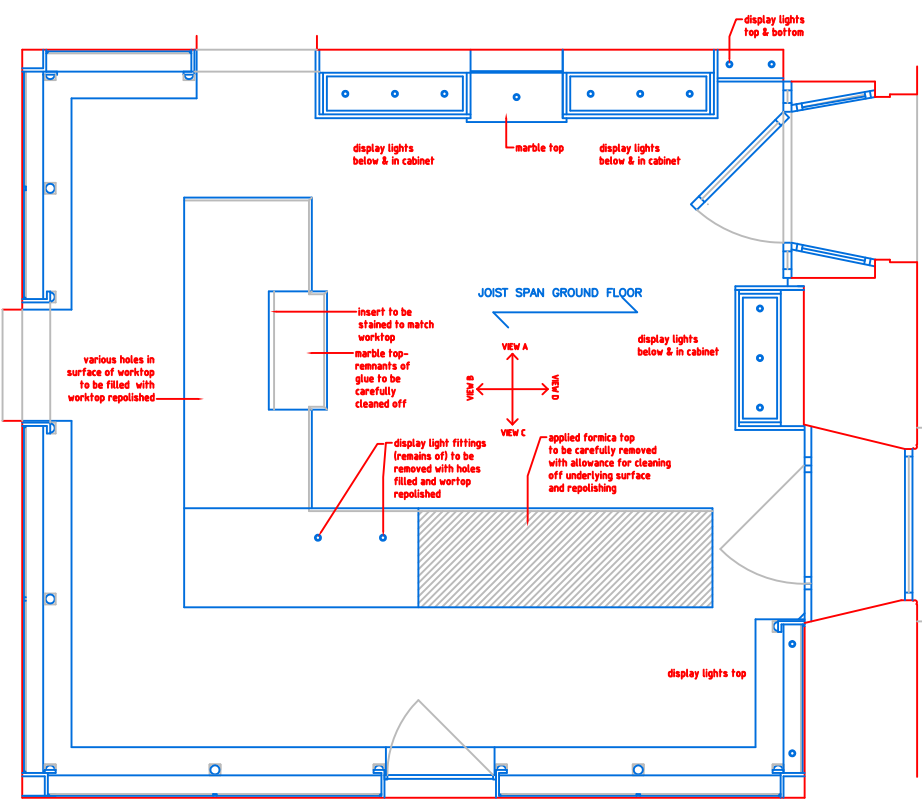
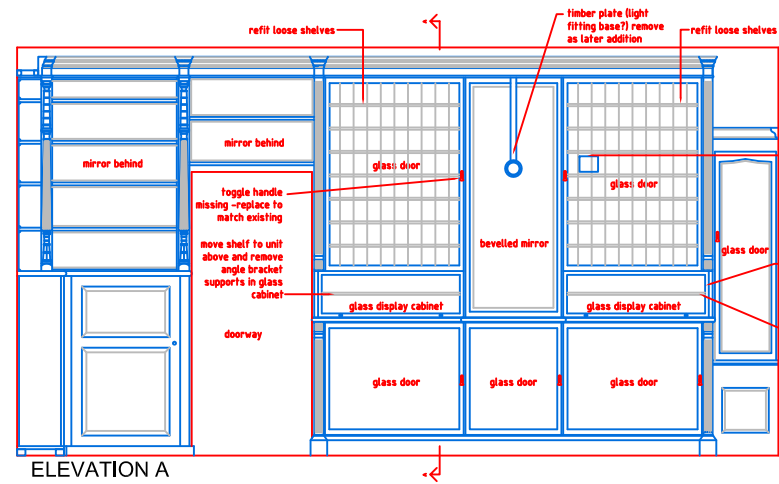
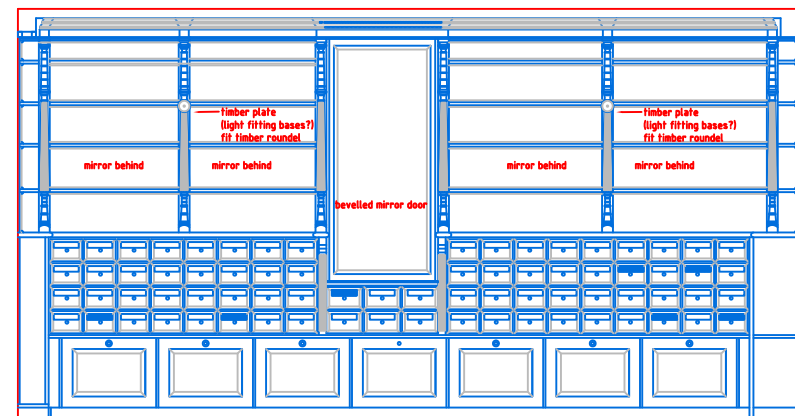
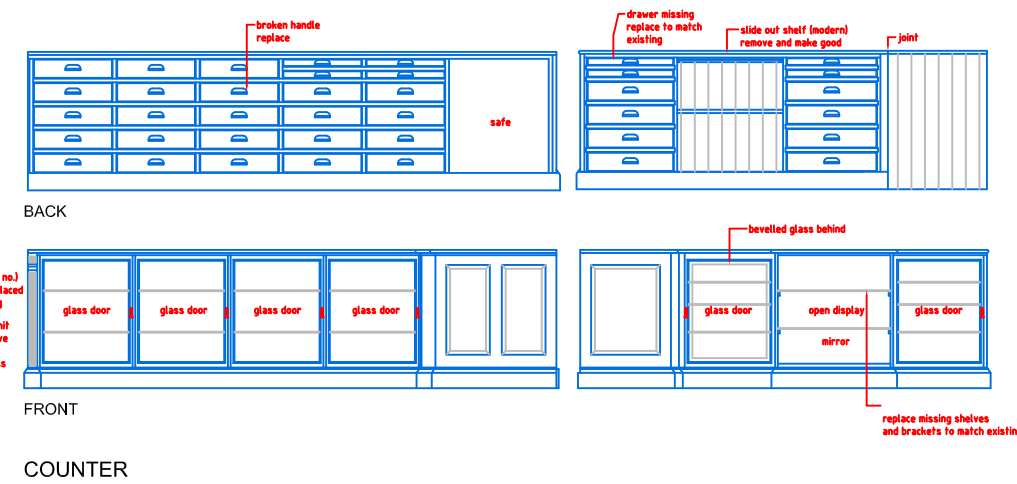
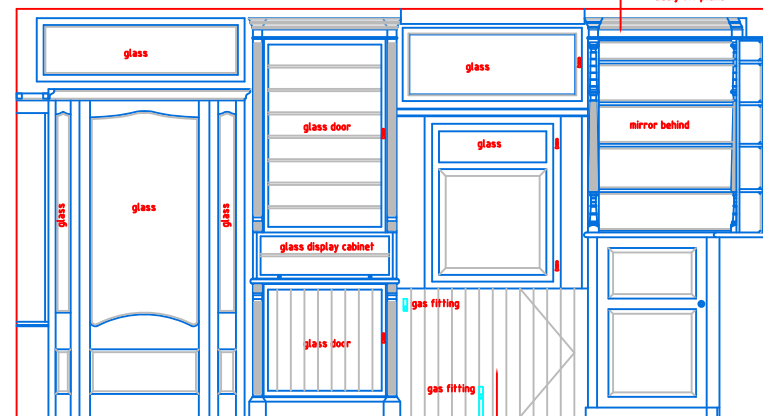
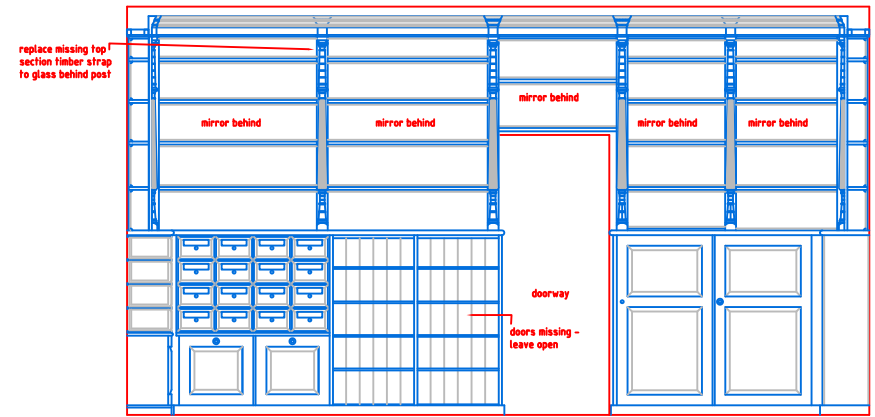
- KEY**
- handle missing (91 handles found loose in drawers - to be refitted with 2 replacement handles required)
 - handle present
 - sign missing (3 signs - 2 broken but re-usable - found - other drawers to have fixing material carefully removed with drawer front repolished)
 - sign present

General repairs and fill to woodwork on all cabinets, doors and drawers, particularly where previous fixings for removed cladding.

General clean down and repolish where required.

Ease all doors and drawers as required.

Interior of glass fronted cabinets to have paper lining removed and lining boards to be stripped back to timber with stained polished finish to match existing.

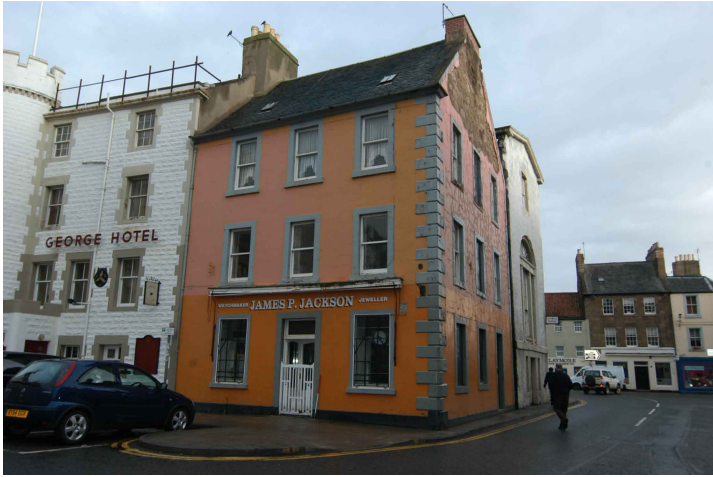
Plate 1 - West-facing elevation

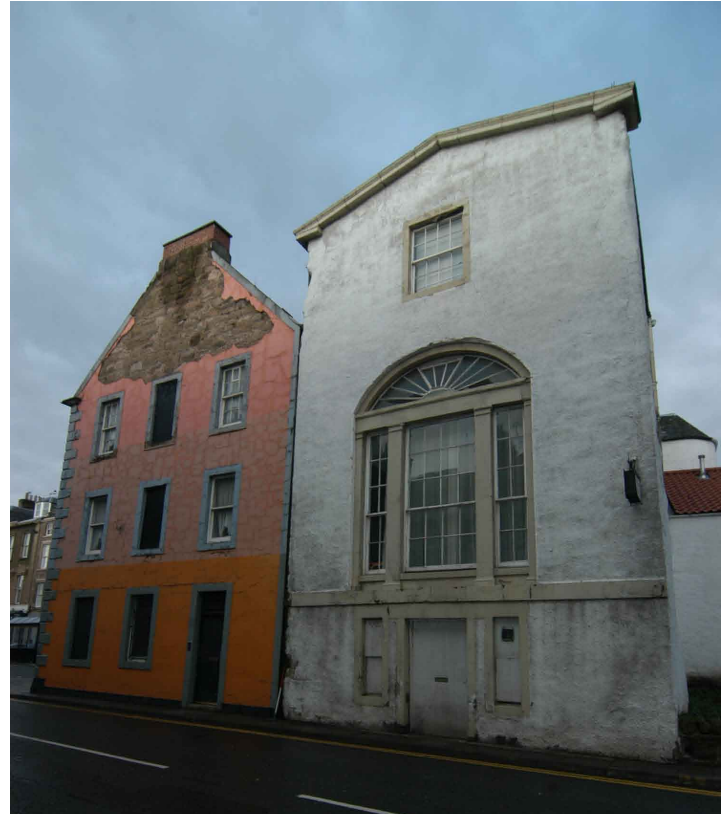
Plate 2 - South-facing elevation and the George Hotel SW extension (1822)

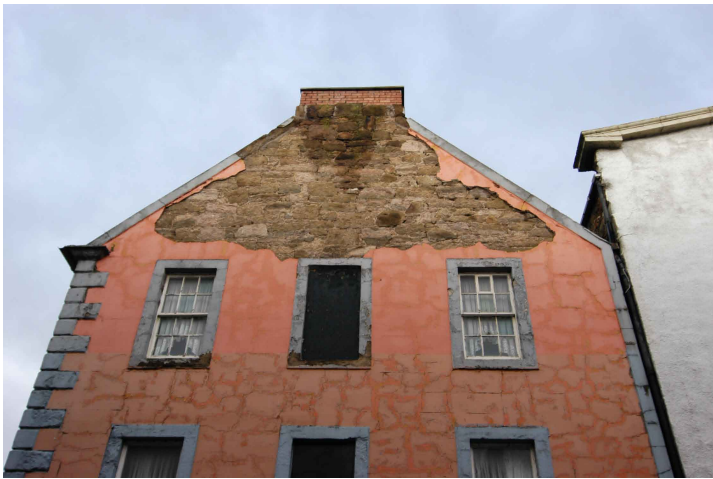
Plate 3 - South-facing elevation showing area where harling has been removed

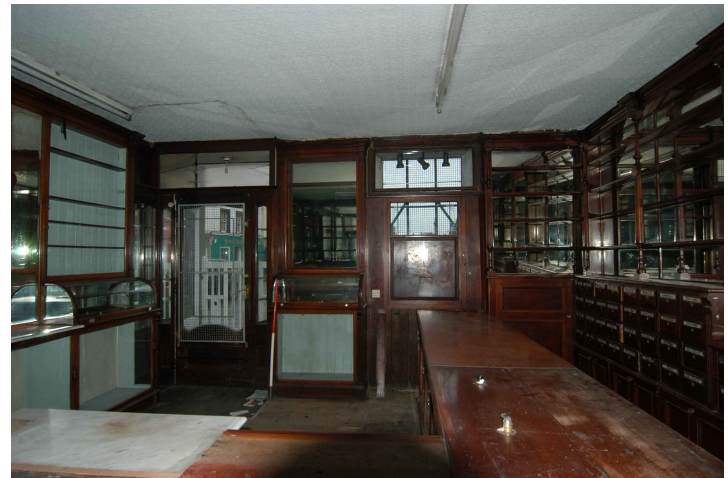
- 4.3.2 The shop was last used as a jeweller's shop. The walls are lined with a complete Victorian dispensary including a drug run (small drawers) of 74 draws surmounted by mirror-backed shelves. A bevelled mirror flanked by hardwood fluted columns occupies the centre of the shelving. Another wall is fitted out with mirrored storage shelves and small draws. Fixtures and fittings including the jeweller's counter and

safe along with electrically lit display cabinets which are part of the original 1860 design. The door to the shop is on the west wall and is flanked by two windows. An L-shaped counter occupies the shop floor. A glass light above the door has been inscribed with *The Laboratory Established 1860*.

Plate 4 - Unit 1, the chemists shop looking west

- 5.3 The most significant feature has to be the fixtures and fittings associated with the former chemist's shop. The drug drawers and mirrored cabinets are a rare survivor and are more or less complete save for the occasional missing glass knob and name plate. This arrangement is to be preserved and conserved for the future.

- 7.2 Following the removal of the chemist's shop fixtures and fittings, any exposed features such as blocked fireplaces and doorways should be recorded. It is likely that only the north-facing elevation will contain a fireplace. If present these pre-1860 features should be recorded in detail for inclusion of the site record.

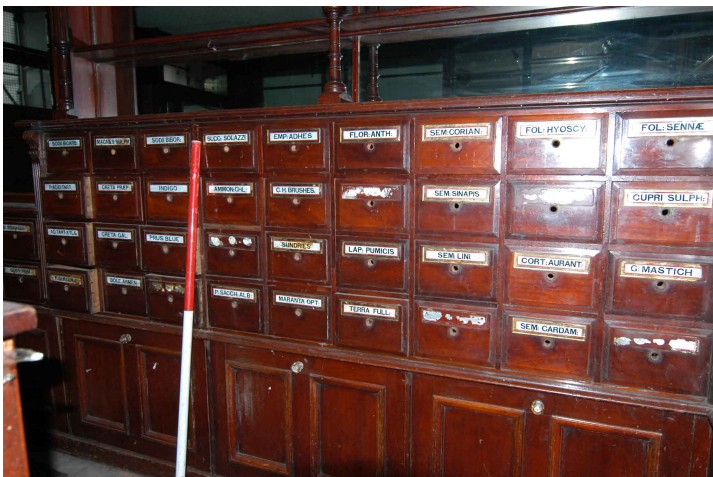
Plate 5 - Unit 1 detail shot of the drug run

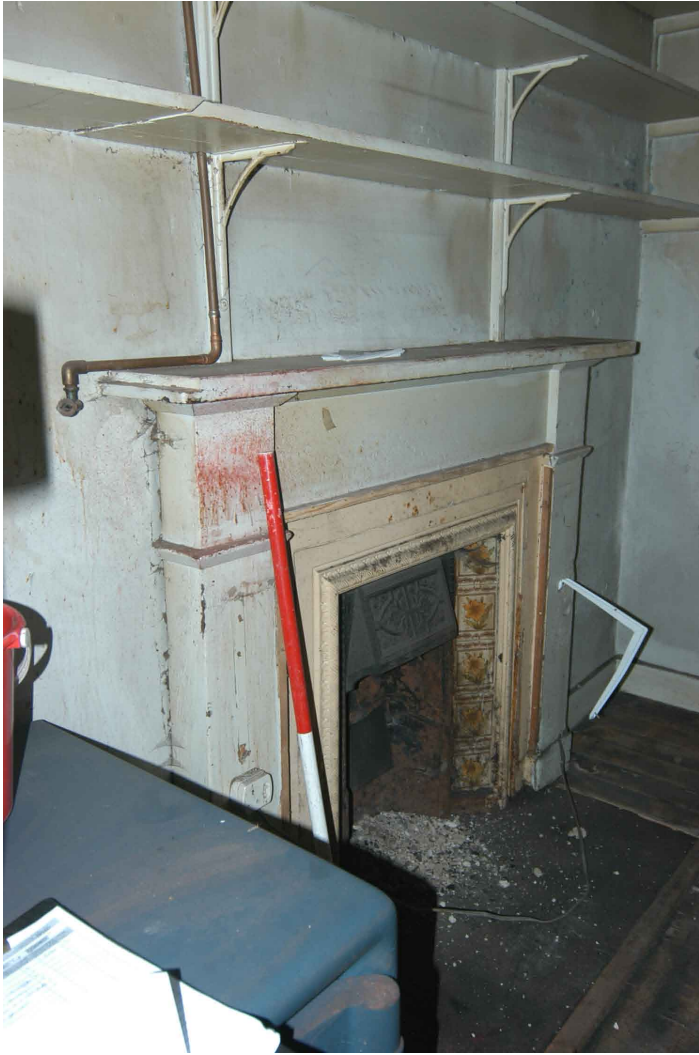
- 4.3.7 This unit was the jeweller's workshop and is lined with wooden shelving. A drop-leaf table is fixed to the lower tier of shelving. The entrance to this unit is via the main shop (Unit 1). A doorway leads from Unit 6 into Unit 7, another rear shop. Within Unit 6 there are also four wooden lockers with shelves above. A mesh-shuttered window is present on the south wall.

Plate 6 - Unit 6 Rear shop fireplace on the south wall

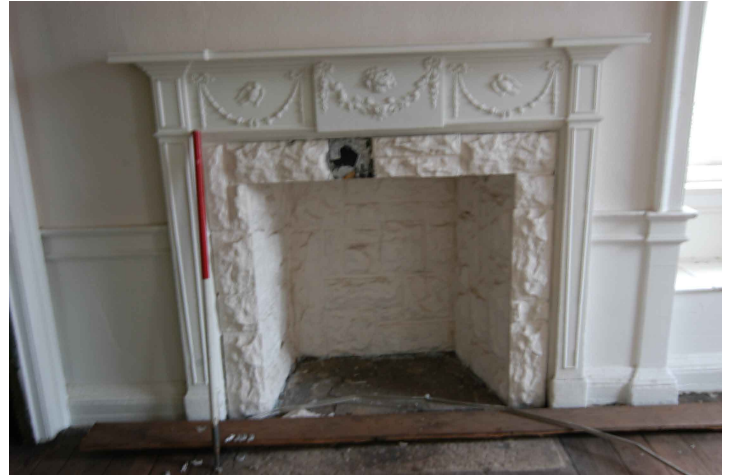
- 4.2.13 A spacious, well lit, living room with two windows on the west wall and another on the south wall. The windows have shutters on the insides. On the south wall there is a neo-classical fireplace which has been lined with mock stonework. The north wall is featureless with a dado rail and moulded cornice. On the east wall there is a recess, presumably for a couch or bed. The walls of the recess are lined with zinc and the reason for this is not known. A six-panelled doorway leads off to a store cupboard (Unit 13).

Plate 7 - Unit 12 neo-classical fireplace

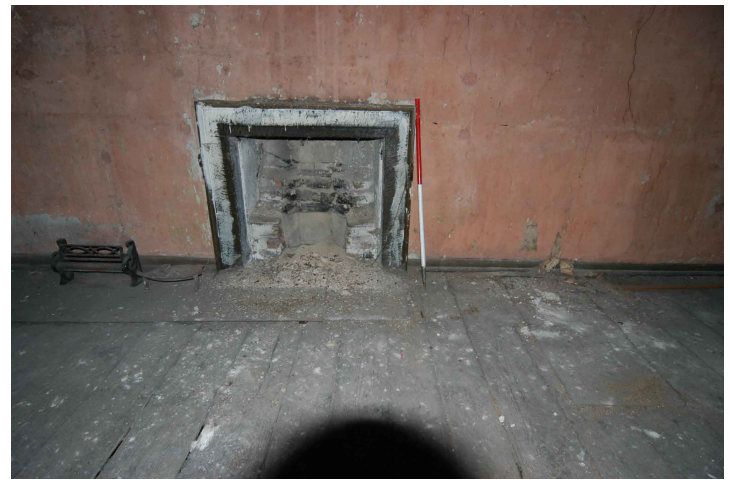
4.2.19 The attic is accessed by a doorway with trapezoidal top-rail. A flight of 13 steps lead up to Unit 18 which was used as living space. The walls are a pinkish-red painted lath and plaster. The ceiling was also lath and plaster but this has been removed leaving a mass of small nails where the laths were nailed to the roof tie-beams and A-frame joists. Where the laths survive in-situ, these appear to be of either late 18th or early 19th-century date. On the south wall there is a small fireplace. On the opposite wall is a small recess for a couch or bed. On the walls surrounding the recess there is a wall covering of linen or some other fabric which is of an early period. The door to the room has four panels surmounted by three panes of glass.

- 5.5 The attic space is largely untouched and Unit 18 has some very early textile wall covering still adhering to the lath and plaster walls forming the bed recess. The ochre painted walls suggest that this room was perhaps used as living quarters for a servant or house maid in the Victorian Period.

Plate 8 - Unit 18m attic room fireplace

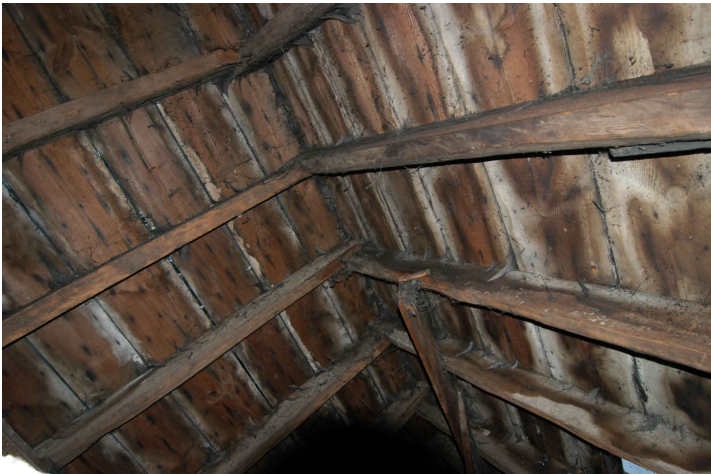
4.3.1 The roof timbers are exposed within Units 18 and 19. The timbers comprise A-frame trusses with upright hangers scarfe-jointed to the tie beams. The A-frame trusses rest on a timber wall plate directly on the wall head. The trusses are numbered with Roman numerals but are not in any coherent order. The beams are semi-rounded and square and are a softwood, probably pine. One beam has a pair of scarfe-joints cut into it, showing that it has been re-used from an earlier roof. The sarking boards appear to be contemporary with the roof trusses. These are pit-sawn timbers measuring 0.27m wide and are of pine.

Plate 9 - A-frame roof joists and sarking

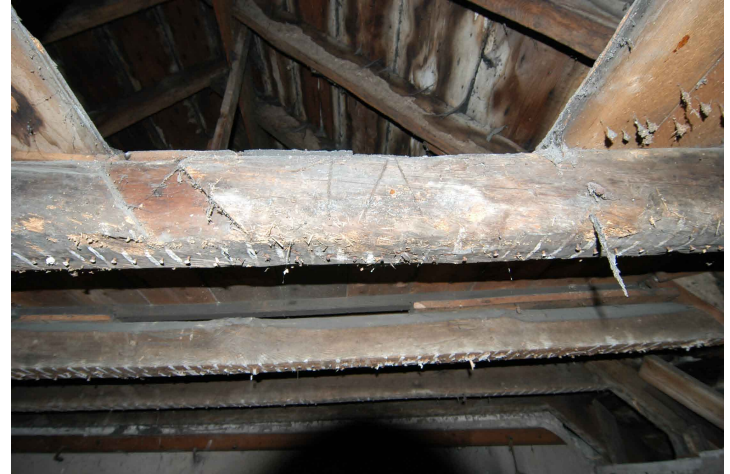
Plate 10 - Evidence of re-use of a tie beam in Unit 19 attic
