**MINGARY, ARDNAMURCHAN, SOUND OF MULL**

**DESIGNATED SITE ASSESSMENT: ARCHAEOLOGICAL REPORT**

**Ref: 53111.03rr**

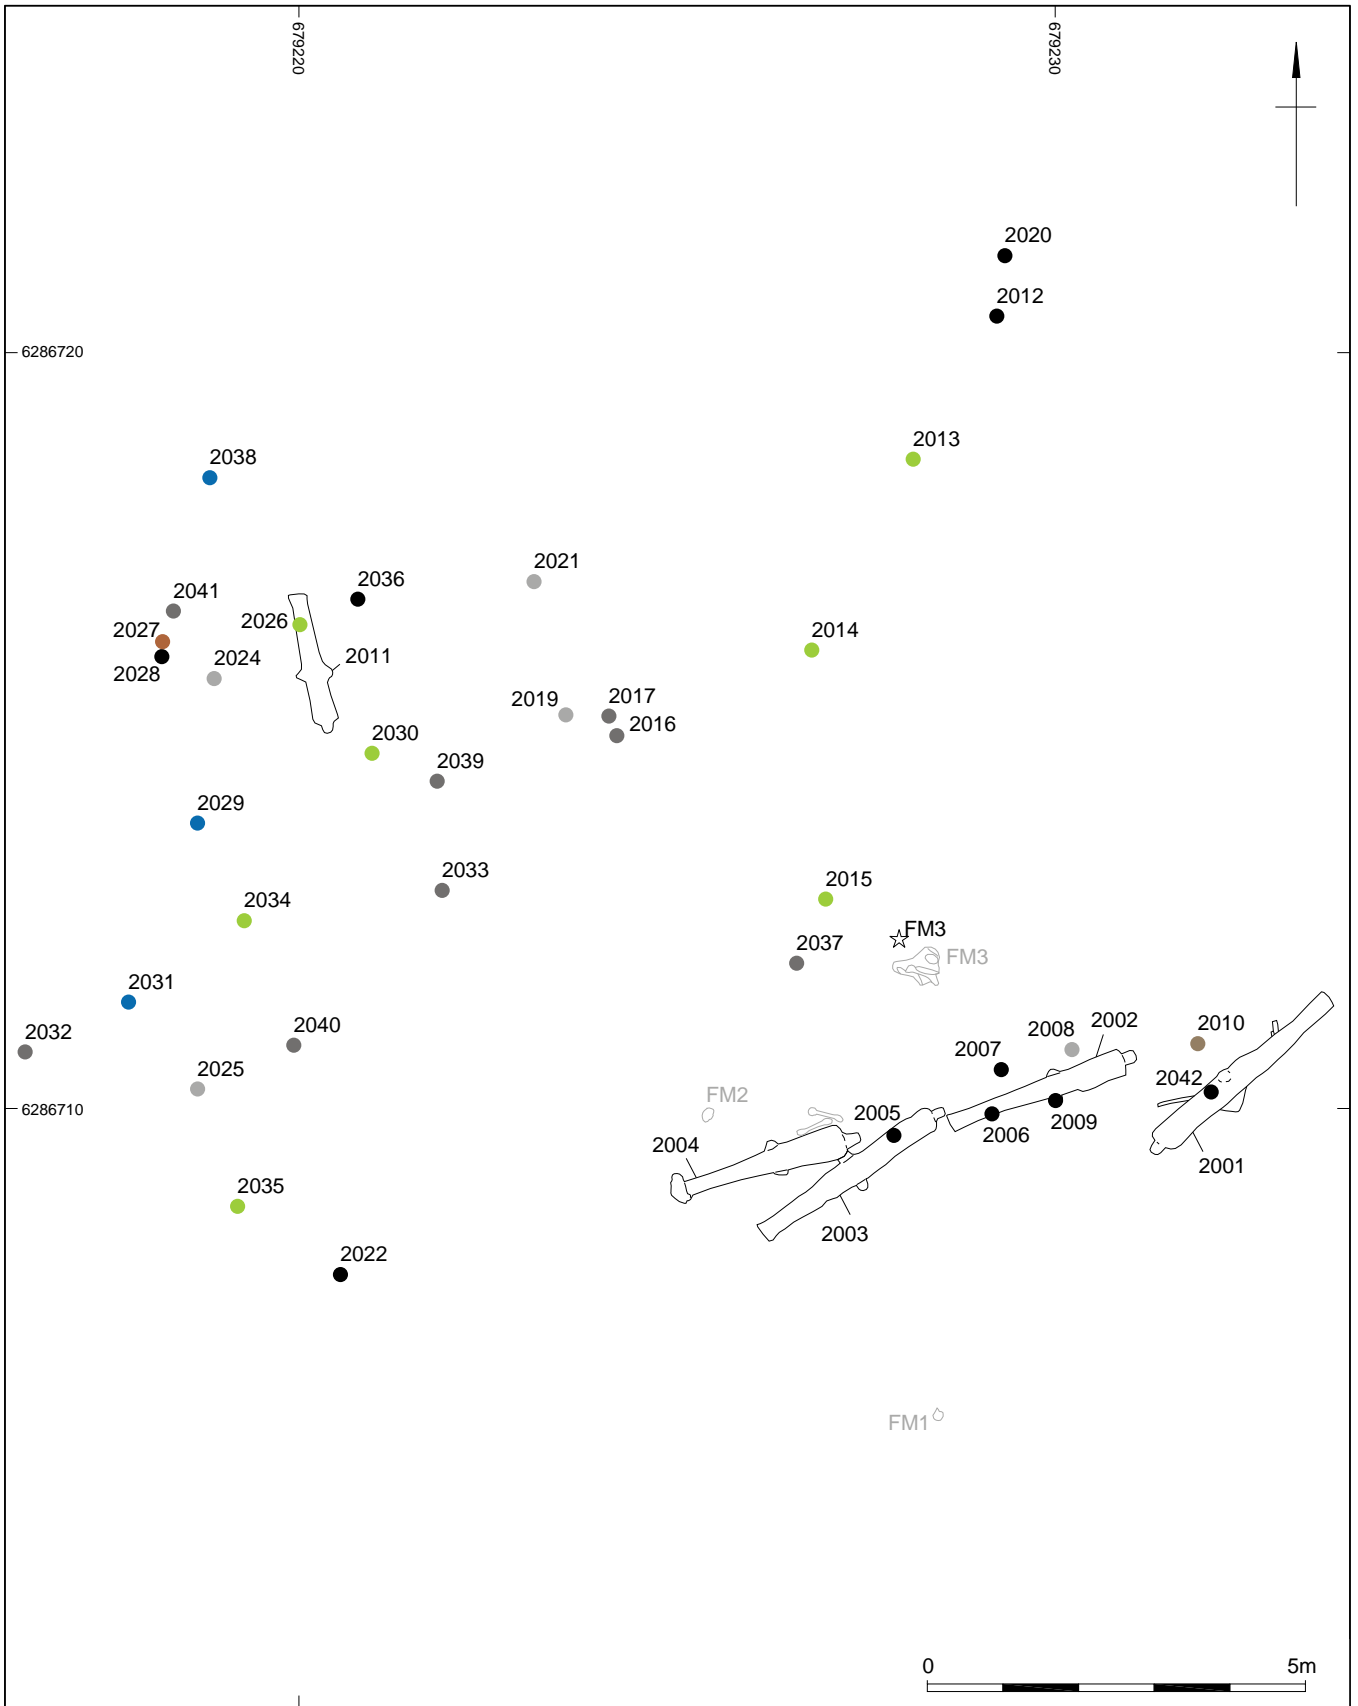
Figure 2

Site plan based on 2002 gun measurements and 2006 diver survey

- 4.1.3. All features on the seabed deemed to be of archaeological interest, including unidentifiable concretions and metal detector hits were allocated a context number from a sequence starting at **2001**, but no features were physically tagged. A full list of context numbers is in **Appendix I**; the results are illustrated in **Figure 2**.

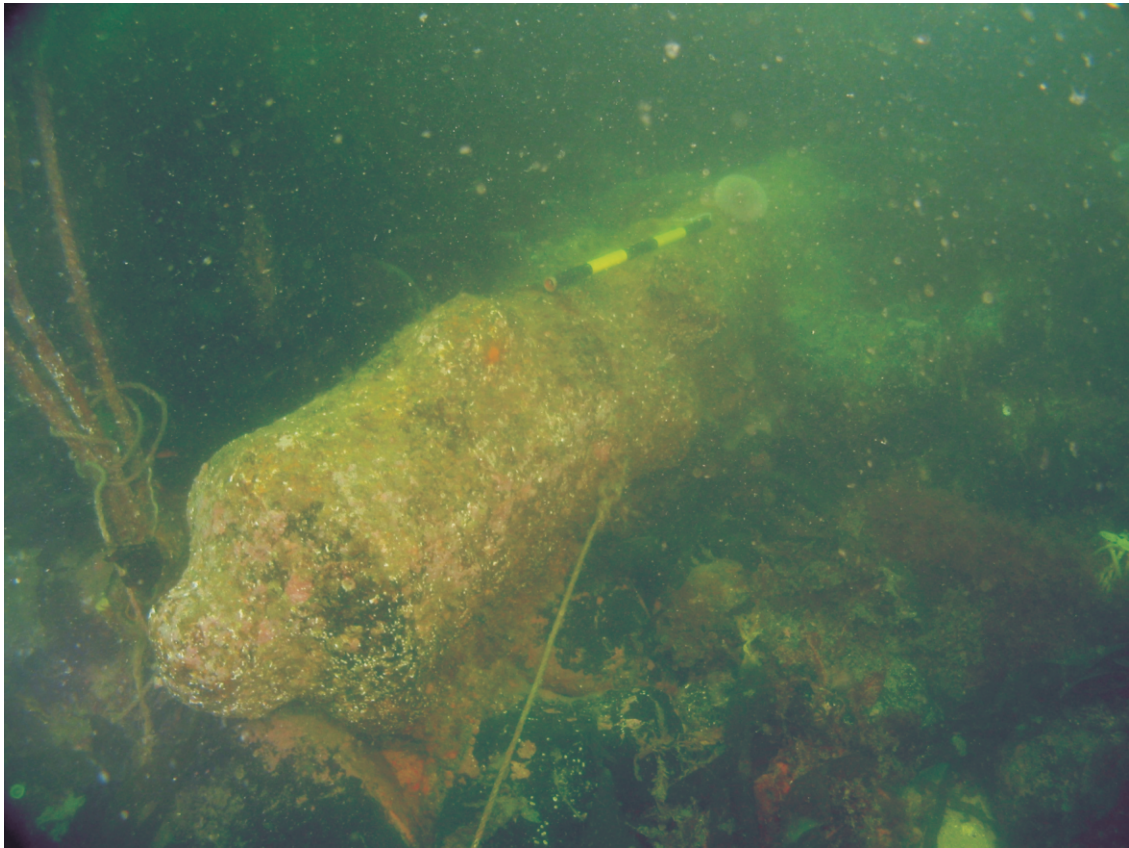
Plate 2. Gun 2011

- 5.5.12. Gun **2011 (Plate 2)** corresponds to C5 on the 2003 site plan, which was then recorded as being 1.88m long. The tracked survey gave a length of 2.3m which, allowing for the system's inherent inaccuracies, corresponds well to the previously recorded tape measurements. The gun lies approximately 7.4m northwest of the muzzle of gun **2004** and is aligned roughly north - south, with the muzzle to the north. It is fully exposed and lies on top of boulders.

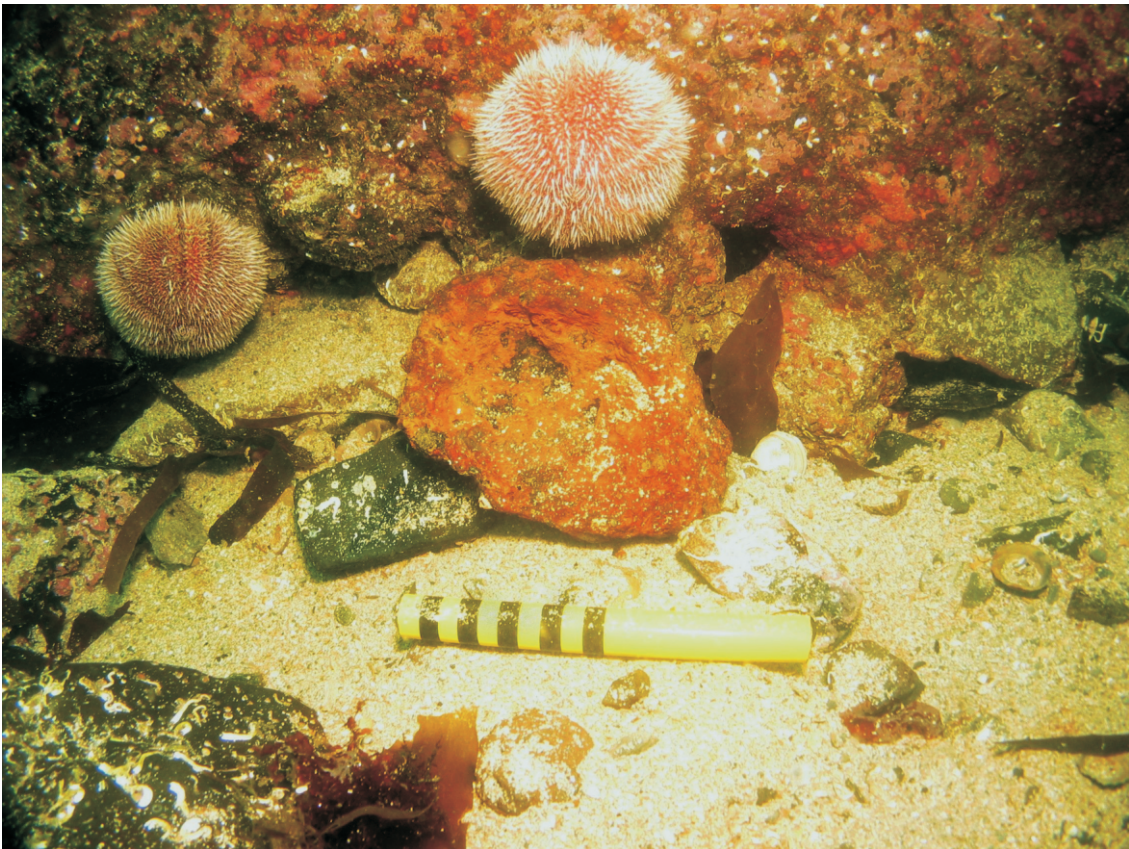
Plate 3. Damage on 2002 and concretion 2007

- 5.5.7. Gun **2002** corresponds to gun C3 on the 2003 site plan, which was recorded then as being 2.62m long. The tracked survey gave a length of 2.9m which, allowing for the system's inherent inaccuracies, corresponds well to the previously recorded tape measurements. The gun lies in alignment with **2003** and **2004**, approximately northeast – southwest, with the muzzle to the southwest and the trunnions parallel to the seabed. It is fully exposed lying on top of boulders and sand, with a free span in the middle section. There are two small rounded protrusions beneath and either side of both the trunnions. On the north side of the gun an area of damage is visible, where it appears that an area of concretion has come away from the gun and then reformed. The fin on the top of the barrel is also visibly rusting.

- 5.5.8. Context **2007 (Plate 3)** is a broken concretion measuring approximately 0.2m long, with a spherical impression in the surface 0.1m in diameter. An estimated  $\frac{1}{4}$  of the sphere remains, and although it was originally thought to be a concretion surrounding a now missing cannonball, closer inspection of gun **2002** suggests that the concretion came from the area of damage around the western rounded protrusion on the north of the gun.

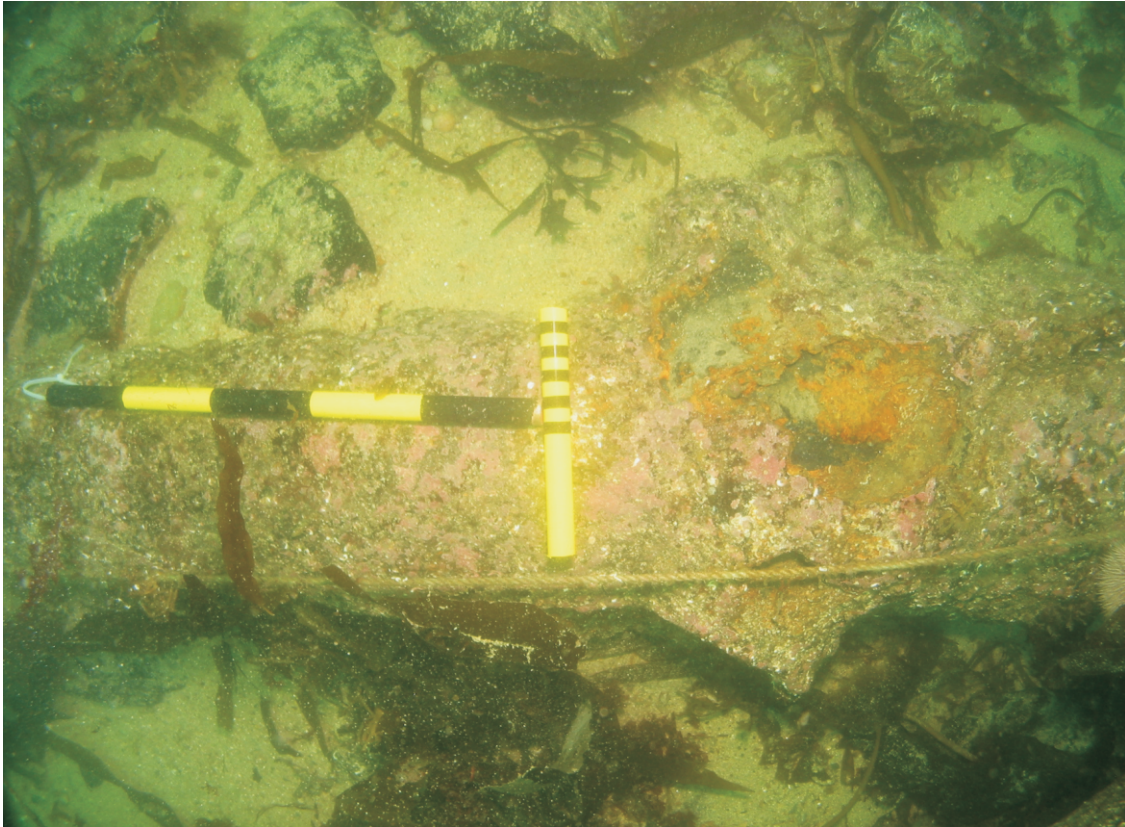
Plate 4. Damage to concretion on 2004

- 5.5.11. Gun **2004** corresponds to C1 on the 2003 site plan, which was recorded then as being 2.4m long. The tracked survey gave a length of 2.2m which, allowing for the system's inherent inaccuracies, corresponds well to the previously recorded tape measurements. **2004** lies in alignment with guns **2003** and **2002**, approximately northeast – southwest, with the muzzle to the southwest. The gun is fully exposed and lies on top of boulders and sand. It has a large area of damage to the concretion on the top, between the trunnions, which has re-concreted, but has visible rusting (**Plate 4**). It appears that the concretion has broken away from the gun itself, which has subsequently formed a new concretion layer. (**Figure 10**).

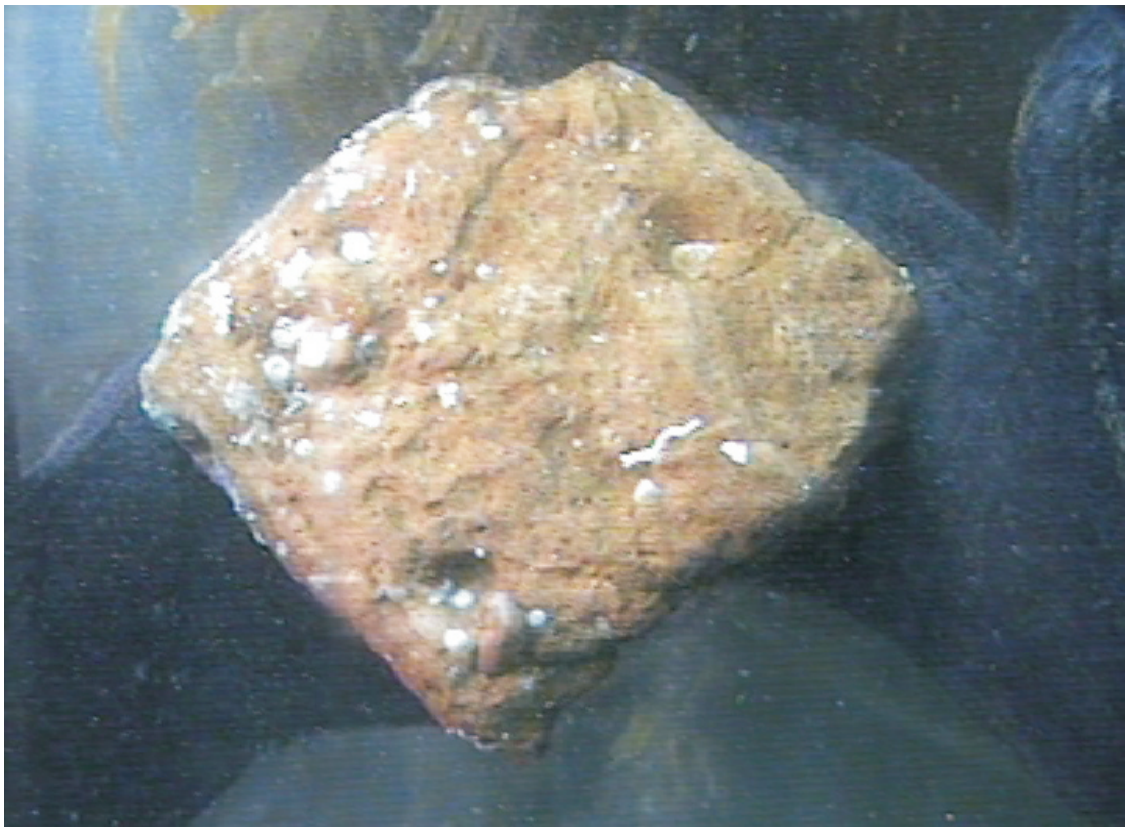
Plate 5. Fragment of brick 2027

- 5.5.13. Context **2036**, which lies to the southeast of gun **2011**, is a possible concretion giving a low metal detector reading. It is approximately 0.25m in diameter with two parallel lines on one side. Contexts **2027** and **2028** were both found under boulders approximately 1.8m to the west of gun **2011**. Of these, **2027** is a fragment of brick measuring 0.15m x 0.10m x 0.02m (**Plate 5**) and **2028** is a small concretion attached to a boulder.

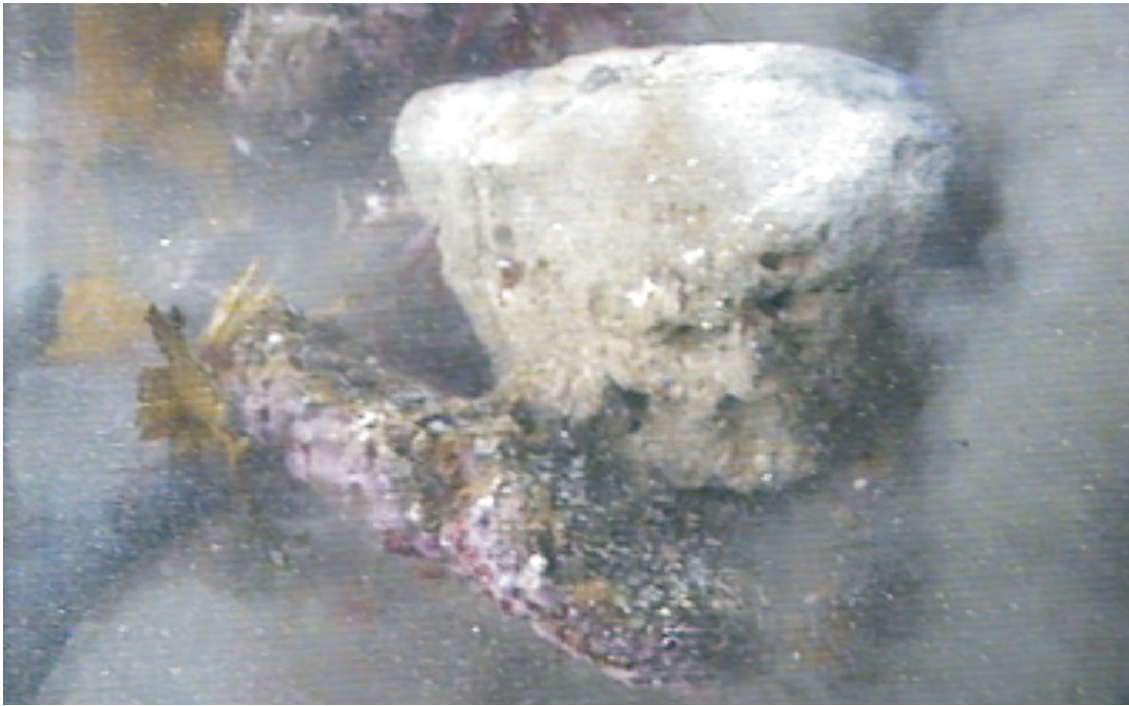
Plate 6. Concretion 2020

- 5.5.14. In addition to the concretions mentioned above, which lie in the immediate vicinity of the guns, a further three were located within the general search area around the guns. Concretions **2012** and **2020** lie close together, approximately 10m to the north of gun **2002**. Of these, **2012** is a collection of small concretions found with a metal detector, lying between boulders whilst **2020** is a rectangular concretion measuring 0.20m x 0.25m x 0.15m attached to a boulder (**Plate 6**). Context **2022** is an irregular concretion measuring 0.10m x 0.12m x 0.15m that lies 5m west of gun **2004**.

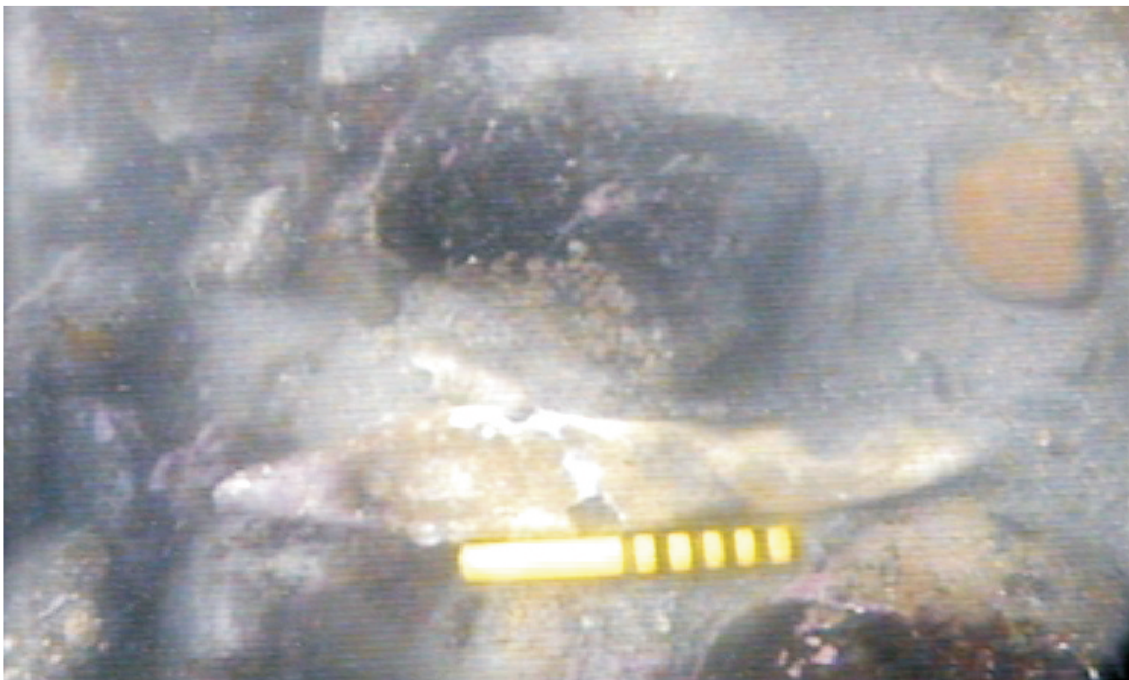
Plate 7. Fragments of lead sheet 2038

- 5.5.15. Four fragments of lead sheet were found, all lying to the west of the guns, in amongst the boulder field. One (**2029**) was found lying loose on the surface whilst the others were found under boulders during the metal detector searches. Context **2031** was a small piece of lead sheeting pierced two oval holes approximately 0.06m apart. One side was more encrusted with marine growth more than the other. Context **2038** was two pieces of lead, the larger one measuring 0.50m long and 0.085m at the widest point. The edges were bent over and there were square-shaped holes down the sides (**Plate 7**). The second piece was mostly buried, so its extents, and relationship to the larger piece, could not be established.

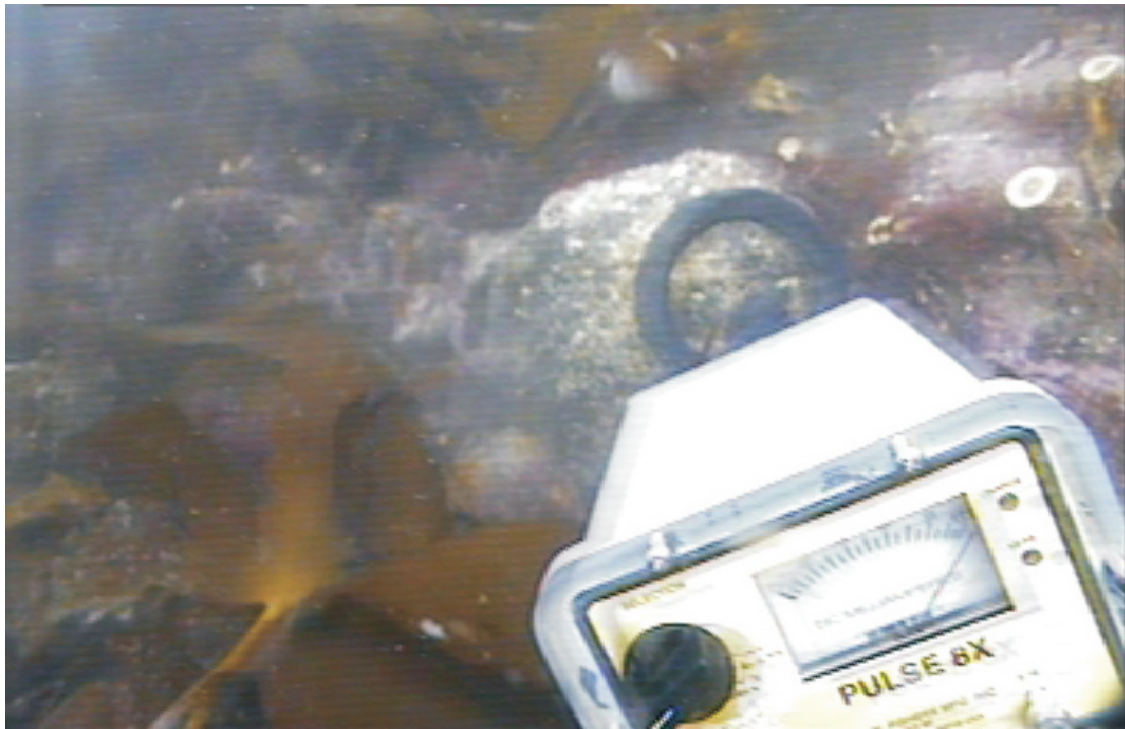
Plate 8. Boulder producing a metal detector reading

- 5.5.16. The metal detector search confirmed that a number of the boulders in the area have a magnetic signature (**Plate 8**). A total of eight boulders (**2016, 2017, 2032, 2033, 2037, 2039, 2040** and **2041**) were identified as producing a reading on the metal detector. For these, context **2019** represents the centre point of an area measuring approximately 2m to 3m in radius within which every second or third boulder gave a reading on the metal detector.
