## *HMS Campania*, Firth of Forth, Scotland

Designated Site Assessment:

**DESIGNATED SITE FULL REPORT**

**Ref: 53111.03p**

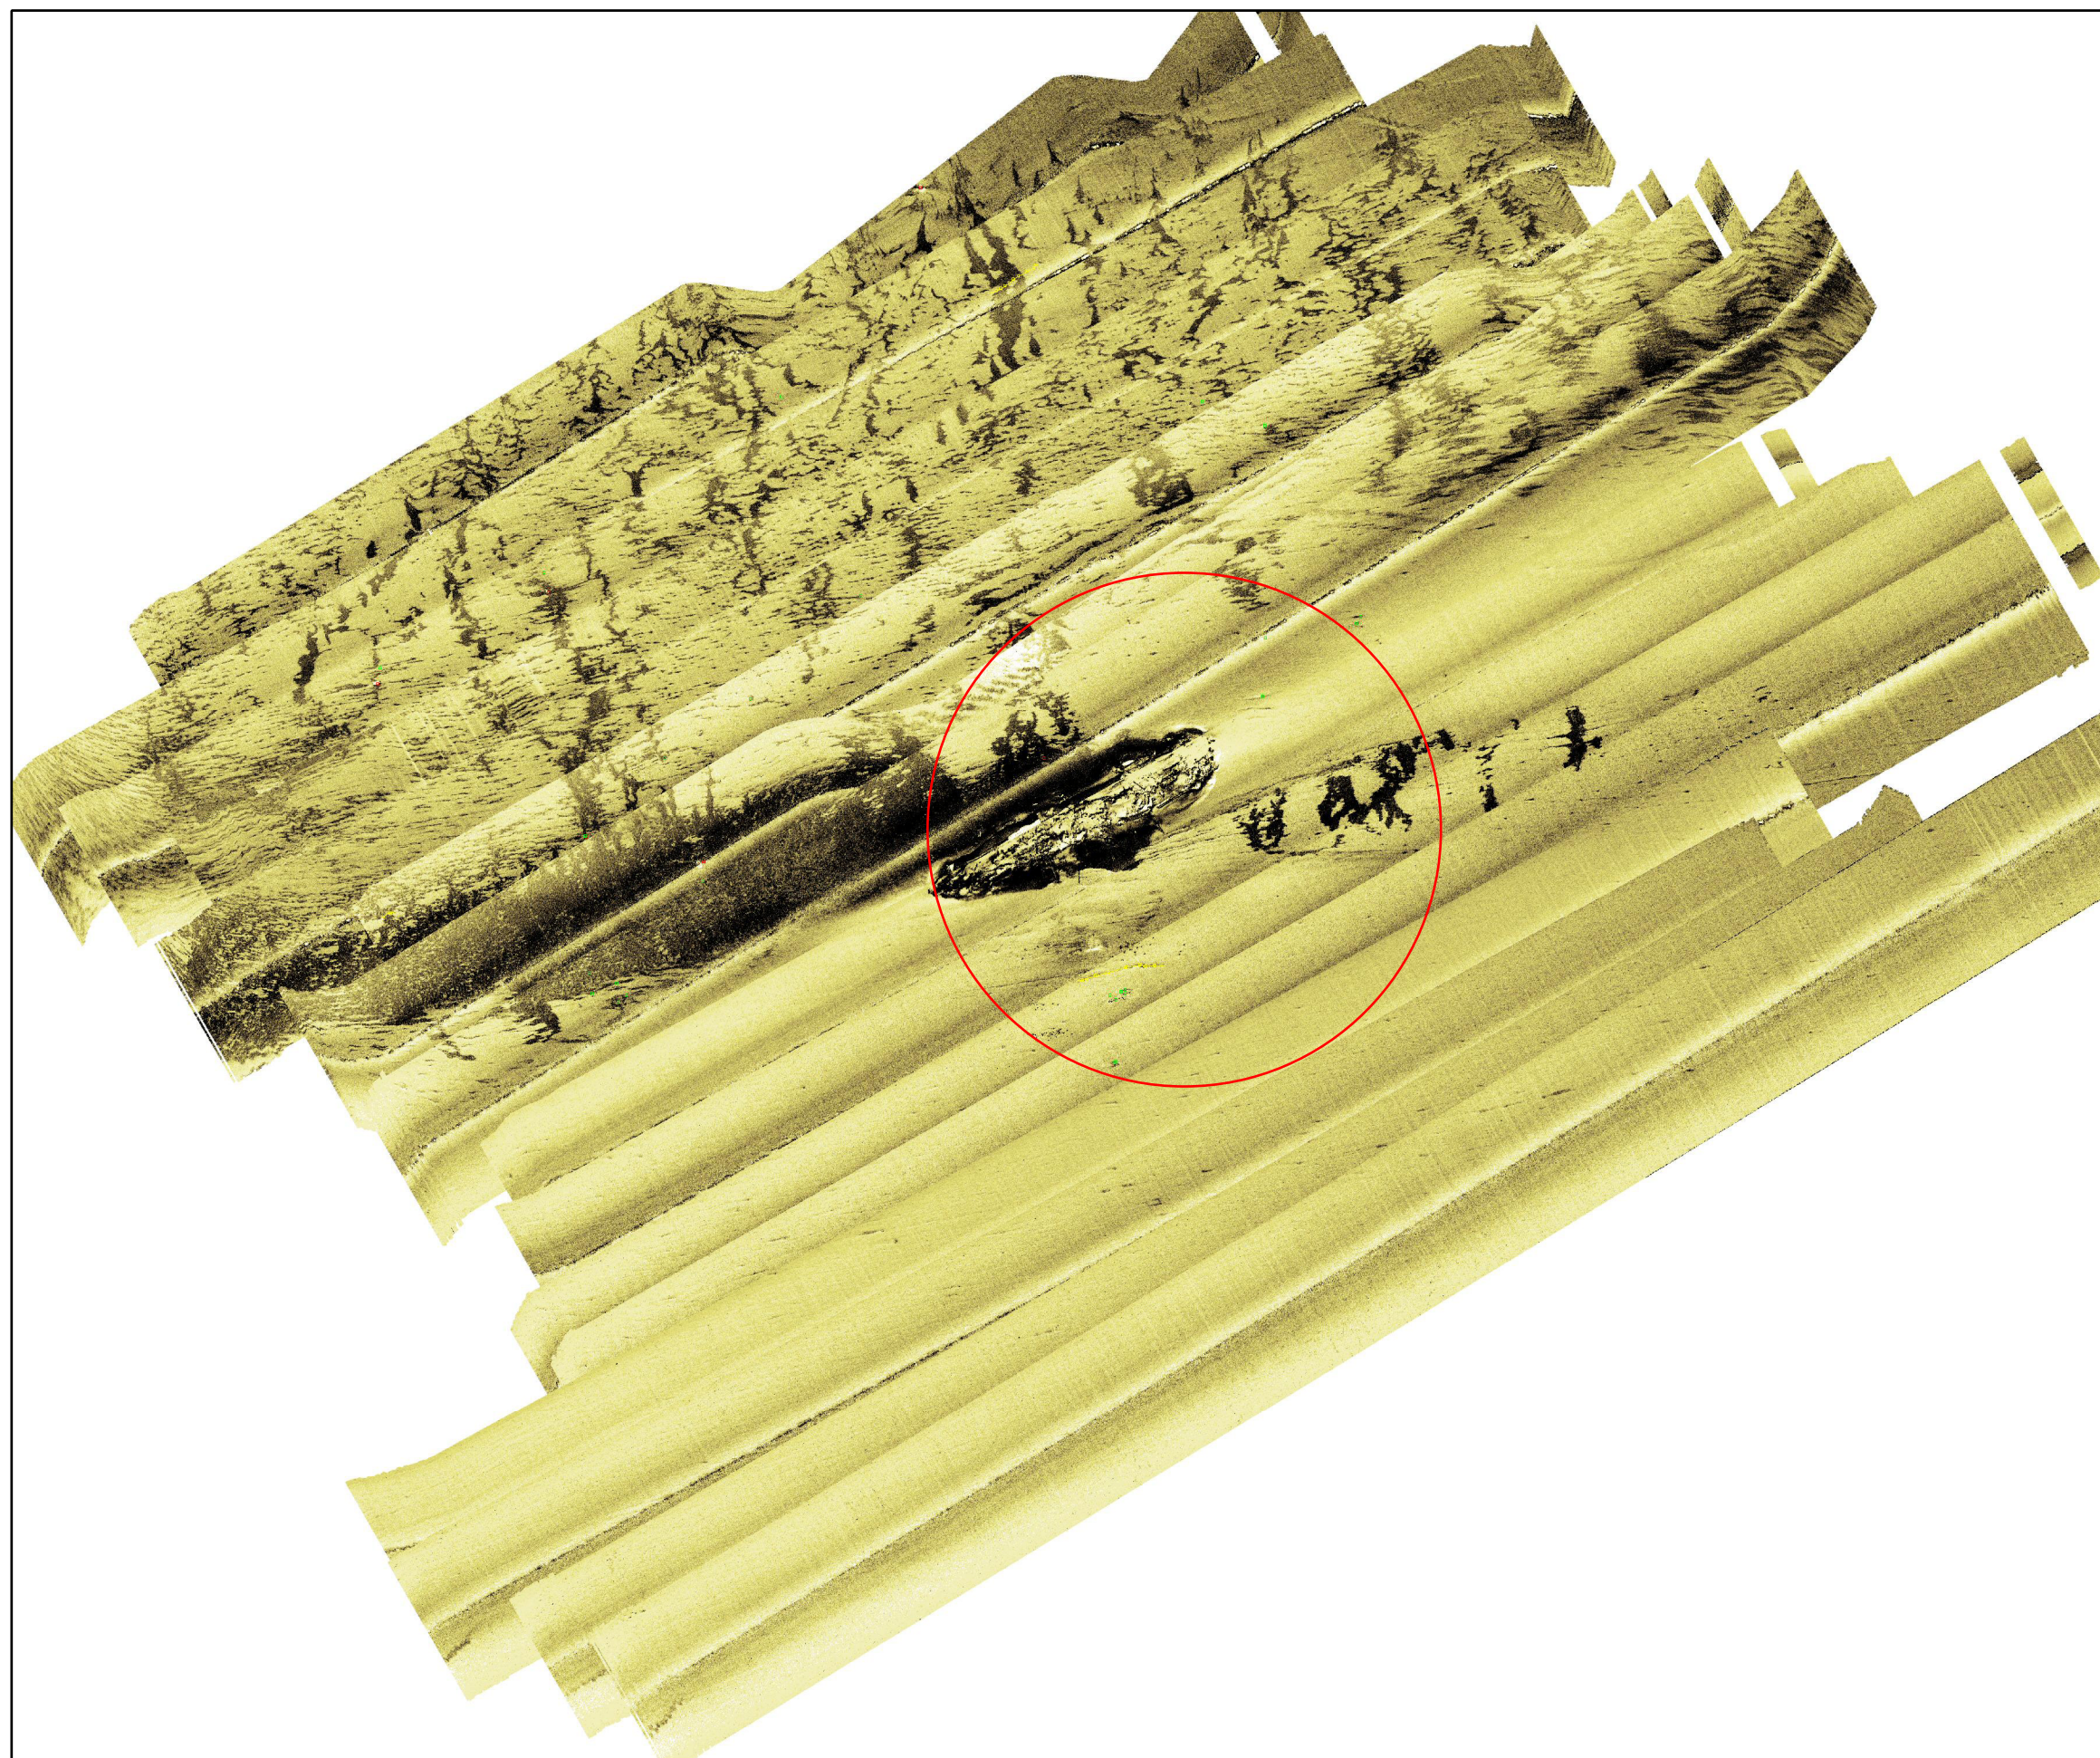
- 5.3.7. Approximately 80 metres south of the main wreck site a collection of objects, including the base of a buoy (**WA3033** and **WA3034**) and associated objects (**WA3030**, **WA3031** and **WA3032**), were identified. Also in this area were an unidentified object (**WA3028**), a length of rope/cable (**WA3029**) and numerous small dark reflectors, which may be due to either small (c.0.5 metre) objects or the seabed geology.
- 5.3.8. Immediately to the north of the main wreck site there are very few identifiable objects. This may in part be due to the complicated seafloor geology of this area, however one object (**WA3014**) has been recorded as standing proud of the seafloor.

- 5.3.11. Approximately 200 metres south-west of the main wreck site, and on the southern edge of the scour mark, is an object (**WA3016** and **WA3024**) which appears to be a thin circular structure approximately nine metres in diameter. This object is apparently of anthropogenic origin and may have been part of the *HMS Campania*'s anchoring/mooring system. Alternatively it may be part of the Royal Navy's degaussing equipment. However, if the latter is accepted then a number of similar objects may be expected within the same area. No other such objects were observed.

Designated Area

- 7.1.5. The current designated area does encompass the main structure of *HMS Campania* but there are a number of anomalies outside the designated area that may also be important elements of the site. It is recommended that these be investigated by a diver survey in order to assess their archaeological importance before any recommendation could be made on whether the designated area should be extended to include them.

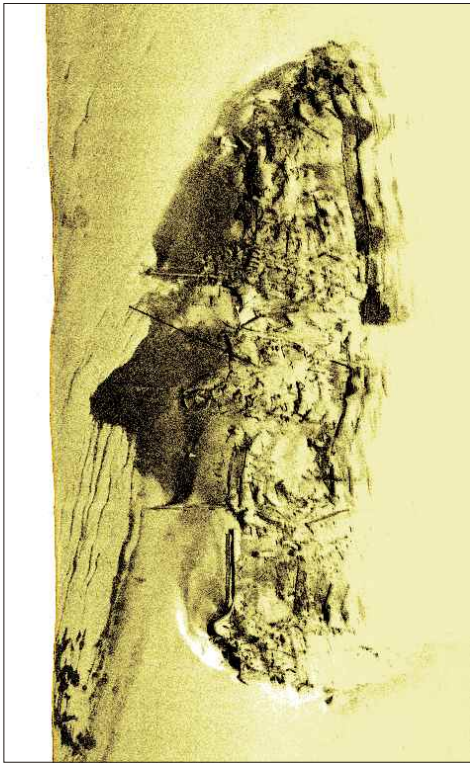
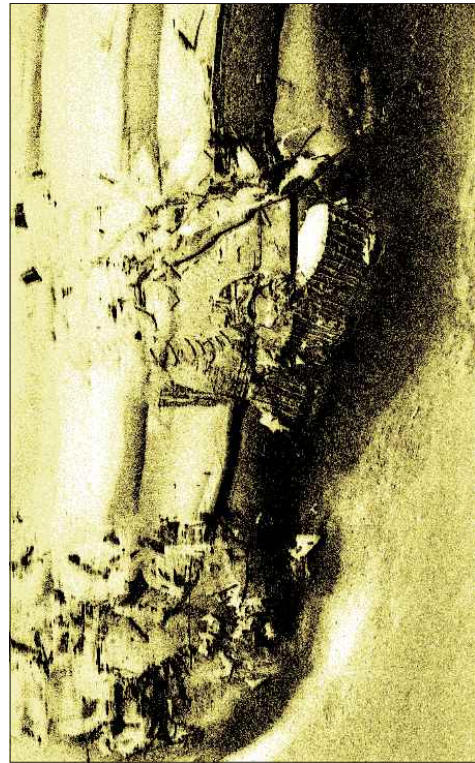
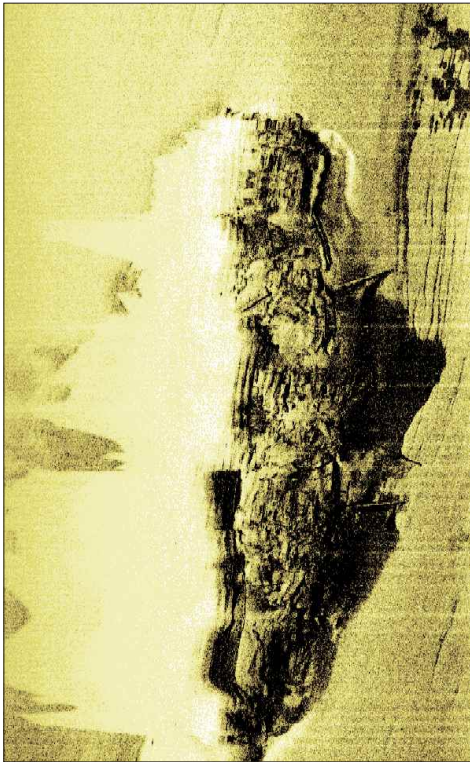
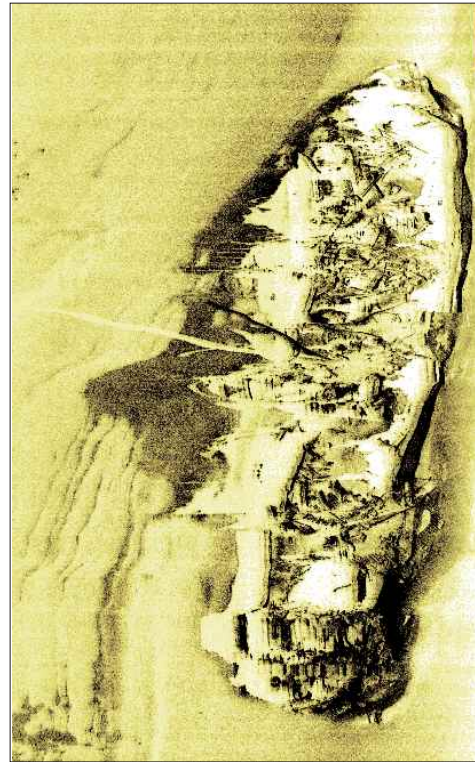
- 5.3.2. The image shows that there is a large amount of structure still present and this has resulted in a complex appearance of the wreck, as shown in **Figure 3**. However, a number of features can be observed in the images. These include part of the flight deck, which has a distinctive lobe shape at the bow of the vessel, and parts of the cranes, of which there were three down each side (**Figure 3**).

- 5.3.3. In 1921 parts of the vessel were dynamited to remove the upstanding features on the wreck that had been deemed to be a hazard to shipping. Some of these features, including the main mast, can be identified in the sidescan image running down at an angle from the wreck onto the seafloor (**Figure 3**).

*HMS Campania Image 1*

*HMS Campania Image 2*

*HMS Campania Image 3*

*HMS Campania Image 4*

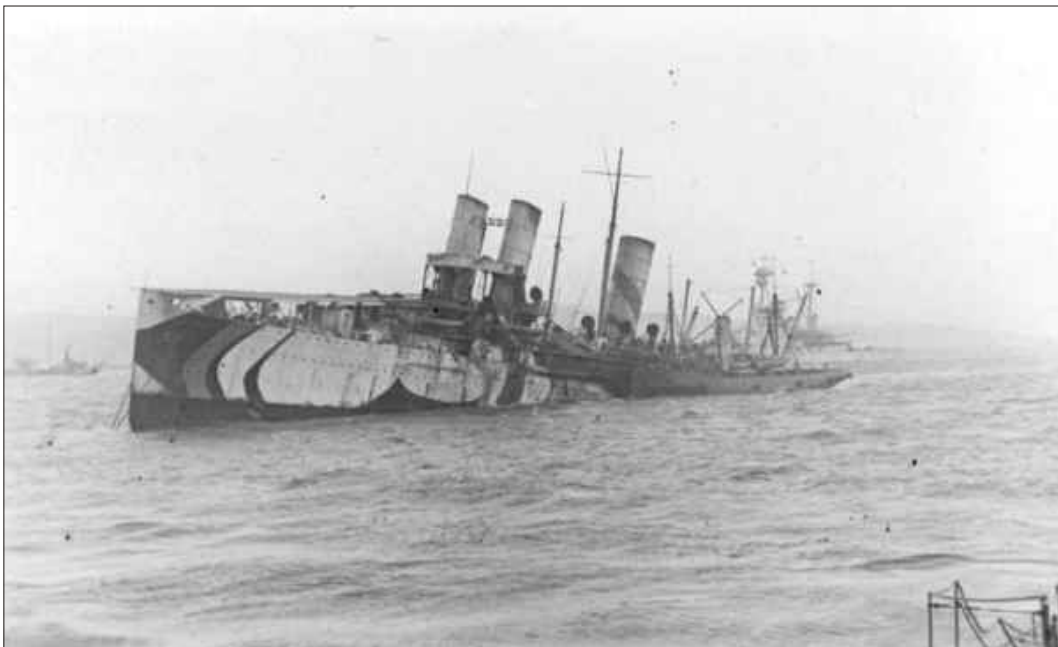
Plate 2. *HMS Campania* sinking following a collision in 1918
