Unknown Wreck, Drumbeg, Highlands

Undesignated Site Assessment Report

Title	Undesignated Site Assessment: Unknown Wreck, Drumbeg, Highlands
Principal Author (s)	John McCarthy
Managed by	Toby Gane
Origination date	25/09/2012
Date of last revision	013/11/2012
Version	83800.15.04
Wessex Archaeology QA	Graham Scott, Dan Atkinson, Jonathan Benjamin
Status	Final Version
Summary of changes	
Associated reports	N/A
Client Approval

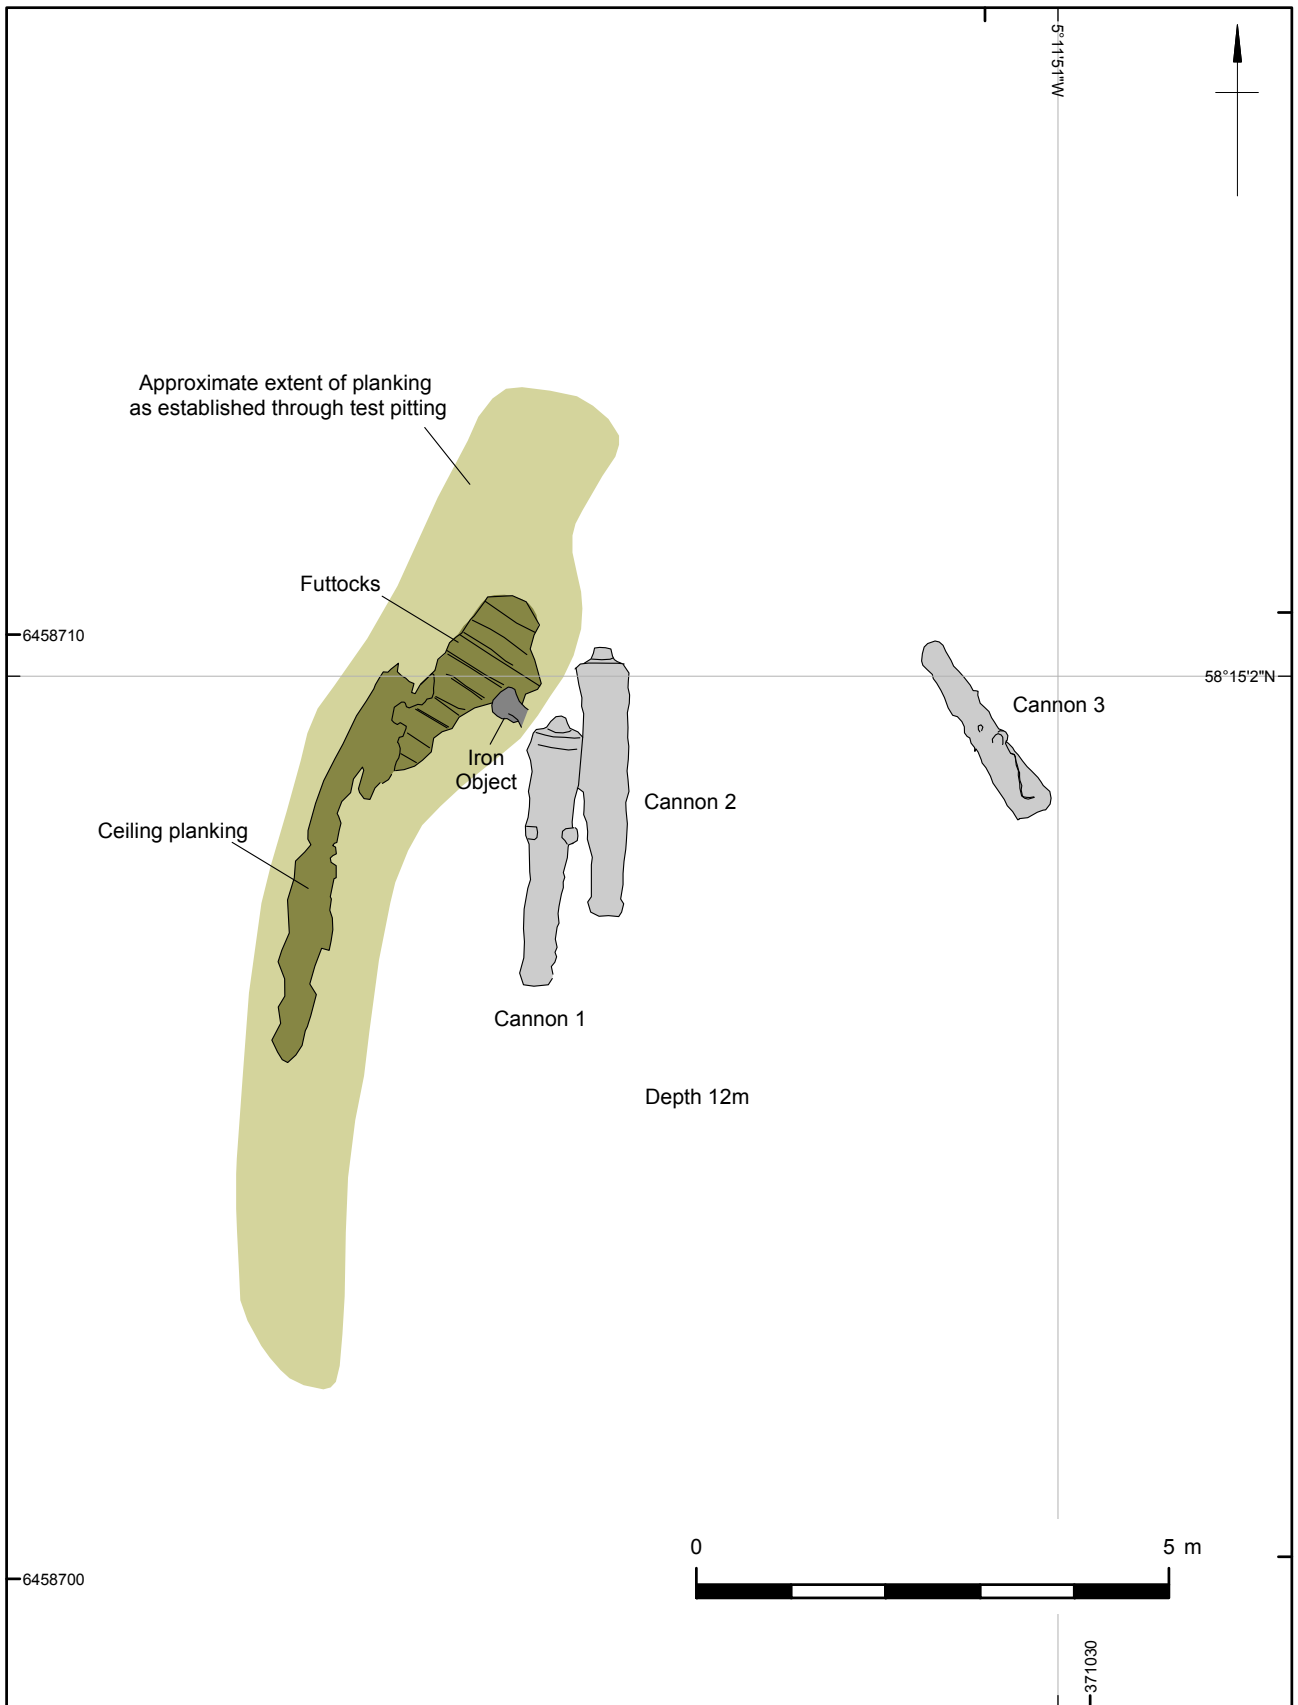
Figure 2

The archaeological features around the cannons

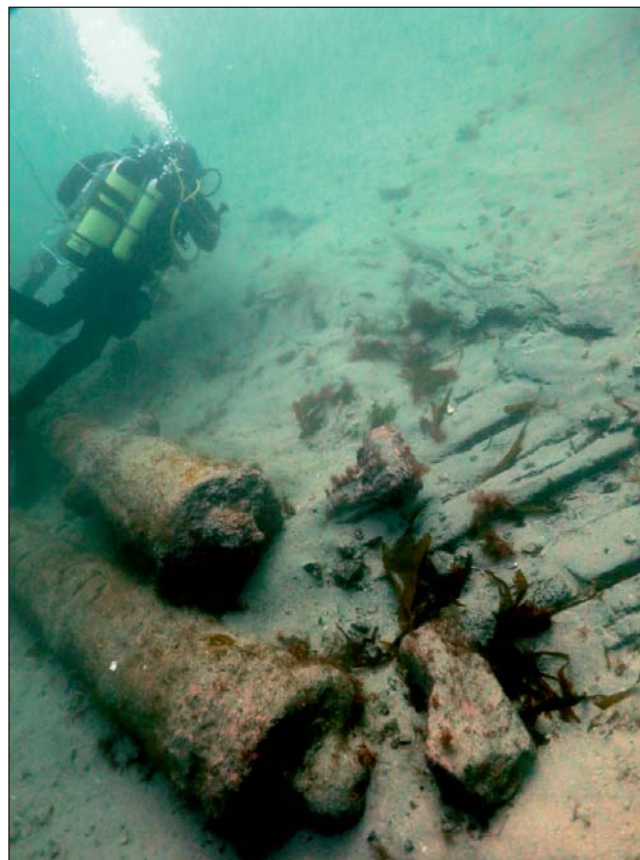
- 5.3.6. Cannon 1 had a total length of 2.23 m. A well-preserved cascabel was noted. No evidence of loops or handles was noted. A raised band around the edge of the breech was clearly discernable. Cannon 2 was similar to Cannon 1 in most respects. Its total length appeared to be slightly longer at 2.26 m and its breech was somewhat smaller at 42 cm although this discrepancy may be a result of concretions. The muzzle face was less concreted. Cannon 2 lay on its side, obscuring the lowermost trunnion. Cannon 3 was significantly smaller than the other two with a muzzle to breech length of 1.9 m. It had a muzzle face diameter of 12cm but was too concreted for a muzzle mouth measurement. The cannon had trunnions but no cascabel or button. Cannon 3 showed evidence of areas of removed concretions around its breech. This was a result of early investigations by the local divers. When no well preserved surface was encountered no further removal of concretions was carried out and the cannon were not moved. The depth of removal is relatively shallow and confined to a small area of the side of the cannon.

Plate 2: Photographs of cannons 1 and 2

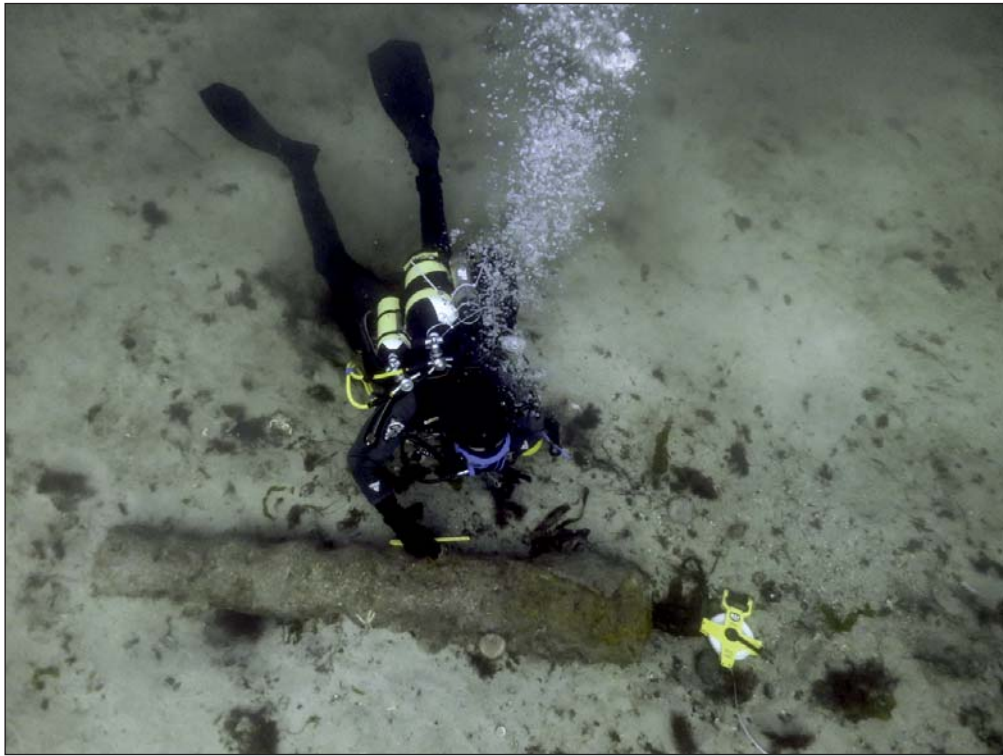
Plate 3: Photograph of cannon 3

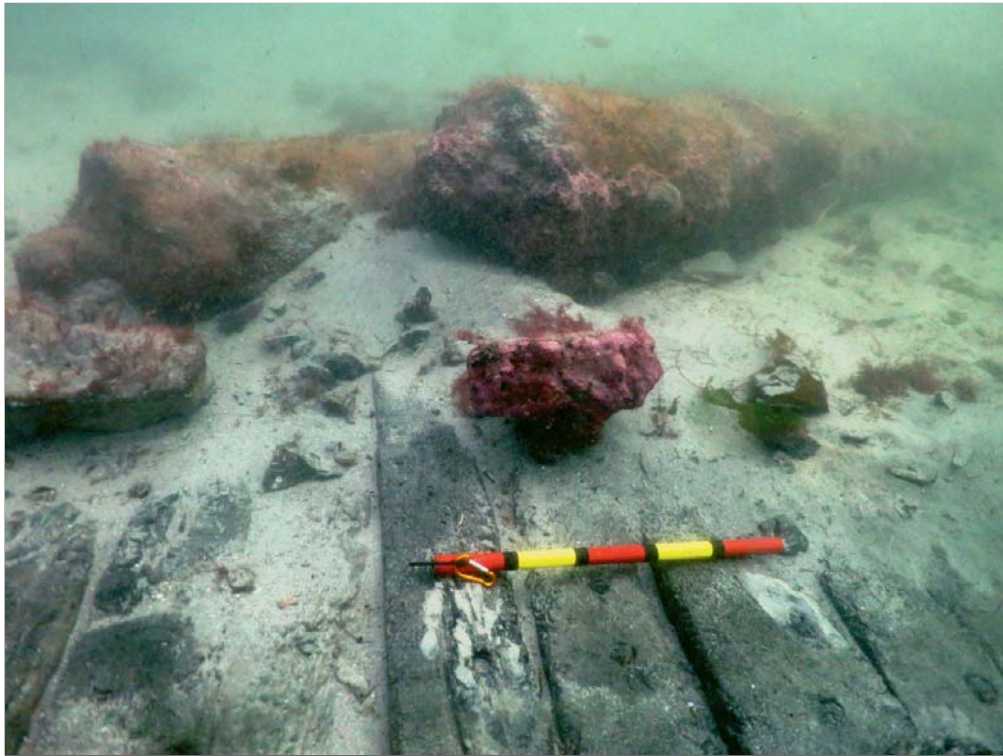
Plate 5: Concreted object beside Cannon 1

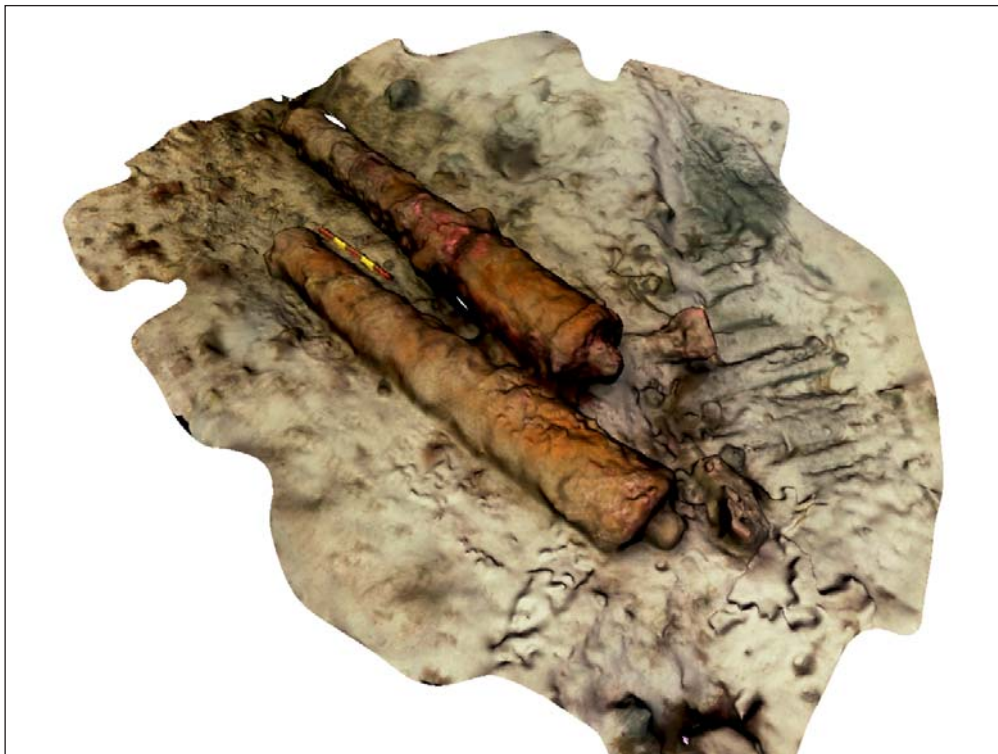
Plate 6: Photogrammetric Model of Cannon 1 and 2

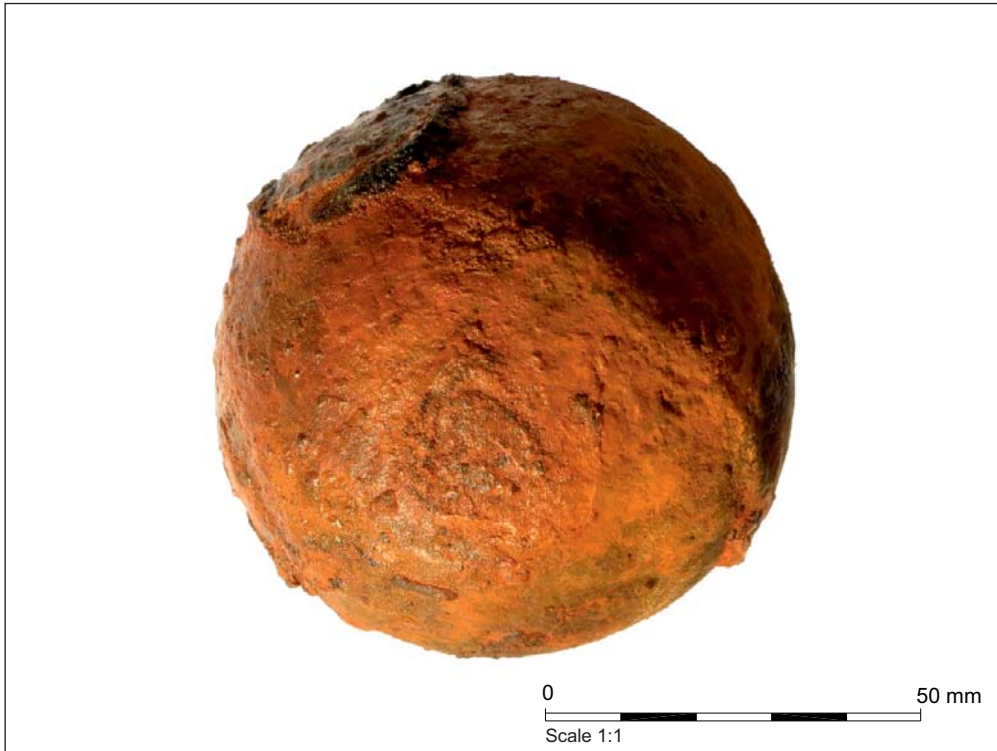
- 4.2.6. The divers recovered approximately six cannonballs in total, all from sediments in the immediate vicinity of the cannons. These were found to be of two distinct sizes, three of approximately 75mm (2.95 inches) and three of approximately 100mm (3.93 inches). All but one of these was in a degraded state and disintegrated shortly after recovery. One of the 100mm cannonballs was in good condition and was stored in fresh water at Mr. Mackay's home. A well-preserved but fragile rigging block and galley brick were recovered by Mr. Errington at the same time and also stored in fresh water at Mr. Mackay's home.

Plate 7: Cannonball recovered by local divers, with a diameter of 75mm

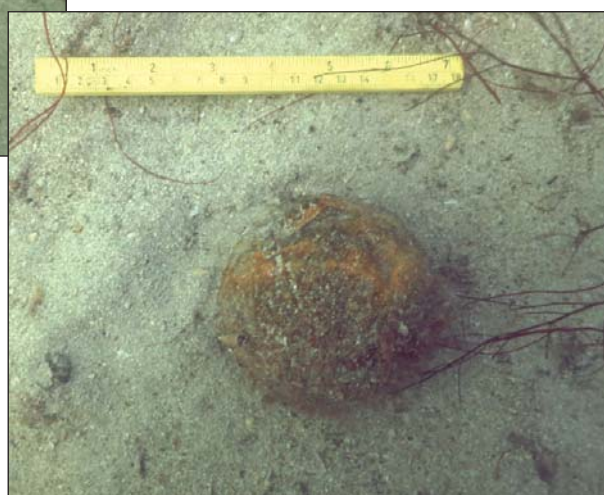
- 5.3.10. A number of cannonballs have been recorded on the site, both during previous excavation by the local divers and during the WA survey. As described above a total of six cannonballs were removed from the site by the local divers although only one was in good enough condition to survive for long out of the water (**Plate 7**). These were found in a cluster adjacent to, or just below one of the cannons and may have been stored together. This cannonball has been passed to conservators and measures around 75mm in diameter and now weighs 641.2 grams (1.4136 pounds). It appears to be cast-iron rather than lead and in this case its original weight was closer to 4 pounds. Two further cannonballs were noted during the WA survey. These were recorded photographically (**Plate 8** and **Plate 9**) but neither was removed from the site. One of these was highly corroded and was lying in mobile sediments adjacent to the cannons. Cannonball 2 was much better preserved and was found on the seabed several metres to the south. This had a diameter of approximately 100mm.

Plate 9: Cannonball 2 recorded *in-situ*

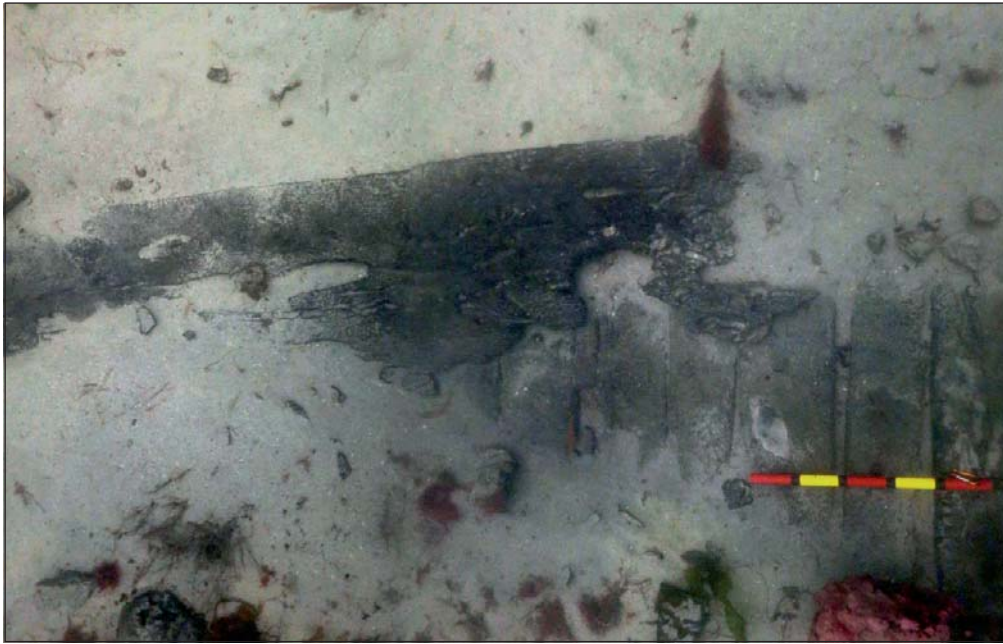
Plate 10: Photograph of ceiling timber framing showing damage by shipworm

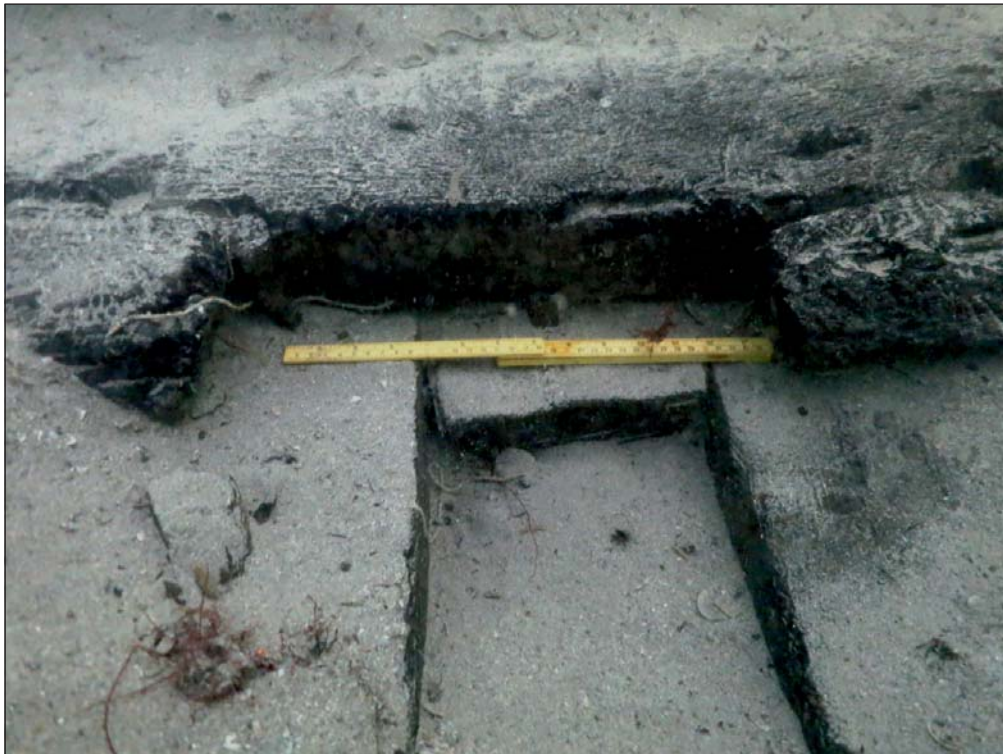
Plate 11: Section of timber framing

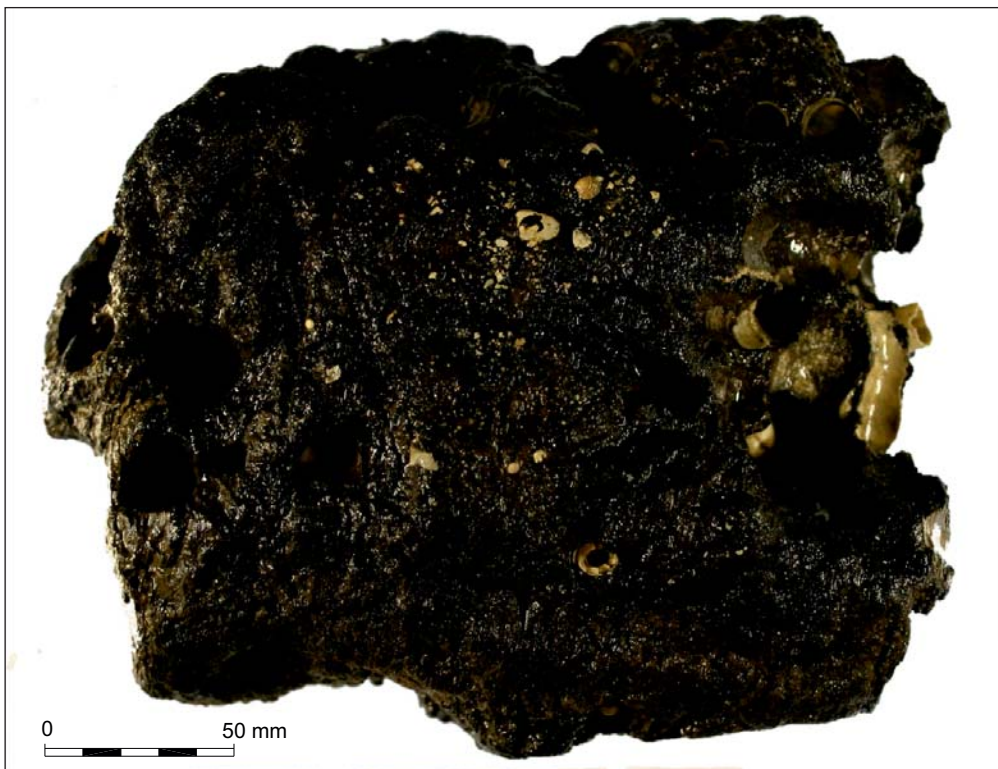
- 5.3.14. Once recorded photographically and measured the exposed timbers were recovered with sediment to minimise risk of further exposure. A single loose and degraded timber fragment, apparently the end of a futtock, was found on the seabed in the vicinity of the primary hull remains. This was recovered by hand for further analysis (**Plate 13**).

Plate 13: Loose timber fragment (possible futtock) showing damage by shipworm (courtesy of AOC Archaeology)

- 7.1.5. Dendrochronological analysis on well-preserved timbers should be considered in the future. WA recommends sending the timber fragment (SF007) to a dendrochronological specialist for wood identification prior to any further survey at the site to allow for a sampling strategy to be outlined. Although SF007 itself is not likely to be suitable for dendrochronological analysis due to the amount of shipworm damage it may help to inform future sampling strategies. Pending a discussion with specialists, it is the opinion of WA Coastal & Marine that any future dendrochronological sampling should be targeted on the framing timbers and in particular on the broken eastern edge. In order to take samples from this area use of a hand saw or underwater chainsaw may be necessary. A more complete exposure and survey of the timbers in the immediate vicinity would therefore be a prerequisite to any such sampling strategy.

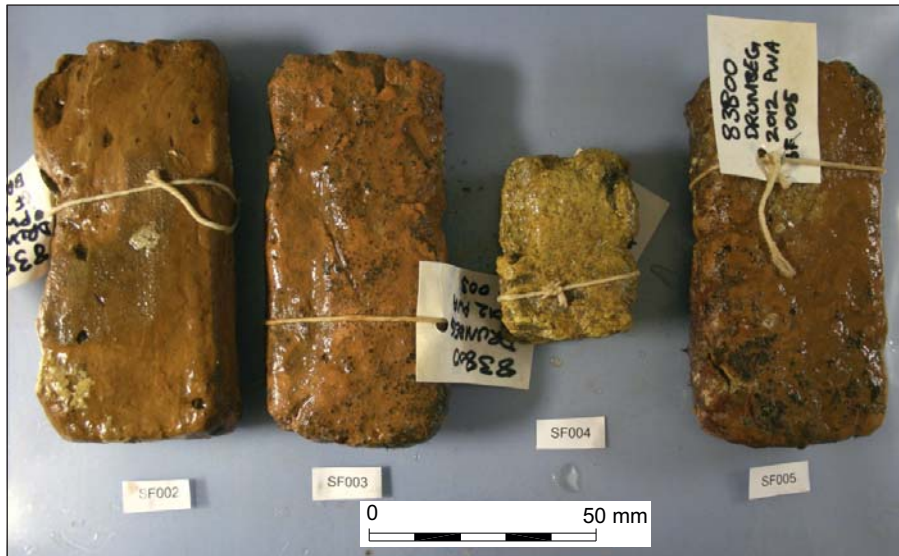
- 5.3.15. A total of five bricks were recovered in total, one of which was passed on by the local divers and four of which were recovered during the WA survey (**Plate 14**). Four of the bricks are broadly similar, measuring approximately 20 x 10 x 5 cm and of orange colour. The fifth is only a half brick and was found amongst the rocks to the north of the site. It is far more yellow in colour than the others. After their location was recorded these were recovered from the site in order to allow for the possibility of thin-section analysis.

- 5.3.16. Similar bricks have been found in other wrecks of this period in Scotland but are more commonly described as yellow. Parallels from 17th/18th-century wrecks of international origins include the *Adelaar*, the *Kennemerland*, the *Lastdrager* and the Fuday wreck. Those found in the *Kennemerland* measured 18 x 8 x 3.5 cm (Forster and Higgs 1973, 296); the *Lastdrager* 17 x 7 x 3.4 cm (Sténuit 1974, 255) and Fuday, 20 x 12 x 6 cm. The Fuday bricks resembled those on the *Kennemerland* and were interpreted as being typical of Dutch origin 'overij sselse steen' (Prescott *et al.* 2008, 11). In other cases these bricks have been interpreted as galley bricks, particularly where evidence of burning on the face of a brick permits such an interpretation (e.g Kinlochbervie). The bricks lack a frog (i.e. a hollow on their upper and lower faces) and as this was relatively common on bricks from the mid-1800s suggests that they are probably earlier..

Plate 14: Galley-bricks (courtesy of AOC Archaeology)

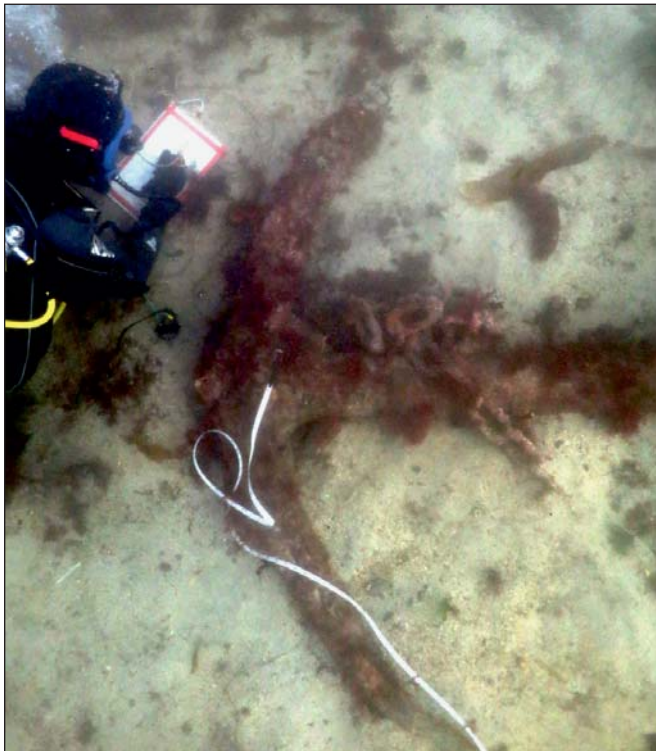
- 5.3.18. Two anchors have been discovered in possible association with this wreck. These will be referred to as Anchor 1 and Anchor 2. Anchor 1 (**Plate 15**) was found adjacent to the cannons by the local divers several years before the wreck was reported to Historic Scotland and seems likely to be associated with the wreck. This anchor was removed to a distance of about 350 m to facilitate an unsuccessful attempt at metal detecting on the site. The new site of this anchor was visited by WA divers during the recent survey. The anchor was found to be lightly covered with red seaweed which was not removed. The shank of the anchor measures 3.08 m long and approximately 14 cm in diameter, widening to 20 cm at the junction with the arms. The anchor has a rounded crown and there are no signs of a stock (**Plate 16**). No ring is present at the top of the anchor although the shaft appears to change from a cylindrical to a square cross section here and there is a mark indicating a nut near the terminal. It is probable that a wooden stock consisting of two beams was attached at this point. One of the flukes appears to have been removed or decayed away at some point while the other is quite degraded. The flukes appear to have been 40 cm long on arms with a total length of 85 cm. The total width of the anchor perpendicular to the shank is 1.65 m. A chain is wrapped around the anchor but this is thought to be a modern chain attached by the local divers when they lifted and moved the anchor.

Plate 15: Anchor 1

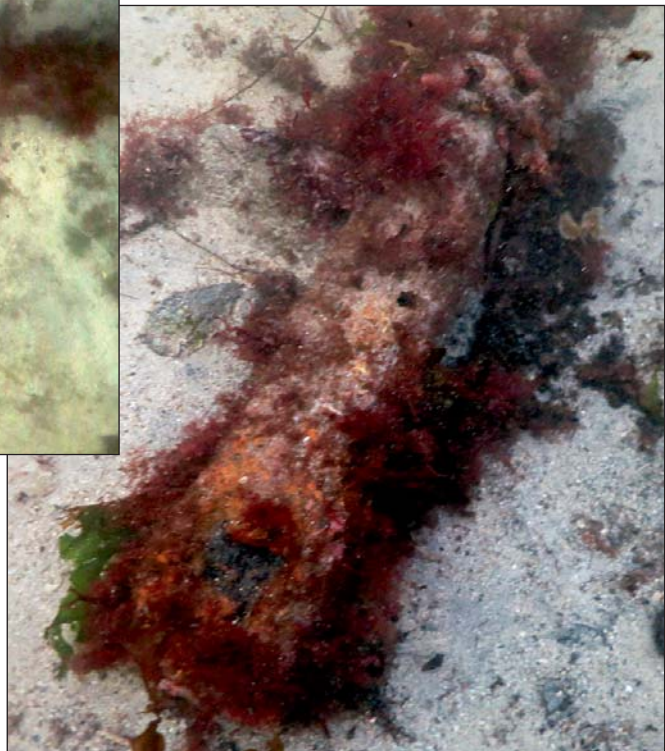
Plate 16: The stock end of Anchor 1

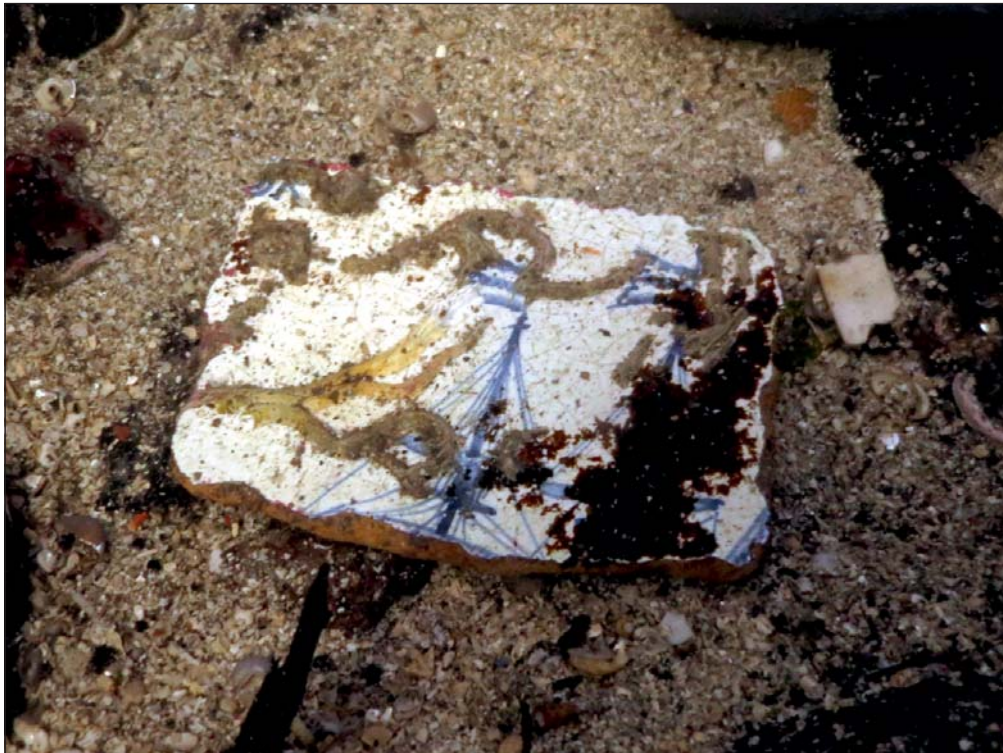
5.3.20. The broken Delft tile recovered to the north of the cannons appears to be one of the most easily dateable items recovered (**Plate 17**). It is the upper half of a Delft tile depicting a three-masted ship flying the Dutch flag. Only the rigging and upper masts are visible as well as the corner decorations of the upper right and upper left corners. There are several worm casts on both sides of the tile and the edges and back appeared eroded. The break through the centre of the tile does not appear to be fresh.

5.3.21. A local researcher in Drumbeg, Mari Mackay, was able to provide the survey team with a rough date for the tile prior to the completion of fieldwork, placing it between approximately 1650 and 1750. WA Coastal & Marine pottery specialists and Ian Betts of MoLAS were later consulted on the tile. They suggested a likely date in the second half of the 17th century and found examples of close parallels for the design which have both the ox-head corner motif and the single-tile three-masted ship design. Dr. Betts uncovered numerous references to tiles of this type, all of which date to the second half of the 17th century. These include Van Dam (1991, 80, no.s 89 and 90), Van Sabben and Hollem (1987, 54, no. 162), Schaap *et al.* (1984, 145, no. 177), and Pluis (1997, 385, A.03.07.10).

Plate 17: 17th/18th century Dutch Delft tile depicting three-masted ship *in-situ* on the seabed at the mouth of a gully

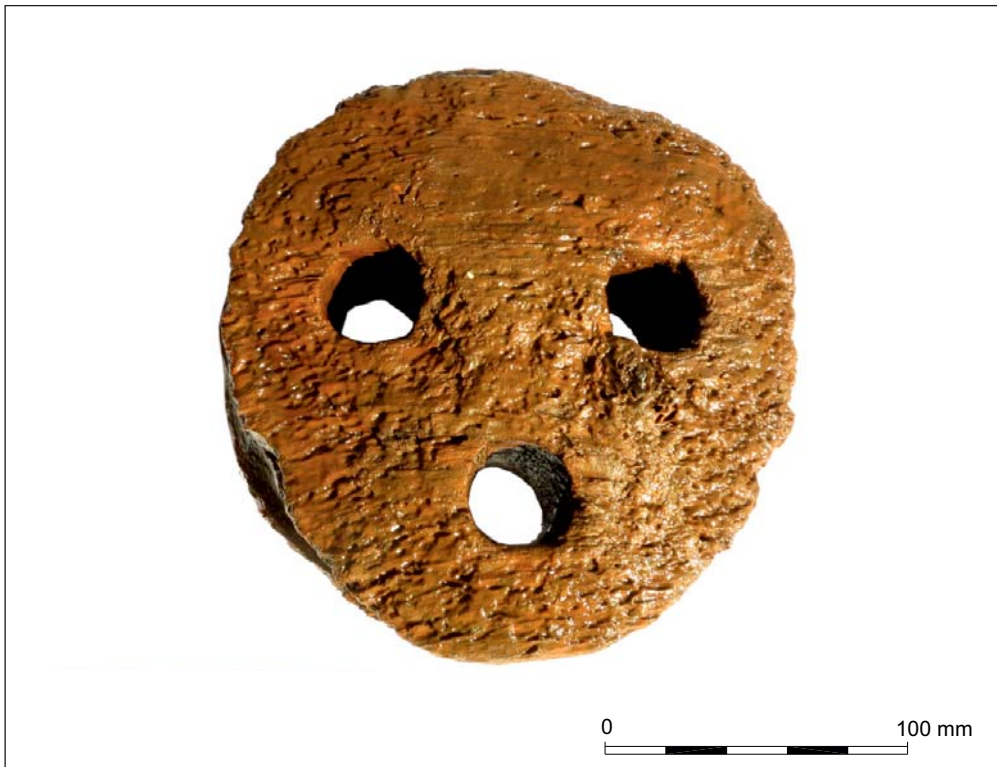
- 5.3.23. A dead-eye rigging block (**Plate 18**) of approximately 22 cm diameter was recovered by local divers while undertaking small-scale dredging around the cannons. The block was recovered and stored in fresh water at Ewen Mackay's residence and was passed to the WA dive team in Drumbeg at the end of the survey. Deadeyes are a common piece of rigging with a long and ongoing usage., commonly found in an upper and lower row near the base of the near the gunwales of a ship and are used in the hauling and fastening of rigging. They are often made of *Lignum vitae* although no analysis has yet been carried out on this example.

Plate 18: Local diver finds: Rigging block
