GLEN DYE STEADING, GLEN DYE BANCHORY ABERDEENSHIRE

**- Standing Building Recording -
Carried out 17th September 2009
by
Murray Archaeological Services Ltd**

**Report No: MAS 2009-38
by
H K & J C Murray**

- Standing Building Survey -

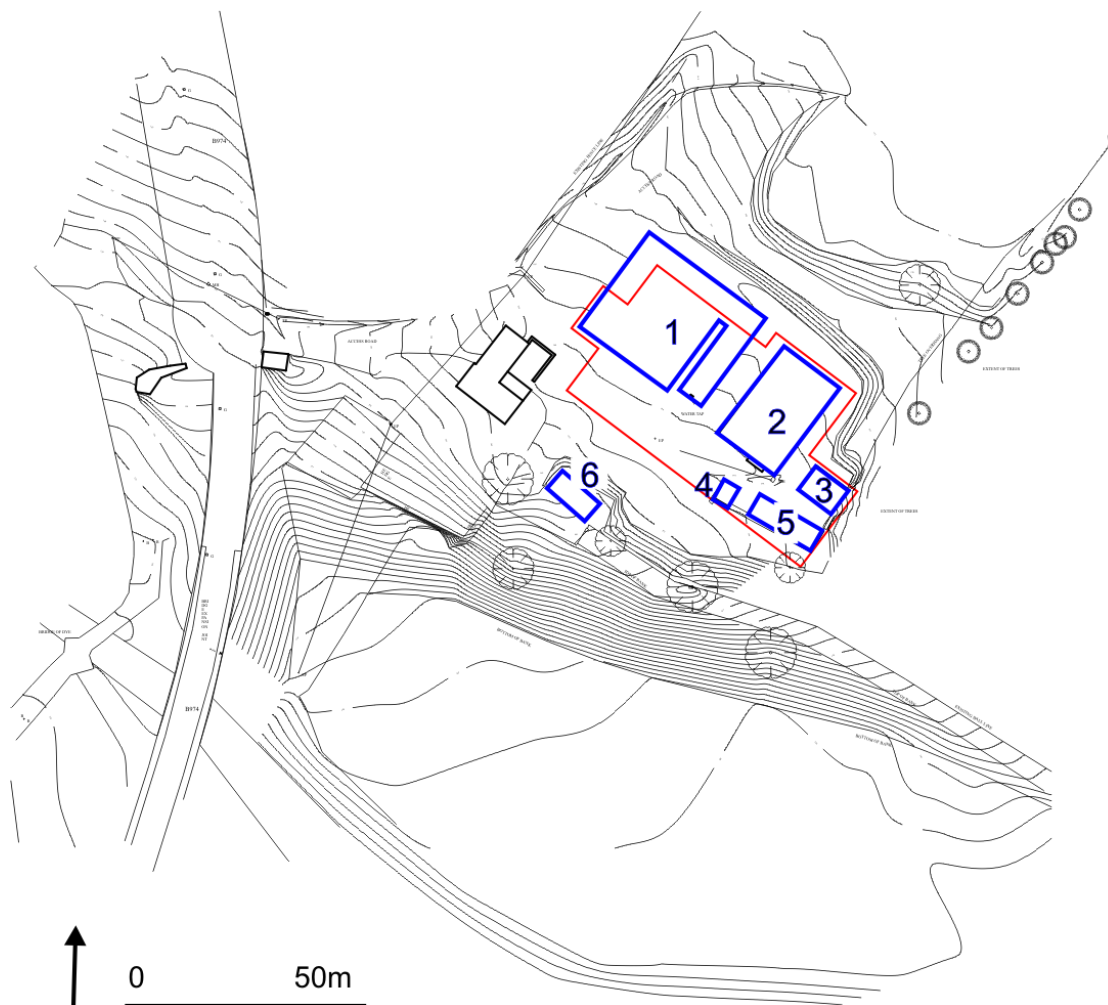
Illus 2 Overall site plan (Annotated from plan by Nord Architecture)

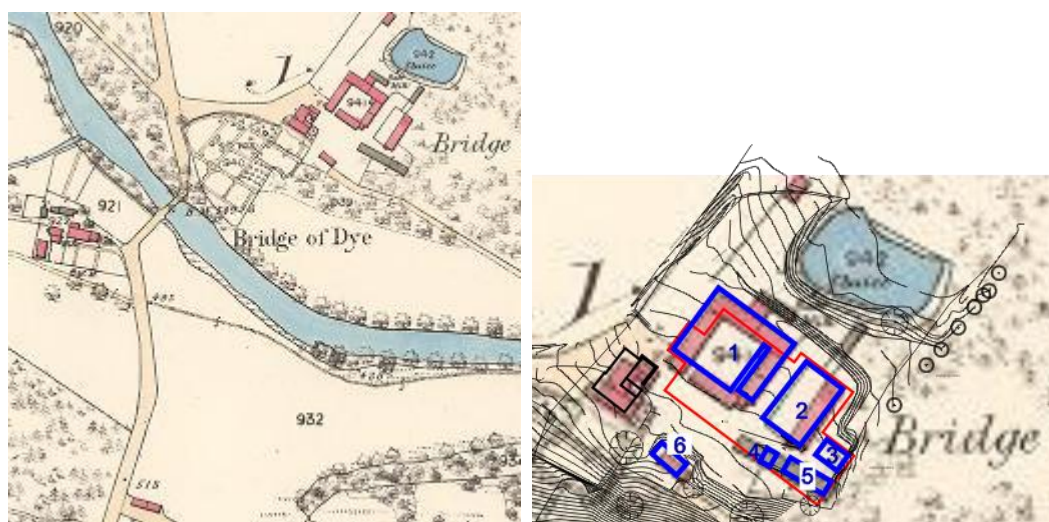
4.2 The 1st edition Ordnance Survey map, surveyed in 1863 (published 1868. Kincardine Sheet XV) shows the Improved steading, much of which survives. Building 1 is shown as a U-plan steading with an additional range across the S side forming a rectangular court within. The N range is shown with an internal dividing wall and a small stone building attached to the middle of the N side (the scars of both the internal wall and the external building survive). A wooden building N of this may have housed the saw mill (no trace). On the 6"/mile map this is marked as a saw mill. A small roofed stone building to the N of the steading and W of the Mill Dam survives today as a corner of a stone wall (Digital photographs 227-8).

Building 2 is shown with the W side an open court. A wooden building to the N of it appears to connect Building 2 with the mill dam. Building 3 (smithy) is not shown. A wooden building is shown on the footprint of Buildings 4 and 5. Building 6 is shown.

Illus 3 1st edition OS map (25"/mile) surveyed 1863, published 1868 (www.nls.ac.uk) Detail with overlay shows site numbers

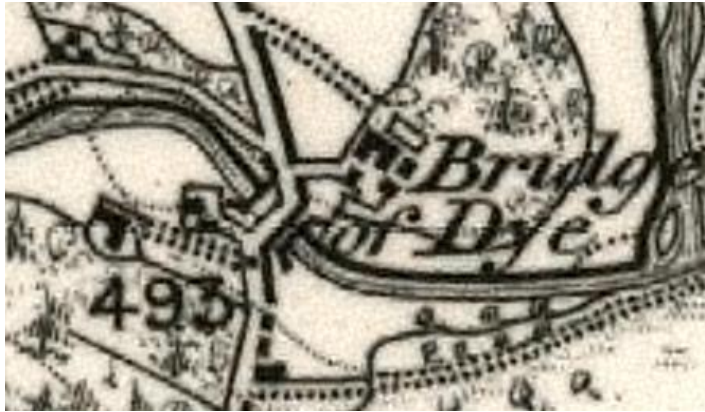
4.3 By the 2nd edition 1"/mile Ordnance Survey of 1894 (pub 1897) the main block of Building 1 appears to have lost its S range and is shown as a simple U-shaped steading. This does not correspond to the plan shown on the 1093 map (below).

Illus 5 2nd edition 1"/mile Ordnance Survey of 1894 (pub 1897) (www.nls.ac.uk)

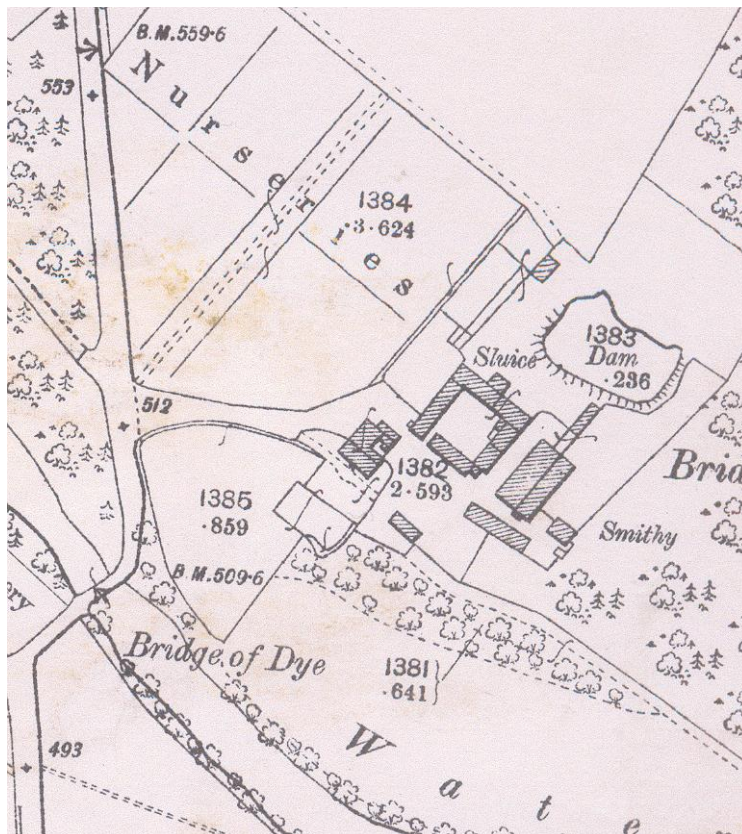
Illus 6 2nd edition 6"/mile O S map of 1903

On the detailed 2nd edition 6"/mile O S map of 1903 the S range of the steading is shown on the same footprint as on the 1st edition. However, the wooden building (sawmill ?) to the N has been removed. The E side of Building 2 has been roofed in

by this stage. Building 3, marked as the Smithy has been built. The building on the footprint of Buildings 4 and 5 has been truncated, no longer extending so far to the W.

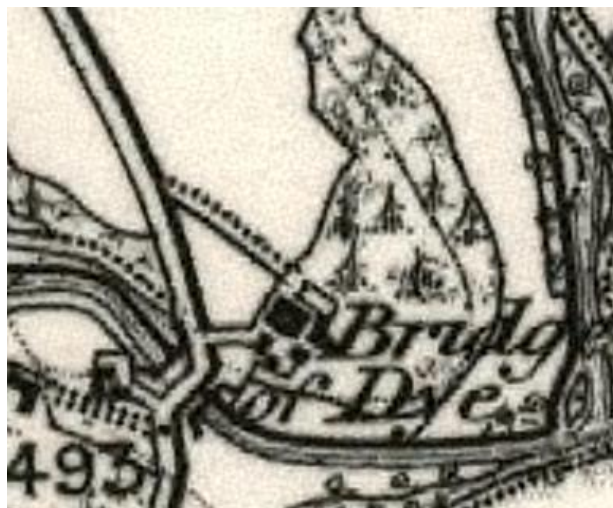
4.4 In the 3rd edition 1"/mile Ordnance Survey map of 1905/6 (pub 1908), the U-shaped court of the main steading block appears to have been filled in to its present outline.

Illus 7 3rd edition 1"/mile Ordnance Survey map of 1905/6 (pub 1908) (www.nls.ac.uk)

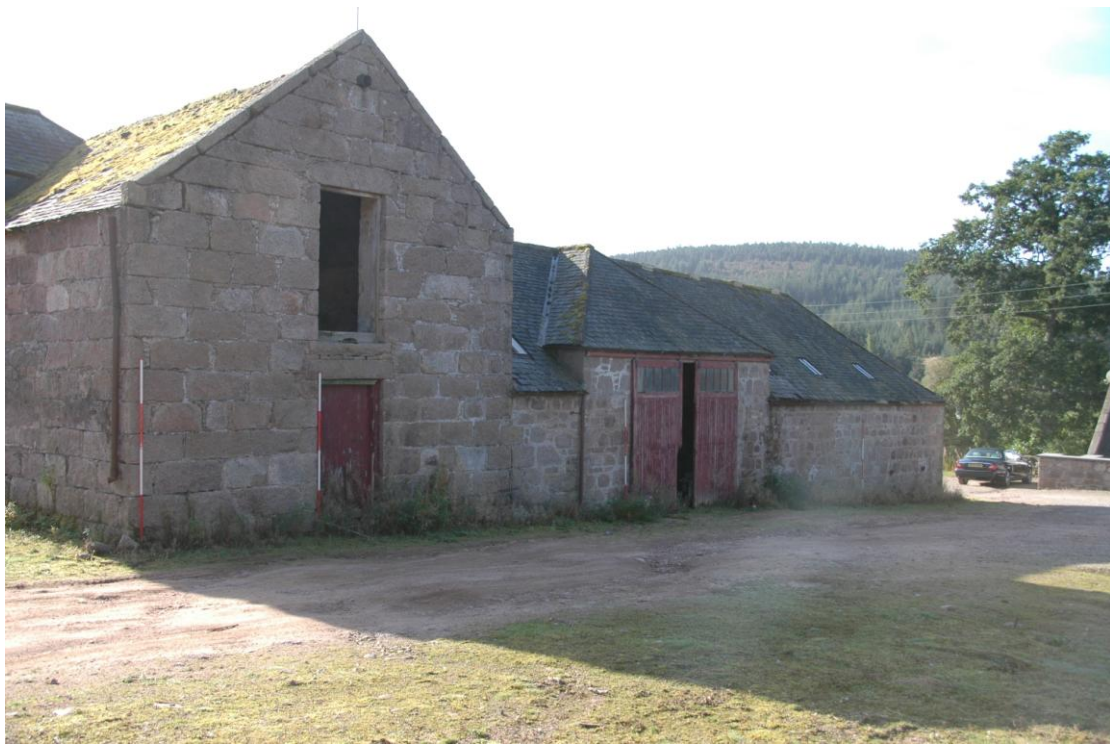
Illus 9 Building 1 from the W with N range on LHS

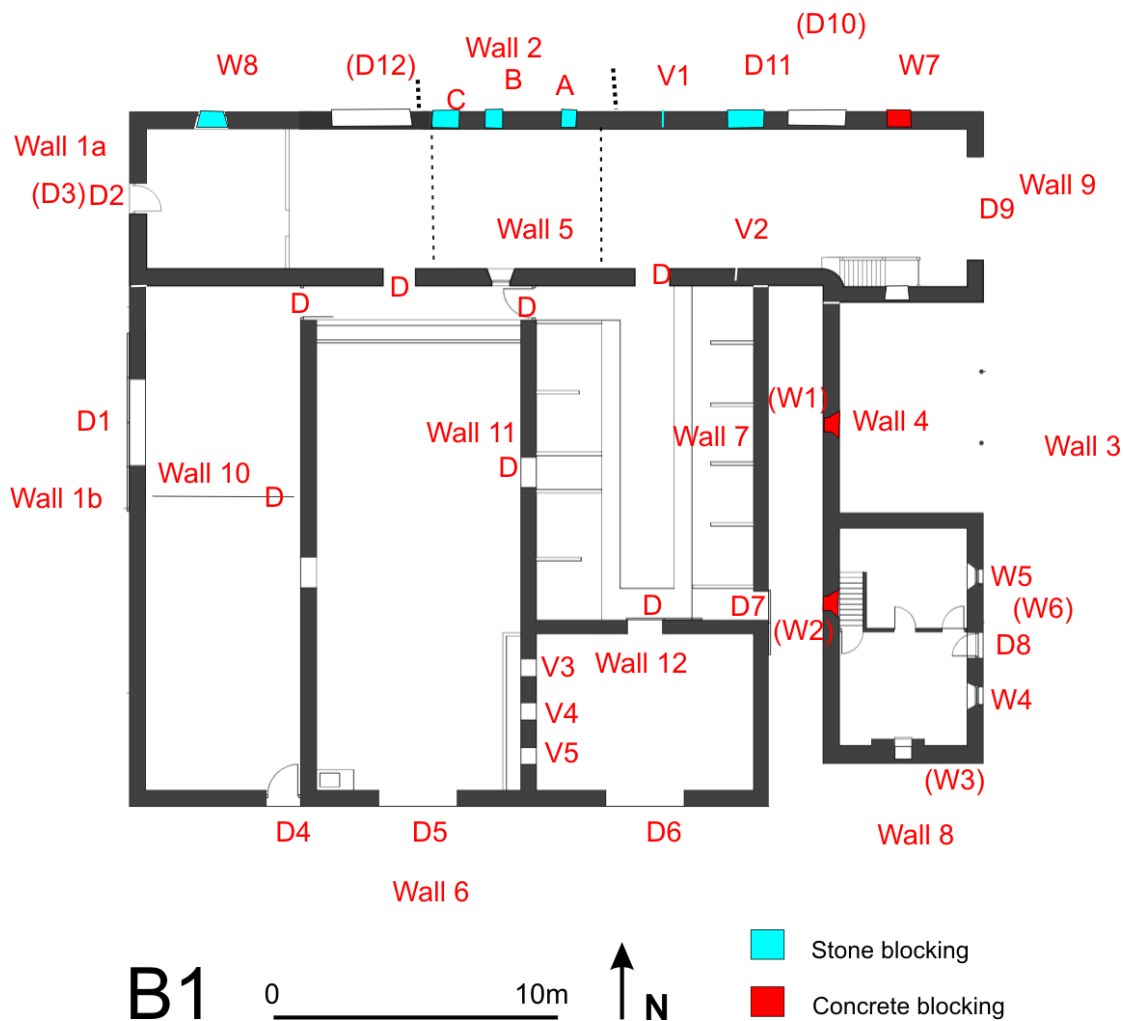
Walls c. 500mm thick of horizontal coursed stone, generally well faced.

The N range walls (Walls 1A, 2, 9, central part of wall 5) are of carefully dressed ashlar blocks of a pinkish granite with small stacks of vertical pinnings between some (but not many) stones. This stonework had been used on all the walls of the N range except where the original E and W ranges and the small N building would have covered it where more roughly dressed rubble stone was used. This difference emphasises the fact that the central part of the S side of the N range would originally have been visible from the original open central yard.

Illus 10 Building 1 Plan (Annotated from plan by Nord Architecture)

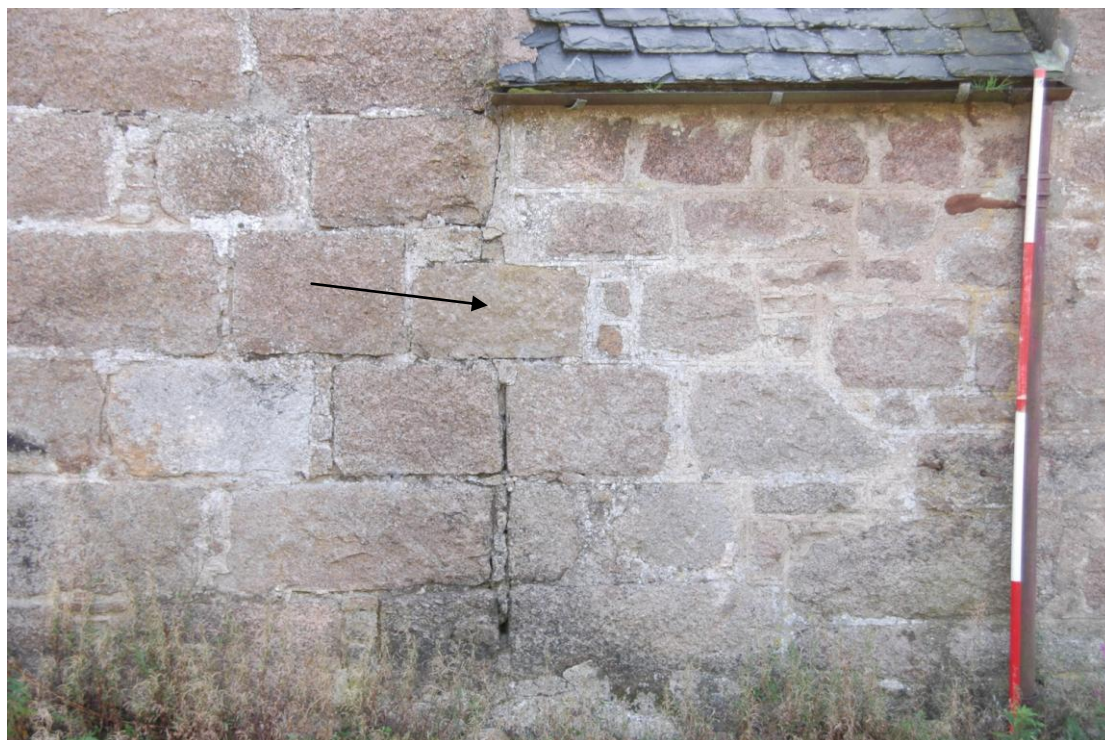
The W wall of the W range (Wall 1b) is of coursed rubble, very distinct from the N range. It abutted the N range wall with a single stone from the N range removed to allow a stone to be set stretching between the two walls.

Illus 11 Building 1 wall 1a and 1b showing different stonework

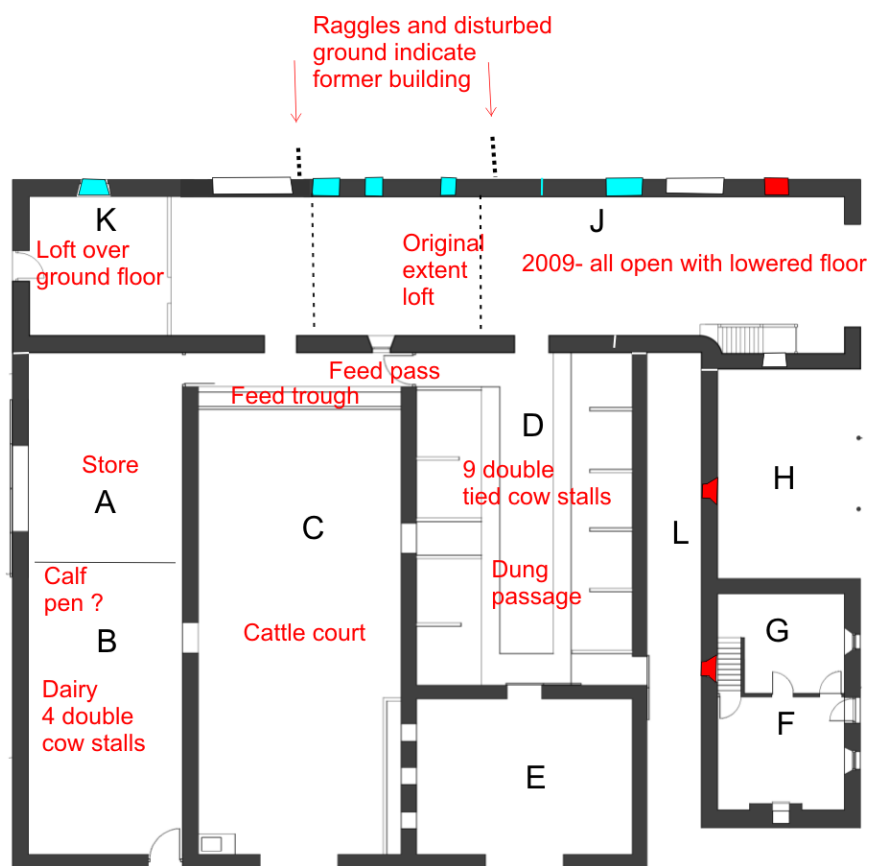
Illus 12 Building 1 functions

Area A: At present Area A is a small store with a large access doorway. However, the division between Areas A and B is made of concrete blocks so originally this may have been a single area.

Area B: Dairy with four double cow stalls along the W wall with dung pass behind. Metal trevies, ties and drinkers remain. The pipe work suggests this was a dairy. The walls are cemented to halfway. There is a penned off area at the N end and an access doorway to Area A. At present this is used for miscellaneous storage.

Area C: Open plan cattle court with feed trough and feed pass at the N end. A second feed trough at S end of W wall. Water tank at SW corner. At present the floor level is between 750mm and 1m below the base levels of internal doors on the E and W. The floor level is likely to have been lowered to allow mechanical mucking out. The original internal doorways were to the dairy to the W and Area E to the E.

Area D: This had a wide doorway to the S and a smaller doorway at the N end to give access to Area A. In the W wall there were 3 vents with wooden shutter. As these were above the E feed trough they may also have been used for putting in feed (possibly turnips if Area D was a turnip store). The floor was cobbled.

Area E: There are 4 double tied cow stalls on W and 5 double tied cow stalls on E on either side of central dung pass and drain which has outflow below floor of Area D. The trevies were of concrete with concrete floor and troughs. Feed/straw access was either from Area D or from the barn, Area H.

Area F: Three cart bays with cast iron pillars supporting the first floor at the front. No maker's marks on the posts. Part of a stone roller against the NE corner would have protected the wall from carts etc.

Area G: At ground floor the S room has a small bruiser with holes in the floor above to pour grain into the hopper. Originally both ground floor and 1st floor had hearths and this appears to have been a bothy. At ground floor level there was a small room at the S end with door and window in the E wall and a stair to the first floor in the NW

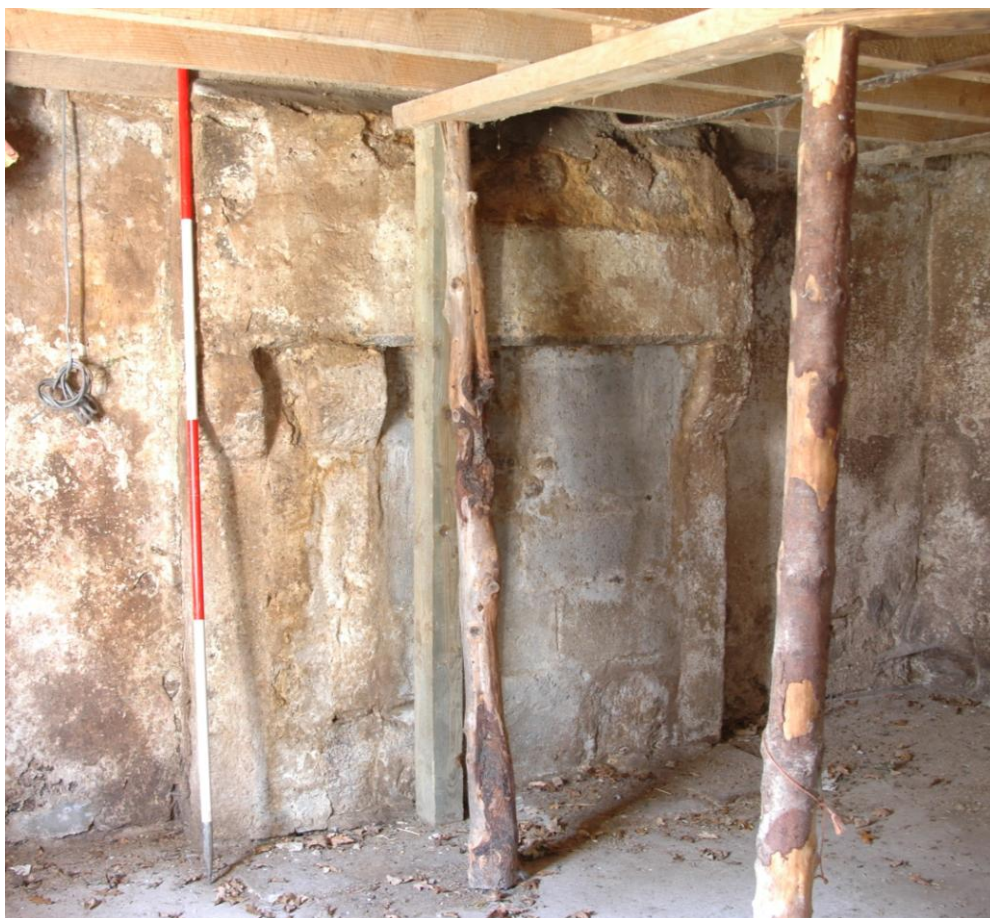
Illus 13 Ground floor fireplace in bothy - Area G.

corner. The hearth had a large granite lintel supported by stone sides with carved capitals. Unusually there were two on the LHS – both clearly original. The fireplace proper was 1.10m internal width, The gap between them may perhaps have held a partition- or may simply have provided a small storage space- for example for the salt box. The fireplace had been infilled with concrete blocks. The N side of this room has two doorways, suggesting that the present single room at the N ground floor may originally have been two small chambers. There was one window in the front (E) wall.

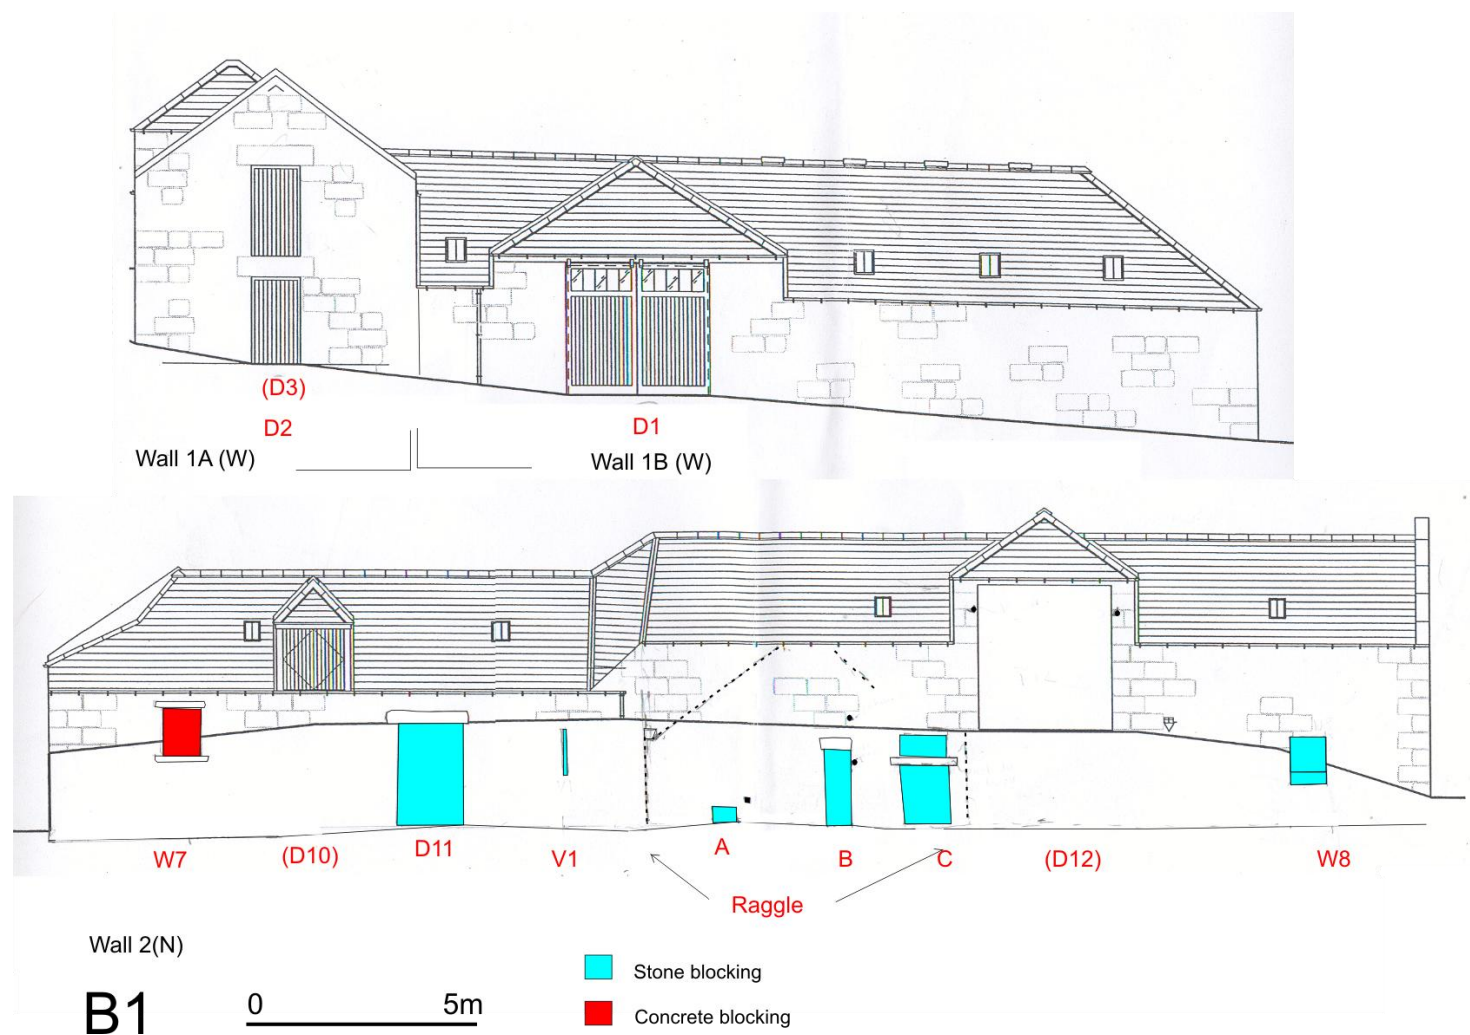
Illus 14 Building 1 N and W elevations (annotated from drawings by Norman McIntosh)

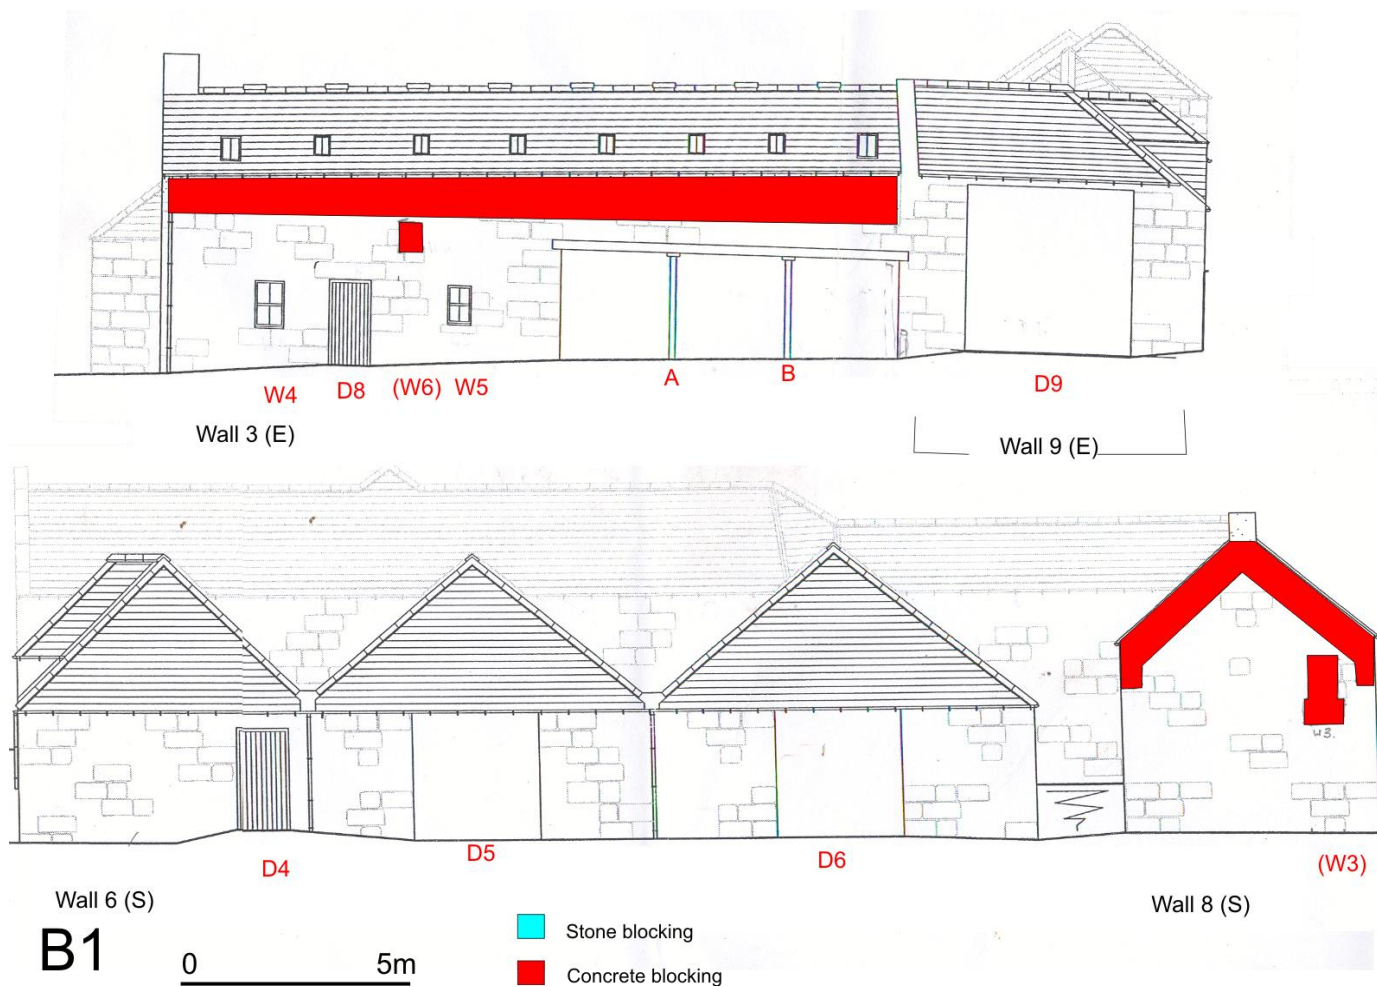
Illus 15 Building 1 S and E elevations (annotated from drawings by Norman McIntosh)

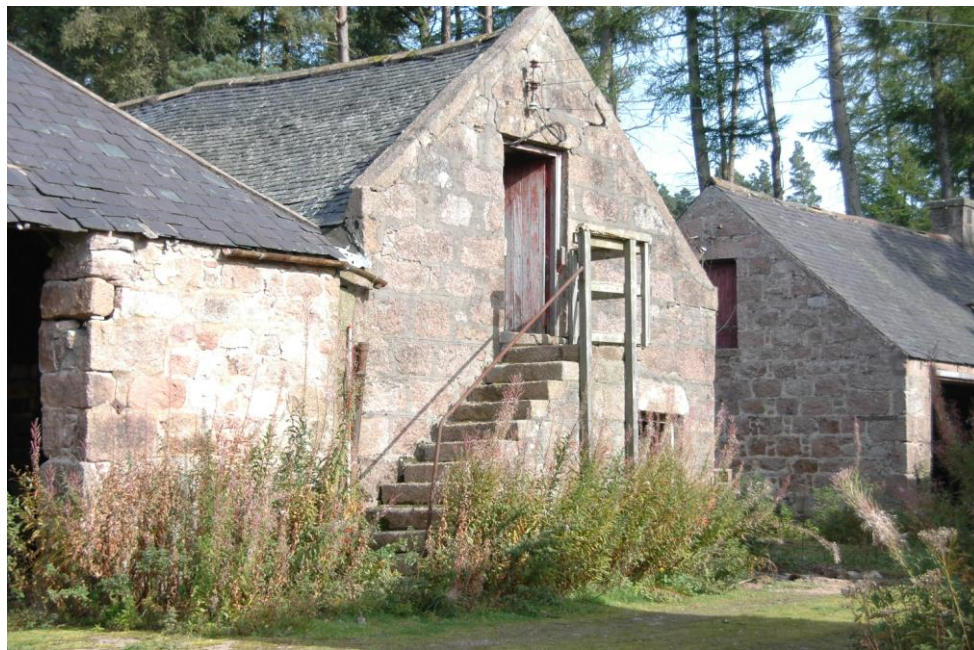
Illus 18, Building 2 S wall looking NE. Building 3 behind on RHS

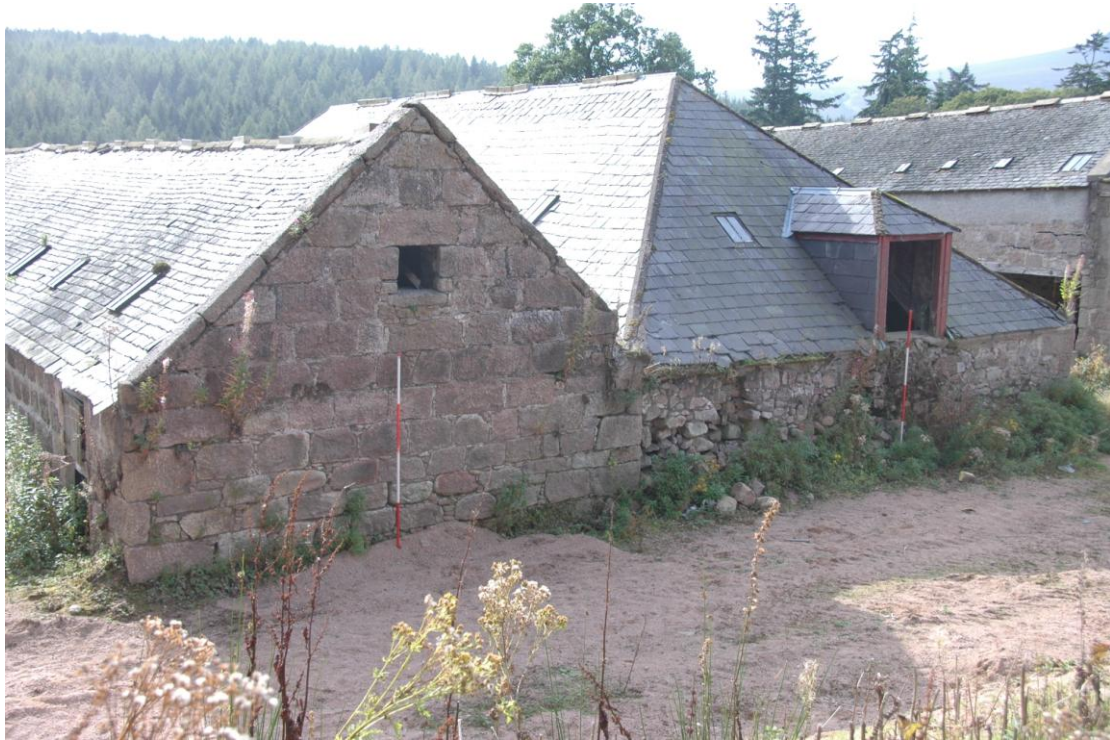
Illus 20 N side of building 2 with older part to LHS and the difference in walling clear between it and the W part on the RHS

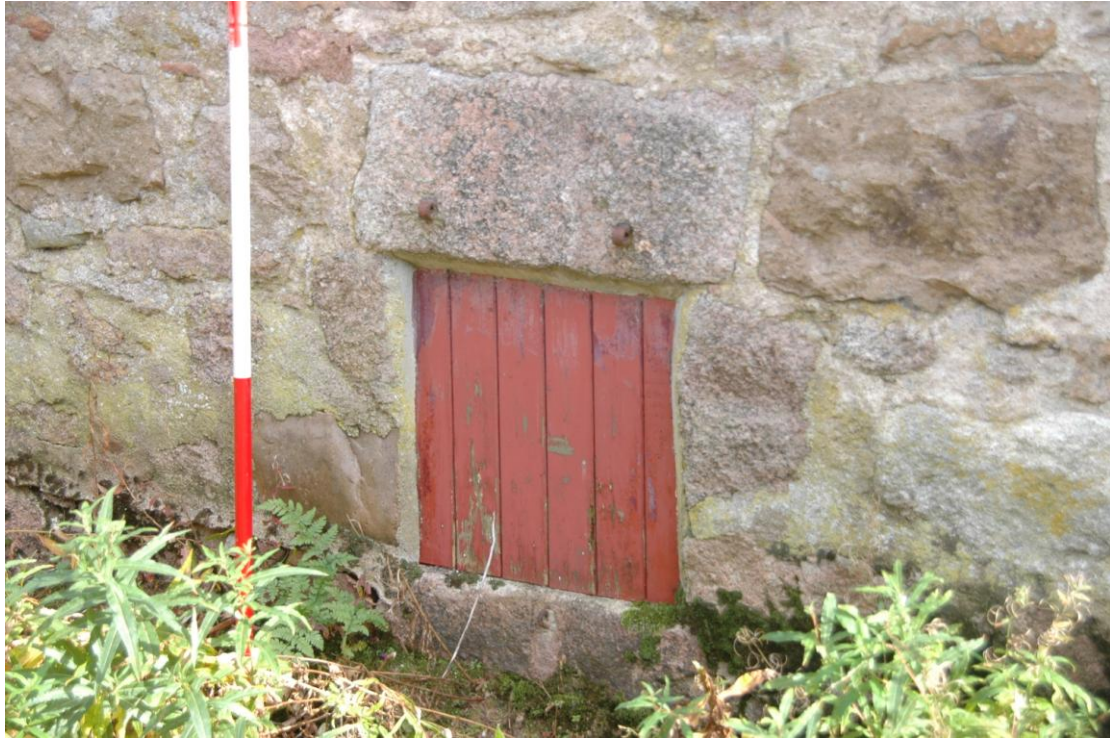
V2-V7 W:500mm H:500mm External wooden shutter swung on iron pivots. They are 1.05m above the level of the cobbled floor- externally the N side of the building appears to be dug into the slope, so the internal floor is deeper at that end than the outside levels.

Illus 21 Vent 2 in the W wall showing pivots for original shutter and later wooden blocking.

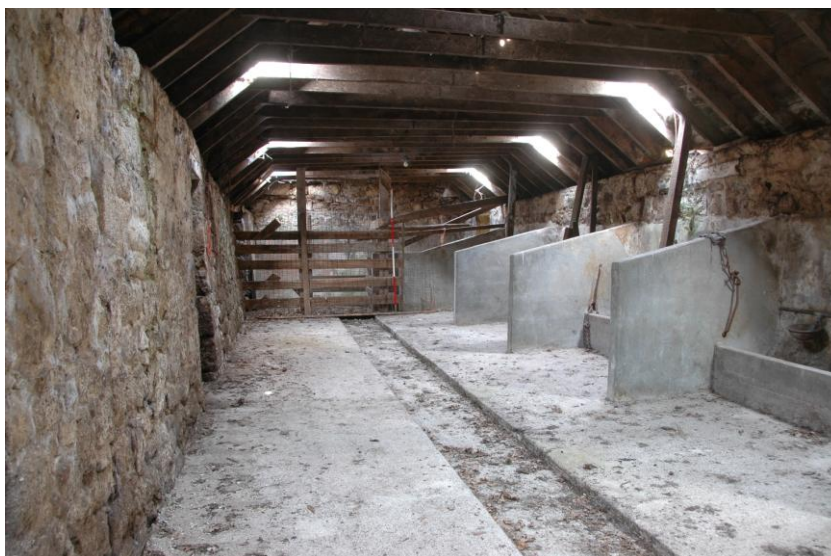
Illus 22 Building 2. Interior of W side with tied cow stalls

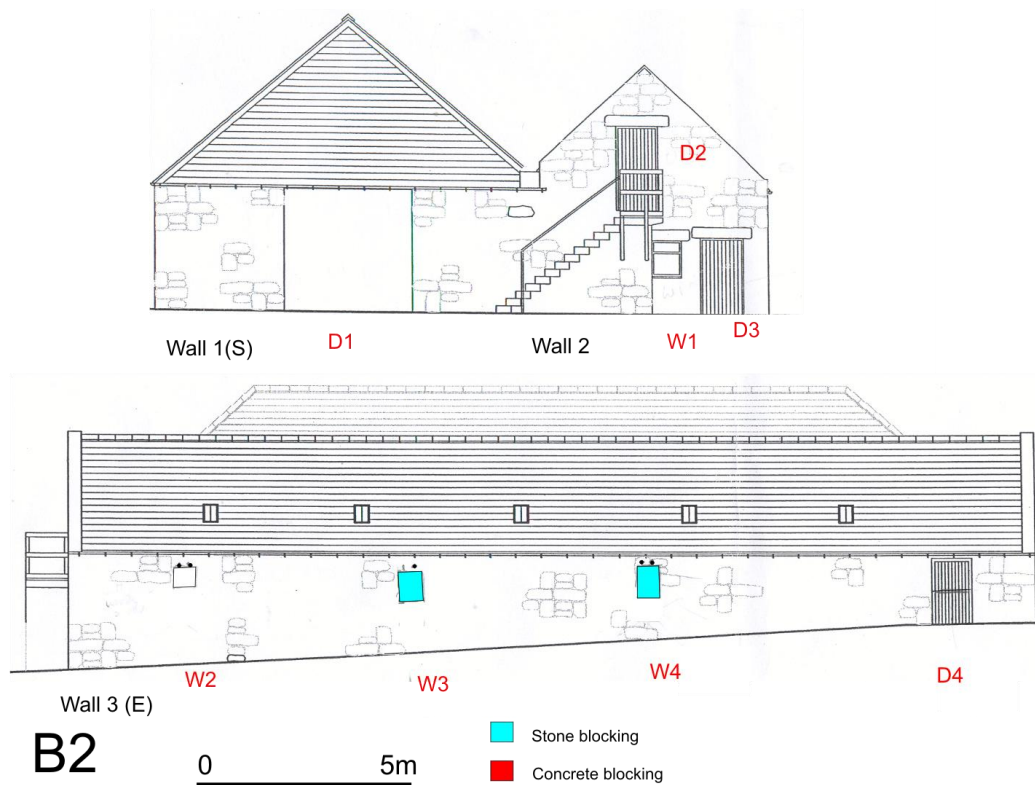
Illus 23 Building 2 S and E elevations (annotated from drawings by Norman McIntosh)

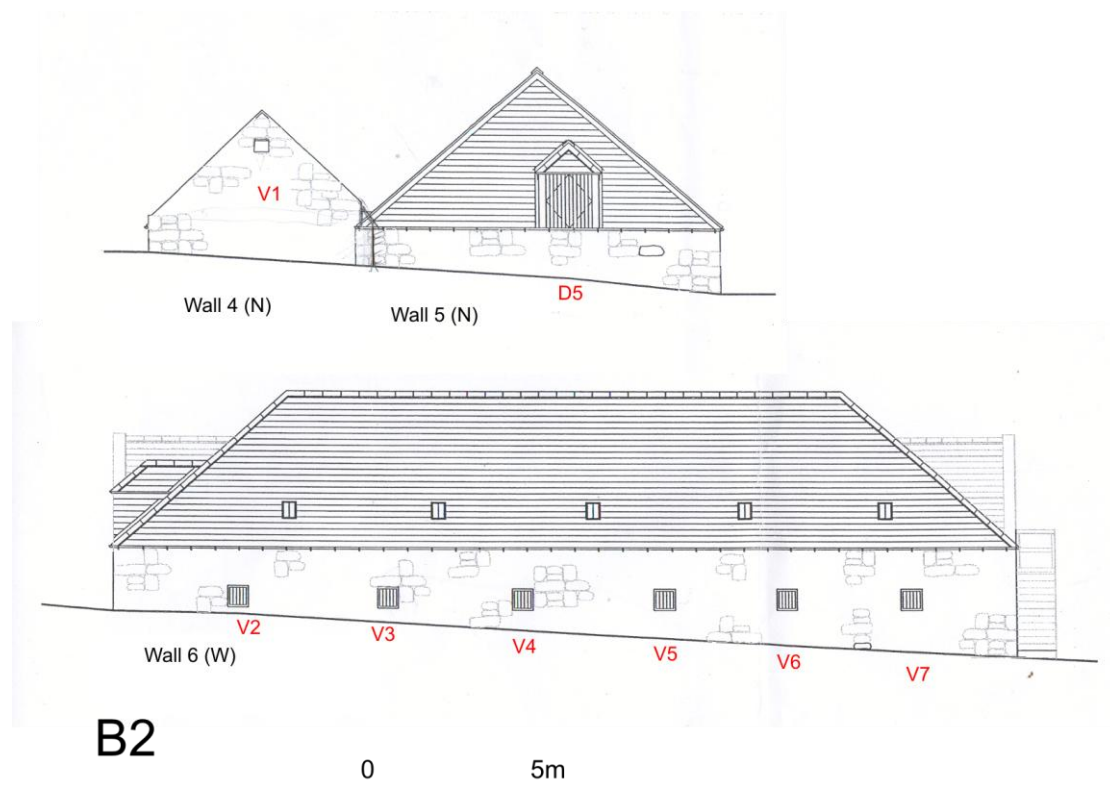
Illus 24 Building 2. N and W elevations (annotated from drawings by Norman McIntosh)

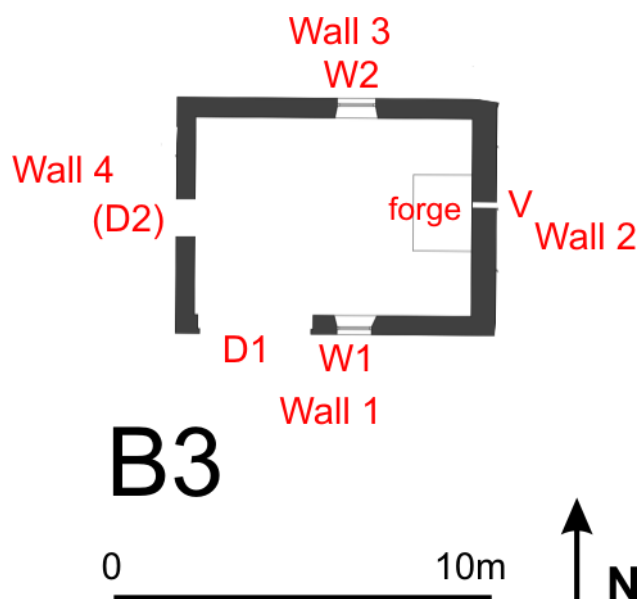
Illus 26 Plan of Building 3 (Annotated from plan by Nord Architecture)

The smithy is built of stone. Walls 1 and 4 which face towards the rest of the steading complex are of roughly dressed squared pinkish granite blocks set in good horizontal courses and with granite rybats at the corners. Walls 2 and 3 that were less visible are of rubble stone with a greater range of stone types used. The roof is pitched and slated with no skews. It has A- frame couples with sarking. The chimney at the E gable over the forge is of granite.

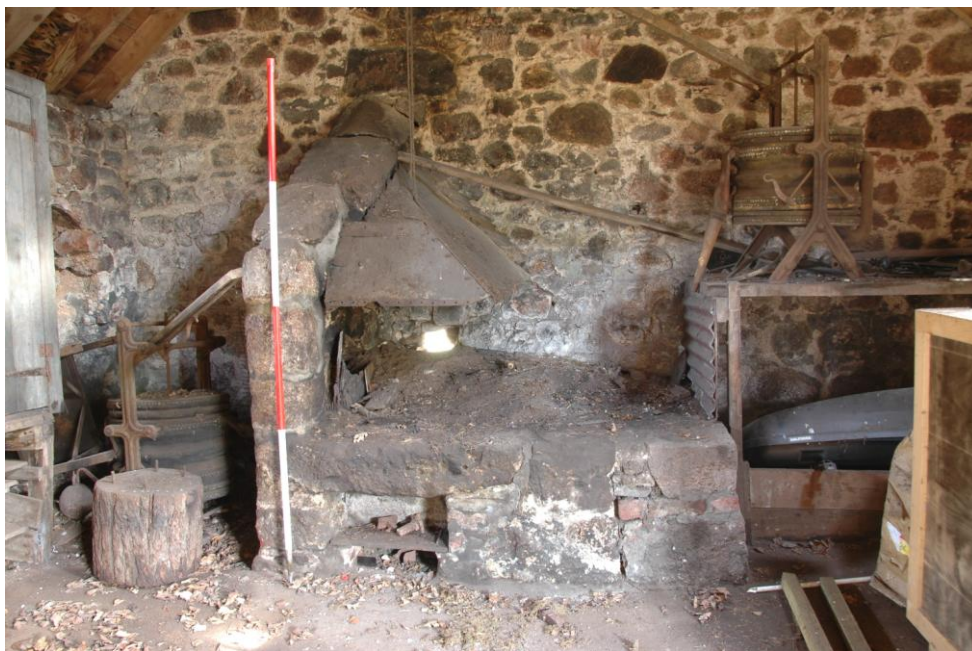
At the E end of the building there is a stone built forge with a raised wall on the N side which appears to link to the chimney and a metal smoke hood. The forge base was 580mm high and 1.55m wide. The original length was 1.46m but this had been extended to 1.96m by a stone and brick addition on the S side. A small vent through the base of the gable wall came through to the back of the forge bed- the vent was 200 x 290mm with a shaped base stone and appears original. Two original bellows were at either side of the forge.

Illus 27 Forge - vent can be seen above forge bed

Building 3 appears to have been purpose built as a smithy and used as such until it became redundant. It first appears on OS maps around 1903 when heavy horses would still have been in common use both on the farm and for forestry operations. There is no direct evidence when it was last used. It is recommended that the bellows should be preserved.

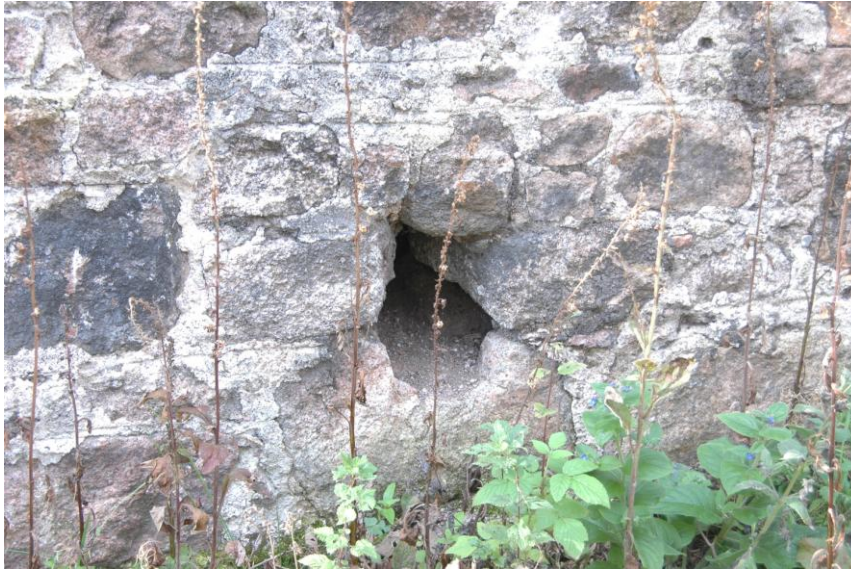
Illus 28 Vent in outer gable

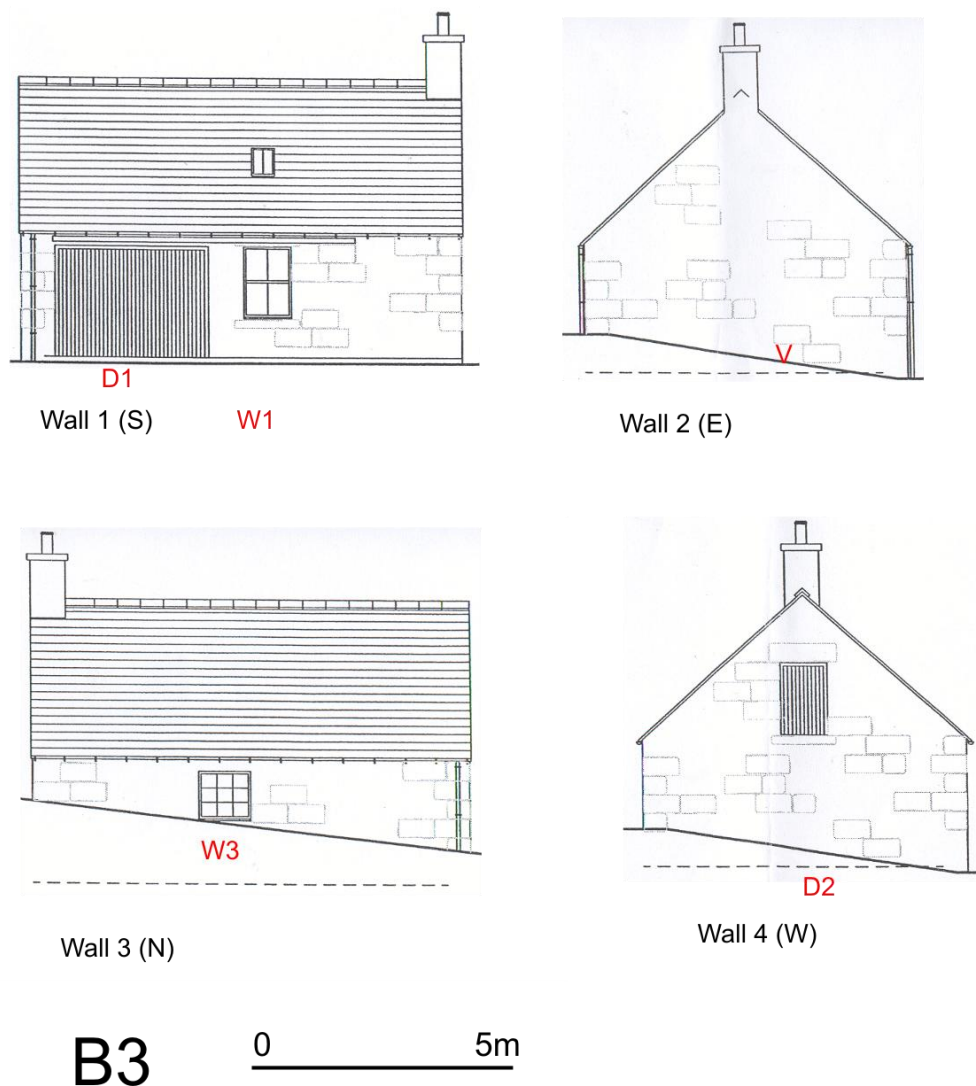
Illus 29 Building 3 Elevations (annotated from drawings by Norman McIntosh)

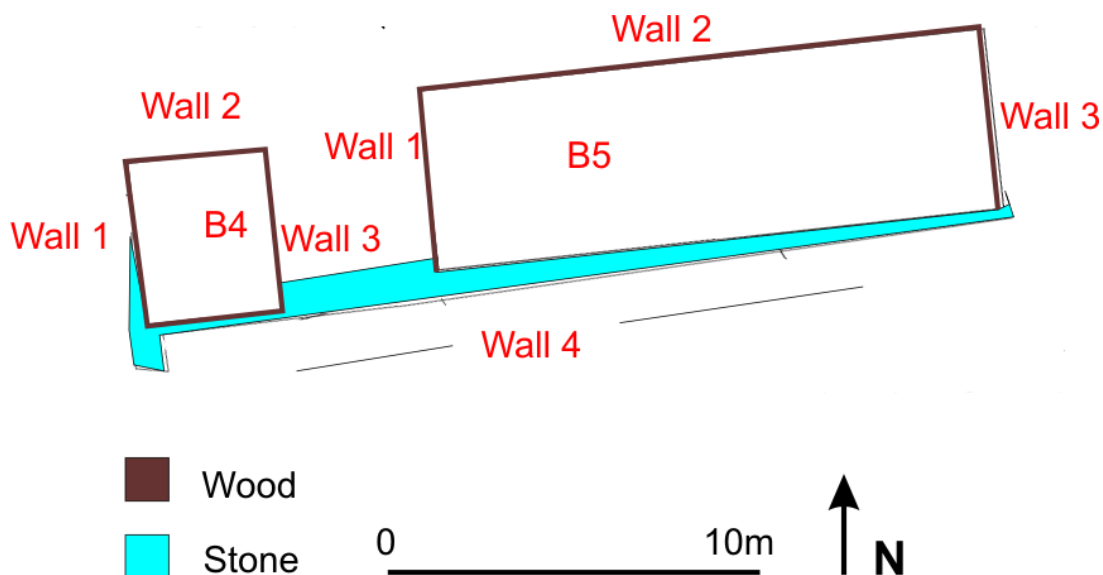
B4 and B5

Illus 32 Plan of Buildings 4 and 5 (Annotated from plan by Nord Architecture)

Both buildings 4 and 5 have N and W walls of vertical weatherboarding – the other walls being partially of concrete blocks set on an earlier stone foundation. Both have single pitched corrugated roofs.

The earlier stone foundation is of roughly squared stone blocks in horizontal courses and appears to have been a revetting wall some 24m long along the S side of a terrace – the ground to the S being considerably lower.

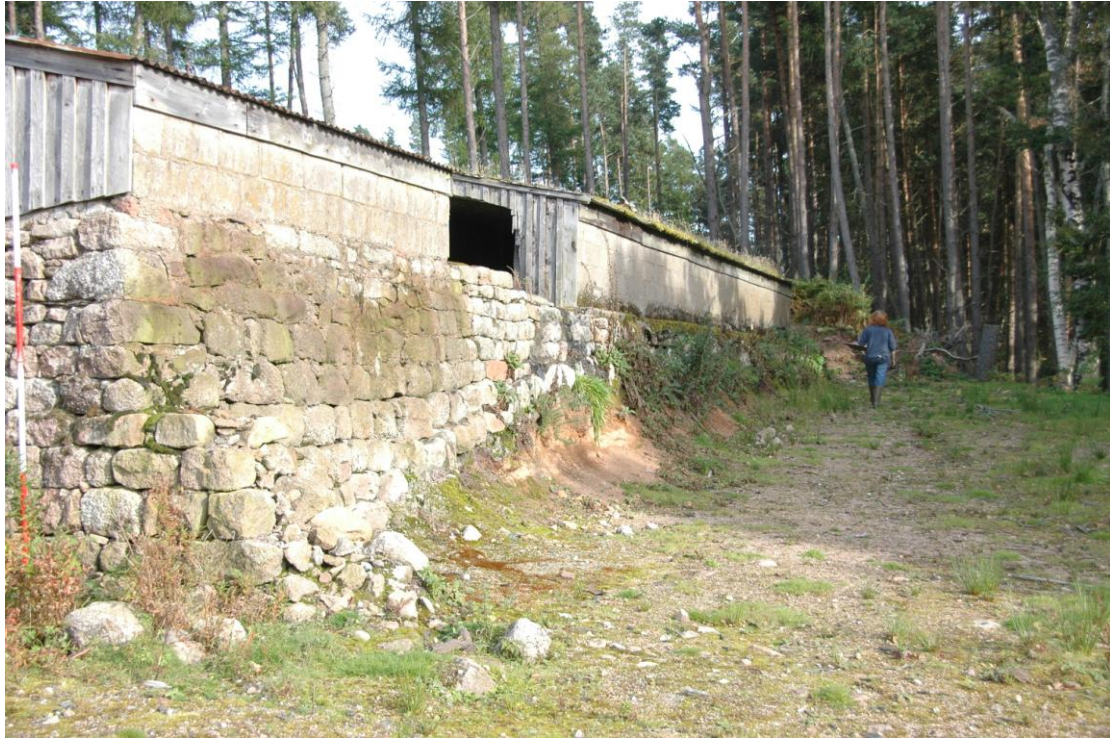
Illus 33 S side of buildings 4 and 5 showing the earlier revetting wall

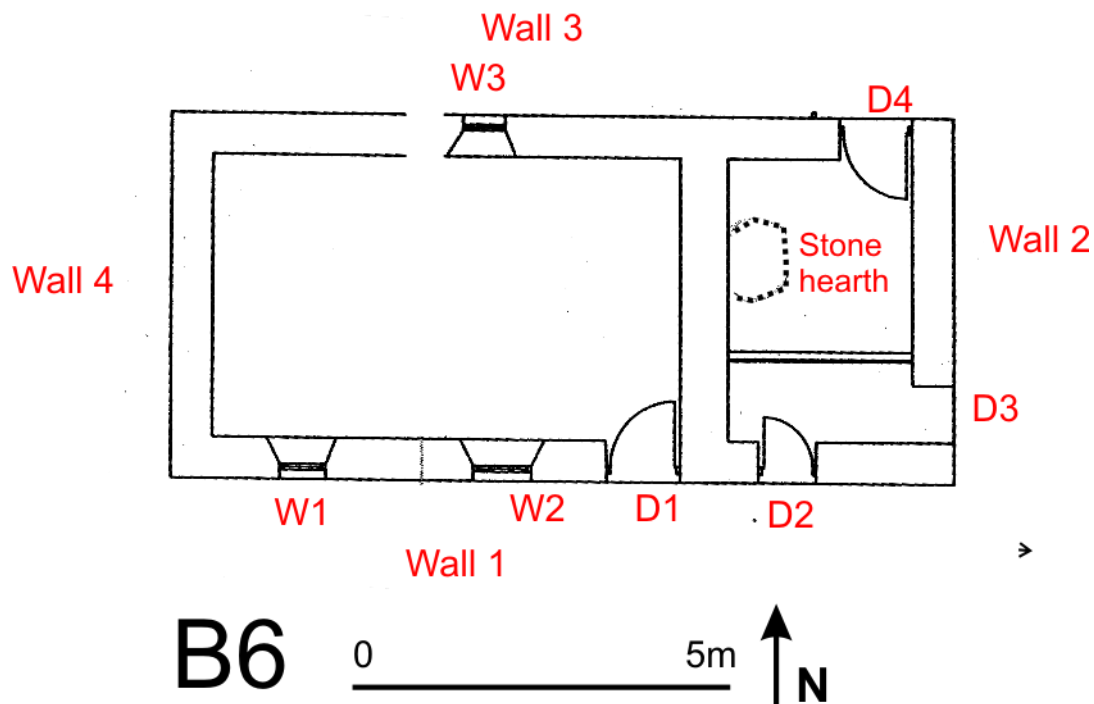
Illus 35 Plan Building 6 (annotated from drawings by Norman McIntosh)

This small building is set to the S of the main steading and E of the farmhouse, cut slightly into the slope on the N side and opening on to a lane on the S side. The walls are of squared dressed blocks of pinkish granite with small stacks of vertical pinnings between some (but not many) stones. This is similar to the wall of the N range steading Building 1. The roof is hipped and at present slated. However, the ridge at the base of the chimney suggests that the building may originally have been thatched. Considerable charring at the level of the eaves on the N wall near door D4 may indicate that the original roof burnt down.

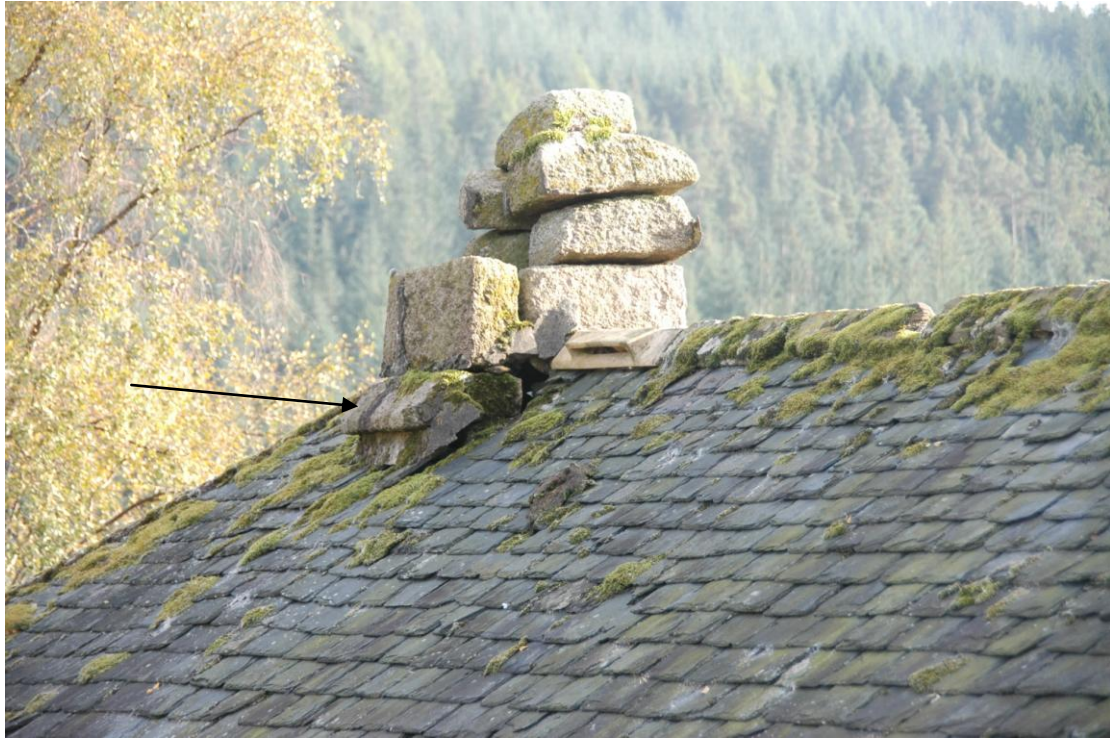
Illus 36 Chimney in Building 6 showing ledge which suggests thatch

The chimney which is set some 3m back from the E end of the building, on the line of the cross wall, is in poor condition but was clearly stone built.
