GLEN DYE STEADING, GLEN DYE BANCHORY ABERDEENSHIRE

**- Standing Building Recording -
Carried out 17th September 2009
by
Murray Archaeological Services Ltd**

**Report No: MAS 2009-38
by
H K & J C Murray**

- Standing Building Survey -

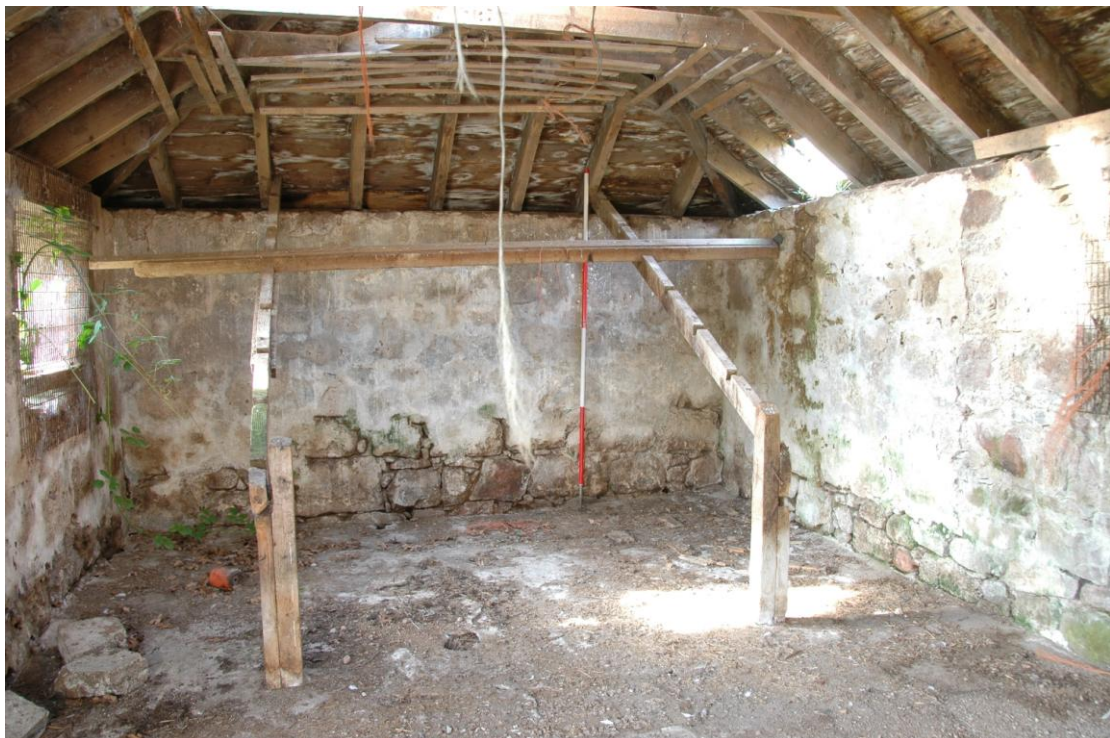
Internally the W room extends for the full width of the building. It has a well made flag stone floor. The windows are meshed on the inside and there is a wooden frame for horizontal racks set into the floor and the W wall.

Illus 37 Building 6 looking W inside W room
Standing Building Survey

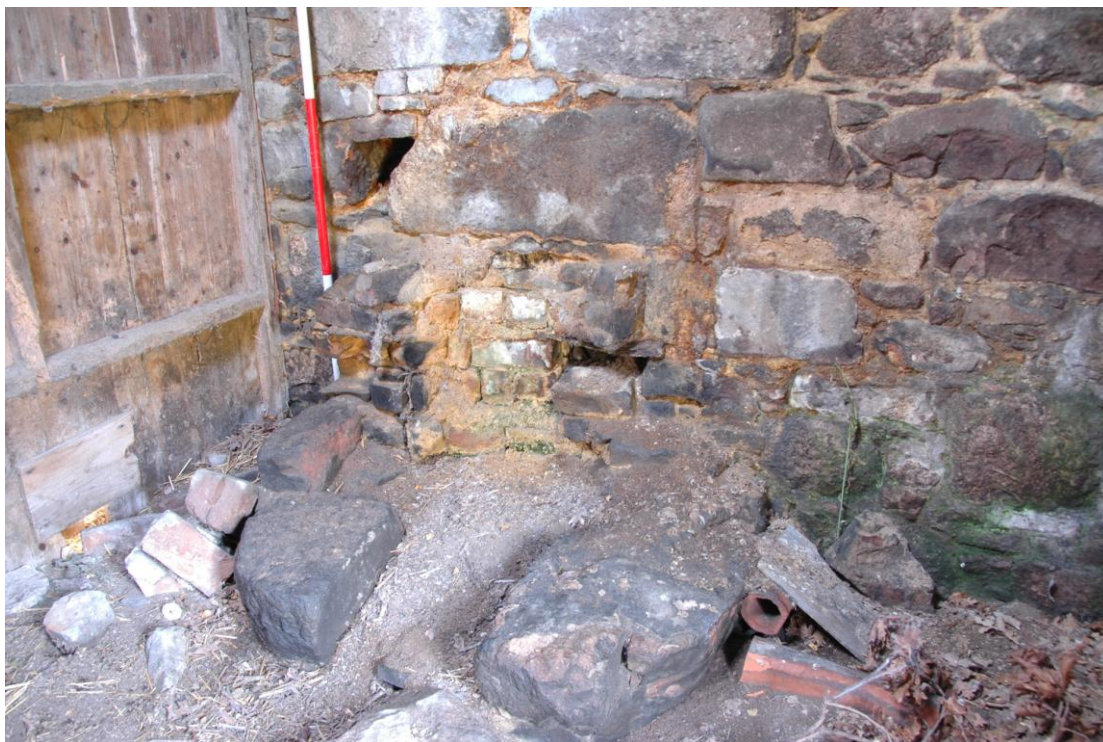
The NE room has a roughly circular stone hearth 1.2m N/S x 820mm e/W and c 200mm high. This was set against the E side of the cross wall below the position of the chimney. However there is no built flue within the wall and it is likely that there had been a hanging lum over the hearth, with only the stone chimney head through the original thatch. The function of the hearth was indicated by a large cast iron pot, with a slightly rounded base and a long, stoppered spout, which had been abandoned in the corner of the room. The pot which was c 550mm in diameter and c. 1.78m high had the maker's name CARRON and the letters NP50 cast on it (possibly 50 gallons?).

Illus 38 **Hearth in building 6**

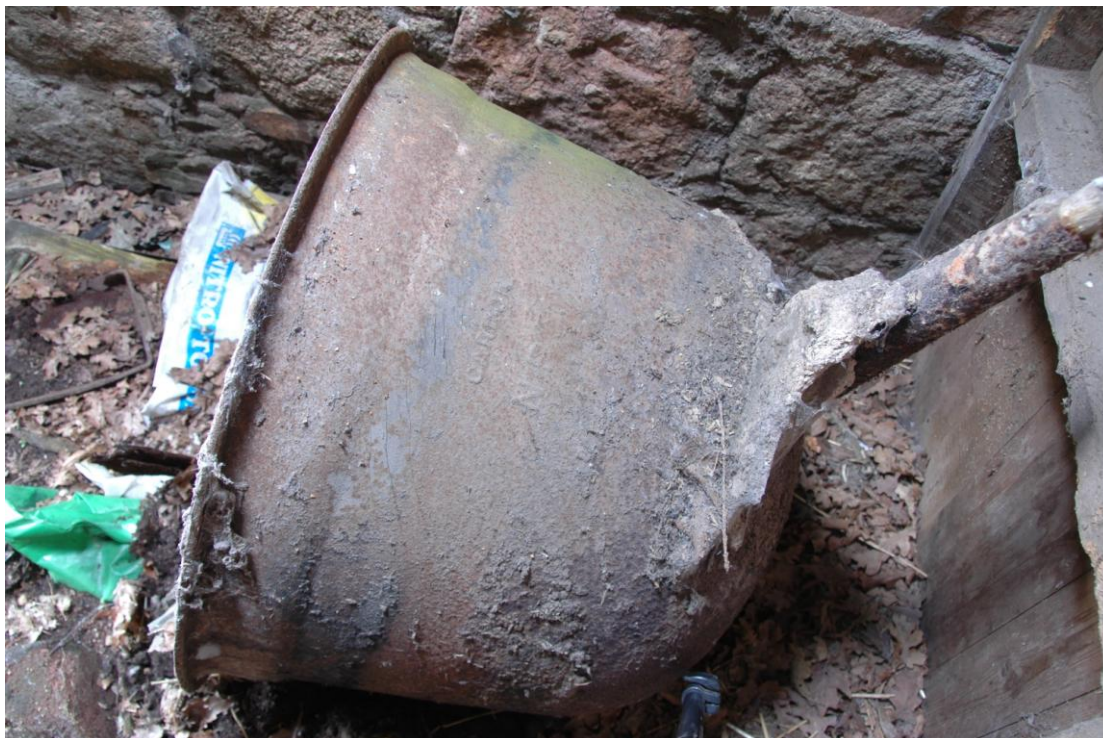
Illus 39 Carron laundry boiler

It is suggested that the boiler should be retained as although originally common, farm boilers of this sort have generally been destroyed for scrap. Carron Ironworks in Falkirk were opened in 1760 and by 1800 were the largest smelting works in Europe.

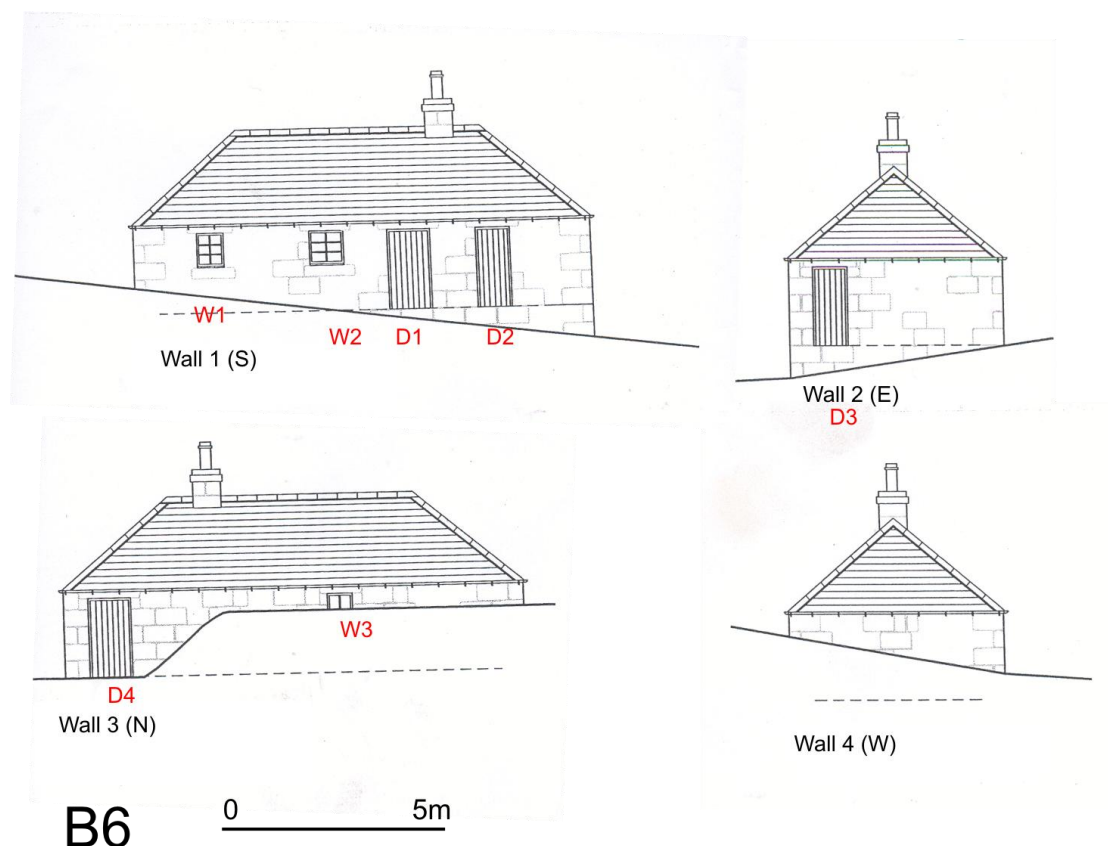
Illus 40 Building 6. Elevations (annotated from drawings by Norman McIntosh)

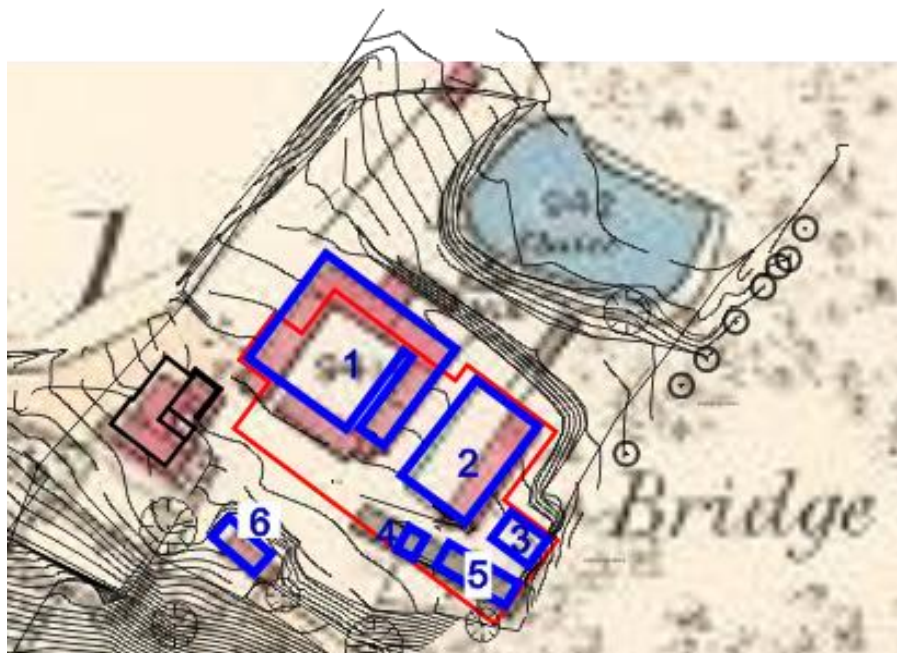
Illus 41 Detail showing overlay of present buildings (blue) over 1863 OS map. Red is the present site boundary.
