## MID-HERMISTON STEADING, 58 HERMISTON

*Archaeological Watching Brief*

*commissioned by Credential (Hermiston) Ltd*

*June 2013*

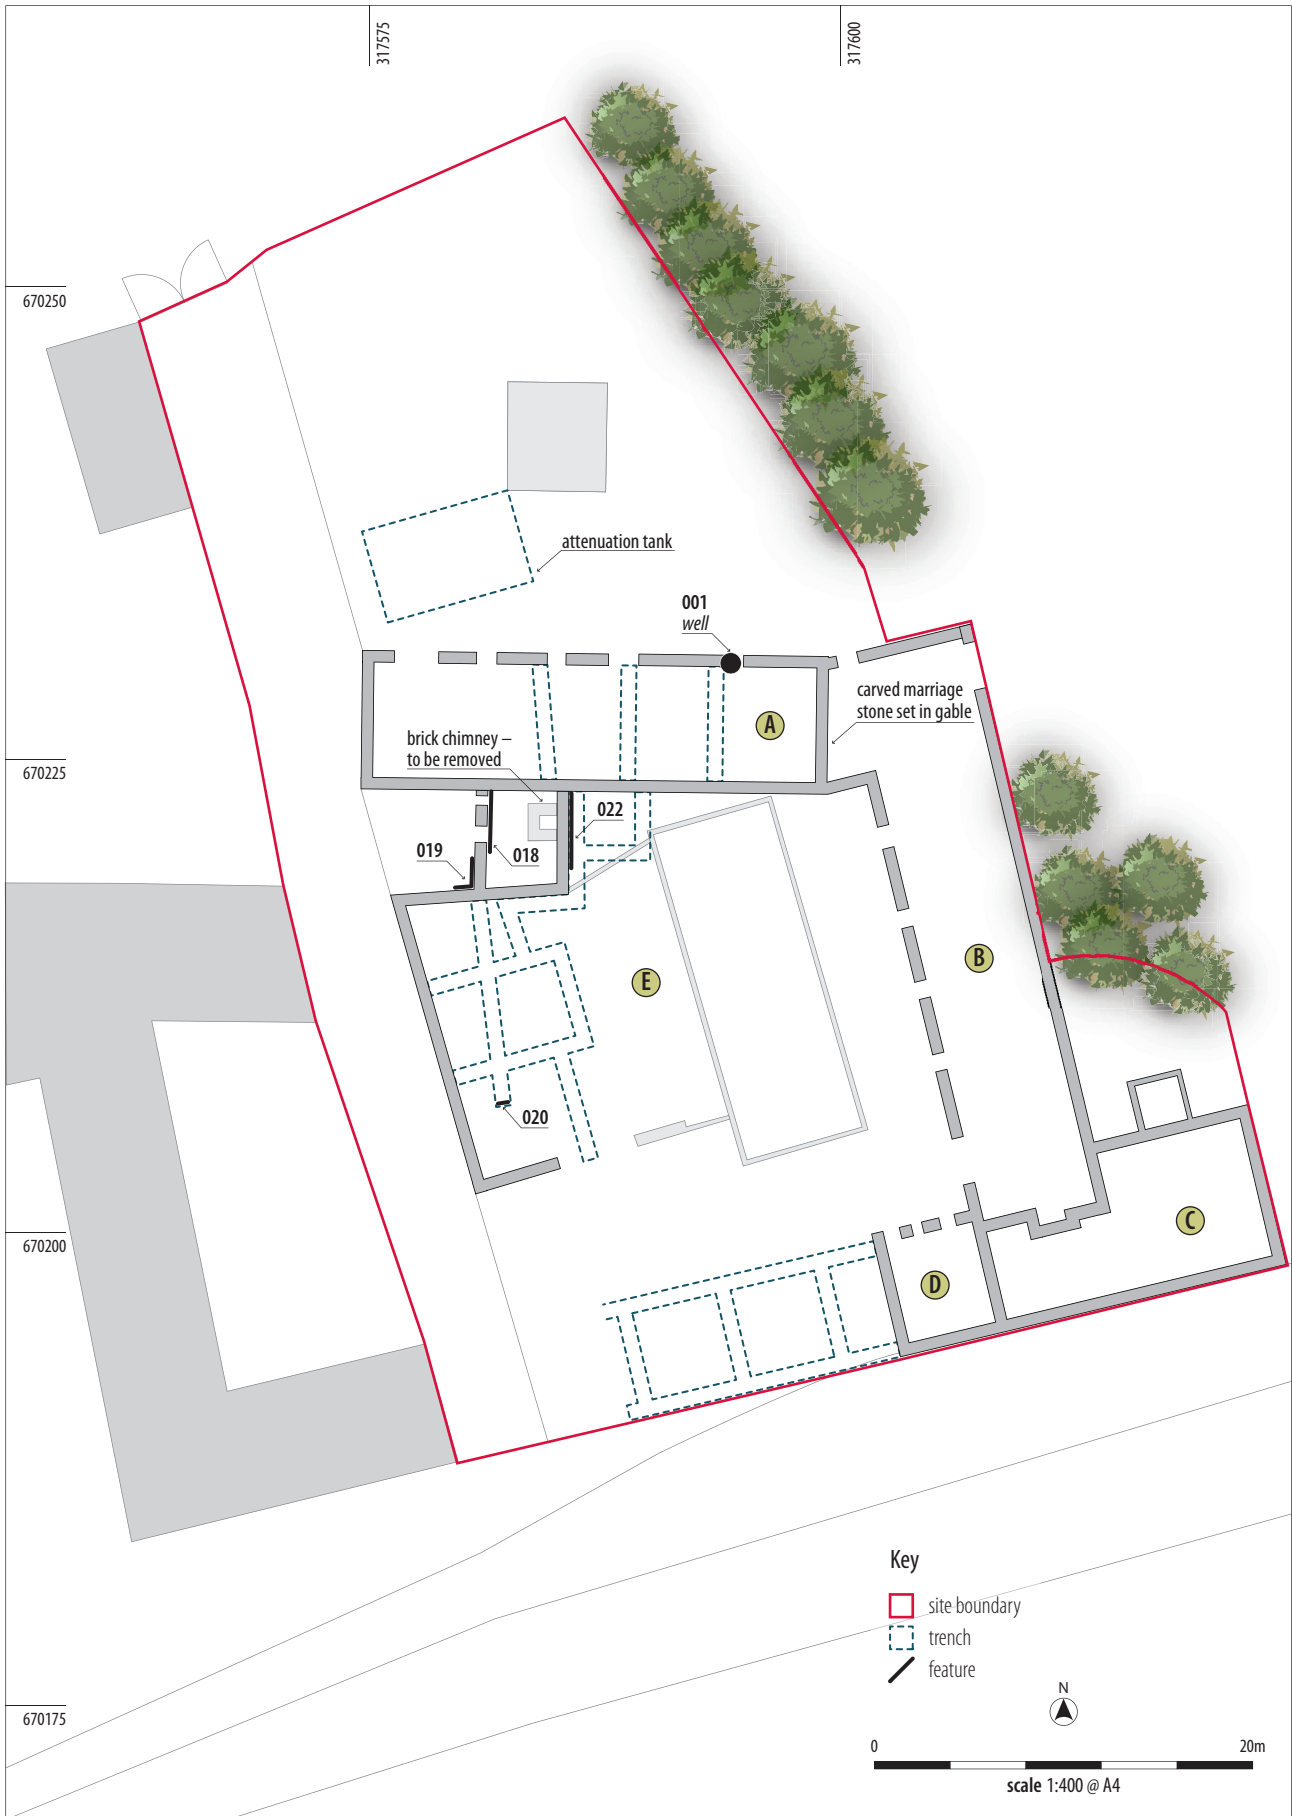
## Illus 2

Plan of recently demolished building foundations and trench locations

All foundation trenches and service trenches excavated as part of the new development were monitored by an experienced archaeologist. Many of the trenches followed the line of the earlier buildings recorded on site therefore exposing the foundation walls to these original buildings (Illus 2). In addition to the foundation trenches a large attenuation tank trench was excavated to a maximum depth of 1.1m (Illus 3).

A circular well 2.00m in diameter was uncovered beneath the foundation walls of Building A (see Illus 2). The well [001] was constructed of sandstone boulders lain in random courses with no bonding material (Illus 5). A cut for the well [002] appears to have been dug into the natural [010]. The well appeared to have been deliberately in-filled with a mix of sandstone building rubbish and garden soil [004] (Illus 6), prior to being capped with a single course of corbelled sandstone blocks at the same time as the construction of the building foundations of Building A. A ceramic field drain [007] running into well

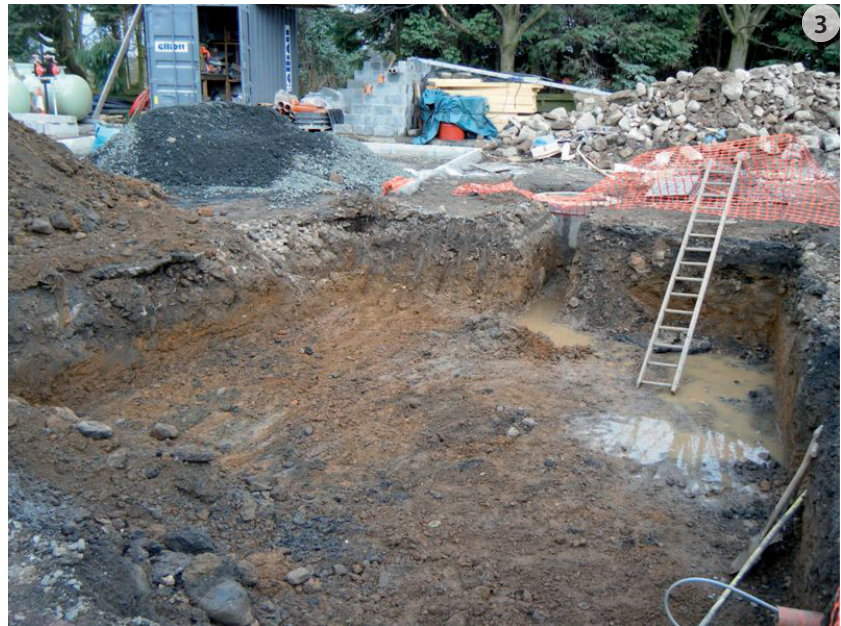
### Illus 3

View of the excavated attenuation tank trench

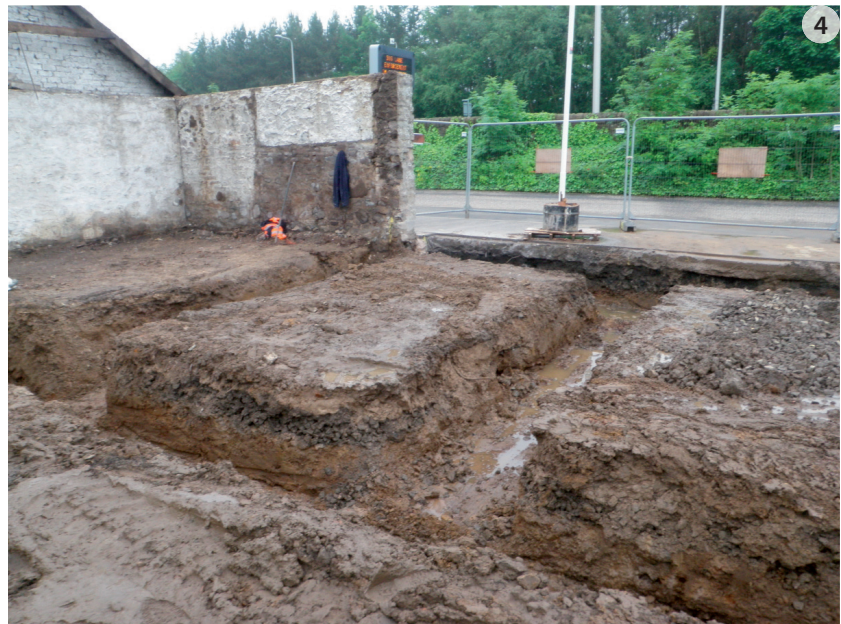
### Illus 4

View of stratigraphy of the foundation trenches

An orange brown sandy clay [010] was observed at approximately 0.60m to 0.80m depth across the site and is interpreted as the geological subsoil. In places this was overlain by a 0.30m thick dark brown silty clay deposit [011] which was most likely a cultivation or garden soil. Demolition material ranging in thickness from 0.30 to 0.50m was observed above this (Illus 4).

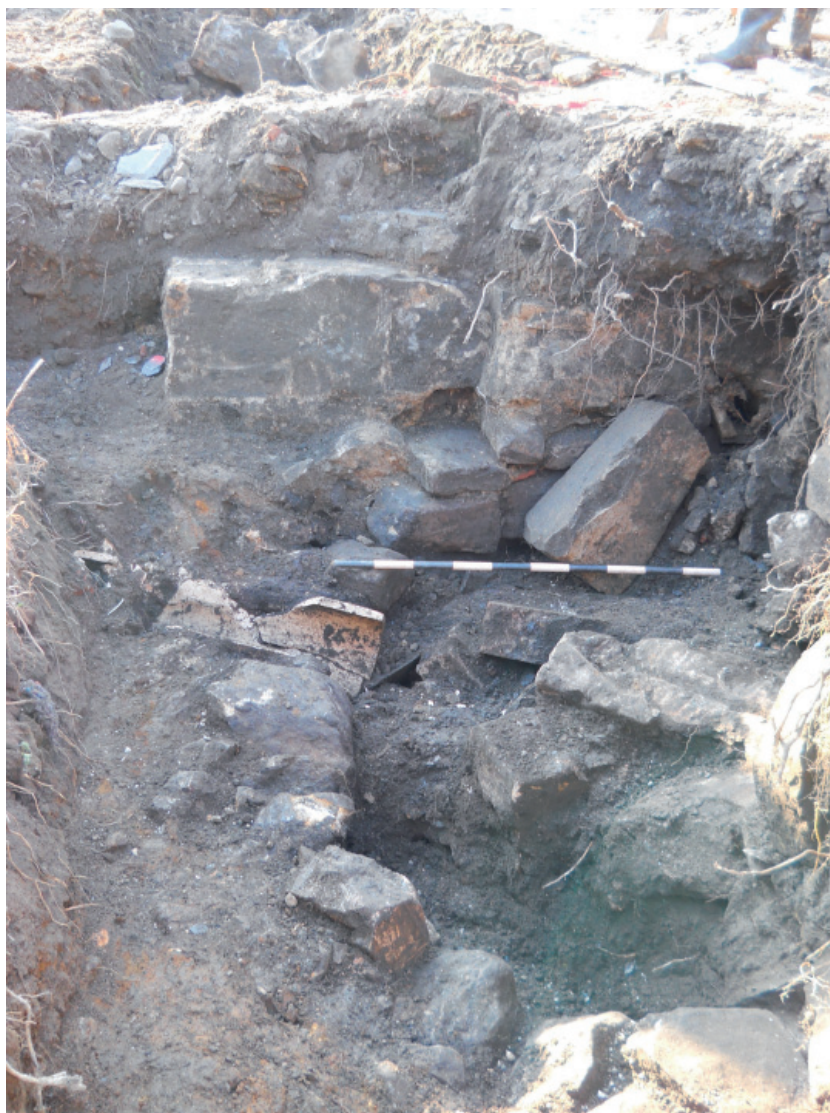
## Illus 5

*Upper courses of the stone-lined well (001)*

[001] was also observed and recorded but it is unclear if this drain was contemporary with the well. Because the well was recorded at the base of the foundation trench it did not impede the construction of the new development. Therefore it was covered with terram and left in situ with no further archaeological mitigation required.

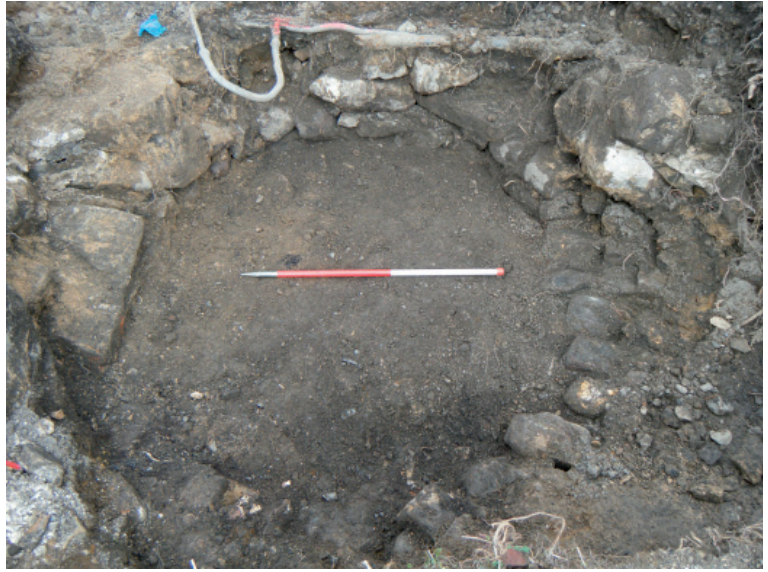
**Illus 6**

*View of the stone-lined well (001) from the south*

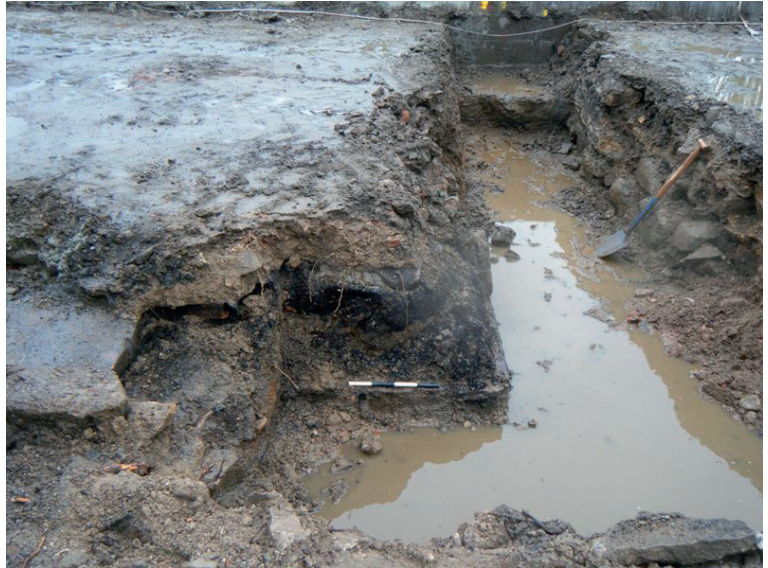
**Illus 7**

A number of foundation walls relating to the 18th and 19th century farm buildings previously standing on the site were also uncovered (*Illus 7*). These buildings were recorded prior to demolition by Headland Archaeology Ltd as part of the previous historic building recording works (Geddes 2008). Contexts [013] to [016] represent foundation walls for of Building A. These foundation wall contexts appear to have incorporated the capping for the well [005] into the foundations of the building. Contexts [018] and [022] appear to be foundation walls attached to the northern wall of Building E.

*Foundation walls within the new foundation trenches*

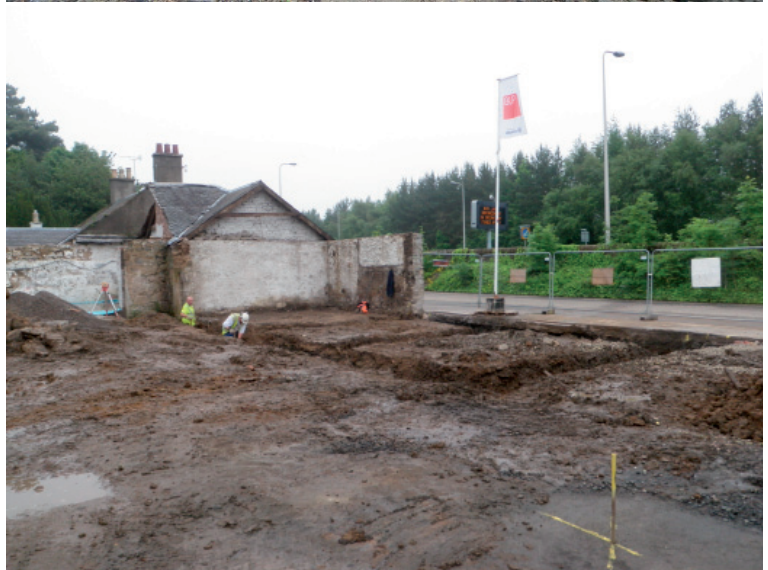
**Illus 8**

A small number of modern drain cuts were also observed running approximately north-south across the centre of Building E (*Illus 8*)

*View of foundation trenches in area of Building E*

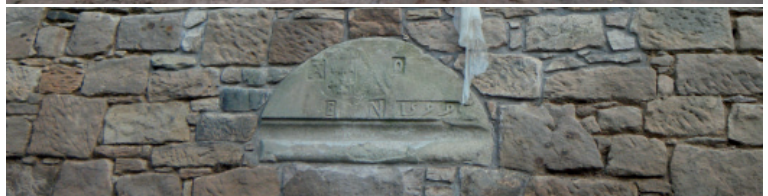
**Illus 9**

The decorative stone marriage plate recorded in the initial historic building record (Geddes 2008) had been reset within the walls of the new development (*Illus 9*).

*Detail of the re-set marriage stone in the wall of Building E*
