Project Code: GRED07

396-410 Gorgie Road, Edinburgh: An Archaeological Appraisal

PROJECT SUMMARY SHEET (GRED07)

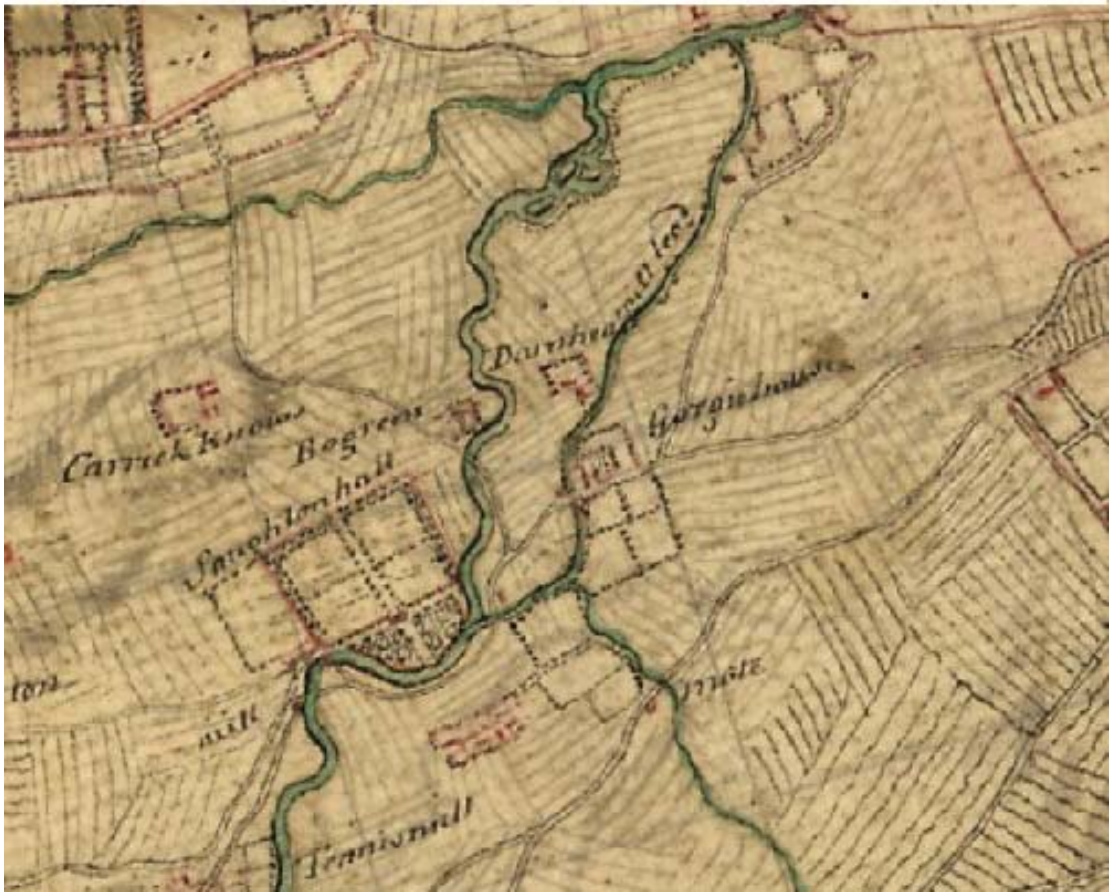
Figure 2: Historic map extracts

Although “Gorgymill” is marked on Bleau’s 1654 map of the Lothians, it is not shown in detail. The earliest detailed plan of the area (Roy 1747-55) shows the location of two or possibly three buildings at “Gorgiehouse” on the eastern bank of the mill lade (Figure 2). The buildings are surrounded by gardens, suggesting a residence was located next to the mill.

Roy 1747-55

OS 1st Edition 1855

All accounts are clear that the building originally took the form of an ‘L’ shape, which was then added to in the 18th century, to create an oblong structure. In the 19th century, after the house had been bought by the Cox family, a new eastern frontage was added (Smith 1928: 279). First edition Ordnance Survey mapping (1855; Figure 2) shows a structure located close to the mill buildings, on the eastern bank of the lade within the development area. Architect’s plans for the glue works held by RCAHMS (Cowie & Seaton collection) and OS mapping from 1905 indicate that this structure was Gorgie House. While some photographs and drawings of architectural detail within Gorgie House exist (in Smith 1928 and, no photographs showing the entire structure were located during the assessment.

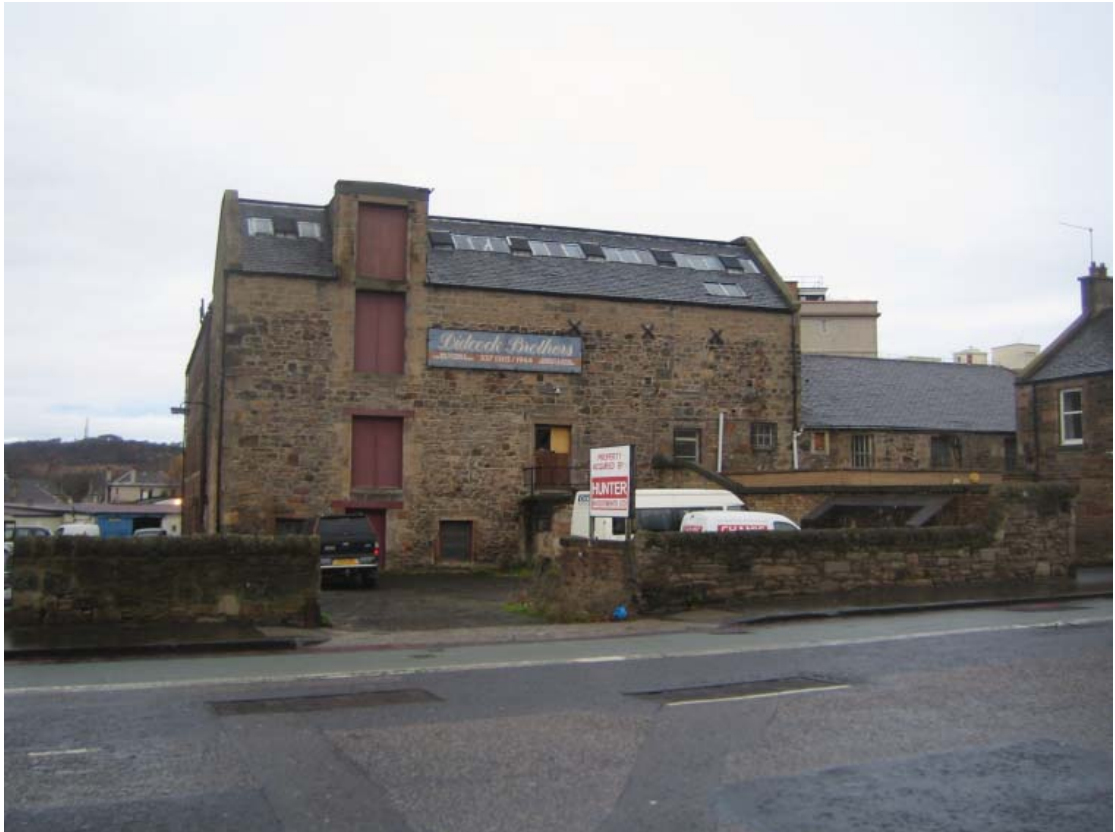
The site continues to be occupied by several sandstone buildings, including the mill, which on outward appearance date to the early 19th century (Plate 1). Several brick industrial structures also exist on the site (Figure 1). Two single storey modern commercial units are also present.

Plate 1: View of standing mill building

The site contains an early 19th century mill and associated buildings. These do not on initial inspection contain original fixtures and fittings related to early use. An assessment by Historic Scotland in 2006 (letter dated 20/9/06) concluded that the structure did not meet the criteria for listing. Nevertheless given its role in the 19th century industry of Gorgie the mill buildings are of some importance.

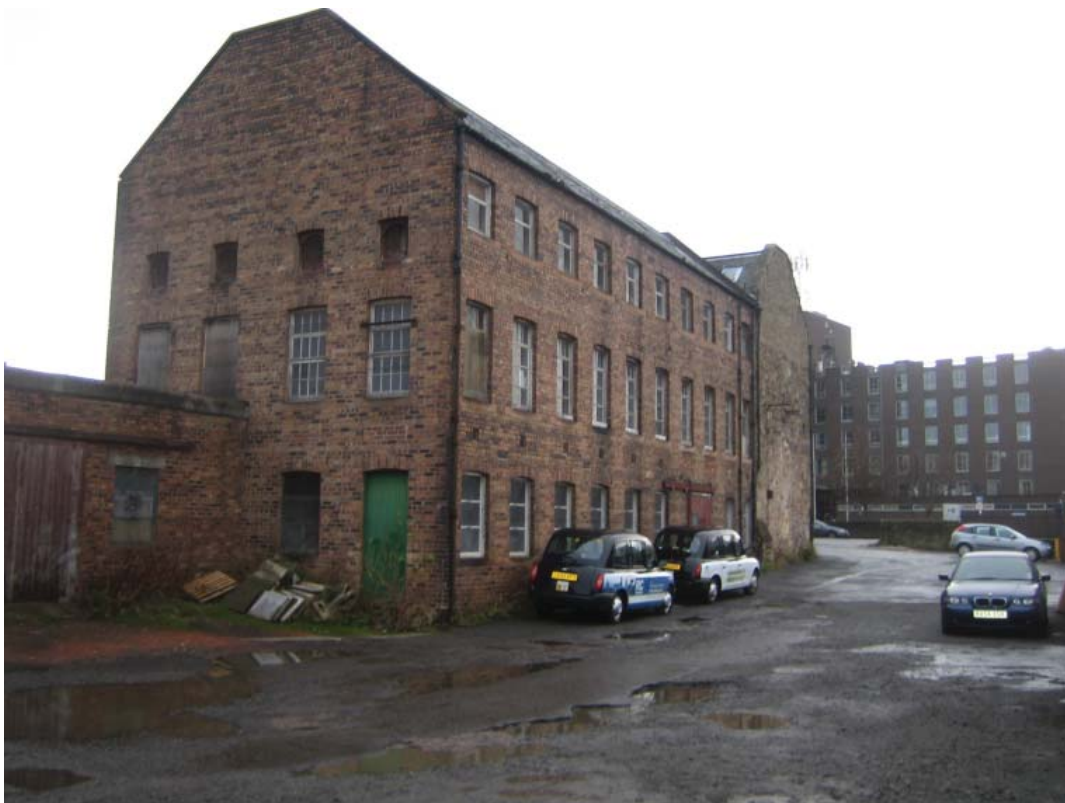
Much of the site is covered by tarmac and there was no evidence suggesting that there has been any significant ground reduction in the modern period (Plate 2).

Plate 2: Brick extension to rear of mill showing current ground surface
