# CATHKIN BRAES WIND FARM, CARMUNNOCK, GLASGOW

Archaeological Evaluation

for Scottish and Southern Energy Renewables

*April 2012*

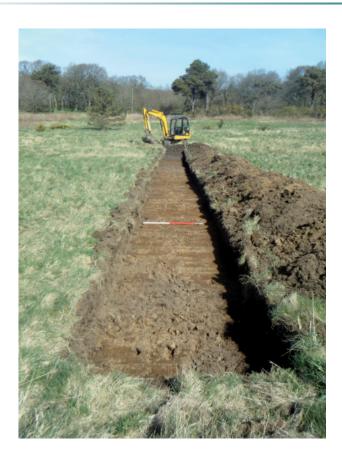
**Illus 2**View of Trench 3

The topsoil in the trial trenches comprised dark brown clayey silt 0.2–0.5m in depth. Not unexpectedly, the topsoil tended to be shallowest on areas of higher ground. The natural geology varied across the site from outcrops of bedrock, predominately in the higher areas, to areas of compact clay. Trenches 1, 3, 4 & 5 contained rubble field drains (Illus 1 & 2) which were oriented either E-W (Trenches 1 & 3), NW-SE (Trench 4) or N-S (Trench 5). These were cut into geological deposits and sealed beneath topsoil.

No features of archaeological significance were recorded in any of the trial trenches.
