**Abbey Tower Lightning Protection,
Kilwinning, North Ayrshire:
Archaeological Mitigation**

Data Structure Report

by Claire Williamson

issued 6th July 2011

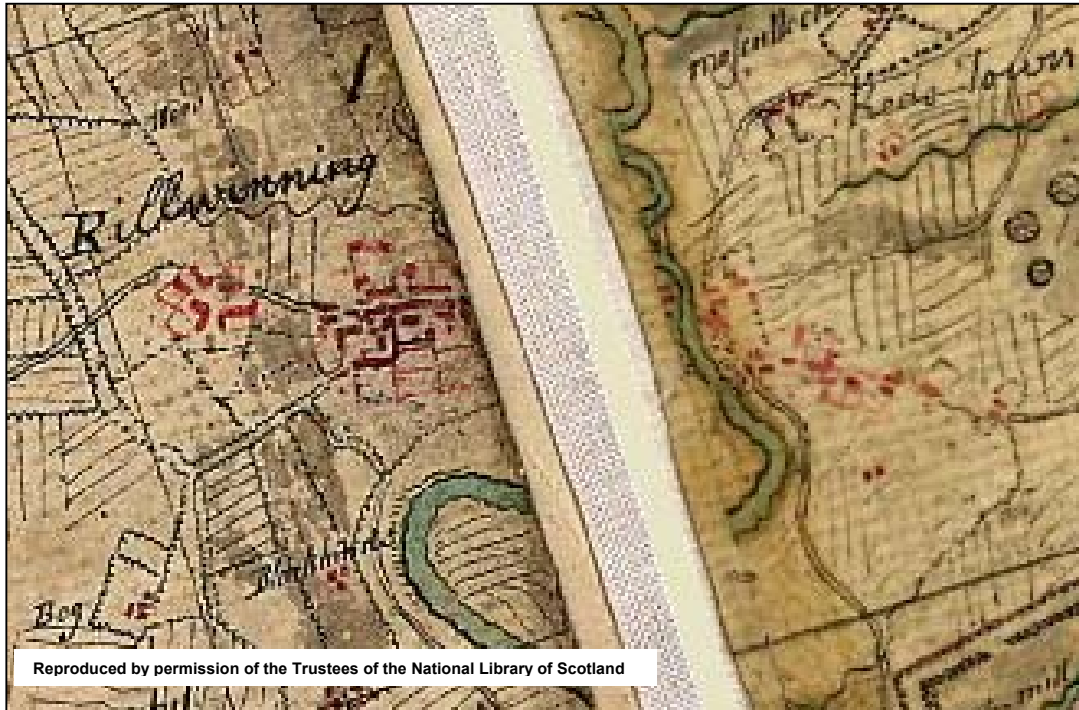
6. The first detailed post-reformation plan of Kilwinning is from 1747-55 (General Roy's Military Survey of Scotland; Figure 1a); it forms a cluster settlement forming from three locales along what is now Main Street. The central hub is located around the Abbey buildings, another is located immediately on the east side of the river Garnock near the Corsehill and the third to the west at Byres.

Figure 1a: Detail from Roy's Military Survey of Scotland 1747-55

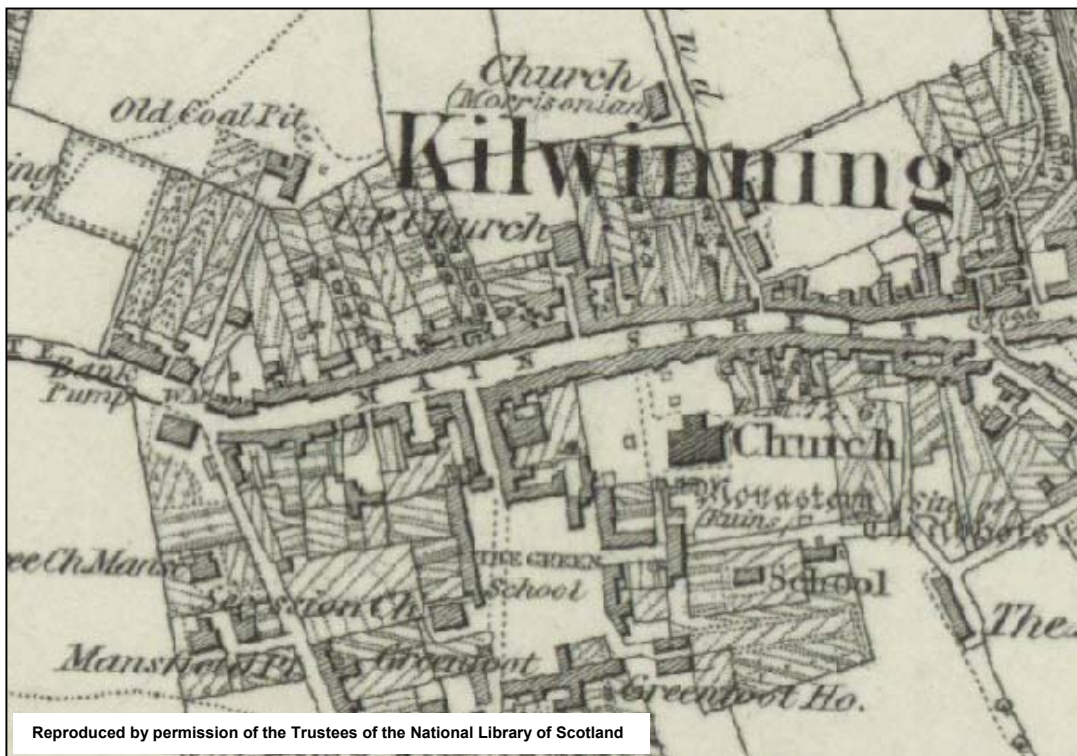
7. By the 1st edition Ordnance Survey (1856) Kilwinning had expanded to include a full street frontage on either side of Main Street (Figure 1b). This rigid streetscape has been progressively altered through the 19th and 20th century with the opening out of the 'square' area at the west end of the Main Street and clearance to form the entrance to the Old Parish Church (removing the original property given to the Freemasons for their Mother Lodge).

Figure 1b: Detail from 1st edition Ordnance Survey (1856)

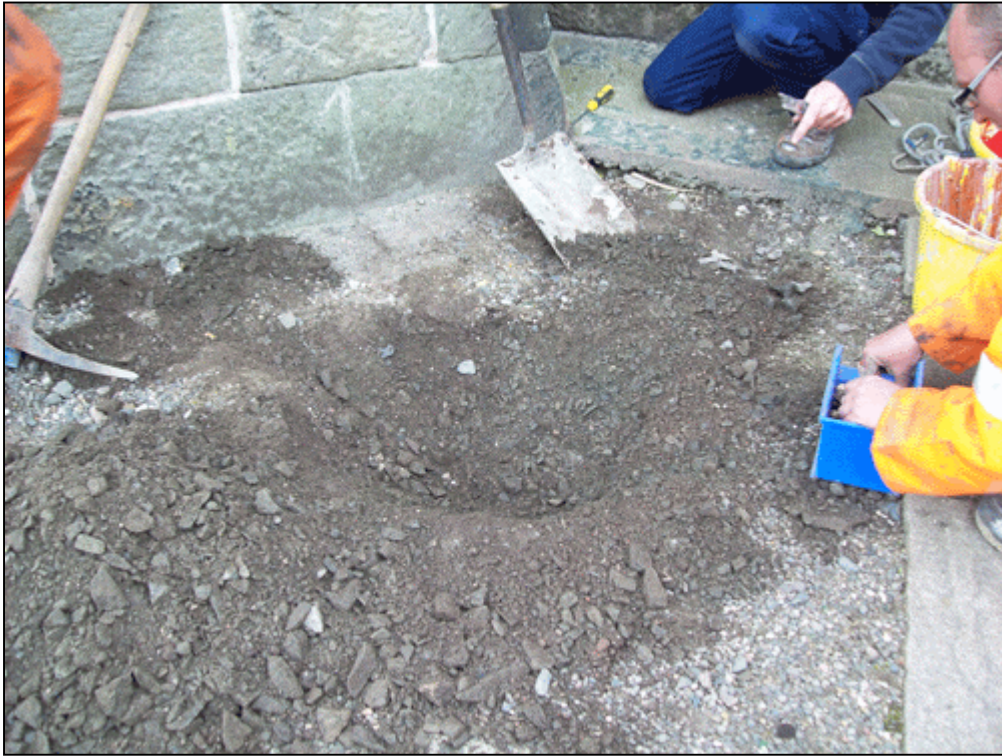
15. The first pit (1) (Figure 3a) was placed close to the northeast corner of the Tower and measured 0.5m square by 300mm deep with a connecting channel running southwest measuring 0.1m wide, 0.4m long and 80mm deep. Prior to excavation, the area to the east of the tower where pit 1 was placed was covered by a modern gravel surface (001) which measured a minimum of 300mm deep. Pit 1 did not reach the base of this deposit and failed to reveal any significant archaeological features.

Figure 3a: Pit 1 from the northeast

20. No significant archaeological features or deposits were uncovered during the groundbreaking works. The area to the east of the Tower has been covered by a modern gravel surface which the pit on this side failed to reach the base of, while the area to the south has likely been heavily truncated by the excavation works carried out during the 1960s excavations by the MoPBW.

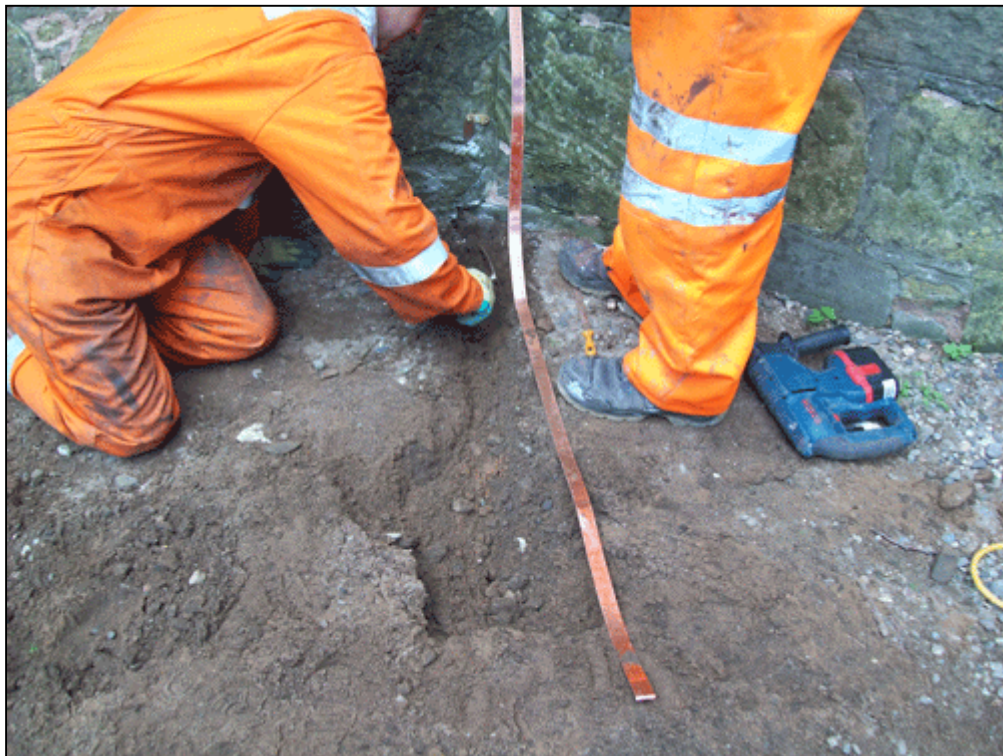
16. Pit 2 (Figure 3b) was then excavated close to the east end of the south side of the tower measuring 0.5m square by 230mm deep with a small channel running NNE towards the Tower which measured 0.1m wide, 0.7m long and 100mm deep.

17. The area to the south where pit 2 was placed was initially covered by a layer of gravel in clayey sand (002) which comprised the current ground surface. This was revealed to be 60mm in depth and underlying this was a layer of mid brown silty sand (003). The full depth of this layer was not revealed. This deposit is likely to have been redeposited due to the large amount of disturbance which would have occurred in this area from the work carried out in the 1960s by the Ministry of Public Buildings and Works (MoPBW). Their aim was to prepare the site of the Abbey for public access and display and their works included extensive excavations across most of the Abbey grounds. Pit 2 did not uncover any significant archaeological features.

Figure 3b: Pit 2 from the south-south-west

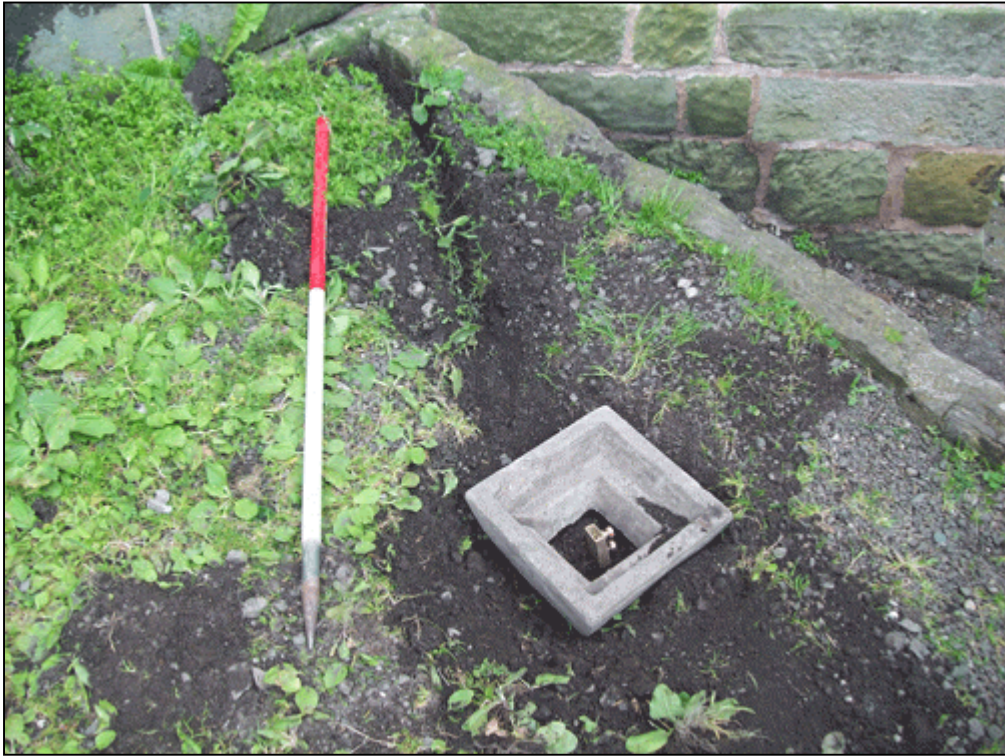
18. Pits 3 and 4 were both located along the west side of the Tower. Pit 3 (Figure 4a), which sat at the south end, measured 0.5m square by 270mm deep with a channel running southeast measuring 0.1m wide, 1.1m long and 70mm deep. Pit 4 (Figure 4b), which sat at the north end, measured 0.4m square by 250mm deep with a channel running northeast measuring 0.1m wide, 0.75m long and 100mm deep.

Figure 4a: Pit 3 from the west-north-west

19. The area to the west of the tower where pits 3 and 4 were located was covered by a layer of dark brown sandy clay topsoil (004) with frequent gravel inclusions. This measured a minimum of 270mm deep but its full depth was not revealed by either pit. While this area may be a reflection of the original ground level in the area it is likely that this deposit represents an area which has been heavily disturbed during the construction of surrounding structures including the new heritage centre to the north of the Tower and also the carpark which sits on the other side of the retaining wall to the west. Indeed pit 4 was also placed in the same position as an earlier earthing rod which has been robbed out in recent times. Neither pit revealed any significant archaeological features.

21. The area to the west of the Tower may well represent an original ground level but it is likely to have been heavily disturbed in recent times during the construction of the Heritage Centre to the north of the Tower and also during the installation of the carpark retaining wall which sits to the west. Indeed pit 3 was already known to be sitting in previously disturbed ground as it was located to replace an earlier earthing rod which had been robbed out.

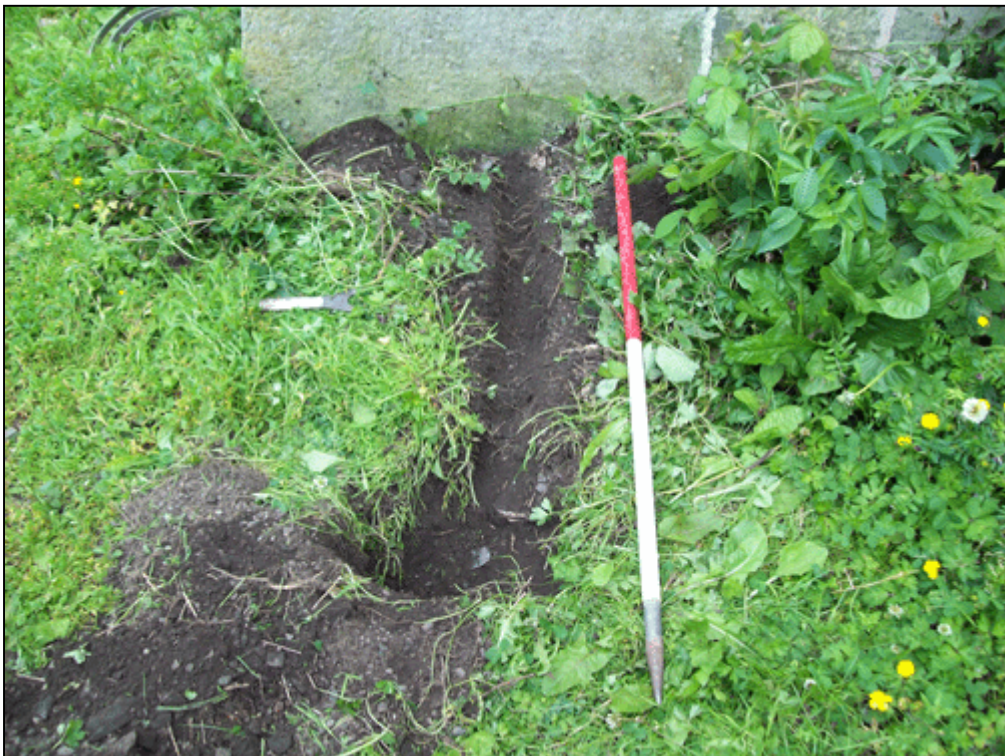
Figure 4b: Pit 4 from the southwest
