**The Gymnasium, Huntingtower,  
Perthshire:  
Archaeological Mitigation**

Data Structure Report

by Louise Turner

issued 30th July 2010

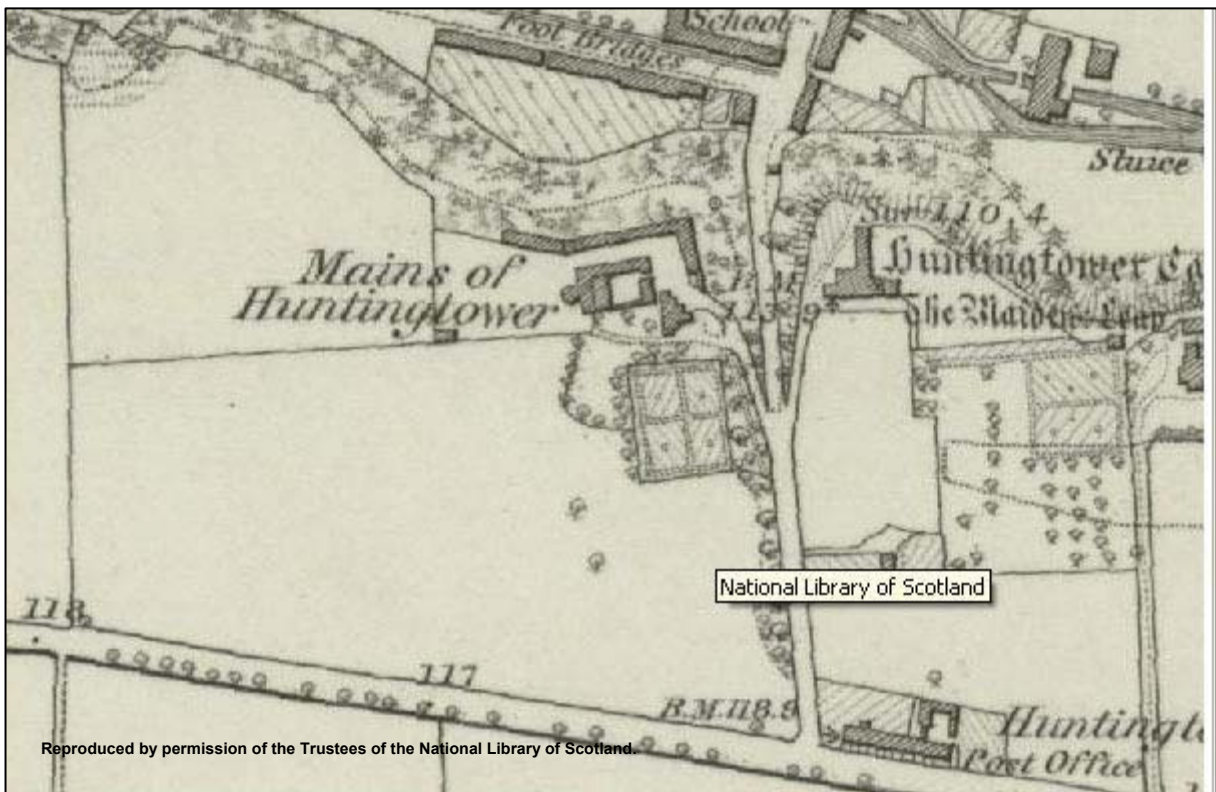
Fig. 1b: Excerpt from 1<sup>st</sup> edition Ordnance Survey Map of 1890

16. Amongst the industries active in the late eighteenth and early nineteenth centuries were paper-making, textile manufacturing and flour-milling. The Ordnance Survey 1<sup>st</sup> edition map of Perth shows this quite clearly (Figure 1b). Here the buildings and associated features of the Ruthvenfield Printworks are shown lying just to the north-west of Huntingtower Castle, showing the encroachment of industry, and also the fragmentation of the estate which, by the mid 19<sup>th</sup> century, had been sold by the Dukes of Atholl. They subdivided the estate into smaller land parcels which they then sold to self-made men such as industrialists or military men (Tulloch, W, 1834-43). One such individual bought Huntingtower castle and its associated lands: General Cunningham of Newton and Huntingtower.

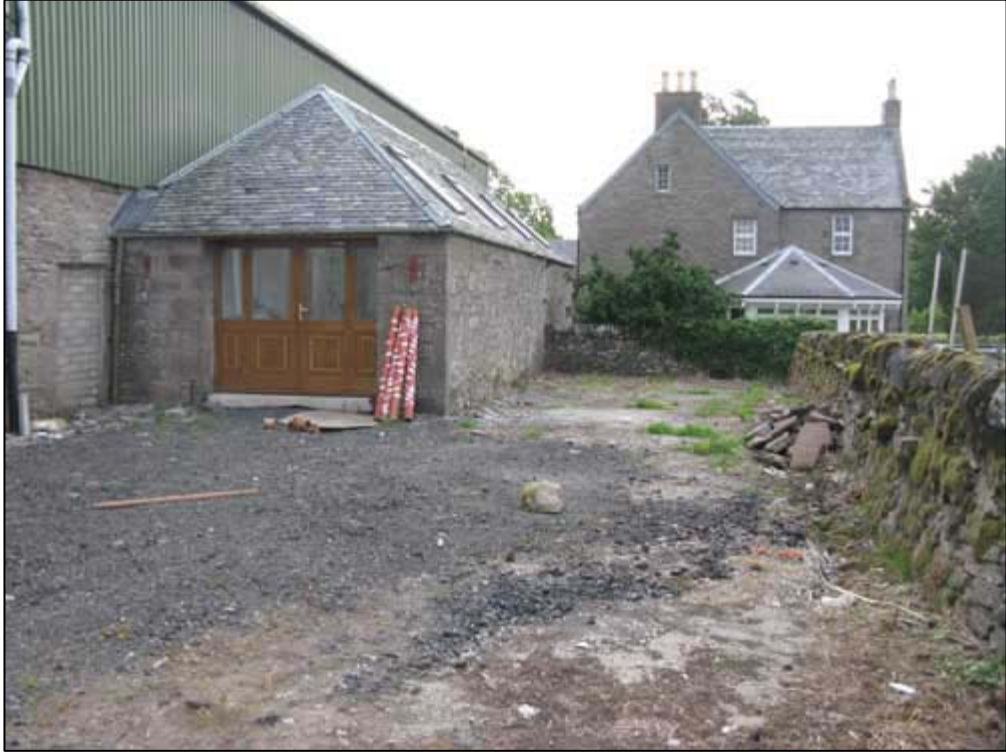
30. Both areas differed markedly in character, reflecting very different land use over the last 100 or 200 years. Area 1 (Figure 3a) had a thin layer of compacted whin chippings (001) forming a surface over a loose dark-brown silty sand (002) 0.4m deep which contained within it a number of large, rounded cobbles, apparently water-worn and measuring up to 0.4 x 0.2m in extent (Figure 3b). This layer also revealed several fragments of modern ceramic, in particular, sherds of glazed white earthenware.

Fig. 3a: Area 1 (Farmyard) – Pre-Excavation

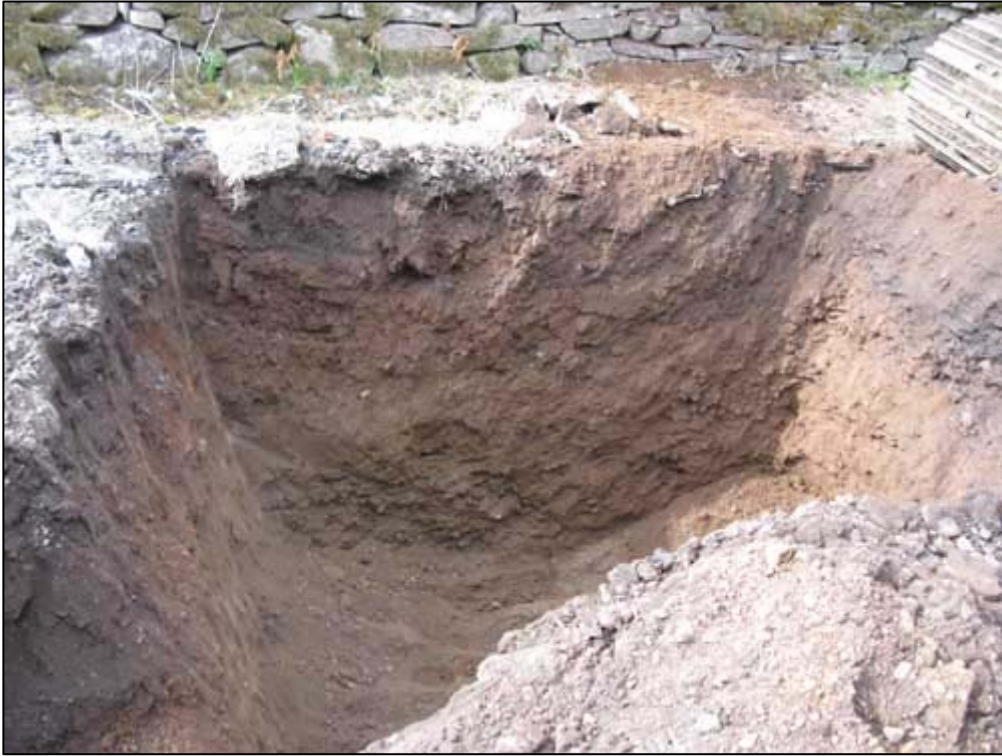
Fig. 4a: Area 1 (Farmyard): Pit for Septic Tank

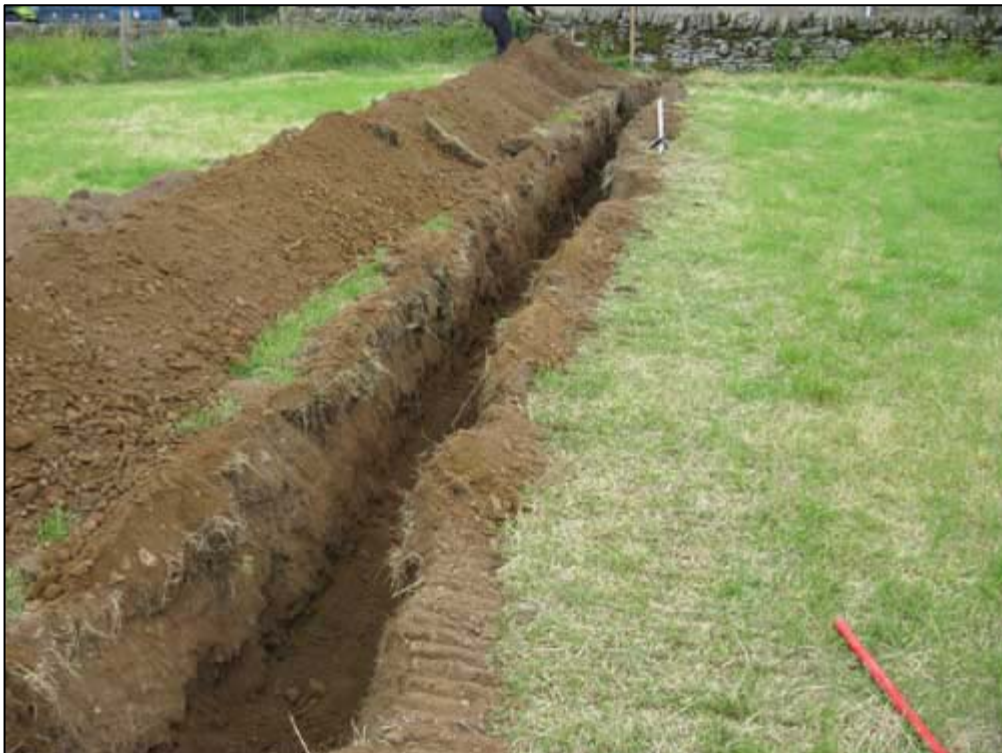
Fig. 4b: General View of Area 2, N end (where works crossed Scheduled Area).

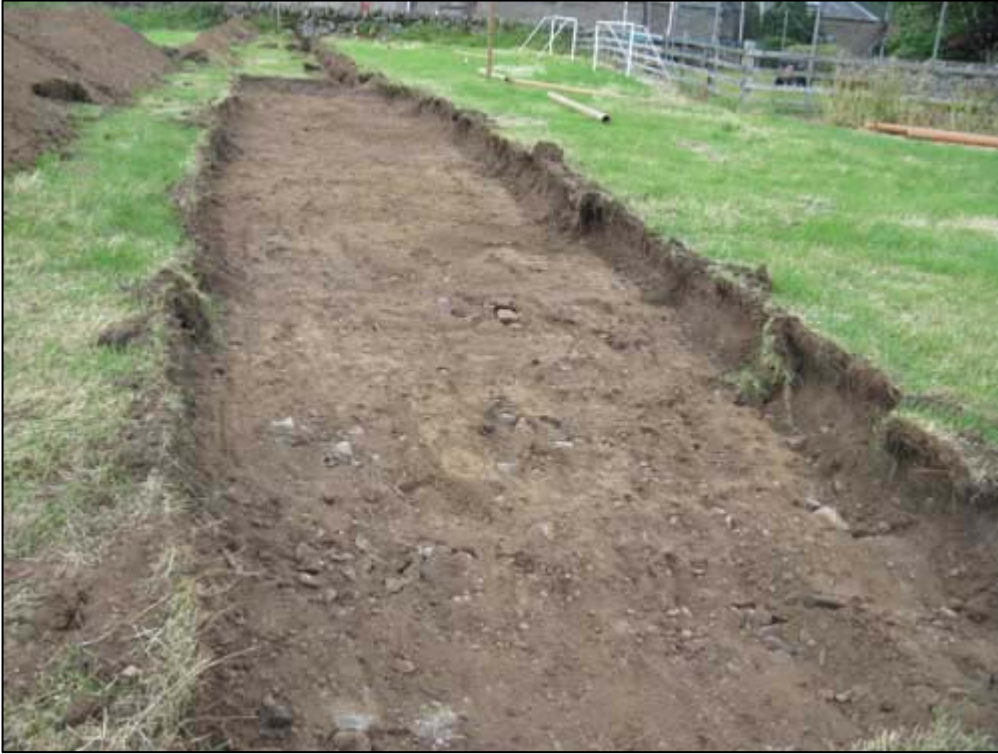
36. Topsoil was removed from the footprint of the soakaway next, revealing the upper surface of the subsoil (Figure 5a). Isolated patches of (102) still remained, but over much of the footprint a deposit of sandy gravel (103) was evident. This was very variable in character, varying in colour from orange to grey with some darker patches present that bore a superficial resemblance to anthropic features. In each case, however, these so-called 'features' proved to result from fortuitous discolouration of the subsoil. Following this initial topsoil-stripping exercise, the tail-race and soakaway were excavated to their full depth (Figure 5b).

Fig. 5a: Area 2 (Field) : Footprint of Soakaway, Topsoil stripped.

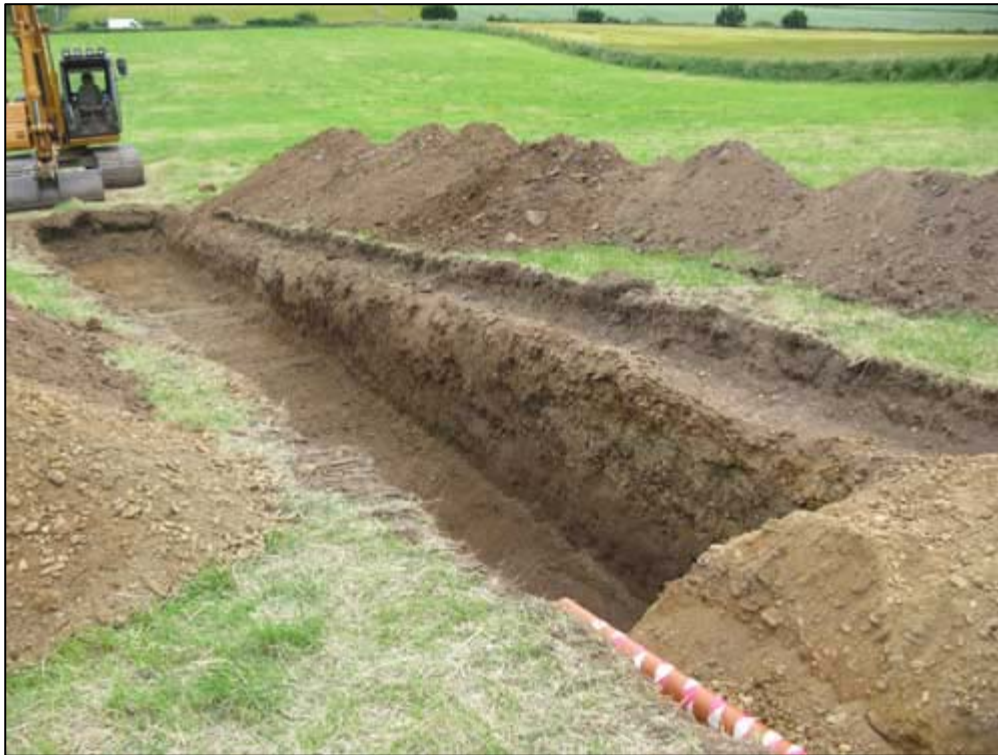
Fig. 5b: Area 2 (Field): Site of Soakaway, Fully Excavated

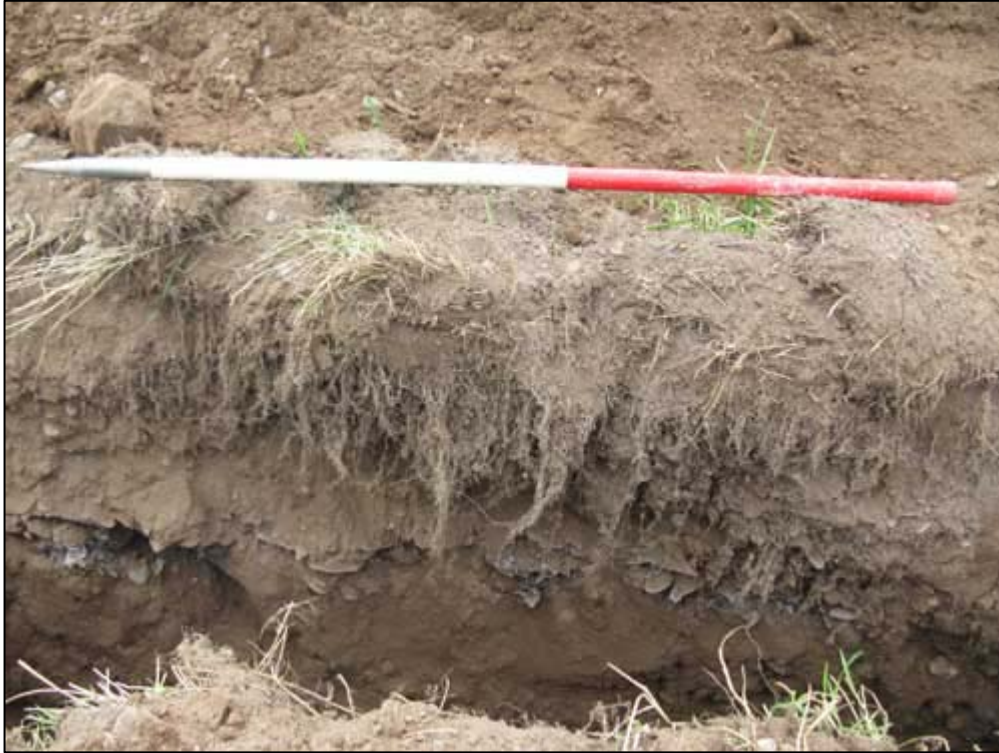
37. Throughout these works, only two features of anthropic origin were identified. The first was a shallow scoop or ditch (104), measuring approximately 3m from N-S and 0.55m deep (Figures 6 a and b). Its fill was identical to the topsoil (101), but for a narrow band of crushed broken slates (105) which lined the base of the cut. These were roofing slates with chamfered edges, probably of late 18<sup>th</sup> or 19<sup>th</sup> century date. The form and extent of this feature could not be established as it extended beyond the limits of the trench, but it suggested that there had been large scale disturbance of the topsoil in the proximity of the farmhouse at some point in the last two hundred years.

Fig. 6a: Shallow Scoop [104] With Layer of Broken Slates (105) Above

43. A shallow scoop into the subsoil (104) at the north end, within which had been placed a spread of broken slates, suggested that the topsoil (101) had been subject to disturbance at an earlier date. This material appeared to represent a dump of abandoned roofing material, presumably removed from the farmyard during earlier renovations, perhaps placed in this area to provide a solid area of hard standing for cattle or other livestock. No other features of anthropic origin were identified within the scheduled area.

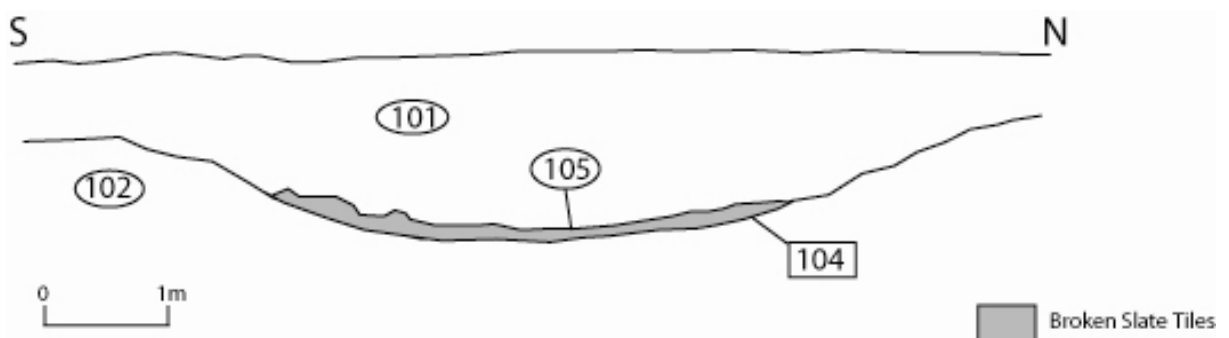
Fig. 6b: S-Facing Section of [104]/(105)
