**Report of Archaeological Watching Brief
July 4th – 30th 2002
Broadhaven, Wick, Highland
ND 381 / 510 (centred)**

**By
Stuart Farrell
B.A A.I.F.A F.S.A.Scot.
August 2002**

This report is for an archaeological watching brief conducted for Delta North on behalf of Scottish Water by the author for a waste water treatment works scheme at Broadhaven, Wick.

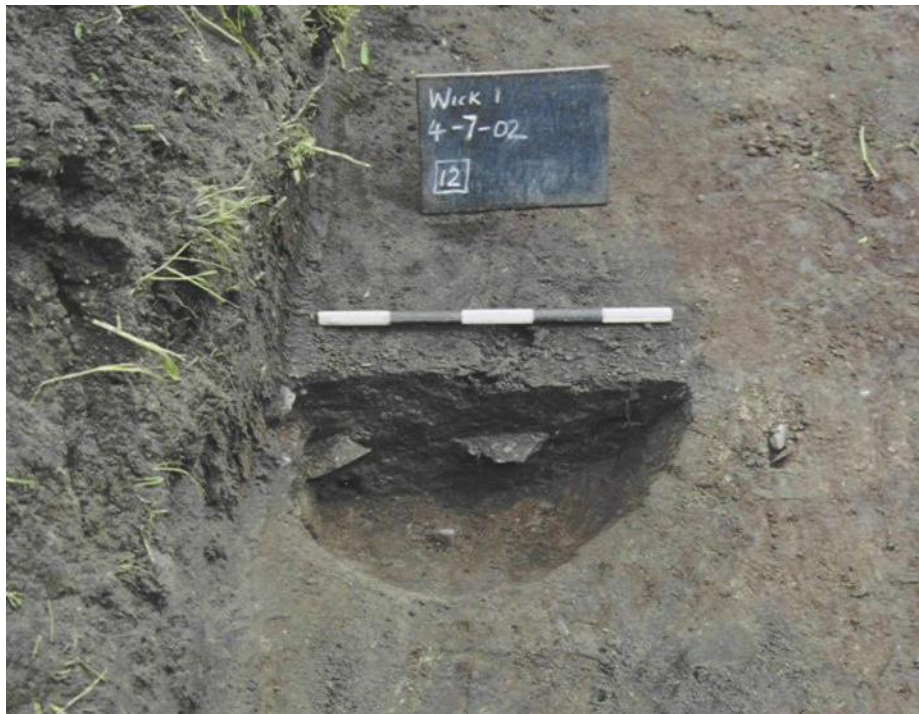
- 10 – Field drain parallel with [9]. Not excavated.
- 11 – Field drain in alignment with existing field boundary. Not excavated.
- 13 – Cut of small pit in area of car parking – excavated due to cable trench for electricity to be situated close by. Excavation reveals a small circular pit 0.55 EW by 0.65m NS by 0.23m in depth. Finds [context 12] include a fragment of possible slate and a sherd of red ware pottery of a 13th – 15th date. (See photograph over)

Top : View of pit 13 facing south showing fill 12 – scale 0.5m
Bottom : View of building facing south – scale 2m

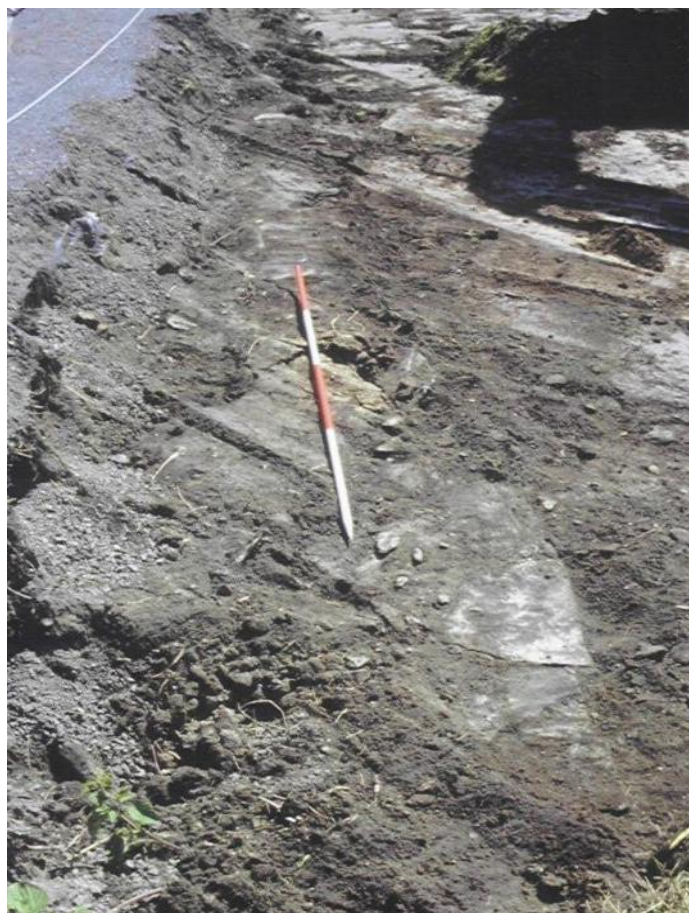
- 18 – Access to field? Area of dumping of stone including modern brick, possible area of access to existing field.
- Building – located as part of excavation for area of public parking. Edge only of building aligned N-S of 14m in length of a maximum width of 1.4m and constructed of flat stones. Situated 0.45m below current road surface. Inspection of section of hole excavated to join into existing sewer (for compound) reveals wall to continue to N along roadside for a further 6m. Full excavation not required as to be covered over with terram and stone for car parking, no features or deposits were revealed to its west side. Possible building is part of a long range likely to be associated with Broadhaven Fishing Station and likely to be similar to those depicted on the 1st edition OS map to the northwest along roadside. (See photograph previous)
