# The Pier, St Kilda

## A Conservation Statement

The National Trust for Scotland

May 2009

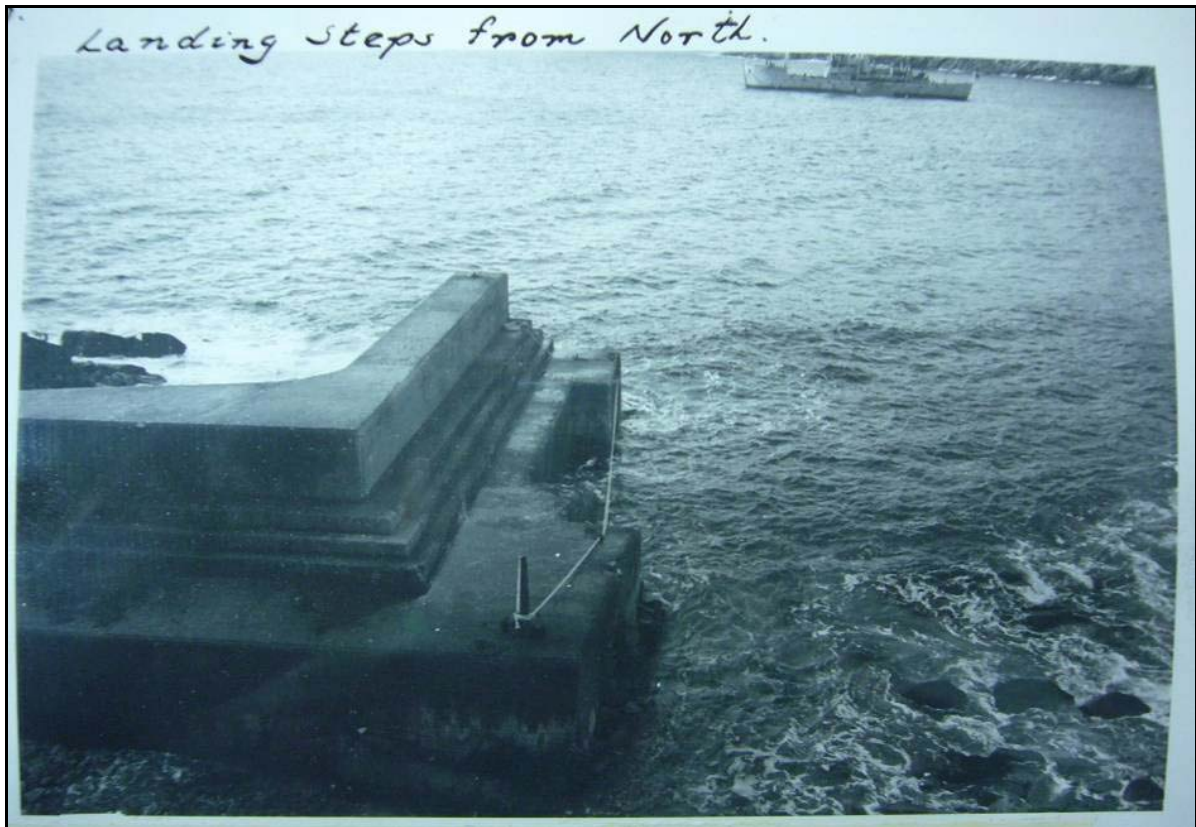
*The pier from the north-east in March 1956, ADM326/3 (NAK)*

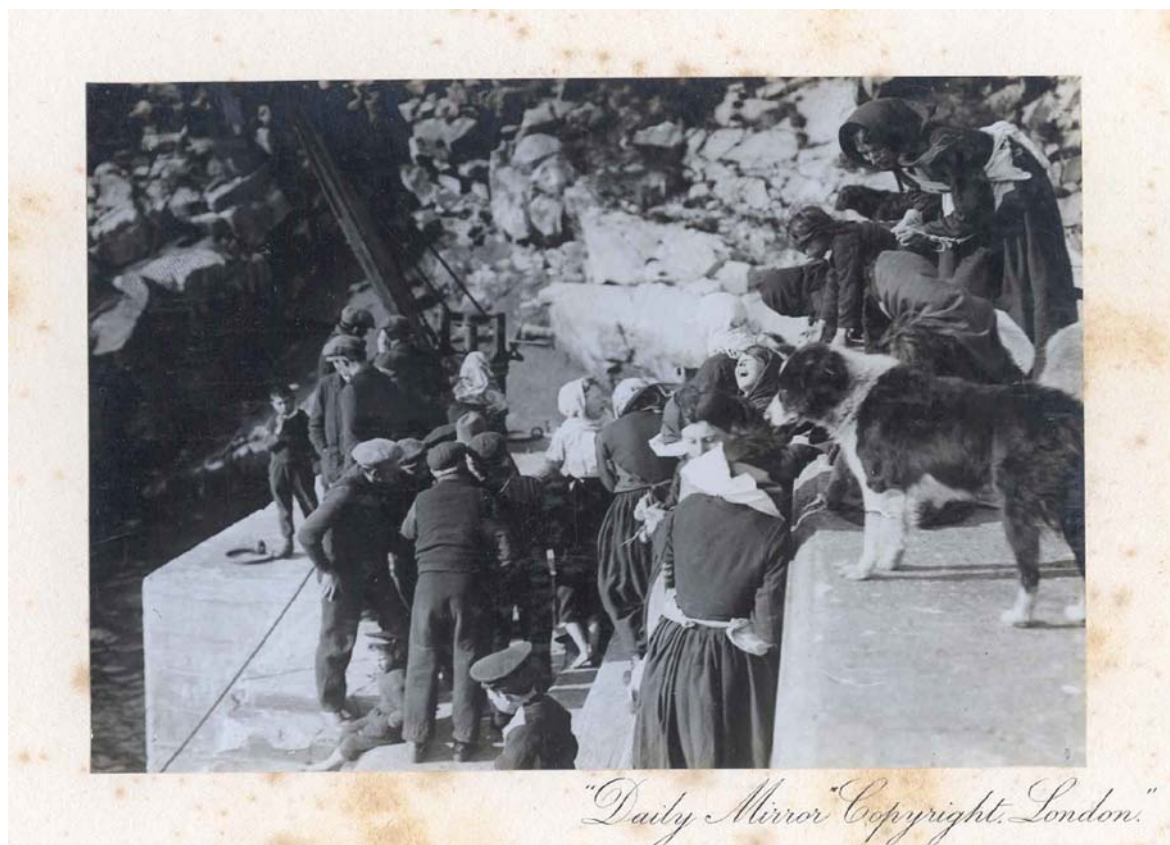
*A historic photograph from 1912 showing a busy day on the pier, probably just after the arrival of a steamer. The 15 tonne crane and mooring rings are visible and the steps have already been damaged by boulders thrown by the sea. © Museum nan Eilean, Western Isles Council*

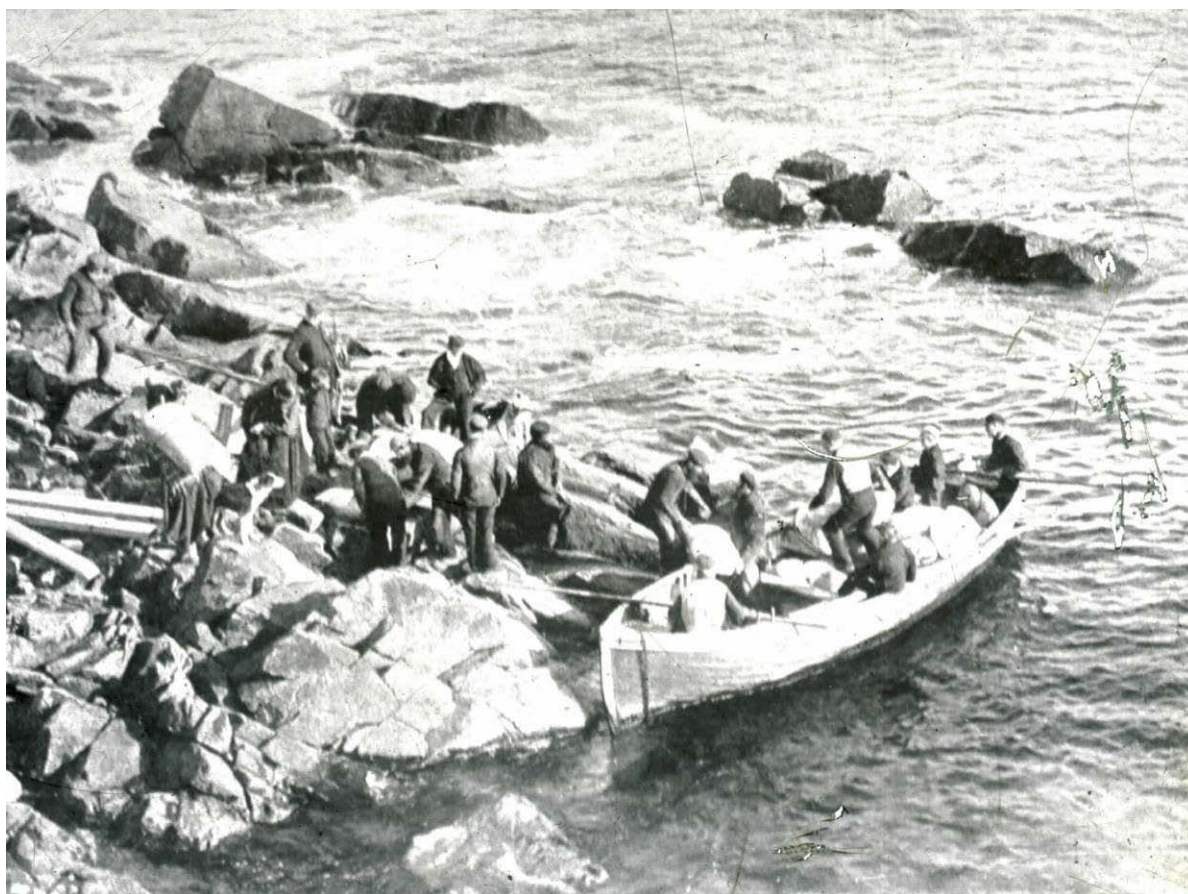
*St Kildans landing stores immediately SE of the current pier (Kearton 1899, p7). See the photograph on p13 for a comparison – the same triangular rock in the background is possible.*

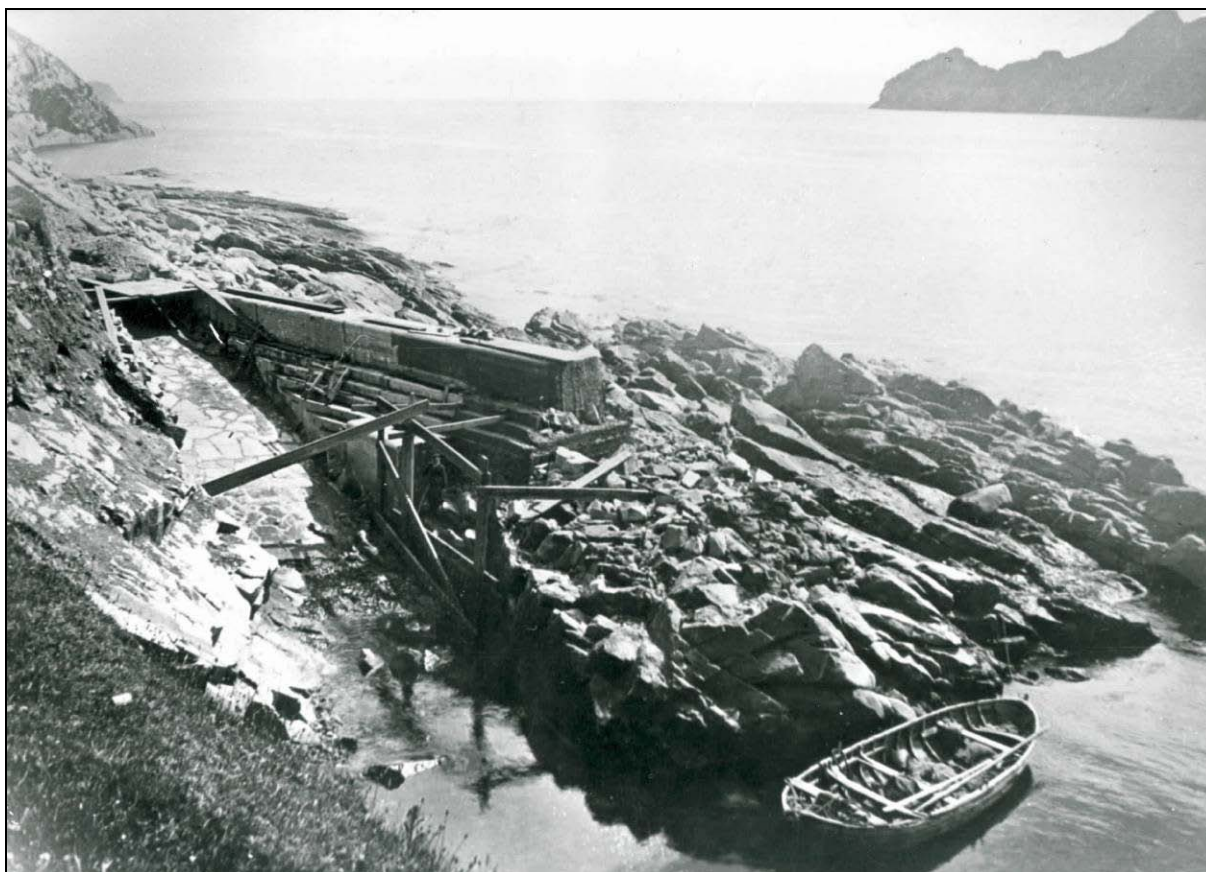
*The pier during construction in 1900, NTS: SKA202*

The main work of constructing a pier, slipway and basin was undertaken between August 1899 and September 1901. The work was undertaken by three Scottish Office supervisors; WE Wookey assisted by Matthews and Cooke and reporting to Colonel Gore-Booth. Able-bodied St Kildan men provided paid labour when they were free from their normal work load.

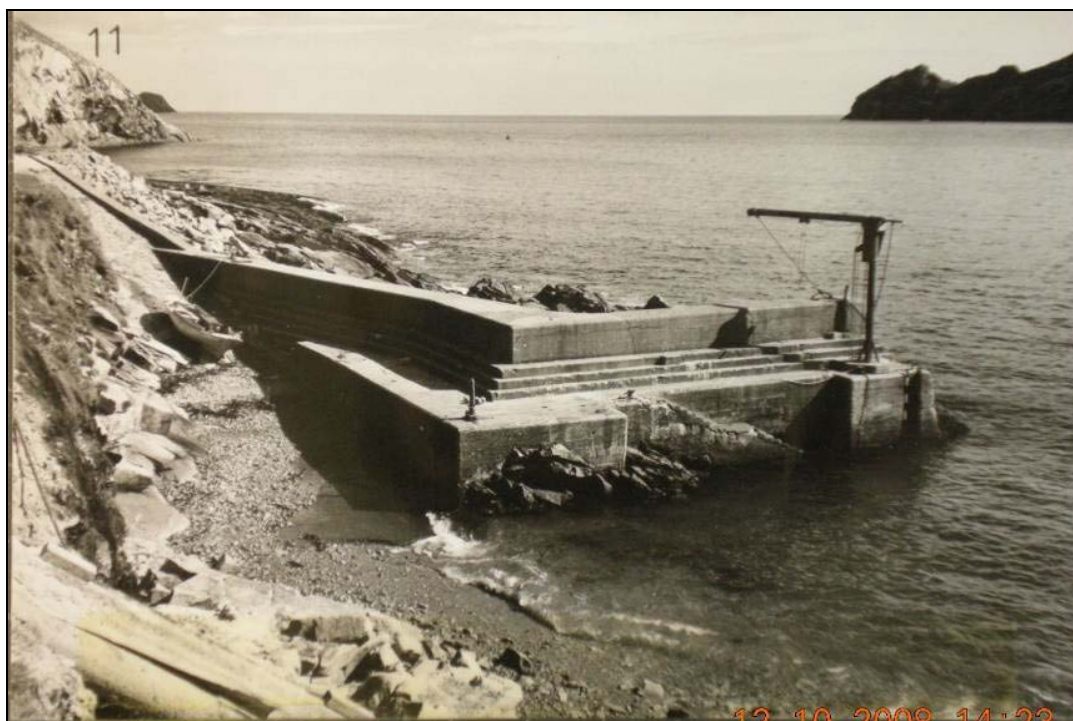
*The pier from the north-west in the late 1950s. The derrick and the tender are MoD. (NAK: ADM362/2)*

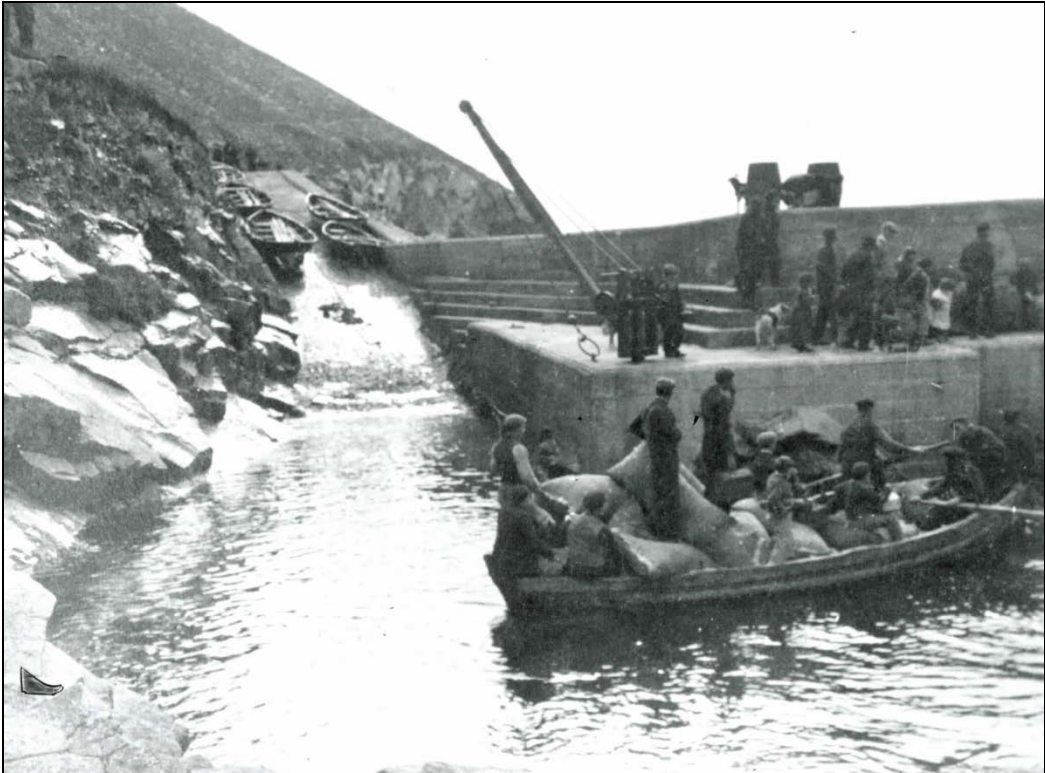
*An image of c.1910 showing the pier, crane and boats (NTS: SKA465)*

A later undated report noted that the ironwork of the crane needed painting and that the band brake was broken. It also mentioned that the locals wanted some ragged rocks at the mouth of the dock blasted as they had damaged a boat. In August 1911, a letter from the St Kildans to the CDB noted the erection of new capstan by a Mr Monk and complained again about rocks sticking out of the landing stage<sup>19</sup>.

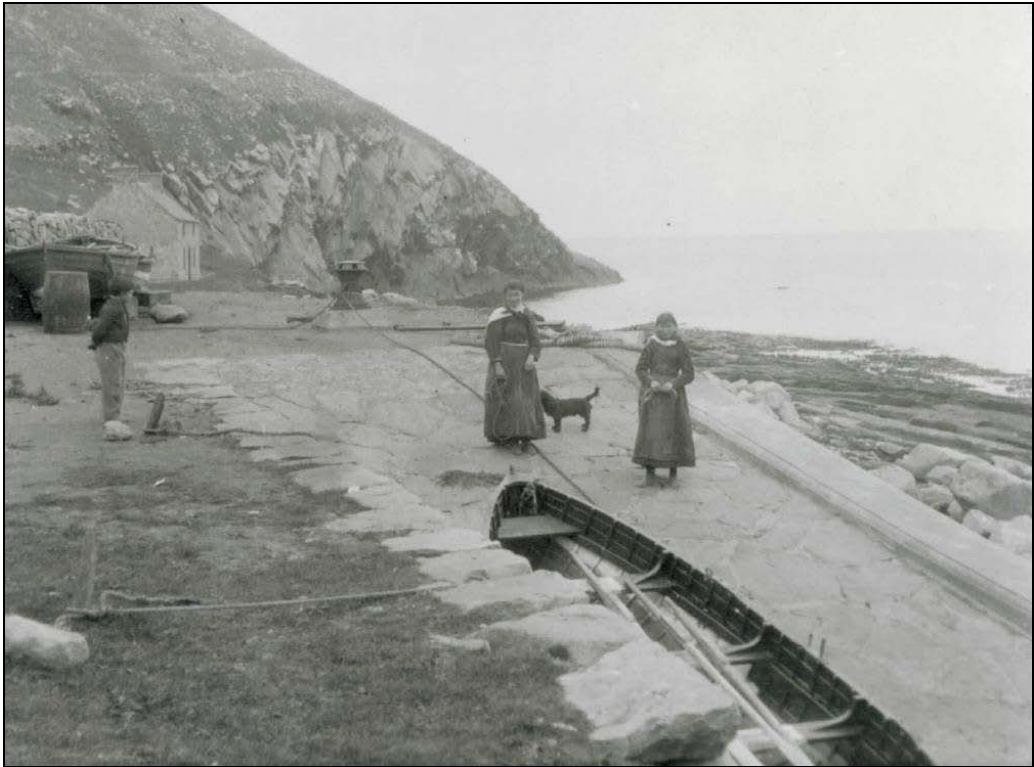
*An image taken between 1901 and 1911 showing the original capstan in position (NTS: SKA165)*

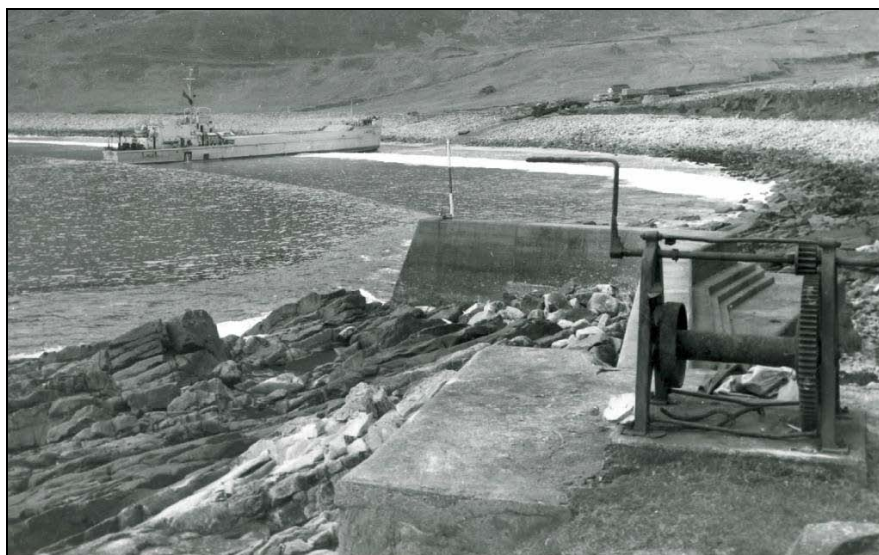
*The pier from the south east in the late 1950s or early 1960s showing the new winch installed by Mr Monk c.1911 (SKA315)*

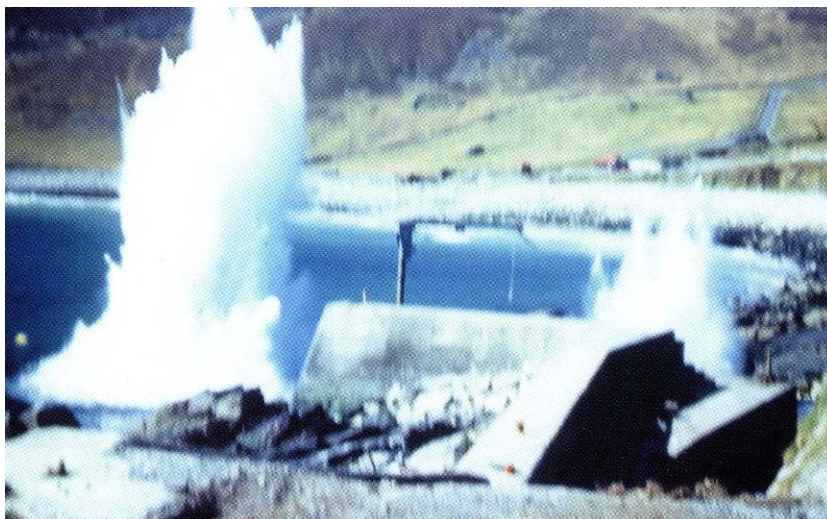
*The pier from the east during blasting to clear boulders in the late 1950s (Mackay 2002)*

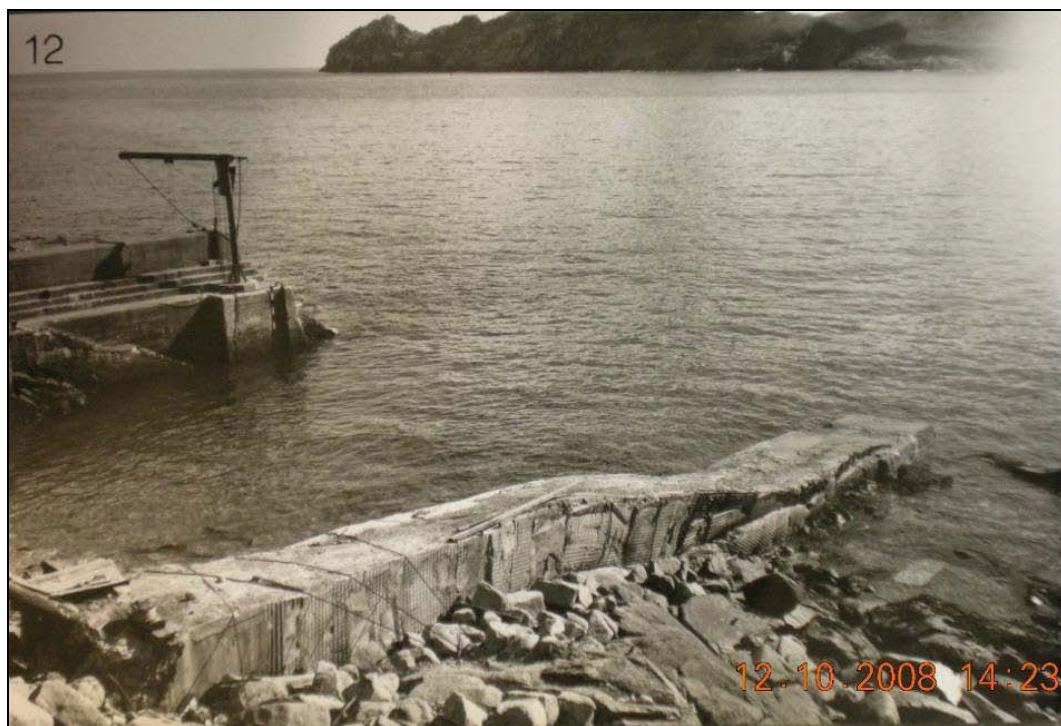
*The newly constructed groyne or 'gabion wall' in the early 1960s (ADM326/2)*

Detailed drawings of the existing pier were produced by Royal Engineers Captain RA Bagnell in 1963 including a sketch of the newly built 'gabion wall' or groyne. At the same time, improved soundings were taken of Village Bay and Glen Bay by Lieutenant Commander Whitehead, replacing those of Captain Somerville in 1909<sup>27</sup>.

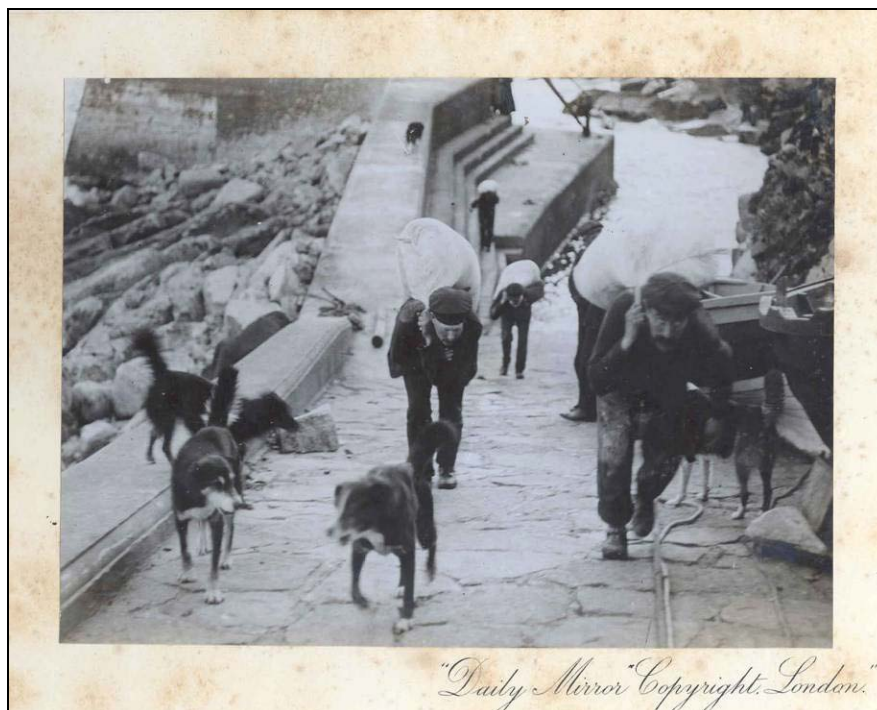
*Goods being taken up from the pier in 1912. This shows the paving and moulded edge on the parapet wall clearly (Museum Nan Eilean collection)*

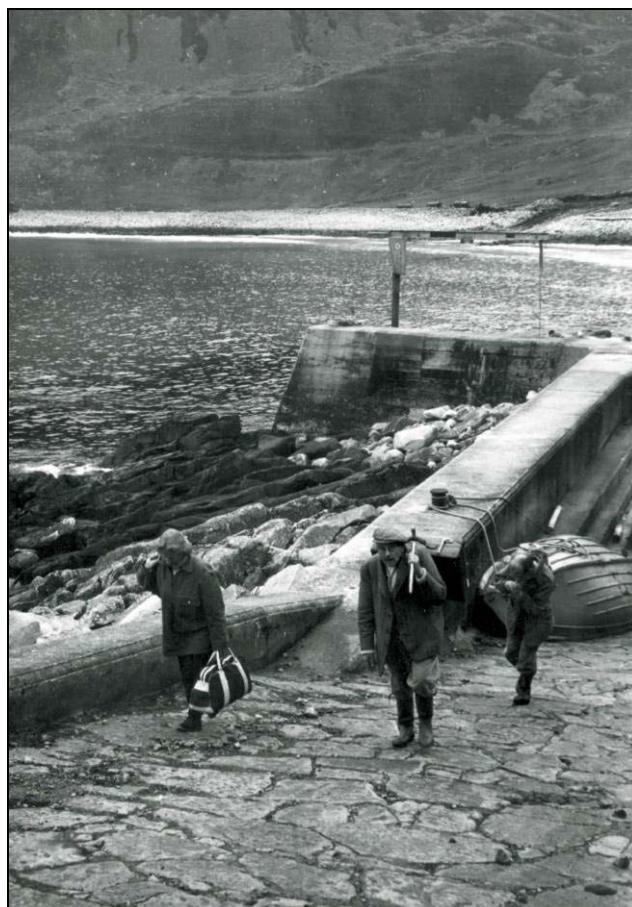
*A similar view from c1960, NTS: SKA163. Note the additional mooring post in the parapet wall.*

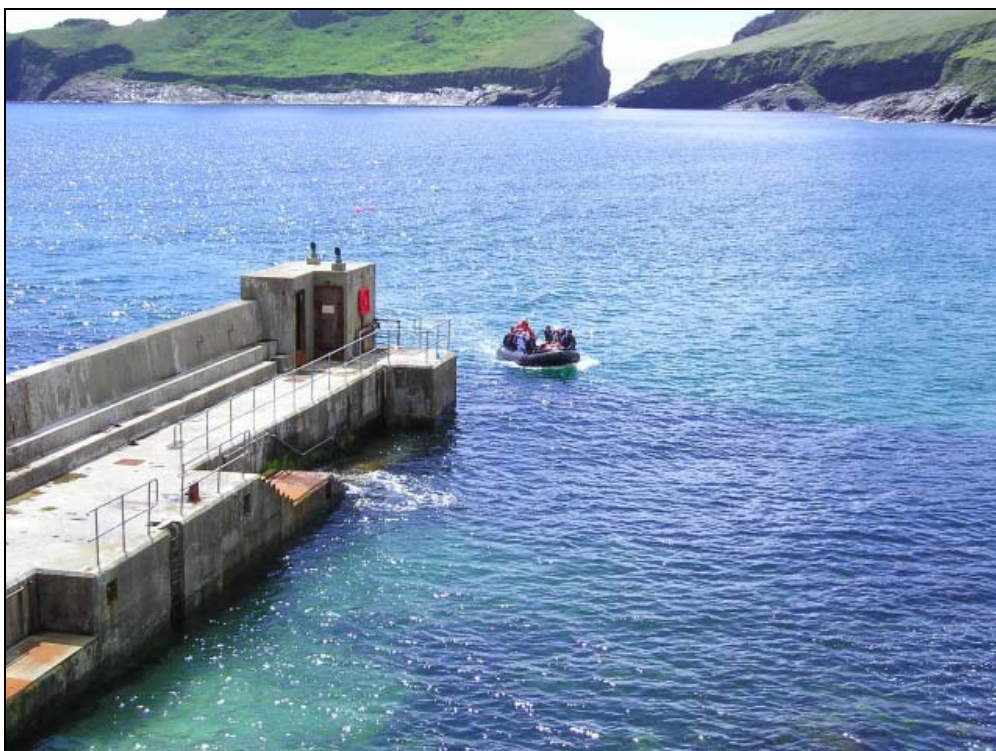
*Visitors approaching the modern pier during the summer of 2008. The building at the end of the pier is the pump house.*

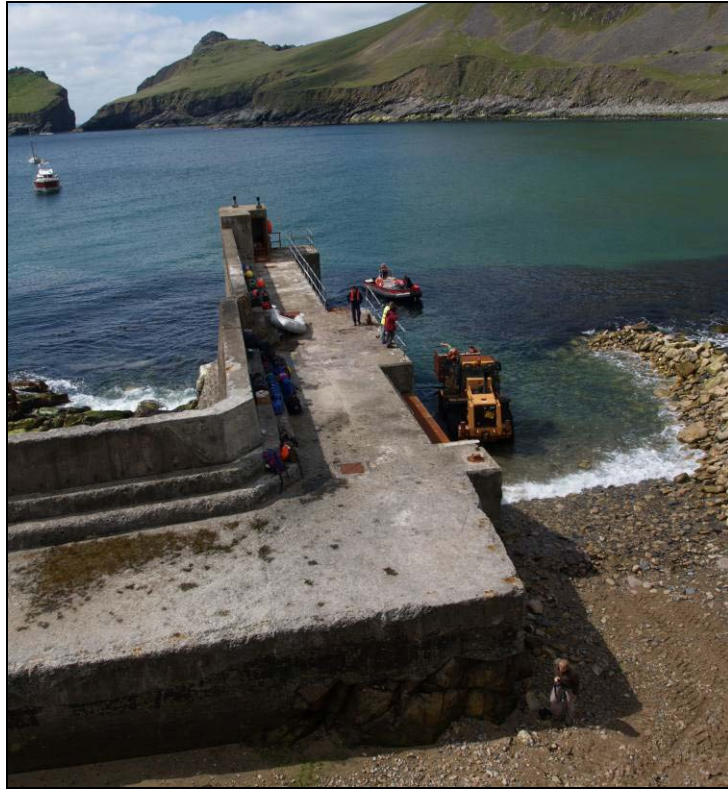
*The modern pier from the north east during 2008. The wheel loader is used to launch the rigid inflatable used by the radar base. The position of the original pier is visible in the parapet wall and as a faint line in the main concrete platform.*

The chosen main contractor for the whole project was Costain Civil Engineering Ltd, whose tender was accepted in February 1969. Costain contracted out the boiler and diesel installations to Blackstone & Co., Gloucestershire. A completion certificate was issued by the Ministry of Public Buildings and Works in October 1970. The original estimated cost was £540,000 but by completion this had increased to over £926,497.18!<sup>30</sup> As well as lengthening the pier and building the pump house, the works included the widening of the pier, obscuring the original moulded edge – the original line of the pier is still visible in the concrete surface.

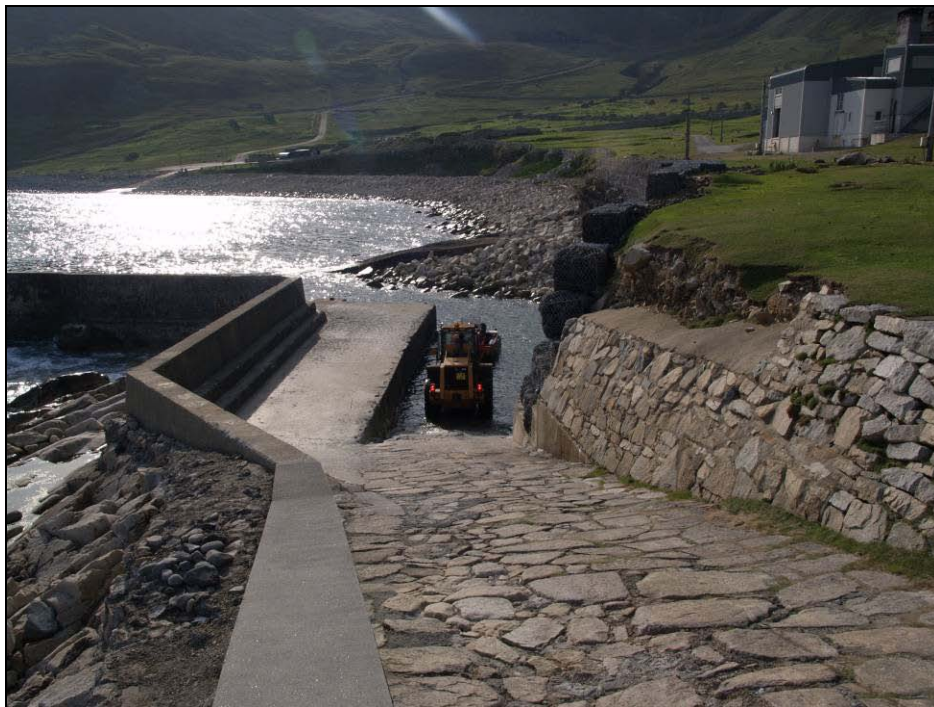
*The slipway, revetment and parapet wall from the south east in summer 2008. The 1960s 'gabion wall' or groyne is visible in the background with the modern gabion-basket revetment to the bank at the right.*

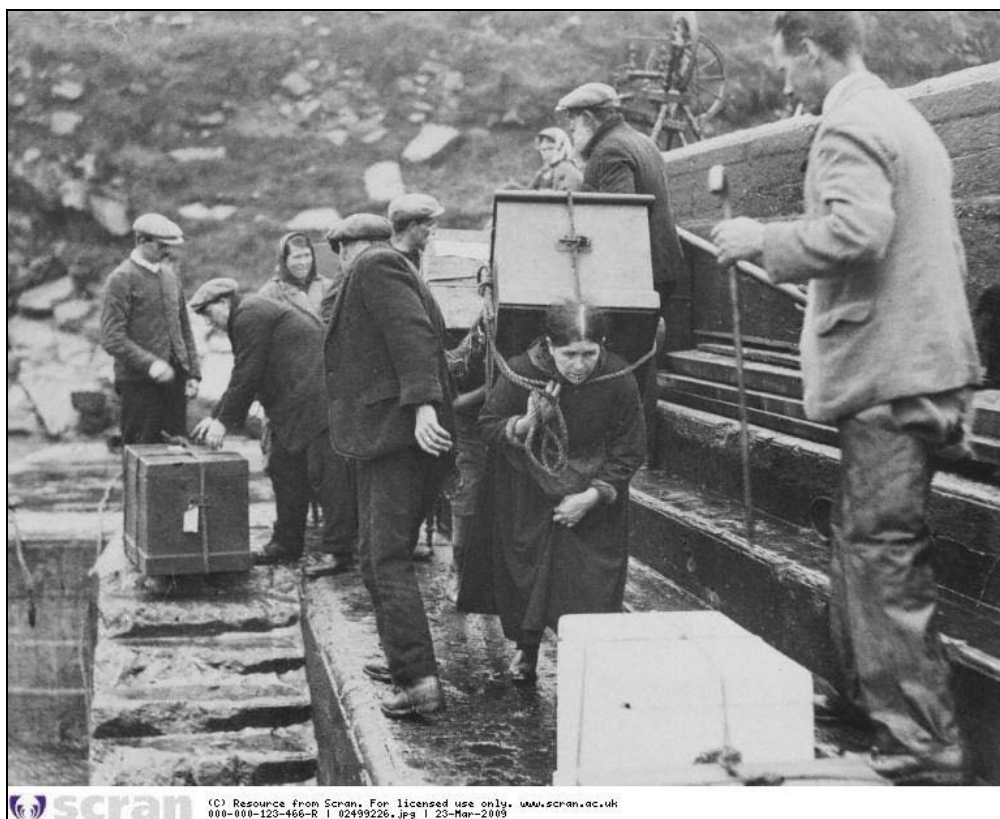
*St Kildans preparing to leave in 1930, note the condition of the steps battered by thirty years of severe winter weather and the nature of the bank behind, now revetted by gabion baskets.*

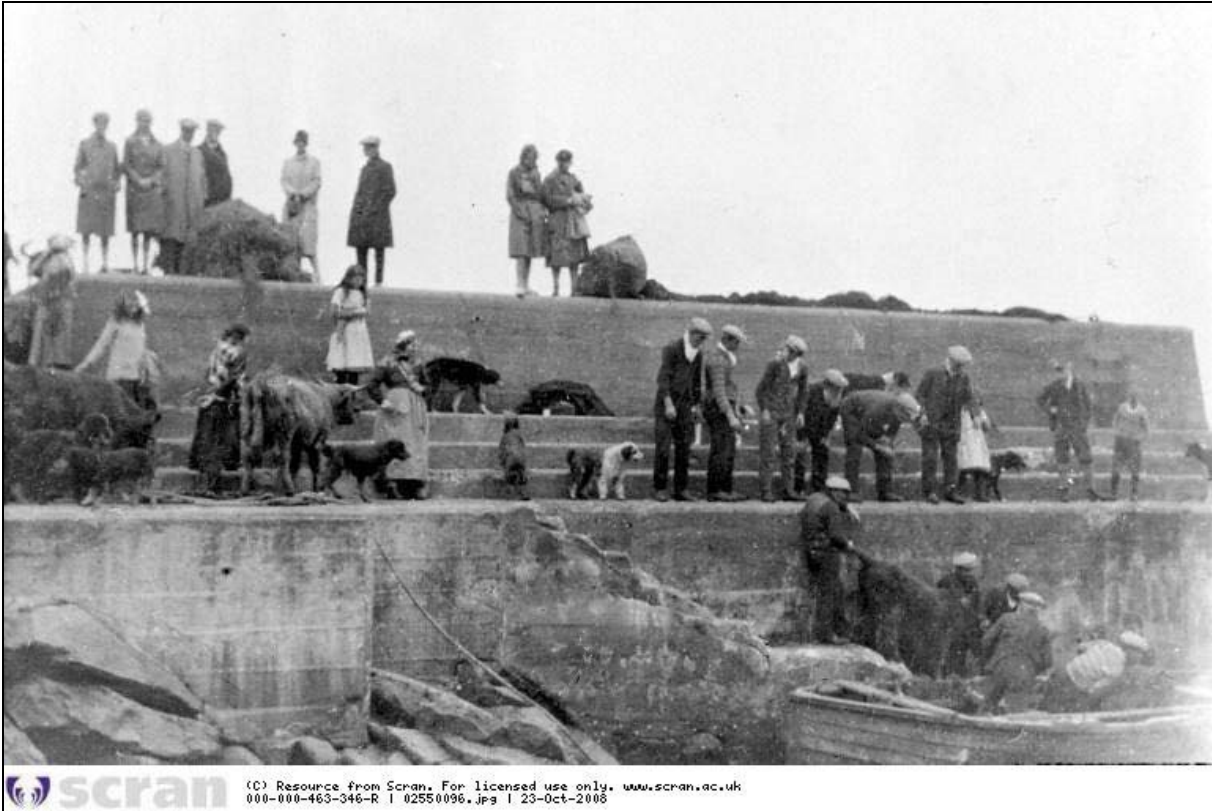
*Another Macgregor image from 1930 showing the community evacuating the island. Note the battered condition of the steps.*
