# LOWER NORTH WATER BRIDGE ANGUS

**- Mason's marks survey -**  
**-Part 2 -**  
Carried out 19<sup>th</sup> August 2008  
by  
**Murray Archaeological Services Ltd**

**Report No: MAS 2008-24**  
by  
**H K & J C MURRAY**

### **-Mason's marks survey Part 2- HK and JC Murray**

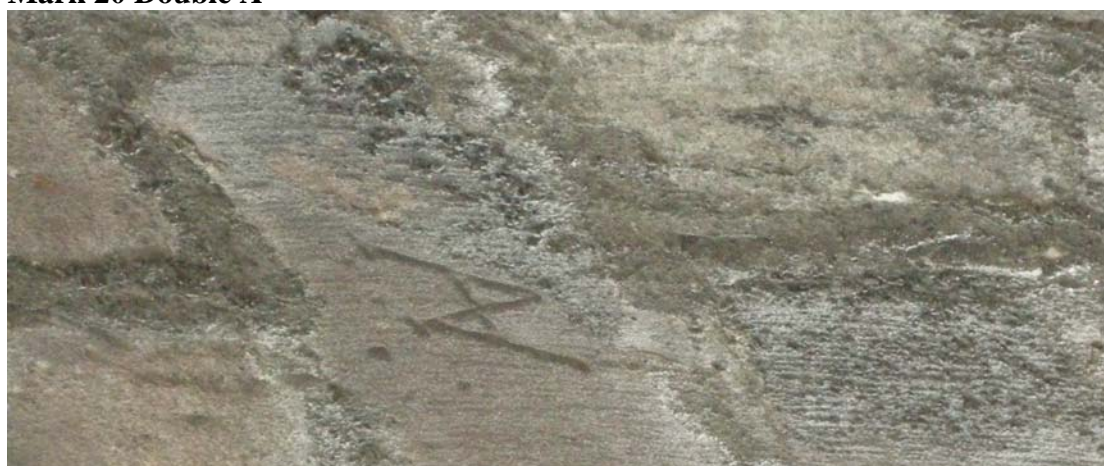
### Mark 20 Double A

Two examples only, both near the apex of arch 4- which was the arch with most A marks.

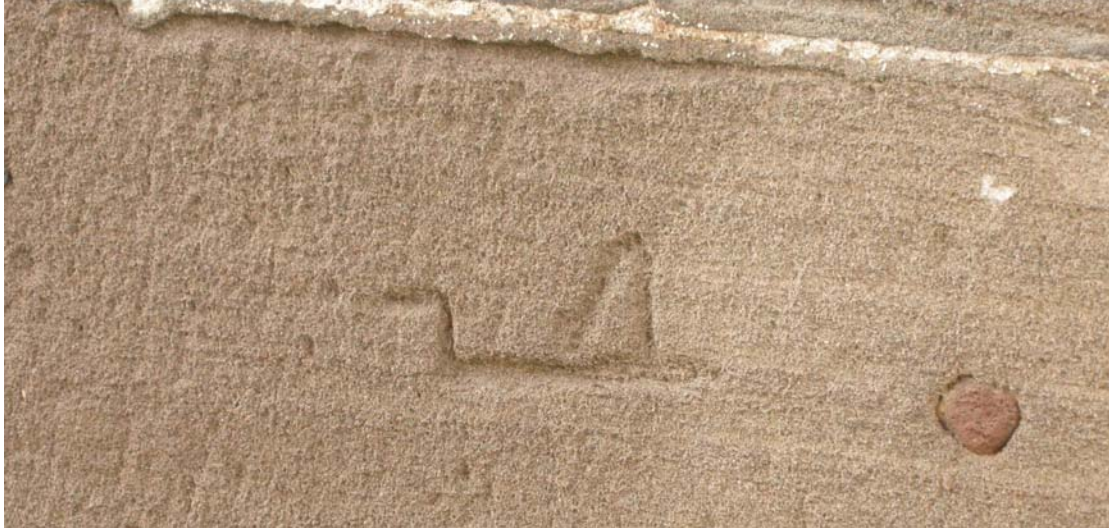
**Mark 21 Triangle on Z**

Two examples, one each on arches 5 and 7 (not visible in 2007); both below impost.

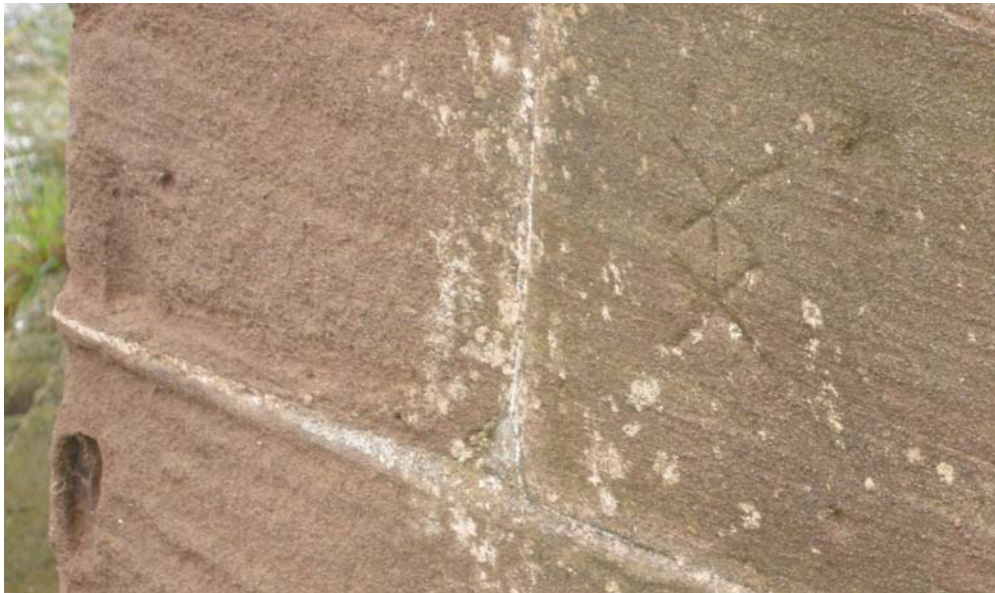
**Mark 22 Diamond + open triangles**

One example only, on cutwater 5. This could be a variant of mark 3 but the internal cross line not seen on any mark 3 and the triangles appeared to be open-ended.

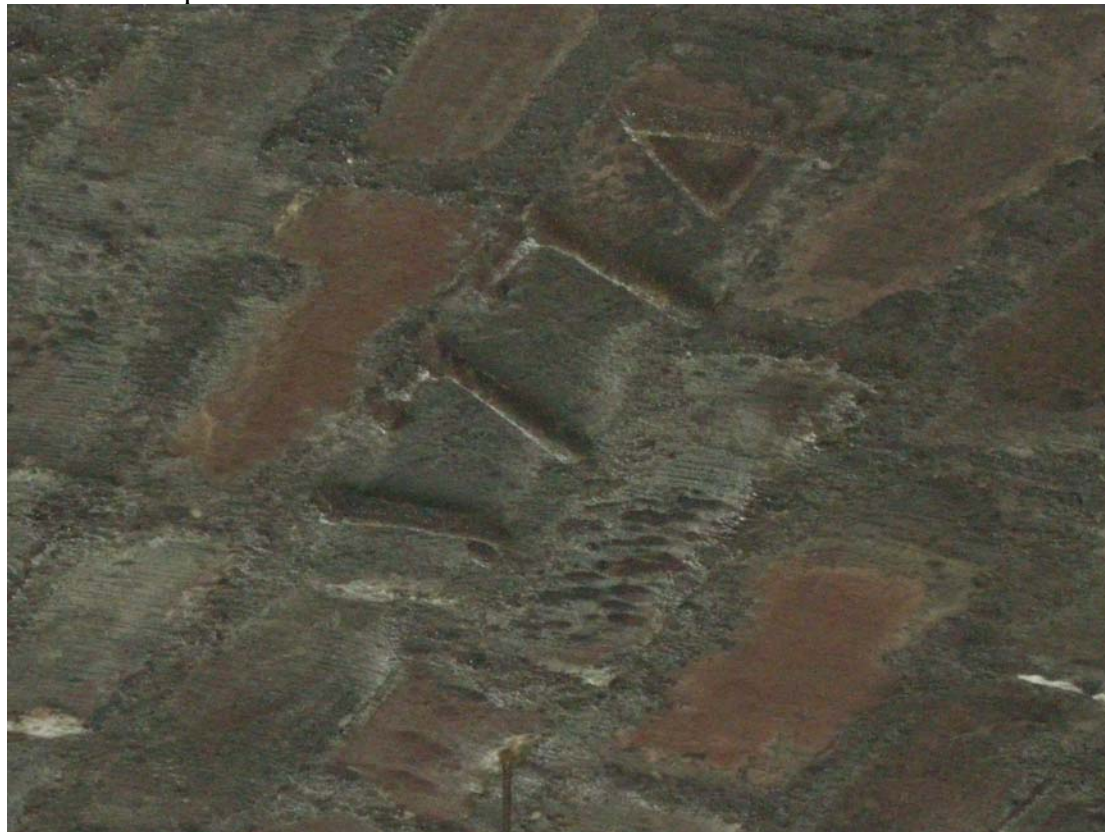
Illus 1 Date stone on underneath of apex of arch 4

At the apex of the underneath of the main river arch, arch 4, there was a date stone with 1774 carved in high relief. This is considered to indicate when the final arch was completed.

Letters **A**, **B**, **C**, and **D** appear to be in sequence from the outside arches with D, moving in towards the main river span 4 which has the letter A. As the top of the underside of arch 4 also bears a stone with the date 1774, it is suggested that these are stones cut in different seasons from 1771 – 1774. It is assumed that much of the cutting may have taken place in winter/spring with the stones set in place through the summer/ early autumn so in fact each season would have overlapped 2 years- the suggested 'years' on the chart below are those of possible construction. In each season a small number of stones cut the year before have been used up (also indicating that these are probably marks put on in the area – possibly in the quarry- when the stones were cut).
