**CASTLE FRASER WALLED GARDEN
ABERDEENSHIRE
SOAKAWAY TEST PITS
-Archaeological Watching Brief-**

HK Murray

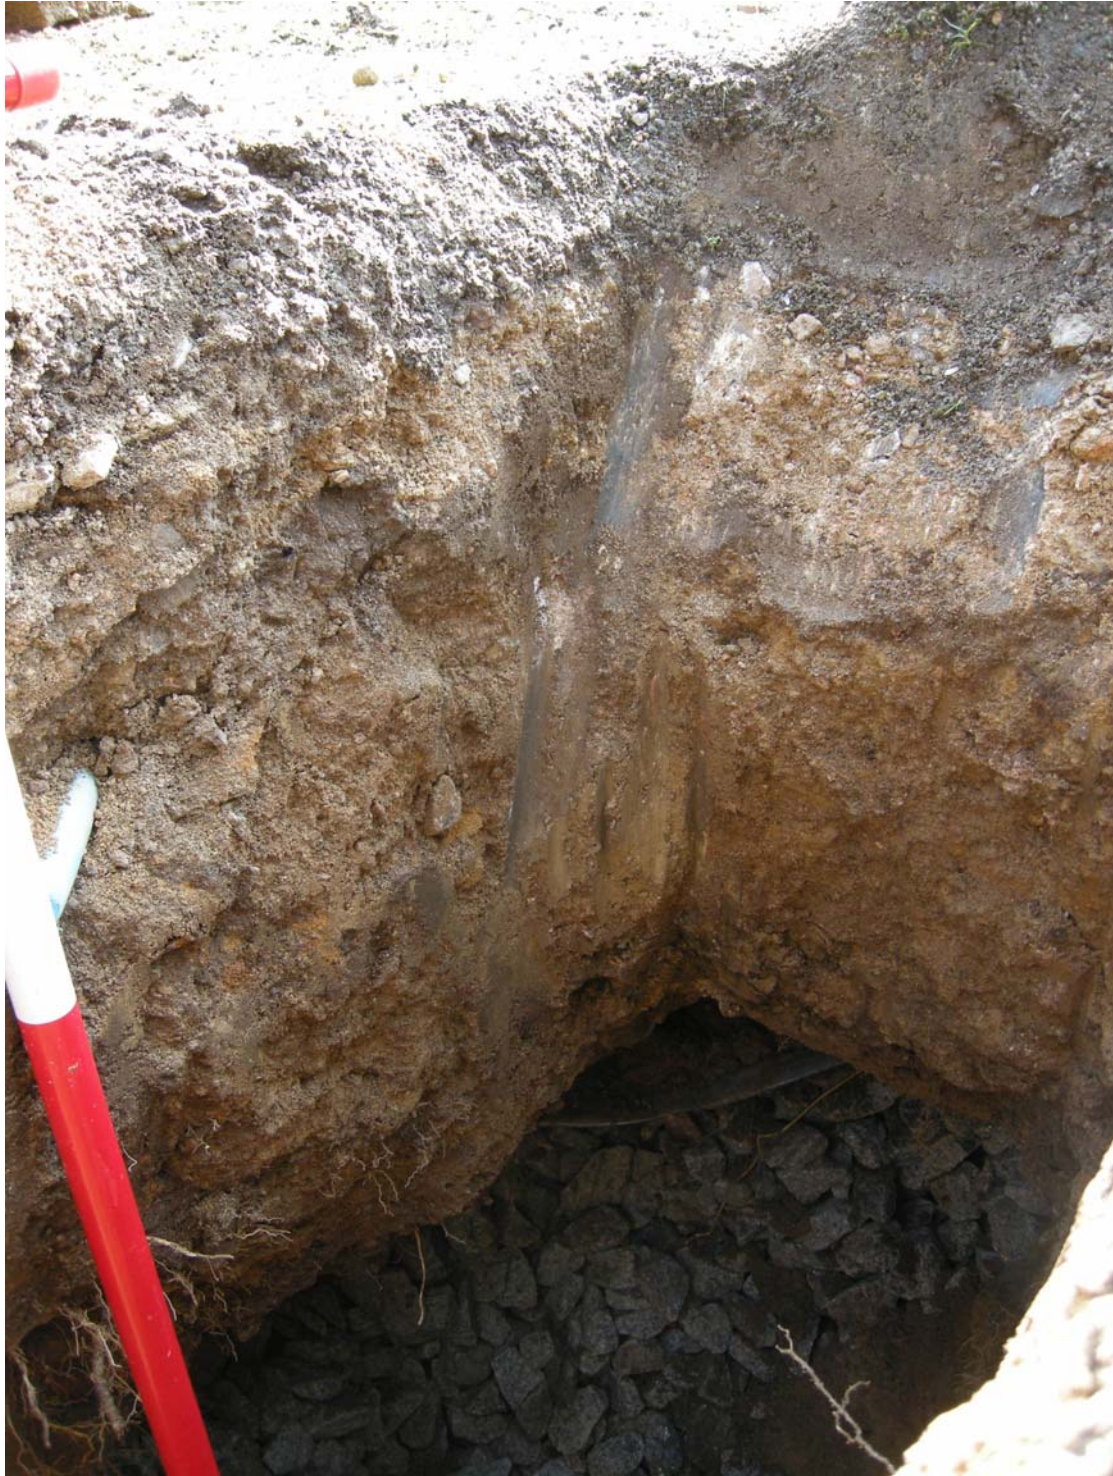
Illus 3 Soakaway in TP1

The S half of the test pit was cut into the top of an existing soakaway formed of small angular stones covered by a membrane of plastic (Illus 3). This extended to the S and E of TP1 from a depth of *c* 700mm below the yard surface to the base of the test pit. A clay drain led into it from the NE corner of TP1. It was sealed by yard makeup (*c* 200mm) and redeposited topsoil. It was cut into

clean hard natural glacial deposits. The stratigraphy at the N and W sides of TP1 showed c 200mm yard make up over c 300mm of disturbed and mixed topsoil and subsoil over natural.

No archaeological features or artefacts were observed.
