**Report of Archaeological Watching Brief
March – May 2004
Fortrose Area Water Mains
Replacement Project, Fortrose, Highland.**

Client: Halcrow Group Ltd on behalf of Scottish Water

**By
Stuart Farrell
BA, AIFA, FSAScot
&
Charles Murray
BA, DPA, MIFA, FSAScot, FMA
(Murray Archaeological Services)
May 2004**

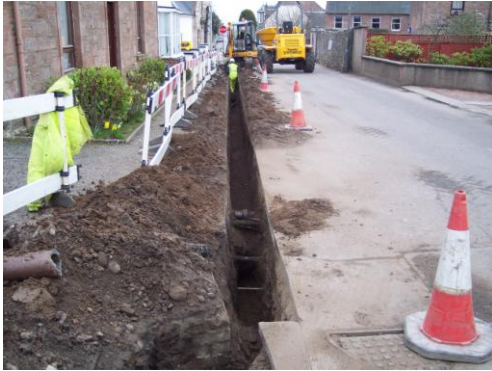
Photograph 1: Looking SE

The total length of the new water mains trench observed was c.106m long and varied slightly in depth from 1m to 1.2m. A top layer of tar c.100mm thick overlay a gravel and granite dust sub-surface c.200mm deep. This in turn overlay a light brown sandy and slightly silty natural. The trench ran the length of the N side of

the street and was much disturbed by services for water, sewerage and electricity supply [see photograph 1, below].

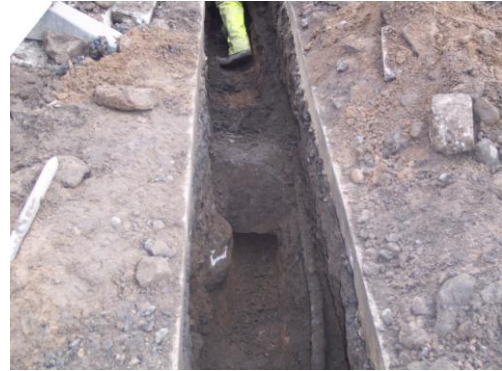
Photograph 2: Looking SE

In an area, comparatively undisturbed, opposite the pathway between No's 4 and 6 Church Street, some large boulders were encountered. Further excavation by hand showed that, while these were not structural, they represented a significant anomaly in the otherwise sandy natural [see photograph 2, below].

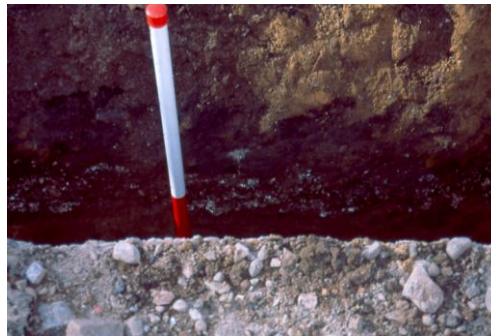
Photograph 3: Looking S – scale 1m.

Further to the NW, opposite the gateway to No.14 Church Street the trench cut through a layer or pit consisting almost entirely of shell mixed with some animal bone. The layer extended for c.1.2m and was c.200mm thick at its centre, tapering to c. 100mm at the sides. It was sealed by a black silty soil, which lay below the tarred pavement and sub-base [see Photograph 3, below]. Given the narrow confines of the trench, it was impossible to determine the extent of the feature or to tell if the shell and black sealing layer was a pit or more general spread. No pottery or other datable material was found in the shell layer.

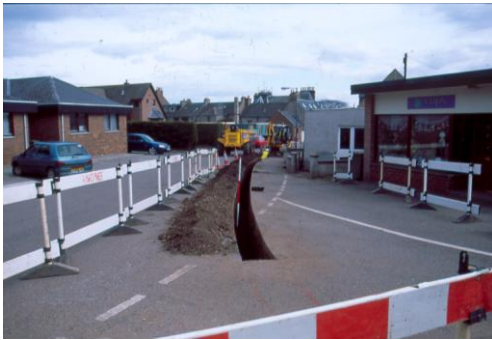
Photograph 4: NW end, looking E.

The trench observed in Station Road extended for c.79m and ran along the S side of the road; beginning at the NW end and running SE [see photographs 4 and 5, over]. The depth of the trench varied from 1m to 1.1m and was 370mm wide. The tarmac layer was c.120mm thick with a c.200mm sub-base of hard pink granite chips. At the NW end of the road, and extending SE for c.30m,

the sub-base overlay a homogeneous dark grey to black garden soil which produced fragments of 19th century pottery and some small pieces of clay tobacco pipe.

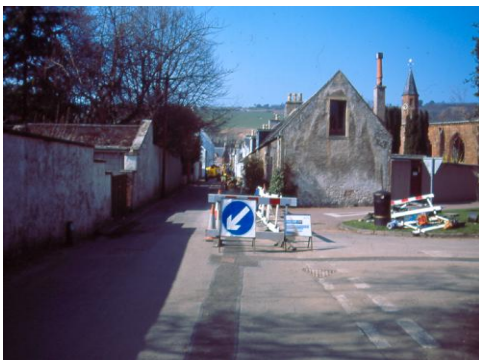
Photograph 6: Looking NW

The section of trench observed in Academy Street began at its junction with Cathedral Square and continued NW for 92m towards the High Street. The trench was excavated along the N side of the street and passed along the western precincts of Fortrose Cathedral [see Photograph 6, below]. The entire length of the trench observed showed the levels to be very heavily disturbed by services such as power cables and sewerage pipes. At 0.9m below the road surface a 3" cast iron water supply pipe was found to run along the line of the trench for its entire length [see Photograph 7, below]

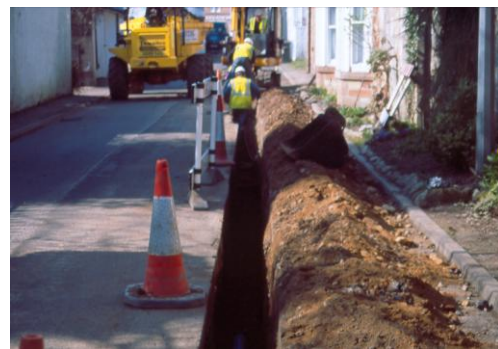
Photograph 7: Looking NW

The cast-iron pipe was broken up and removed in order to achieve the required depth of c.1m in the trench. Clearly, all evidence of earlier levels was totally destroyed by this cast iron pipe and the other services, finds in the soil included concrete and brick. Only to the north end of this trench was the natural observed

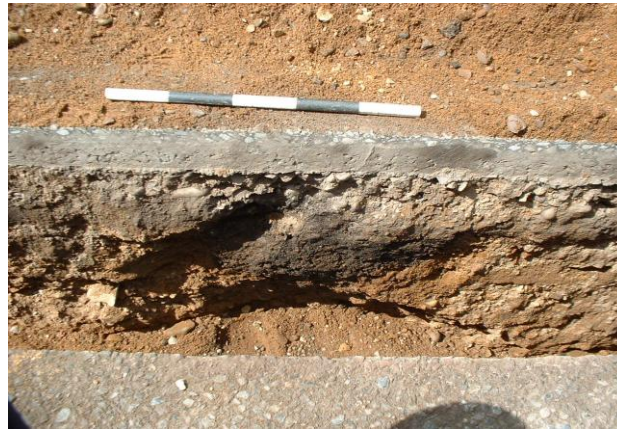
Photograph 8 : Detail of pit in section – scale 0.5m.

One small feature was noted at NH 73558/57565 of a small pit 220mm below road surface to a depth of 290mm and 400mm wide of a dark grey black fill with specks of charcoal but no finds. Date unknown.

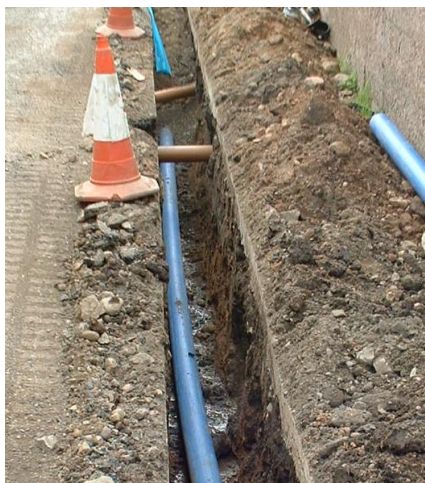
Photograph 9 View up Courthill Road

To the end of Courthill Road (towards the Plough Inn) area to west of village hall topsoil was to a depth of 1m whilst below hall road was directly onto natural of orange-brown sandy gravel with area again heavily cut by services. No indication of any features in road possibly due to the steepness of the slope.
