Report of Archaeological Evaluation
March 24th 2003
Boath Road, Inverness
NH 91920 / 55509 (centred)

Client: Ewen Gillies Builders Ltd

Planning Application No: 02/00159/FULNA

By
Stuart Farrell
B.A A.I.F.A F.S.A.Scot.
April 2003

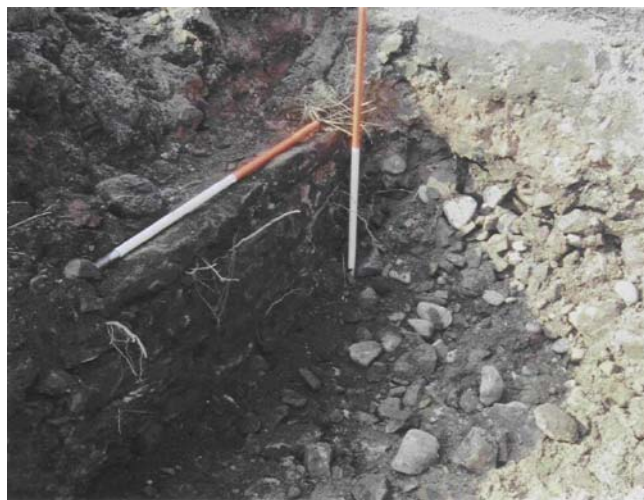
Photograph 1 – View of walling facing W – scales 1m x 1m

Length – 7m x 2m aligned NW-SE – Trace of building of rubble pink sandstone found along SW edge for length of 5m and 34mm wide for a height of 0.6m (see photograph below), removed at SE corner of trench by engineers test pit. Behind wall is infill of rubble of small rounded stones in possible foundation trench, though cut of foundation trench could not be located due to collapsing section. Material above existing ground surface located at 0.7m below existing ground surface of rubble infill from demolished buildings also mixed infills of dumped material including mixed deposits and tarmac.

It is likely that due to the alignment of the walling revealed is that it matches those buildings depicted on the OS maps for 1868 and 1905 and are probably of a mid 19th century date. With the small structures marked on the OS map of 1868 and visible on aerial photographs of 1947 located to the E end of the site (see figure 4) being outhouses for toilets that were located as infilled cesspits. Overall the site has seen heavy dumping of waste material including mixed soils and deposits, concrete and rubble. Some of the rubble comes from the demolition of the buildings that stood here (information from local residents was that buildings were pulled down prior to 1960). The site has also seen other investigations in the form of engineers test pits, which has limited the area of investigation, though it is not unlikely that other archaeological features may yet survive.

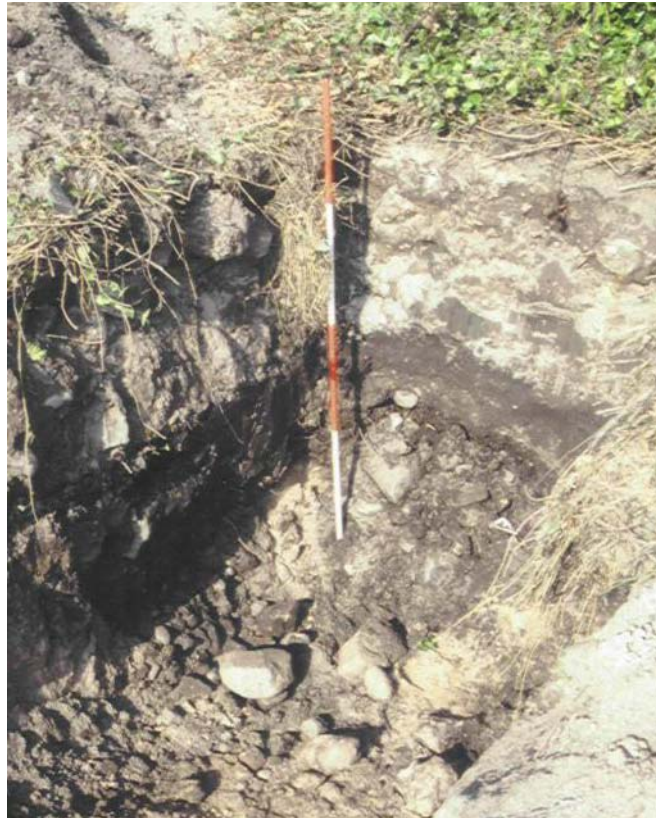
Photograph 2 – View of pits in section facing E – scale 2m

Length – 10m x 1.7m aligned E-W – electricity supply cable revealed running through middle of site. Also 2 former engineers test pits. No trace was made of the building though due to its alignment it may have been located under or removed during the excavation for the electricity supply cable. 2 former cesspits (?) located in section at E end (see photograph below) 1.1m below existing ground surface (ground above infilled modern debris including concrete and modern brick) with one pit containing modern material, the 2nd pottery and glass of a late 19th century date. As before large amount of rubble infill from demolished buildings. No other features located.
