Report of Archaeological Desktop & Walkover Survey Carbost Water Mains Renewal Project NG 3903/3104 - NG 3207/3341

Client: Halcrow Group Ltd on behalf of Scottish Water

By Stuart Farrell B.A A.I.F.A F.S.A.Scot. September 2003

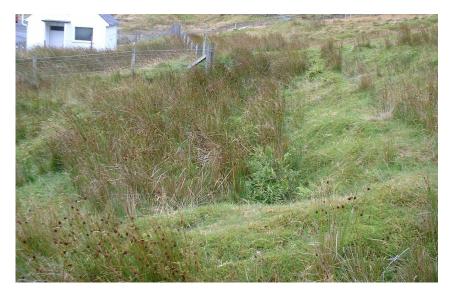
Below: View of house 1 facing SE.

1 – Merkadale HSMR – N/a NMRS – N/a Grid Ref: NG 38888/31019 Type – Building Rectangular unroofed building marked on 1st and 2nd edition Ordnance Survey maps, not marked on 1968 or latest OS map. Walkover reveals depression of building 10.5m x 4m with walls 0.5m thick and to a height of 0.4m built into natural slope on S heavy with reeds. Part of house at NE corner lost due to edge of fence of adjacent telephone exchange building.

Recommend that pipeline be moved to opposite site of road or be placed in road as site number 3 lies close to road edge.

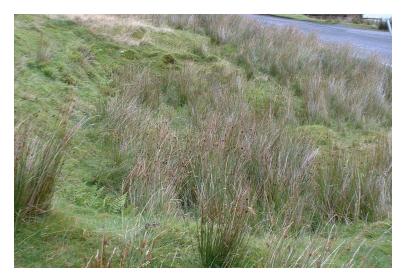
Below: View of house 2 facing NW.

2 – Merkadale HSMR – N/a NMRS – N/a Grid Ref: NG 38868/31034 Type – Building Rectangular unroofed building marked on 1st and 2nd edition Ordnance Survey maps, not marked on 1968 or latest OS map.

Walkover reveals depression of building 10.5m x 4m built into natural slope on S, entrance visible to NE. Trace of enclosing wall to rear to SW.

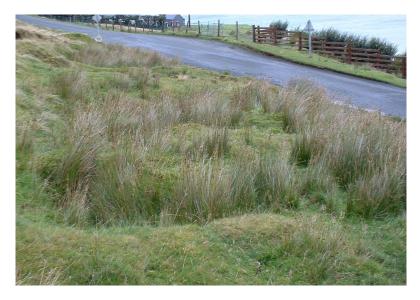
Below: View of house 3 facing NW.

3 – Merkadale HSMR – N/a NMRS – N/a Grid Ref: NG 38854/31044 Type – Building Rectangular roofed building marked on 1st and 2nd edition Ordnance Survey maps, not marked on 1968 or latest OS map.

Walkover reveals 2 compartment building 11m x 5.5m though not as discernible as site 2 due to erosion to N edge.

Sites 1-3 probably part of township of Merkadale. Recorded in NMRS (NG33SE 15) of 'A township of 1 roofed, 6 unroofed buildings and some field walls is depicted on the 1st edition OS [1881 sheet 34]. 13 roofed buildings, one of which is a church and another which is a school, 2 unroofed buildings, 5 enclosures and some field walls are shown on the current OS 1:10,560 [1968].' Visible on aerial photograph of 1946 (4019) as 3 structures with surrounding walls.

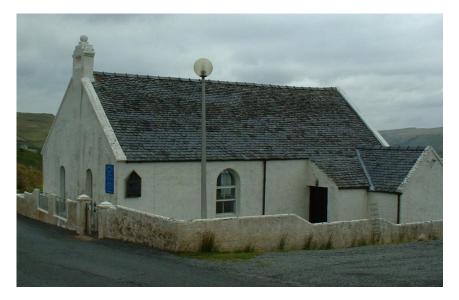
Below: View of church facing NW.

5 – Carbost HSMR – N/a NMRS – N/a Grid Ref: NG 38604/31204 Type – Free Church No information available in HSMR or NMRS.

Walkover reveals building harled with slate roof, stepped bell tower with ball finial. Round headed windows, small vestibule to NE corner.

No recommendations to be made as pipeline to be on opposite side of road.

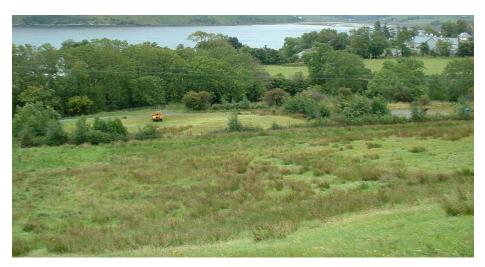
Below: View of landscaped area to E of distillery facing NE.

9 – Talisker
HSMR – N/a
NMRS – N/a
Grid Ref: NG 3775/31796
Type – Warehouse
Rectangular roofed warehouse marked on 2nd edition Ordnance Survey map and on OS map of 1968, not marked on latest OS map. Probably part of site 10 – Talisker Distillery.
Visible on aerial photograph of 1946 (2017).

Walkover reveals no trace of building as area around distillery has been landscaped.

No recommendations to be made as route of pipeline to SE.

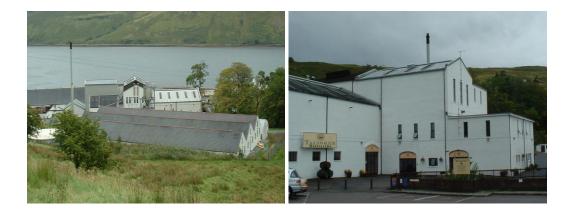
Over Left: View of rear of distillery facing NE. Over Right: View of front of distillery.

10 – Talisker HSMR – NG33SE 6 NMRS – NG33SE 6 Grid Ref: NG Type – Distillery No information available in HSMR or NMRS databases. Noted by Barnard (1887) that distillery opened in 1830 and extended soon after, expanded in 1900 and rebuilt in 1960 (Minsky and Craig, 1994). Visible on aerial photograph of 1946 (2017) as complex of buildings.

Walkover reveals distillery in current operation.

No recommendations to be made.

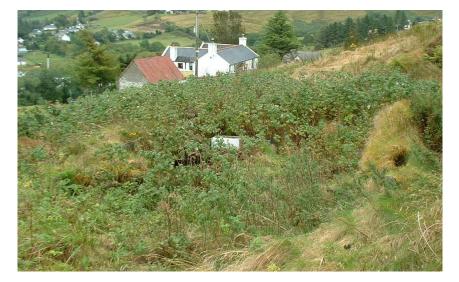
Below: View of site facing E.

15 – Carbostbeg or Fernilea HSMR – N/a NMRS – N/a Grid Ref: NG 37443/32102 Type – Building Rectangular building marked on 1st edition, marked as 2 compartment building with small addition to the NW within enclosing wall on 2nd edition Ordnance Survey map, marked as roofed on OS map of 1968, not marked on latest OS map. Not visible on aerial photograph of 1946 (2016).

Walkover reveals single rectangular building aligned E-W open partly at W end 5m x 5m with walls up to 0.7m high and 0.5m wide with modern rubbish dumped within, overgrown with bracken.

No recommendations to be made as site sits above road, pipeline should cause no damage to site.

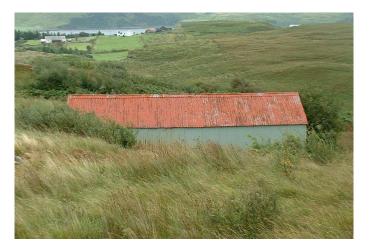
Below: View of building facing E.

21 – Portnalong or Heilla HSMR – N/a NMRS – N/a Grid Ref: NG 34284/34968 Type – Building Not marked on 1st or 2nd edition OS maps. Marked as roofed OS 1968. Visible on aerial photograph of 1964 (027) as roofed building.

Walkover reveals roofed building of corrugated-iron c5m x 12m and 1.8m high.

No recommendations to be made.

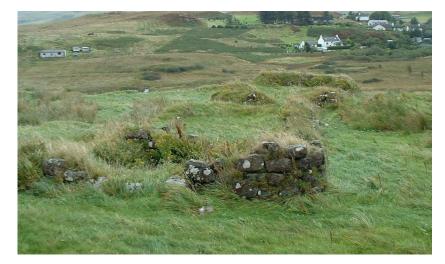
Below: View of houses facing E.

24 – Ardtreck
HSMR – N/a
NMRS – N/a
Grid Ref: NG 3444/3458
Type – Building
In area of township of Portnalong or Ardtreck recorded in NMRS (NG33SW 10) of 'A township of 8 unroofed buildings and a length of head dyke are depicted on 1st edition OS (1881 sheet 33). 16 roofed and 4 unroofed buildings are shown on OS of 1968 (1:10,560).'
2-compartment building marked on latest OS map with length of field wall to NW. Visible on aerial photograph of 1947 (3293) as a 2-compartment building. Visible on aerial photograph of 1964 (027) of 2 compartment's with enclosure on N side.

Walkover reveals 2 houses both $10m \times 5m$ with walls up to 1m high and 0.5m wide. House to W of 2 compartments.

No recommendations to be made.

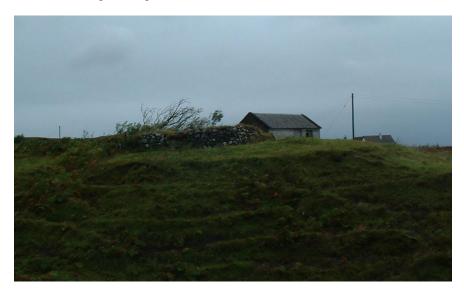
Below: View of buildings facing N.

25 – Fiskavaig HSMR – N/a NMRS – N/a Grid Ref: NG 34022/34120 Type – Buildings Group of 3 buildings marked on 1st edition OS, 1 roofed building and enclosure marked on OS of 1968 and latest. Part of township of Fiskavaig recorded in the NMRS (NG33SW 8) of 'A township of 12 unroofed buildings, 2 enclosures, one of which may be a field dyke is depicted on 1st edition OS (1881 sheet 33). 21 roofed, 1 partially roofed and 1 unroofed building and a head dyke are shown on OS of 1968 (1:10,560)'.

Visible on aerial photograph of 1947 (3293) as 1 roofed and 1 partially roofed buildings. Visible on aerial photograph of 1964 (024) as partly roofed building.

Walkover reveals a single rubble built building $c7m \times 5m$ with walls up to 1m high and o.4m wide with possible enclosure to west side, 2^{nd} building to N roofed, used a shed.

No recommendations to be made as both buildings very visible.

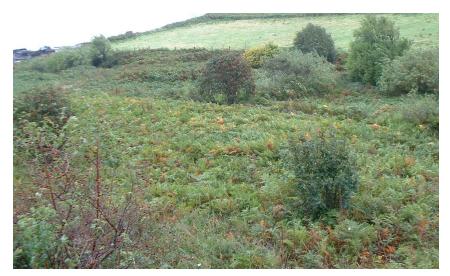
Below: View of site of enclosure facing NE.

26 – Fiskavaig HSMR – N/a NMRS – N/a Grid Ref: NG 33346/34354 Type – Enclosure

Enclosure aligned N-S marked on 1st edition OS, not marked on 2nd edition OS or OS of 1968 or on latest map. Part of township of Fiskavaig recorded in NMRS (NG33SW 11) of 'Township of 9 roofed buildings, 8 unroofed buildings and 3 enclosures is depicted on 1st edition OS (1881 sheet 33). 3 roofed buildings, 1 partially roofed and 7 unroofed buildings and 3 enclosures marked on OS of 1968 (1:10,560)'.

Visible on aerial photograph of 1964 (021) as small stretch of field wall.

Walkover reveals no trace of enclosure though area heavy with bracken, only a small stretch of wall visible to E.

No recommendations to be made as site lies below road off pipeline route.

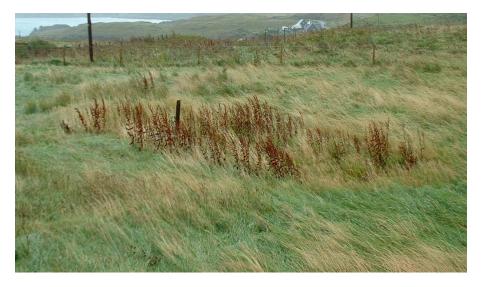
Below: View of site facing E.

28 – Fiskavaig HSMR – N/a NMRS – N/a Grid Ref: NG 32710/33981 Type – Structure, possible Not marked on OS map of 1968 or earlier editions, marked on latest map.

Walkover reveals no trace of a building except a rectangular depression aligned NE-SW c7m x 5m.

Pipeline to follow edge of road.

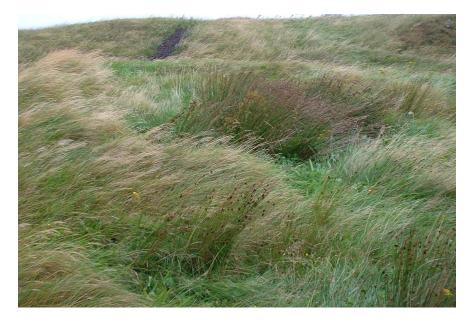
Below: View of structure facing NW.

29 – Fiskavaig HSMR – N/a NMRS – N/a Grid Ref: NG 32654/33924 Type – Buildings

Group of 3 buildings marked on 1st edition OS, marked as unroofed on OS of 1968. Marked as building and enclosure on latest. Part of township of Ard An T'Sabhail recorded in NMRS (NG33SW 7) of 'Township of 29 roofed buildings, and 6 enclosures and 3 lengths of head-dyke is depicted on 1st edition OS (1881 sheet 33). 30 roofed buildings, 12 unroofed buildings and 3 lengths of head-dyke marked on OS of 1968 (1:10,560)'.

Visible on aerial photograph of 1964 (018) as round-ended building with nearby lazy beds.

Walkover reveals single square building visible as turf bank 6m x 6m spread to 1m and 0.5m high, denuded on north side with possible entrance to SW.

Pipeline to follow edge of road.

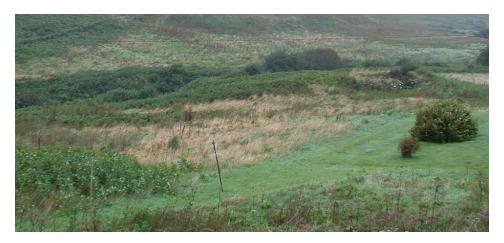
Below: View of site facing NNE.

30 – Fiskavaig HSMR – N/a NMRS – N/a Grid Ref: NG 32314/33914 Type – Structure Building on latest OS. Not on 1st edition, marked on 2nd edition OS with length of wall, marked as roofed OS on 1968. Visible on aerial photograph of 1964 (018) as roofed building.

Walkover reveals unroofed rectangular structure aligned NE-SW 7m x 5m heavily overgrown with bracken entrance to SE. No sign of path to rear as marked on latest OS map though area heavy with bracken.

No recommendations to be made.

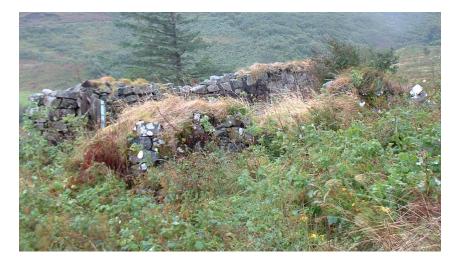
Below - view of structure to E side of road facing SE.

31 – Fiskavaig HSMR – N/a NMRS – N/a Grid Ref: NG 32137/33757 Type – Buildings Group of 7 buildings and 2 enclosures marked on 1st and 2nd edition OS, only 2 building's with an enclosure marked on latest OS. Visible on aerial photograph of 1964 (018) as 3 roofed buildings.

Walkover reveals early 20th century house with enclosing hedge to west side of road. Small roofless building to east side of road at NG 32159/33757 4m x 6m with walls up to 1.6m high and 0.4m wide with remains of wooden door to N. No trace of any buildings to S of house.

Route of pipeline to follow edge of road.

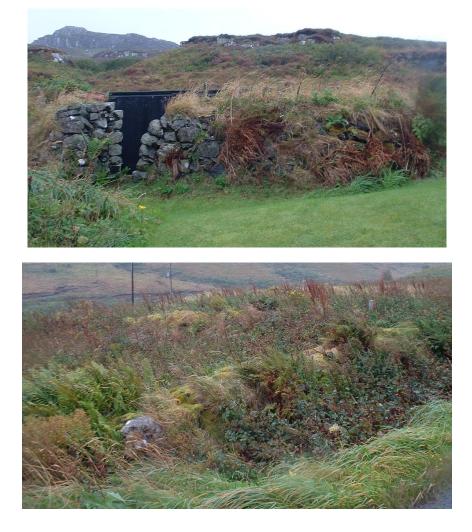
Top: View of roofless building to S facing W. Below: View of enclosure facing SE.

32 – Fiskavaig HSMR – N/a NMRS – N/a Grid Ref: NG 32209/33541 Type – Buildings Group of 7 buildings and an enclosure depicted on 1st and 2nd edition OS, 4 buildings and an enclosure marked on latest. Visible on aerial photograph of 1964 (018) as 2 unroofed and 3 roofed buildings and enclosure on east side of road.

Walkover reveals modern house on site to N edge, 2 buildings to S. 1^{st} with corrugatediron roof, 2^{nd} is roofless but has later shed built within of c 5m x 7m with walls up 1m high and 0.5m wide with entrance to E. Enclosure to edge of road U shaped open to burn on north side with walls 13m x 14m up to 1m high and 0.4m wide at NG 32151/33586 with entrance to E. Existing concrete water marker to southern corner of enclosure.

New route to be on west side of road.

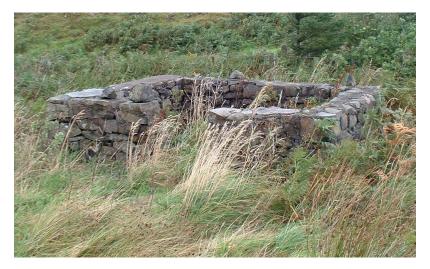
Below: View of building facing N.

34 – Portnalong HSMR – N/a NMRS – N/a Grid Ref: NG 3388/3543 Type – Building Unroofed building on OS map of 1968 not marked on 1st or 2nd edition OS maps or latest OS map. Visible on aerial photograph of 1964 (027) as roofed.

Walkover reveals unroofed building by turning area 3m x 4m with entrance to E. Walls 0.8m high and 0.4m wide.

No recommendations to be made as building is very much visible.

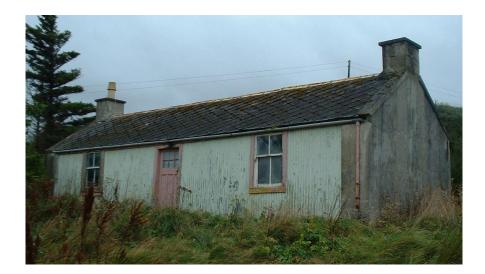
Below: View of empty house facing W.

35 – Portnalong HSMR – N/a NMRS – N/a Grid Ref: NG 3378/3538 Type – Buildings, possible 2 possible unroofed building's on OS map of 1968, not marked on 1st or 2nd edition OS. Marked on latest OS map. Visible on aerial photograph of 1964 (027) as roofed buildings, yard and possible small enclosure.

Walkover reveals no trace of building and enclosure only small garden though area heavy with bracken. One roofed building to W edge of site currently abandoned dating to early 20^{th} century.

Route of pipeline to follow edge of road.

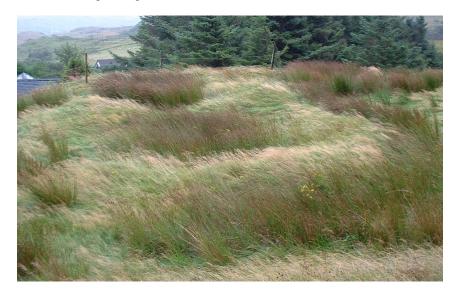
Below: View of building facing E.

40 – Fiskavaig HSMR – N/a NMRS – N/a Grid Ref: NG 32701/33851 Type – Building, enclosure Not marked on 1st or 2nd edition OS, marked as unroofed on OS of 1968. Marked on latest OS map. Nothing visible on aerial photograph of 1964 (018).

Walkover reveals rectangular building of 2 compartments aligned E-W 11m x 5m turf with reeds within with walls spread to 1m and to height of 0.3m. Enclosure on south side 13m x 13.5m with walls to W and S side 1m wide and 0.3m high.

No recommendations to be made as sits well above road. Pipeline to follow edge of road.

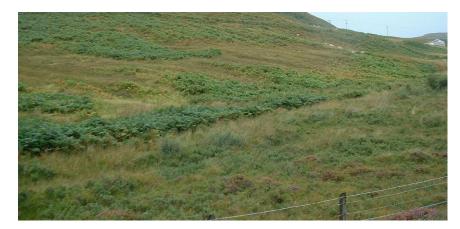
Below: View of lazy beds facing NW.

41 – Portnalong HSMR – N/a NMRS – N/a Grid Ref: NG 352/346 Type – Lazy Beds Visible on aerial photograph of 1947 (3292). Partly visible on aerial photograph of 1964 (030) but not clearly defined.

Walkover reveals beds to be partly discernible though to lie to south side of drain and partly covered with bracken. Beds are c1.8m wide and c2m apart.

No recommendations to be made.

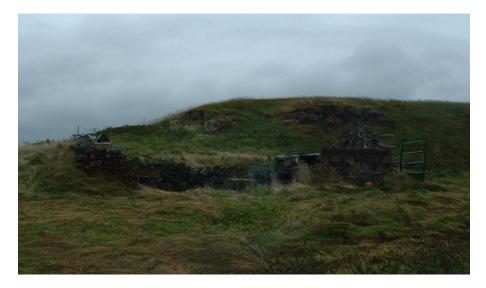
Below: View of building facing E.

43 – Portnalong HSMR – N/a NMRS – N/a Grid Ref: NG 3458/3563 Type – Building Site revealed during walkover of ruined building currently used as creel store. Building is c11m x 5m with walls up to 2m high and 0.6m wide.

No recommendations to be made.

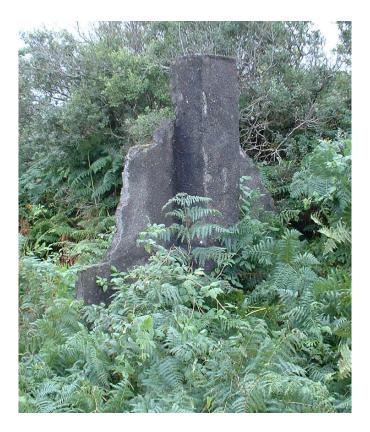
Over: View of Gable end.

44 – Portnalong HSMR – N/a NMRS – N/a Grid Ref: NG 36140/34194 Type – Building Site revealed during walkover of ruined building 4m x 7m only gable end and chimney surviving at N by road edge, concrete floor. Early 20th century in date. Currently used partly as parking area.

Pipeline currently to pass close to this site, route to be moved to road edge or opposite side of road.
