# Report of Archaeological Desktop & Walkover Survey Kilcoy Water Mains Renewal Project

NH 5676/4959 - NH 5822/5115 & NH 5757/5120 - NH 5850/5222

Client: Halcrow Group Ltd on behalf of Scottish Water

By Stuart Farrell B.A A.I.F.A F.S.A.Scot. October 2003

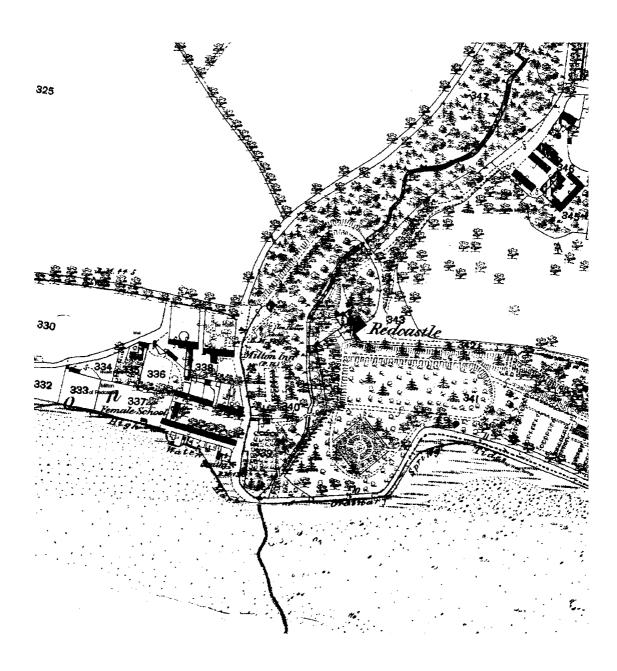
Figure 2: 1<sup>st</sup> edition Ordnance Survey of 1880 of Milton 1:2500

L-shaped roofed building marked on 1<sup>st</sup> edition OS (see figure 2) of 5 compartments. Not marked on 2<sup>nd</sup> edition OS (see figure 3) on OS 1:10,000 of 1994 or latest OS map. Not visible on aerial photograph of 1946 (3312) or 1954 (40) or 1962 (182) or 1967 (58). Walkover reveals no trace of any building only area of grass field.

T-shaped roofed building marked on 1<sup>st</sup> edition OS (see figure 2) of 5 compartments. Not marked on 2<sup>nd</sup> edition OS (see figure 3) on OS 1:10,000 of 1994 or latest OS map. Visible as small rectangular grass covered mound on aerial photograph of 1946 (3312). Nothing visible on aerial photograph of 1954 (40) and 1962 (182), though in area of shadow and 1967 (58).

Marked on 1<sup>st</sup> edition OS (see figure 2) of 5 compartments. Not marked on 2<sup>nd</sup> edition OS (see figure 3) on OS 1:10,000 of 1994 or latest OS map. Also buildings to south and north as part of terraced row.

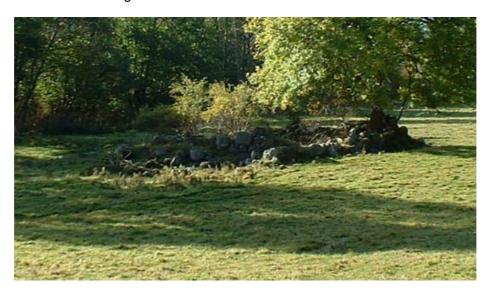
Below: View of site facing SW.

Walkover reveals rubble footings of a rectangular building c12m x 5m with walls up to 0.5m high and 0.4m wide.

No recommendations to be made as site situated away from proposed route.

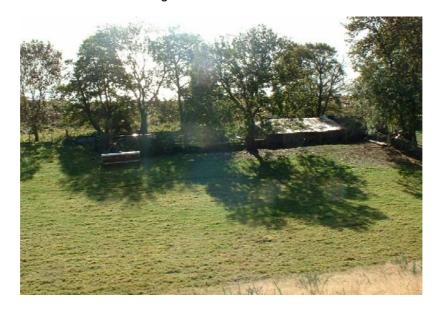
Below: View of site from road facing south.

Walkover reveals stone enclosure (possibly building) with 2 sheds of wood and corrugated iron.

No recommendations to be made.

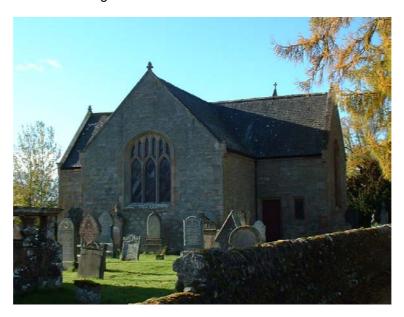
Below: View of church facing SW.

Noted in HSMR and NMRS of 'Alexander Ross-restoration and raising roof 1891'. Noted by Gifford (1992) to having been built in 1745, building raised c1800 and again in 1891. Possibly built on earlier foundation as medieval and later funerary monuments in graveyard. Church noted by Alston (1999) and Beaton (1992) to date after 1800. Walkover reveals church still extent and still in use.

Watching brief to be made in area surrounding church due to church being medieval in date. See also site 22.

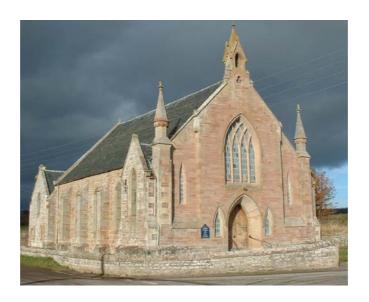
Over: View of Church facing NE.

Walkover reveals building of pink and yellow sandstone in a possible gothic revival style, currently Free Church of Scotland.

No recommendations to be made.

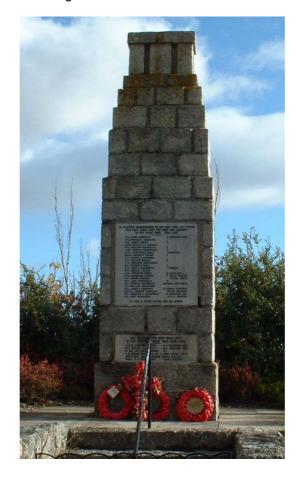
Below: View of Memorial facing SE.

Walkover reveals memorial set off road in small garden of grey granite blocks with panels

of 1914-18 and 1939-45.

No recommendations to be made.

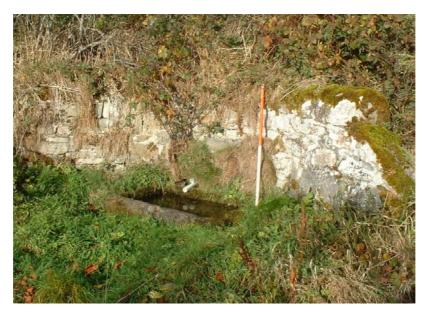
Below: View of site facing N – scale 1m.

Site revealed during walkover survey of sandstone trough 1.1m x 0.7m with cast-iron pipe (and later plastic pipes) by road edge with rubble sandstone wall to rear.

No recommendations to be made as route of pipeline to be at edge of field above site.
