ARCHAEOLOGICAL DESK-BASED ASSESSMENT AND WALKOVER SURVEY

Laggan / Strathmashie Forest

Client	Forestry Commission Scotland
National Grid Reference	NN 58200 93246 (Centred)
Site Code	LAG14
Report Number	2014-12/LAG14
Authors	Lynn Fraser and Mary Peteranna
Date	05-04-2014
Revised by	Mary Peteranna
Date	07-04-2014
OASIS No.	rosscrom1-176567

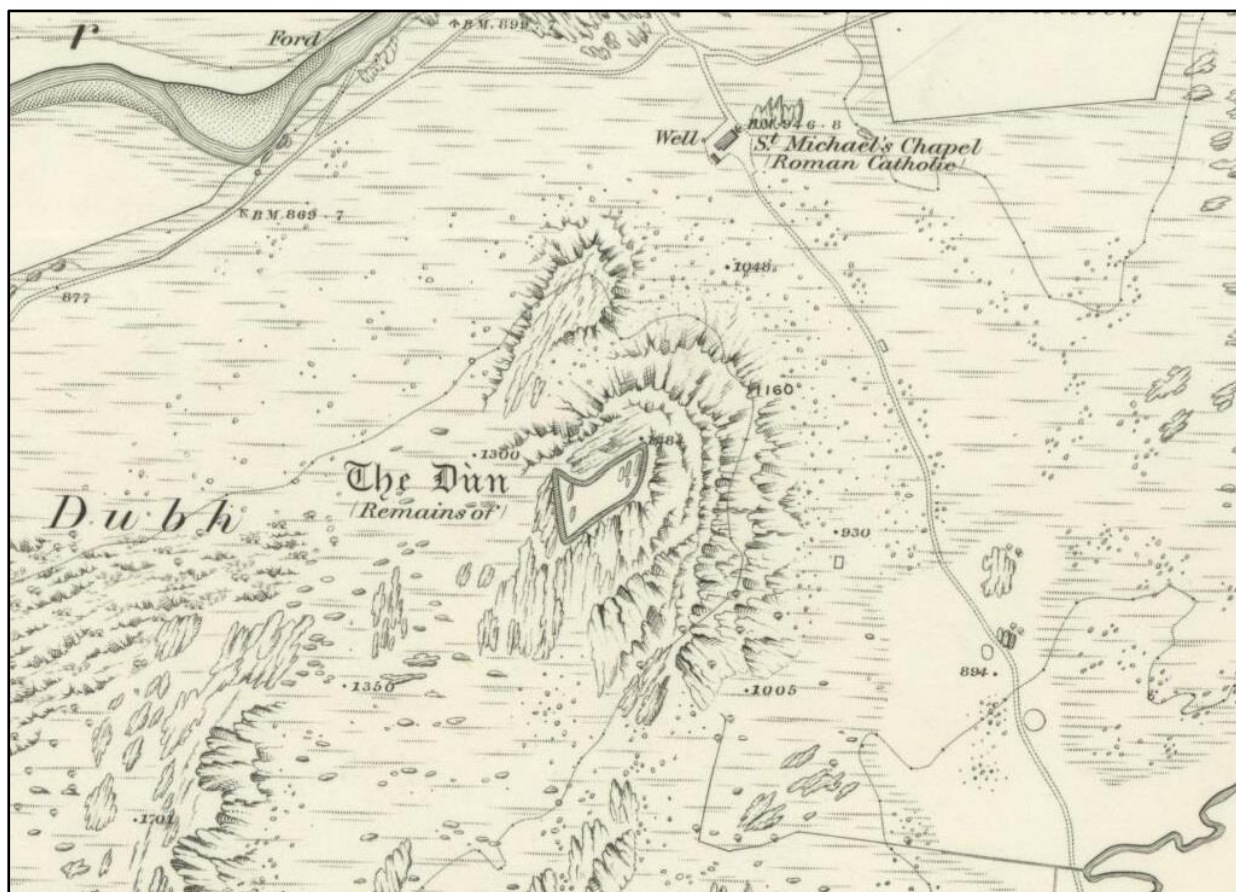
Figure 2: Excerpt from the 1st Edition OS Map. ©NLS

The Ordnance Survey (OS) of 1869 (Figure 2) depicts the survey area as open moorland with a track running along the northwest edge of the survey area. *St. Michael's Chapel (Roman Catholic)* is shown as one sub-rectangular building and one small rectangular building on the NE side of the survey area within an amorphous enclosure.

A track running along the NE edge of the survey area is shown with one unroofed building on the NE side of it. Close to the SE edge of the survey area, a rectangular unroofed building or pen is shown. *The Dun (remains of)* marks the location of Dun-da-Lamh as a substantial sub-oval structure on the summit of the hill beyond the SW side of the survey area. A possible boundary wall runs along the base of the rock outcrop, close to the western boundary of the survey area.

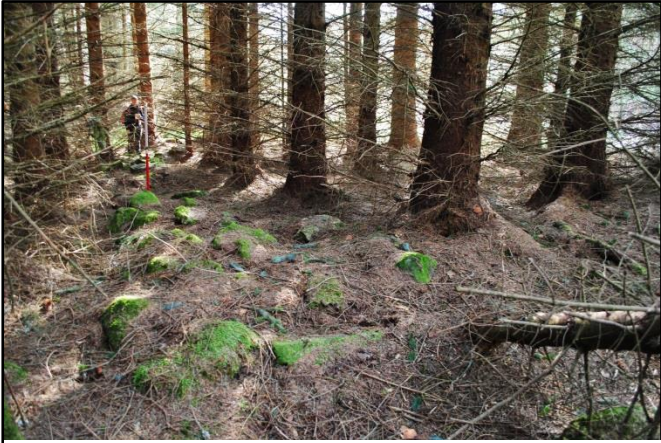
Four archaeological sites (Figure 3) were recorded during the survey, all of which had previously been identified. Site 1 was a sub-rectangular stone-built enclosure situated 5-10m to the north of the forest track (Plate 1). It was planted over with mature trees and covered in pine needles and brash. This may be the enclosure shown marked on the 1st Edition OS map. Site 2 (Plate 2) was the remains of a stone and turf building, which appeared to have rounded corners suggesting some

Figure 1: Site 1, an enclosure, looking WNW

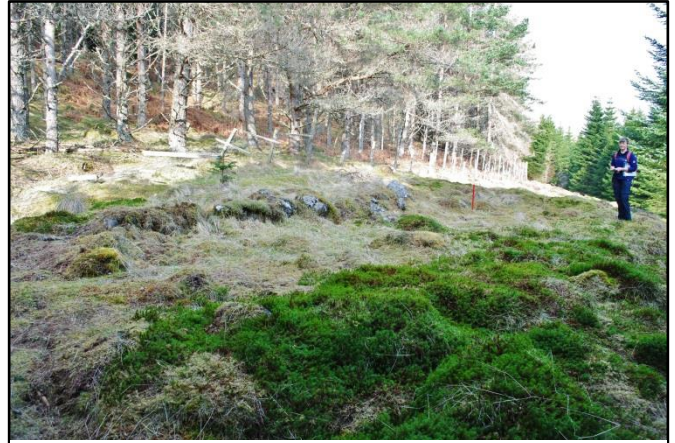
antiquity. It was recorded in the vicinity of the unroofed building depicted on the 1st Edition OS map. Site 3 (Plate 3) was another set of stone and turf footings of a sub-rectangular building, which was revetted into the bank on the northwest side. This structure is not depicted on the historical mapping suggesting that it was in a much degraded state by the time of the first OS visit in 1869. The final site recorded (Site 4) was a concrete water tank located on the slope above, and to the south-southwest, of St. Michael's Chapel.

Figure 2: Site 2, a building, looking NNW

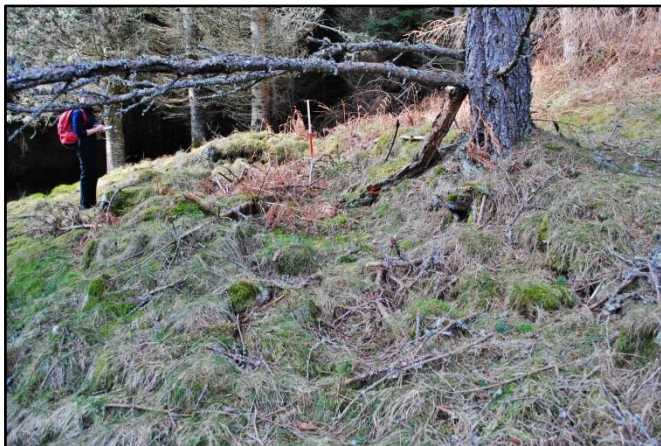
Figure 3: Site 3, a building, looking SW

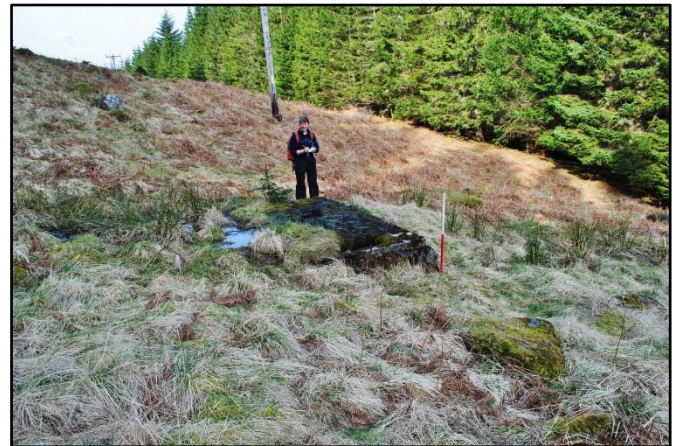
Figure 4: Site 4, water tank, looking NW

It should be noted that Site 4, the water tank, appears to be incorrectly located on the Highland Council Historic Environment Record.
