ROSS & CROMARTY ARCHAEOLOGICAL SERVICES

## **New house site, Rhitongue, Sutherland: Archaeological Watching Brief**

National Grid Reference	NC 60504 59866
Planning Reference	10/04188/FUL
Site Code	RTE11
RoCAS Report	RTE11-10
OASIS Number	rosscrom1-103599
Client	Peter MacDonald
Author	Lynn Fraser
Date	27 June 2011

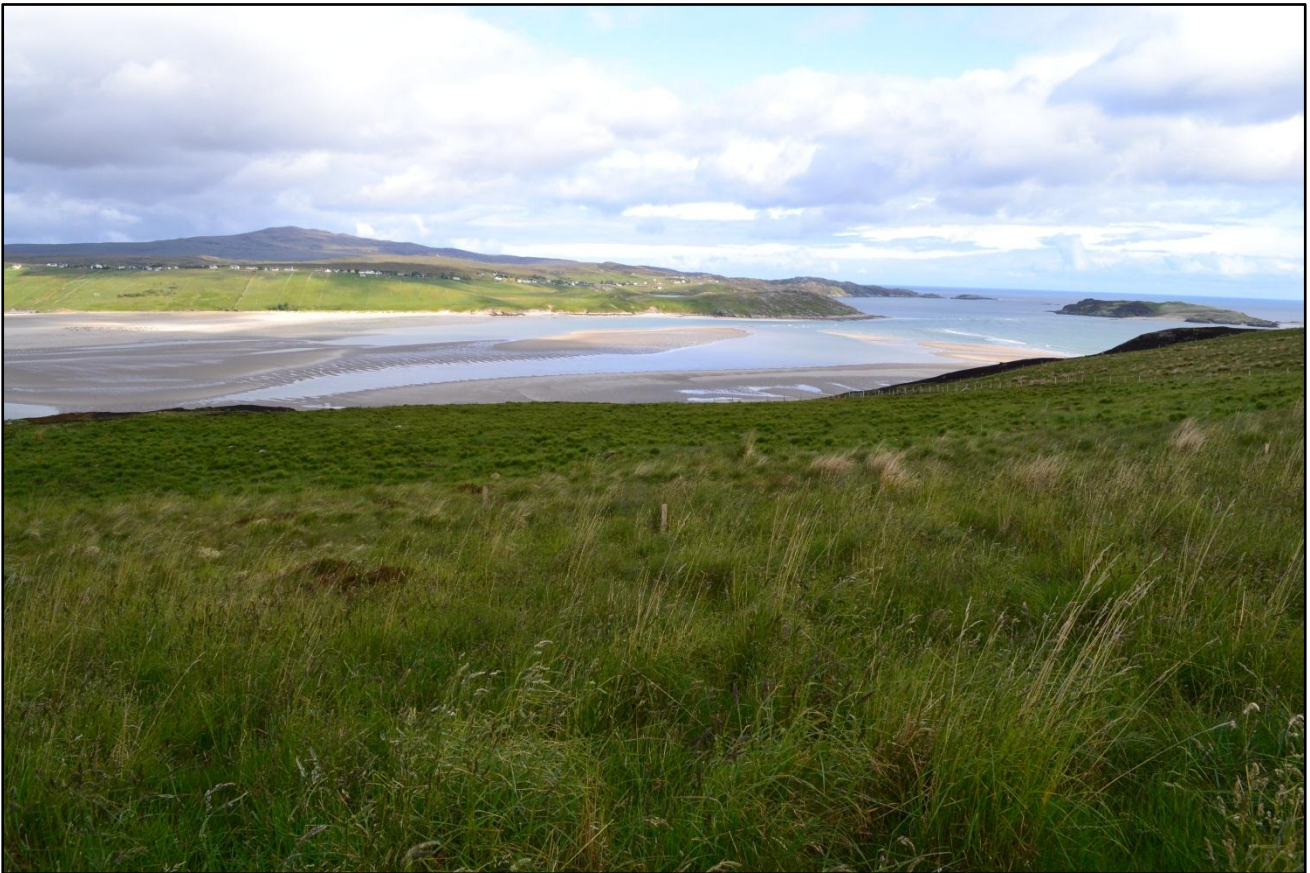
The site sloped downhill from an existing track in a north-westerly direction and, prior to clearance, was grass covered (Plate 1). Below the turf there were two strata: context 101, a rich, black, peaty soil, which overlay context 102, a mid-brown clay/silt matrix. Beneath these contexts the sub-soil was formed of a grey gleyed material, which was exceptionally hard in places (Plate 2). There were very few stones within any of the contexts. Patches of decaying vegetation appeared in patches within the gleyed material but formed no more than a thin layer. The trench depth varied from 25cm – 34cm, the deepest areas being at the lower end of the slope.

**Plate 1:** View of the site, pre-excavation, looking towards the north-north-west

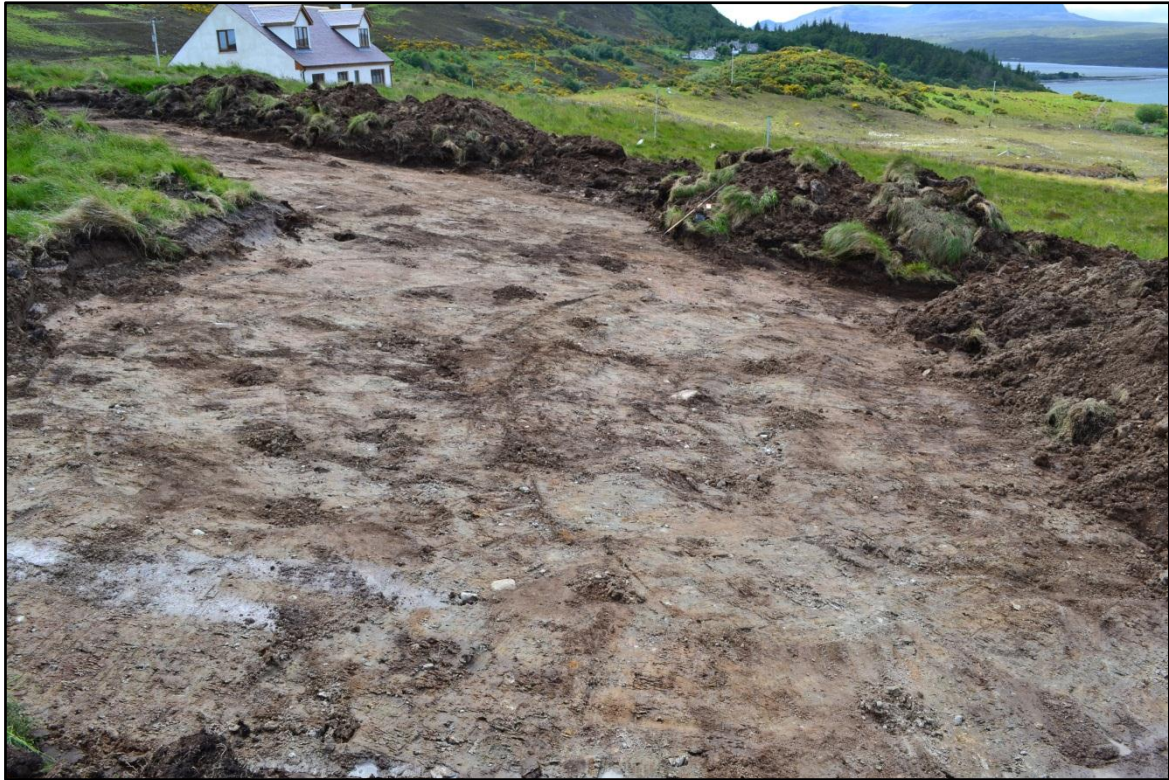
**Plate 2:** View across the plot towards the south-west showing the existing house at 115 Rhitongue and Rhitongue Broch on the gorse covered mound (top right).

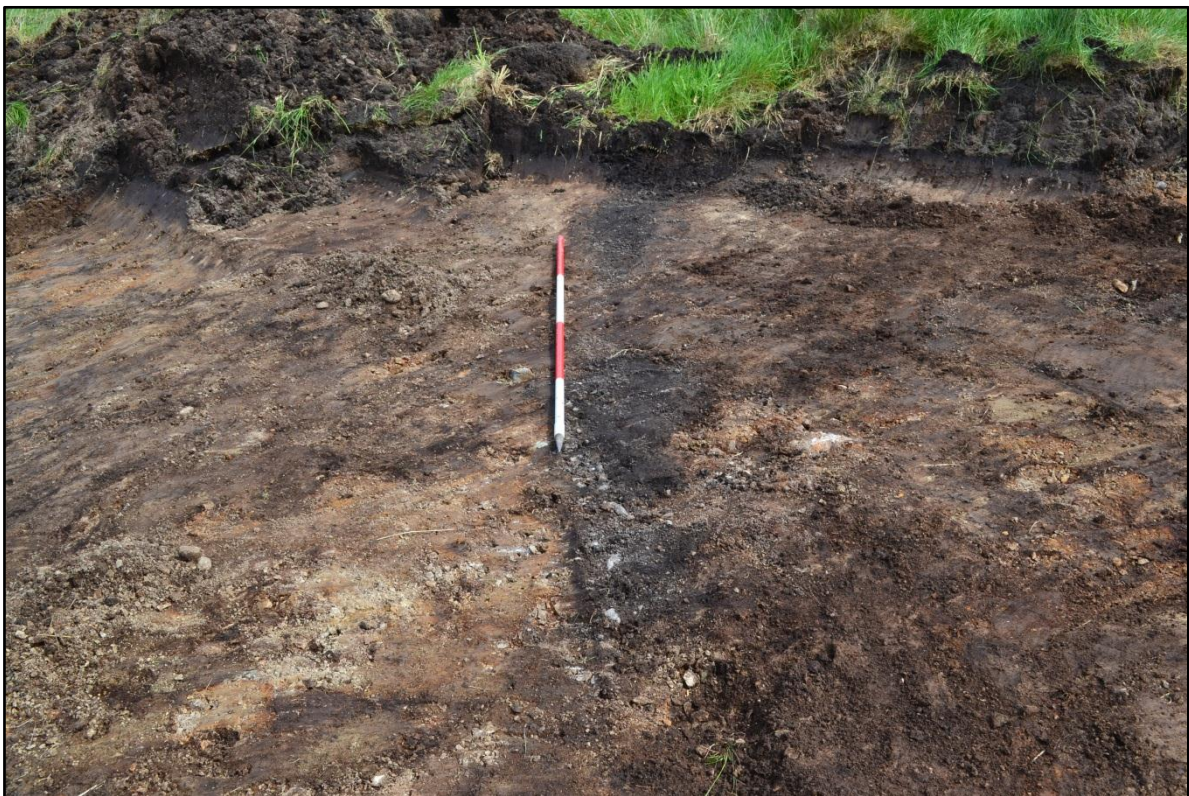
The only archaeological feature uncovered was a possible field drain close to the existing track at the south-eastern side of the site (Plate 3). There were no artefacts found.

**Plate 3:** View towards the north-east of the field drain

RTE11: Index of Features								
Feature	Type	Location	Dimensions (m)	Plans	Photos	Contexts	Finds	Comments
1	Field drain	SW end of the driveway approx. 1m from the existing track	approx. 2.8m x 0.3m		6-8	104, 105		Shallow, stone filled
