## FORT HOUSE, LEITH

*Archaeological evaluation*

*for City of Edinburgh Council*

*November 2011*

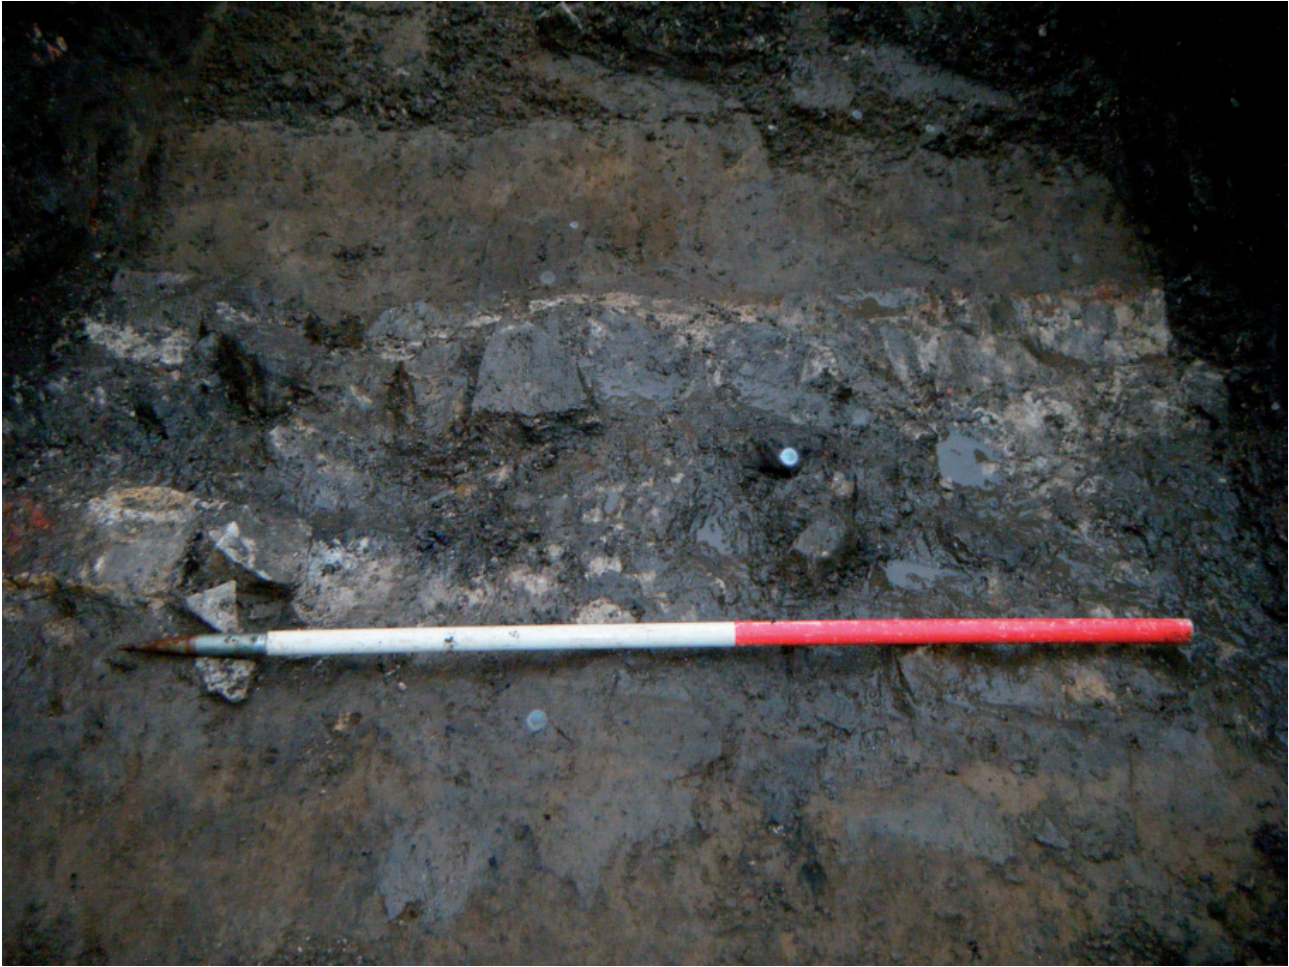
**Illus 5**  
Wall [017], Trench 2

Trench 2 was located across the southern end of the stable block. Beneath topsoil [001] were up to 0.9m of dark brown silt with demolition rubble [045]. An E-W sandstone wall [017] 0.75m wide was found cut [016] into mottled light brown sand [046] at the base of the trench (Illus 5). The cut was backfilled with dark brown sand [018]. This wall corresponds with the wall of the stable block (see Illus 1). A NE-SW sandstone wall capped with concrete and black tar [019] was found across the south-eastern corner of the trench. A sondage was excavated into the brown sand deposits at the base of the trench [046]. These were found to be 0.23m in depth and directly overlay clean sandy subsoil [002].

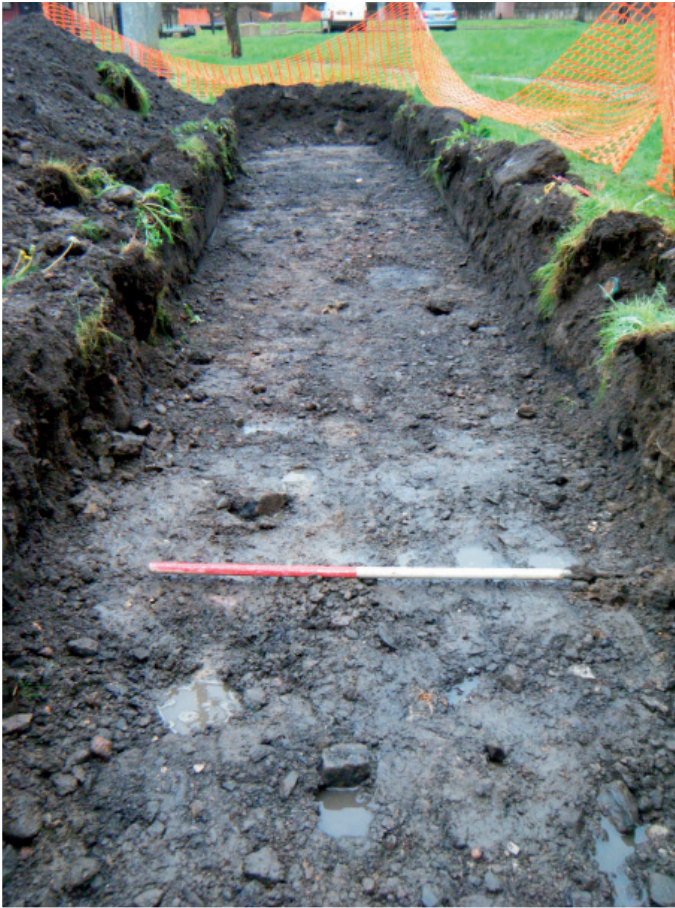
**Illus 6**

Gravel surface [021], Trench 3

this, the majority of the trench comprised a compact cobbled surface topped with loose gravel [021] (Illus 6). Set into this material was a hard stone or concrete pad, approximately 0.4m square, thought to be a possible 'target' location as shown on the second edition Ordnance Survey map (1878; see Jones 2011). At the east end of the trench was a compact sandstone surface [020] set into clay and similar to [010] in Trench 1. This appeared to truncate surface [021].

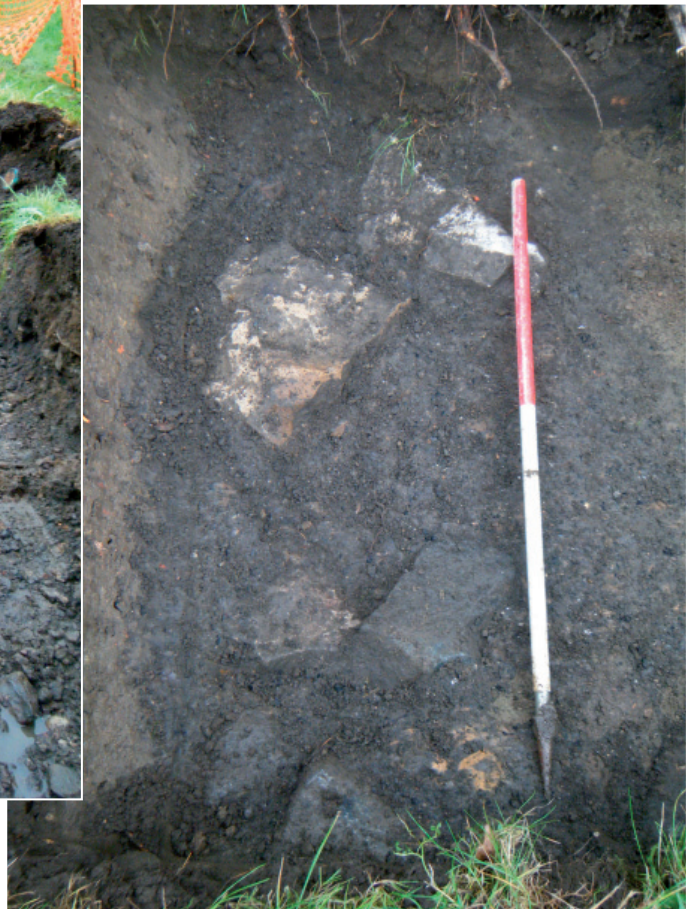
**Illus 7**

Wall [033], Trench 4

Trench 4 was located in the western part of the area over a building. The trench comprised 0.4m of topsoil and demolition material [001/045] above a series of walls at the south end. At the north end the trench was up to 0.9m in depth above natural sand. Two E-W walls [033] and [031] ran parallel across the trench (Illus 7). These comprised large sub-rounded cobbles set in black clayey silt. Wall [031] had been truncated by a modern brick and concrete drain [032] to the south. The north end of the trench comprised a concrete surface [022] overlying reddish gravel bedding [030]. A possible wall was noted at the north end of the trench, which corresponds with the building seen on the first edition Ordnance Survey

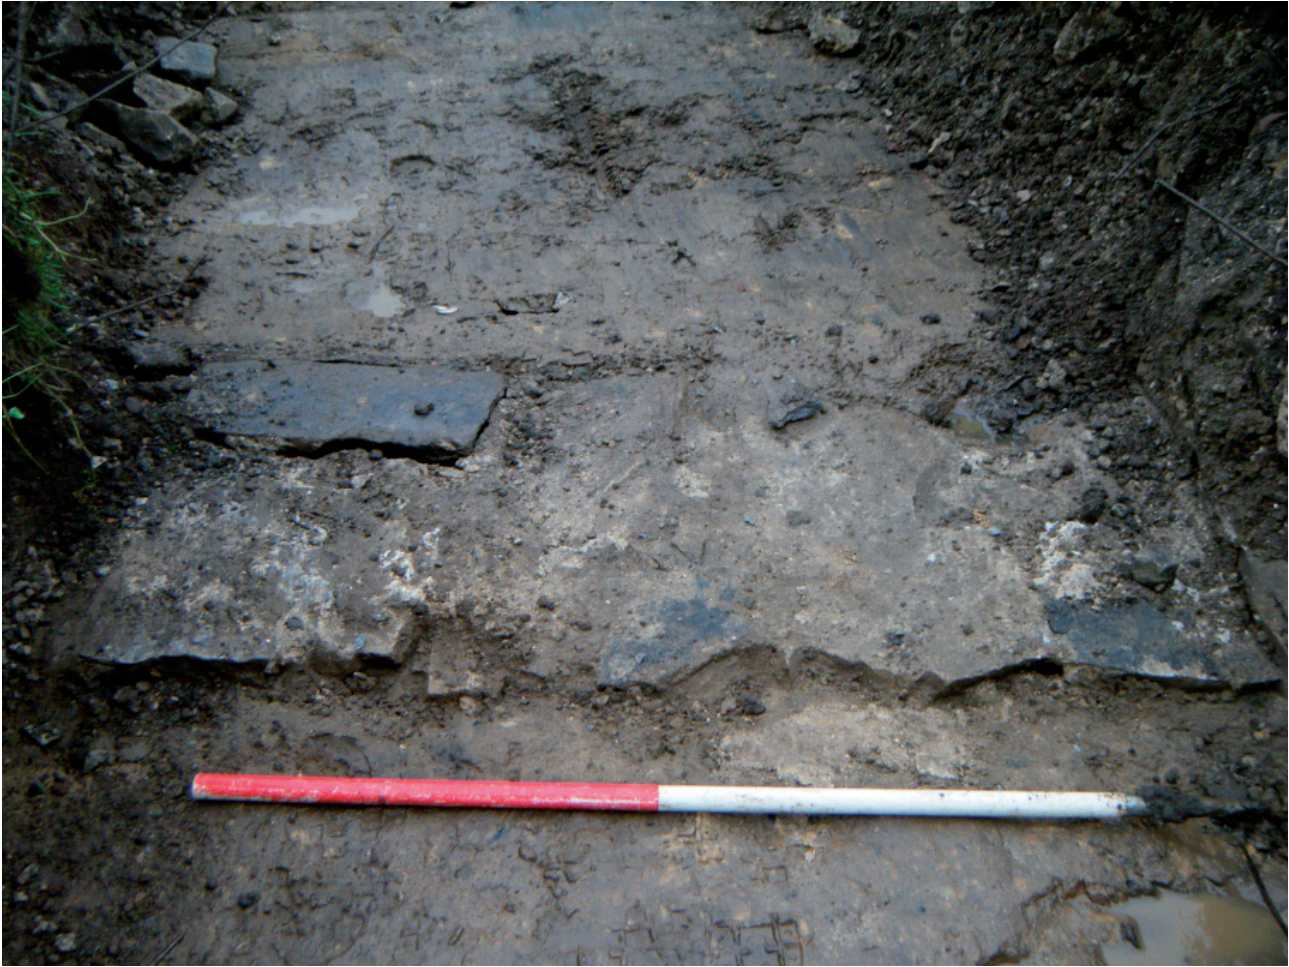
**Illus 8**  
Wall [025], Trench 8

Trench 8 was located on grass across the gun store and stable block (Illus 3). At the northern end of the trench topsoil [001] was 0.2–0.3m in depth and overlay a layer of concrete bedding chips [044] within a wire mesh. This overlay a brick and concrete structure [024] at the northern end of the trench. To the south was an E-W sandstone wall [025] 0.55m wide, with at least 2 courses surviving (Illus 8). This corresponds to the southern wall of the gun store as seen in Illus 1. A blocked brick drain [026] was found in the western section. The bricks were frogged and marked 'WINCHBURGH' and the drain had been blocked with large sandstone blocks (Illus 9). To the south of this was an E-W sandstone wall [027], with at least 2 courses. The wall was 0.6m in width and had been truncated at the eastern end. Perpendicular to wall [027] and along the eastern section was wall [028]. The wall extended for 3.6m along the edge of the trench. There was a clear 'kerb' on the western edge of the wall, which appeared to demarcate the edge of a cobbled

surface [029]. The surface was very compact and was topped with gravel; it extended to the end of the trench and lay inside the stable building. The walls relate to the north wall and an internal wall of the stable block, as shown on Illus 1.

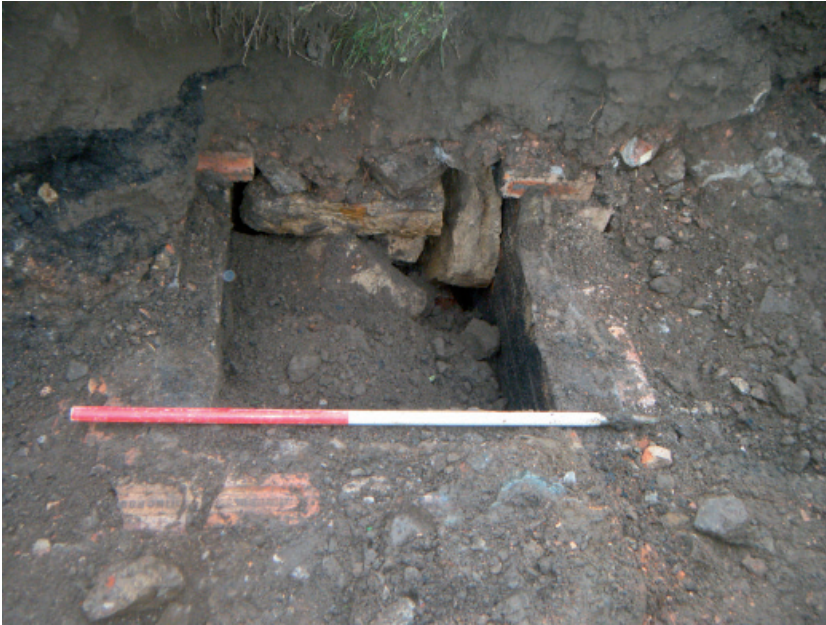
**Illus 9**  
Brick drain [026], Trench 8

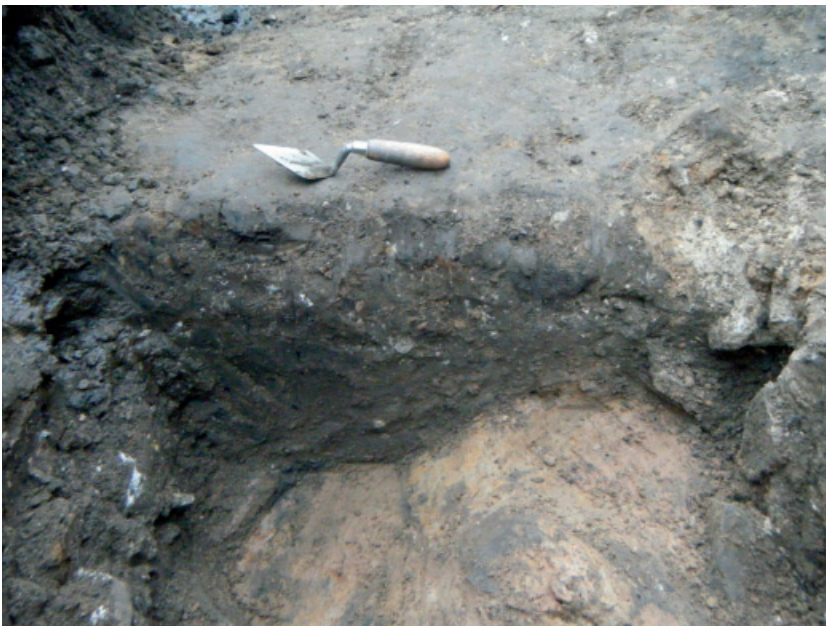
Trench 16 was excavated in an area of grass in the area of the parade ground. The trench contained 0.3m of topsoil [001] over 0.3m of mixed demolition and rubble [045] including red gravels, over natural sand [002]. At the east end of the trench was a deposit of mortar [047], which overlay a ditch [041] (Illus 3). The ditch, approximately E-W, extended for 4m before appearing to turn to the south (Illus 2). The southern edge of the ditch sloped gradually to a rounded base; the northern edge was not exposed (Illus 10). The ditch was filled with compact sandy silt [040] with frequent charcoal and broken sandstone and occasional oyster shell. Finds from the possible ditch included pottery, clay pipe, metalwork and glass, dating to the latter half of the 18th century (see below). An environmental sample was taken from the fill of the ditch.

**Illus 10**  
Ditch [040], Trench 16
