Project Code: DHWI08
Planning application reference number: 05/02336/FUL
Date of report: November 2008
Client: Windjen Power Ltd

Dunion Hill Windfarm

Report on archaeological survey

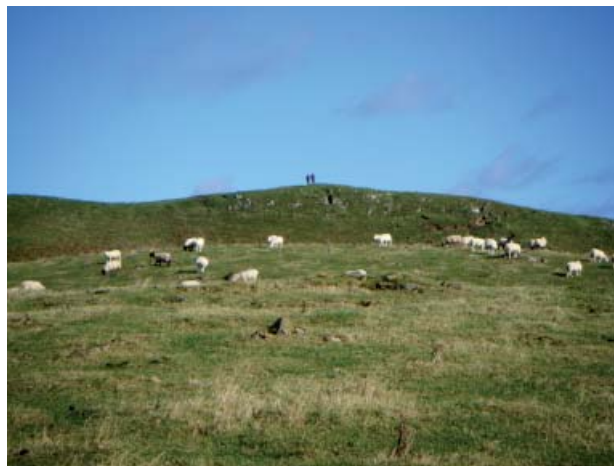
Illus 1

HA28, Prehistoric cairn seen against the skyline. From SW.

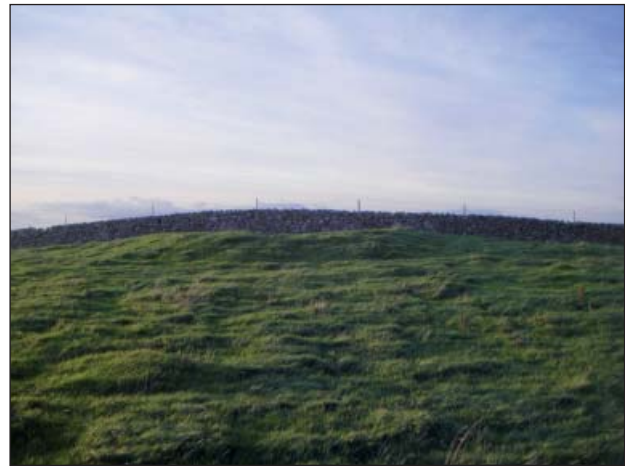
Illus 2

HA05, Robbed prehistoric cairn under stone dyke. From SE.

Site No: HA 05
 Entec Ref: N/A
 HER/NMRS No: N/A
 Grid ref: NT 61908 18257
 Location: Black Law
 Class: Prehistoric cairn
 Description: A circular cairn is situated on the summit of Black Law. The cairn is 12.5 m in diameter and up to 0.7 m high. The stone dyke along the W site boundary crosses over the cairn, which clearly has been robbed presumably to provide building stone for the dyke. The cairn is turf clad but with a few stones protruding through the turf.

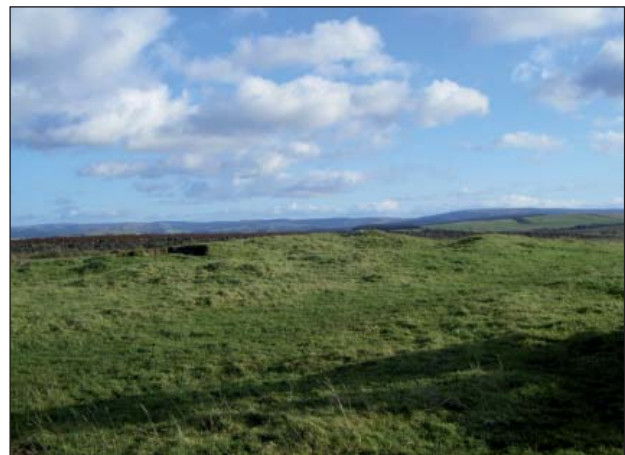
Illus 3

HA23, Robbed prehistoric cairn. From NW.

Site No: HA23
 Entec Ref: N/A
 HER/NMRS No: N/A
 Grid ref: NT 61617 16922
 Location: Watch Knowe
 Class: Robbed prehistoric cairn
 Description: The cairn is located at the summit of a low knoll some 380 m to the north of Watch Knowe. The cairn is abutted by a turf and stone bank (HA10) and has been heavily robbed in the middle. The cairn is 0.9 m high and appears now to be oval measuring 20 m NW to SW by 14 m, but this shape could be caused by the disturbance. The cairn is turf covered with a few stones protruding through the turf.

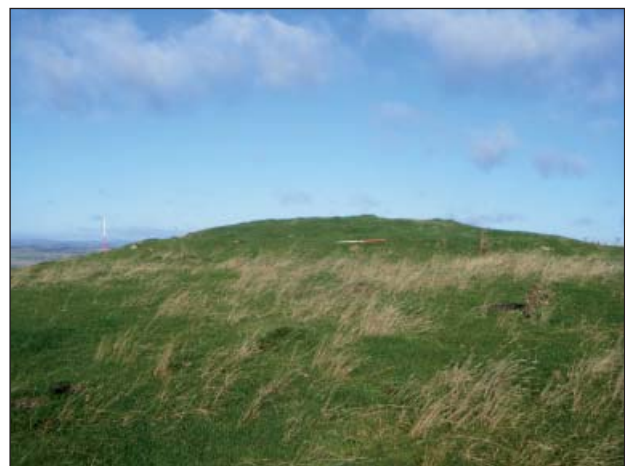
Illus 4

HA28, Prehistoric kerbed cairn. From SE.

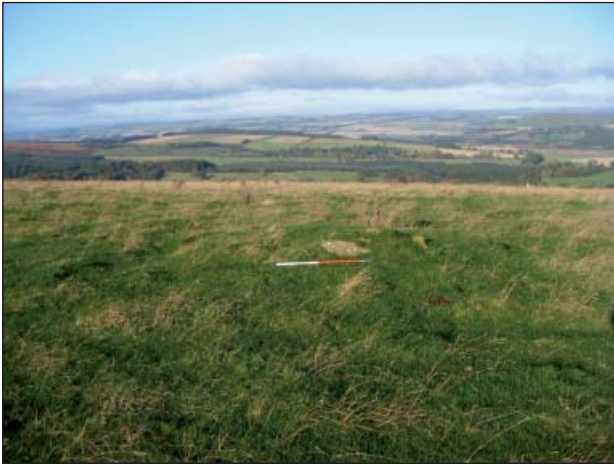
**Illus 5**

HA16, Small cairn. From SE.

Site No: HA16
 Entec Ref: O
 HER/NMRS No: N/A
 Grid ref: NT 61115 17160
 Location: Hill Pond
 Class: Cairn
 Description: A circular cairn is situated on a gentle W facing incline near the top of the W facing slopes above Bedrule with extensive views to the S and W. The cairn is turf clad but with several stones poking through the turf. The cairn is 4.5 m in diameter and up to 0.5 m high.

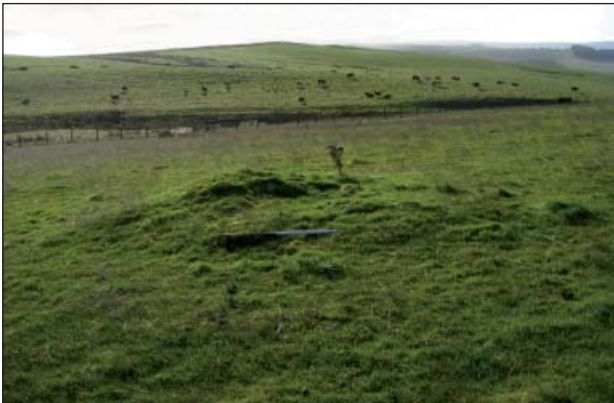
**Illus 6**

HA17, Small cairn. From NW.

Site No: HA17
 Entec Ref: P
 HER/NMRS No: N/A
 Grid ref: NT 61236 17041
 Location: Hill Pond
 Class: Cairn
 Description: A small cairn is situated on a gentle SE facing slope some 80 m to the W of Hill Pond. The cairn is largely grass covered with a few stones poking through the turf. The W half of the cairn appears to have been robbed. The cairn measures 4 m in diameter and is 0.4 m high.

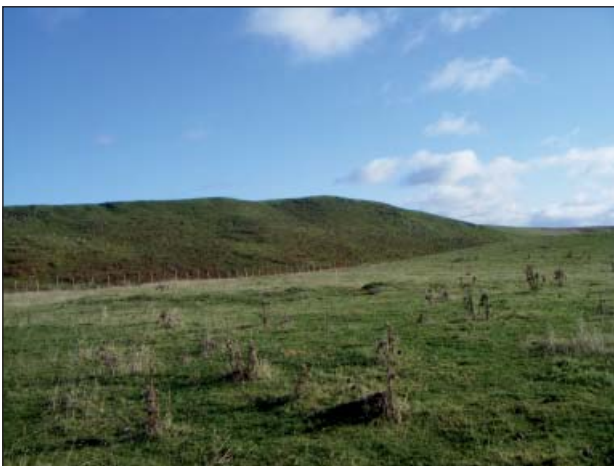
**Illus 7**

The circular earthwork at site HA26 (Illus 7) has also been attributed to the prehistoric period, due to its poor state of preservation of its bank. A large diameter (19 m) indicates that it is not likely to be a roundhouse so it is tentatively identified as an enclosed cemetery of Bronze Age date.

HA26, Circular earthworks. From W.

Site No: HA26
 Entec Ref: T
 HER/NMRS No: N/A
 Grid ref: NT 60942 16933
 Location: Fulton Burn
 Class: Circular earthwork
 Description: A circular feature 19 m in external diameter is situated near the edge of a plateau at the top of the W-facing slopes above Rule Water. The feature is defined by a low bank spread to 2 - 3 m wide and up to 0.2 m high. There were no clear indications of an entrance leading into the structure. It does not look to be recent due to its poor state of preservation, and is likely to be a prehistoric structure.

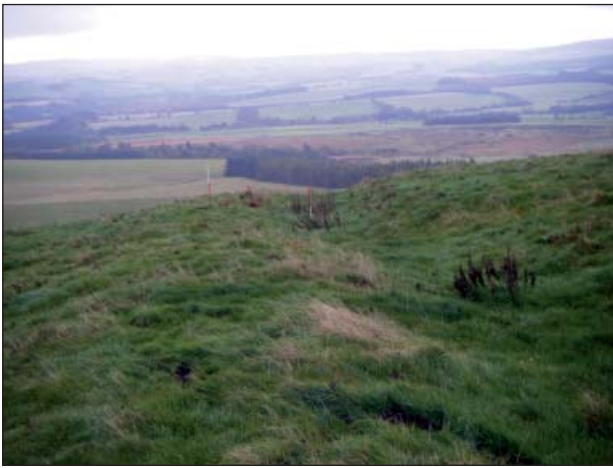
Illus 8

HA02, Bank and ditch of linear earthwork. From NW.

| Description: | A linear earthwork crosses the ridge between Black Law and Dunion Hill. The earthwork is aligned SE to NW and comprises a ditch 4.5 m wide and up to 0.9 m deep with a bank on its N side that is up to 5.5 m wide and 0.7 m high. The feature extends beyond the site boundaries to the E and W and has been traced over a total distance of some 1150 m. The length within the site boundary is just less than 200 m and contains some of the best-preserved segments. Within the area the bank has been cut through in places by a number of tracks, most notably to the NW where it has been truncated and obscured by the construction of the current track leading up to the installations on the summit of Black Law. The bank is also damaged by a quarry (HA03), immediately to the SE of the track. |

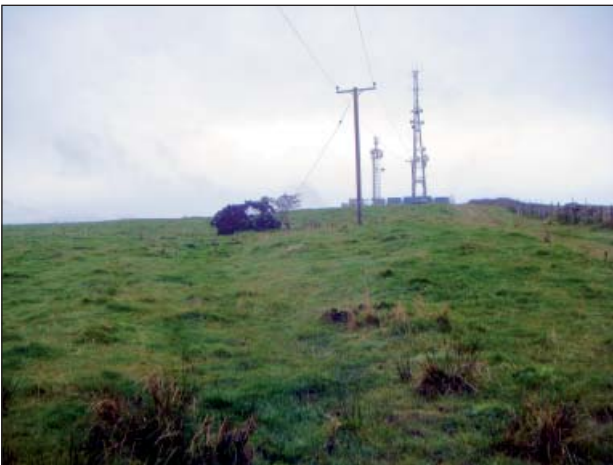
Illus 9

the application area, most severely to the northwest where it has been truncated by a quarry (HA03) and the construction of a track (Illus 9).

HA02, Damaged section of linear earthwork. From NE.

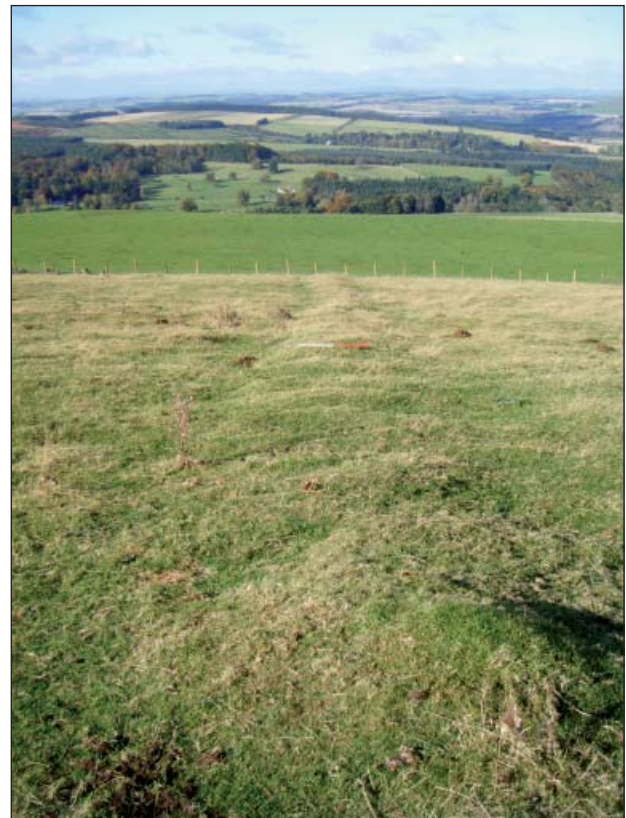
Illus 11

Most of the earlier sites are banks that mark the upslope limit of enclosures or fields (HA 07, 13, 25 27) (Illus 11). Bank HA27 at the southwest corner of the application area is fairly sinuous and cut by the later straight bank HA29 (Illus 12) dated to the middle of the 19th century on map evidence. Bank HA07 next to Merlin Dean seems to be closely associated with an area of parallel drainage extending into the area beyond the application area boundary to the east.

HA25, Enclosure bank extending towards improved field. From E.

Site No: HA25
 Entec Ref: N/A
 HER/NMRS No: N/A
 Grid ref: NT 6088 1700 (site centre)
 Location: Fulton Burn
 Class: Enclosure
 Description: A rectangular enclosure defined by low turf banks spread to 2 m wide and up to 0.3 m high is situated on the upper W facing slopes towards the SW corner of the site. The E bank of the enclosure is barely visible in contrast to the banks to the N and S. The banks enclose an area 60 by 120 m up against the E side of a ruinous stone bank along the current head dyke, but it is possible that the banks of the enclosure extended into the improved pastures to the W.

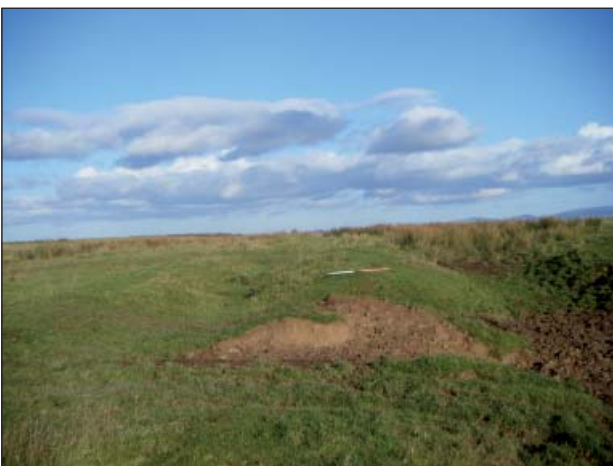
Illus 10

A second cross-ridge dyke (HA21) was located some 1200 m to the south crossing the lower ridge between Black Law and Watch Knowe (Illus 10). This earthwork also appears to be spanning the ridge between two watercourses, in this case from the head of Fulton Burn near Hill Pond to one of the upper tributaries of Greypeat Burn some 800 m to the northeast. The best-preserved segments of the earthwork lie to the northeast of Hill Pond where it comprises a bank flanked by a larger ditch to the south and a smaller ditch to the north. There were also traces of a second bank on the north side of the smaller ditch. The double ditch layout is only preserved in shorter segments. However, air photos from 40 years ago show that the double ditch layout continued all the way across to the current application area boundary to the northeast.

HA21, Bank flanked by ditches. From SW.

Site No: HA21
 Entec Ref: 12, N
 HER/NMRS No: 3020015/ NT61NW 13
 Grid ref: NT 61696 17193 – NT 61347 16996 (end points)
 Location: Hill Pond
 Class: Linear Earthwork
 Description: An earthwork runs across the ridge to the N of Watch Knowe from the upper sources of Greypeel Burn in the NE and across to the basin at Hill Pond to the SW. The earthwork can be traced as a ditch over a distance of some 400 m from the stone dyke at the site boundary to the NE to the mill dam to the SW. The ditch is cut by an area of furrows and drains (HA22) in the area to the E of Hill Pond.
 The best preserved segments are near the middle where the earthwork comprises a 2.5 m wide and 0.7 m deep ditch to the S with a 4 m wide and 0.4 m high bank to the N and a second ditch on its N side that is up to 2.5 m wide and 0.5 m deep. There were slight indications of a second bank, 2.5 m wide and 0.2 m high, on the N side of the smaller ditch. The bank is only preserved in short segments, indicated by a double line on Figure 2.

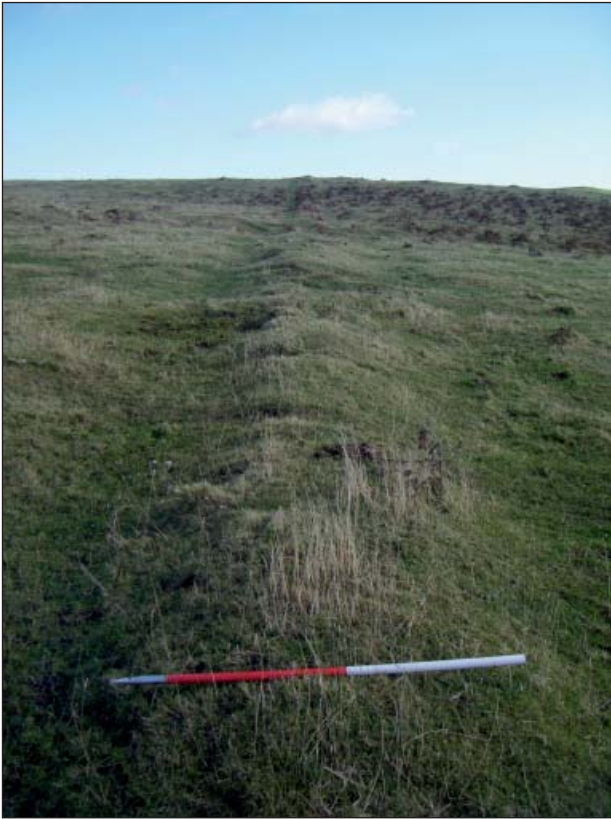
Illus 12

HA30, Mid 19th century earth and stone bank. From W.

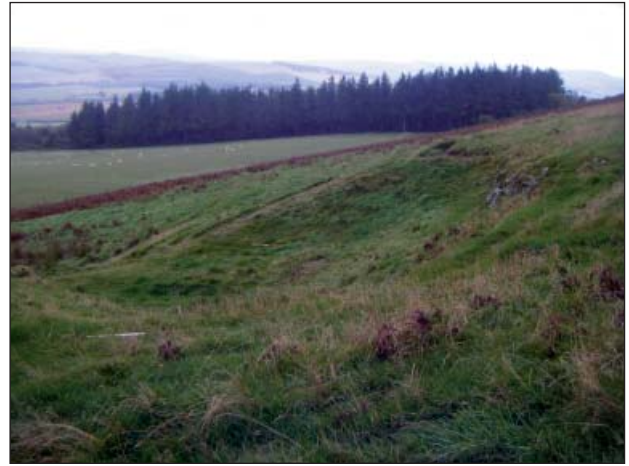
Illus 14

HA04, Quarry with stone dyke in the background. From N.

| Description: | Ten small stone quarries are located on the upper SE facing slopes below the summit of Black Law. The quarries are generally covered by turf with rock-faces and stones exposed in places. The five quarries nearest the summit are all fairly small, 4 to 7 m across and might represent prospecting pits. The remaining quarries measure from just under 10 to over 30 m across and are likely to have provided the stone for the dykes down slope to the SE and SW (HA06). |

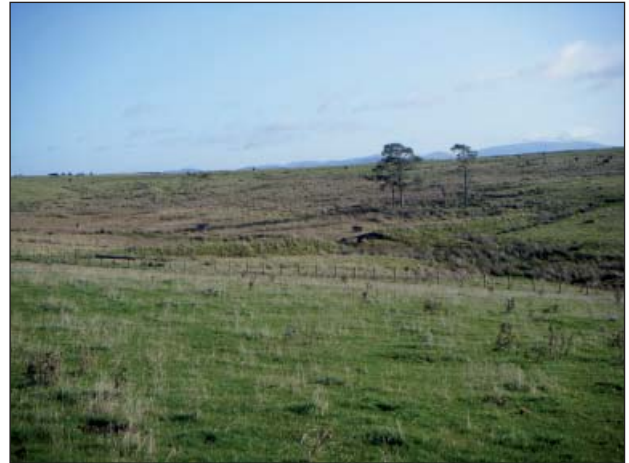
Illus 15

On the current 1:25,000 OS a small triangular body of water named Hill Pond is located in the S half of the area (Illus 15). Today the pond is reduced to an area of wet marshy ground. The pond is a former mill pond created by building a dam (HA20) across the upper parts of Fulton Burn. The water from the pond was channelled through a mill lade around to the west and into a stream leading down to Bedrule Farm steading. Remains of what presumably is an earlier mill dam were recorded some 400 m to the west (HA24) (Illus 16). The outflow from this dam seems to have followed a small stream flowing into Rule Water some 600 m to the S of Bedrule Farm steading. The dam was blocking a relatively small basin, and it is likely to have gone out of use when the larger dam was built to the east.

HA20, Mill dam. From W.

Site No: HA20
 Entec Ref: 13,S
 HER/NMRS No: N/A
 Grid ref: NT 6133 1702 (site centre)
 Location: Hill Pond
 Class: Mill dam and lade
 Description: A mill dam is depicted on the OS 1st edition 6 inch map surveyed in 1858. A mill lade runs from the dam around to the W through a small col below the cliffs to the W and drains into a stream leading down to Bedrule Farm. The dam is still visible but the body of water is now reduced to wet marshy ground.

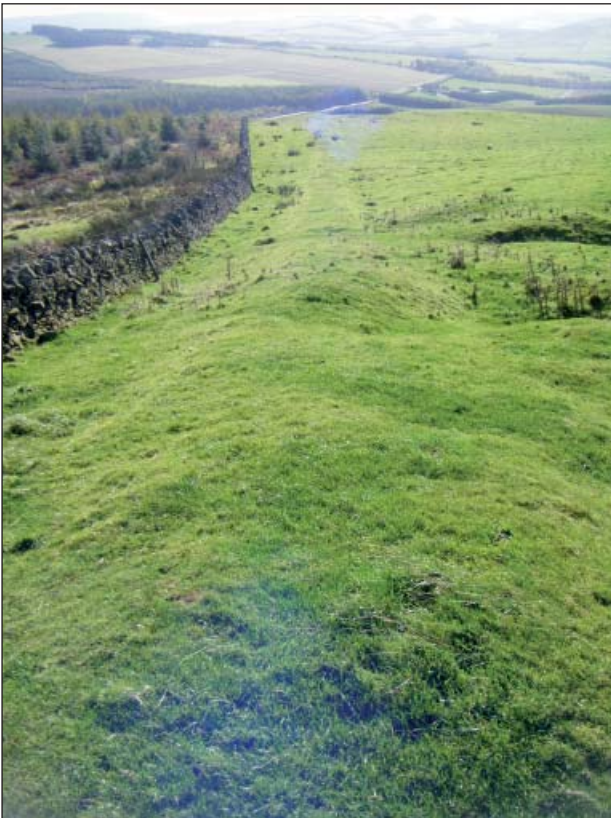
Illus 13

Bank HA10 runs along the line of the parish boundary between Bedrule and Jedburgh (Illus 13). The bank can be traced on the 1968 air photos from the B6357 to the south of Watch Knowe up to the top of Merlin Dean some 2.5 km to the north. The bank is likely to mark the old parish boundary that was replaced by straighter sections of turf dyke (HA09, 12) during improvements in the early 19th century.

HA10, Bank along parish boundary. Later stone dyke to the E. From N.

Site No: HA10
 Entec Ref: M
 HER/NMRS No: N/A
 Grid ref: NT 1751 17570 – NT 1603 16351 (end points)
 Location: Watch Knowe
 Class: Field bank
 Description: A turf and stone bank runs N to S along the W side of the area. It appears to have shallow ditches on both sides. The bank is spread to 2.5 m wide and is up to 0.7 m high. It extends over a distance of 1240 m within the site, but continues beyond the site both to the N and S. At the N end the bank runs parallel with and on the E side of the stone dyke along the site boundary, before crossing into the area at a point where the stone dyke changes direction. The bank follows a gently curving line that takes it up to 50 m W of the dyke before approaching the dyke again at the summit of Watch Knowe and then running roughly parallel with the dyke for some 180 m before crossing the dyke out of the area. As well as crossing the summit of Watch Knowe, the bank also runs across a prehistoric cairn (HA23) on the summit of a lower knoll some 380 m to the north. At the N end the bank defines the W limit of a small patch of agricultural drains (HA11) that appears to extend beyond the site boundary to the E.

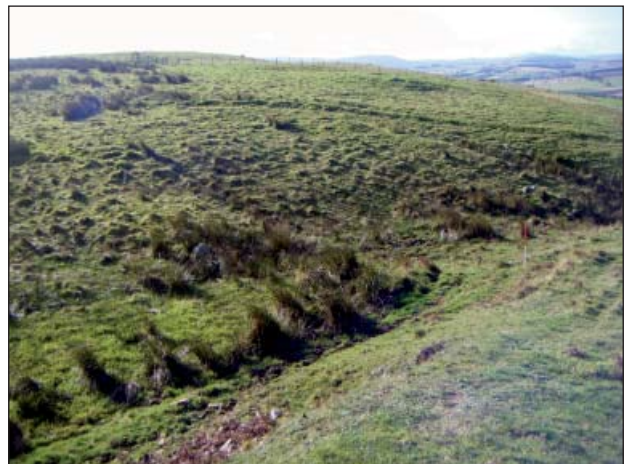
Illus 16

HA24, Mill dam. From N.

Site No: HA24
 Entec Ref: N/A
 HER/NMRS No: N/A
 Grid ref: NT 60930 17064
 Location: Fulton Burn
 Class: Mill dam
 Description: Remains of a dam are located at the outlet of a small basin some 350 m to the W of Hill Pond. The remains comprise earthworks up to 5 m wide and 0.6 m high, that used to form a 14 m long barrier across the stream course. It is now reduced to two segments 3 m and 9 m long on either side of the channel. A small watercourse leading down to Rule Water some 600 m to the S of Bedrule farm steading is likely to represent the line of the mill lade.
