**Project Code: JWDG08-003**  
**Client: James Watt Dock LLP**  
**Date: December 2011**

**James Watt Dock, Greenock, Inverclyde**  
**Archaeological Monitoring**

PROJECT SUMMARY SHEET

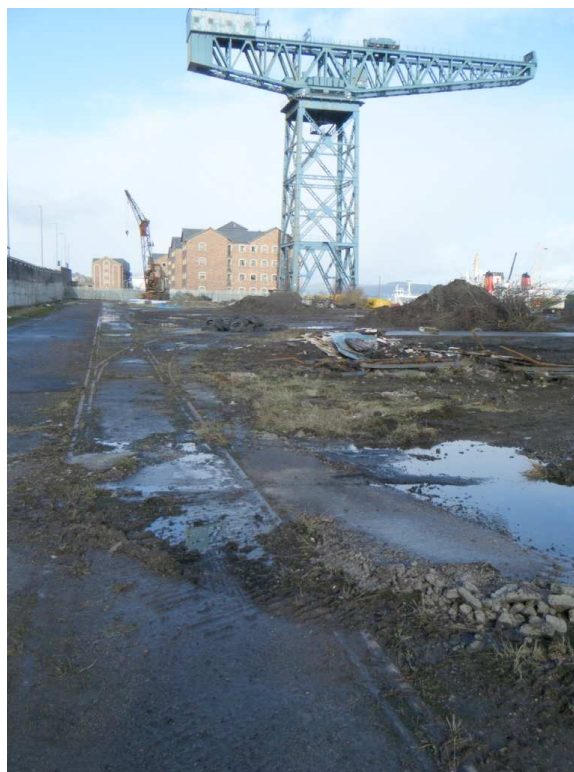
**Illus 5: View of the listed cantilever crane**

The cantilever crane was built in 1917 by Arrol and Co Ltd for the Greenock Harbour Trust and was used primarily for the fitting out of ships (Illus 5) The crane can be identified on the 1938 revision of the Ordnance Survey. The 150 ton steel cantilever crane comprises a lattice girder tower supporting a roller track on which rotates the asymmetrical cantilever truss gib with motor room and counter weight towards the shorter end. This crane was a considerable achievement in its day and is still in complete working order.

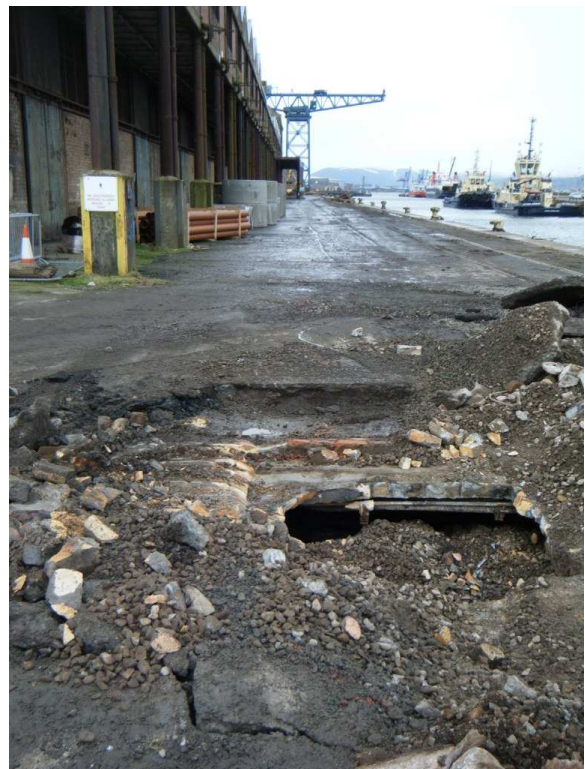
**Illus: 10 Detail of the service culvert**

Excavations were monitored at the NE corner of the warehouse, close to the southern bay of the docks. This revealed the junction of a large brick-built service culvert (Illus 1, 10 & 11) that was aligned both N-S along the dock side and E-W along the N side of the warehouse. A number of cast-iron pipes and more modern cables were visible in this culvert. Along the cobbled surface at the E end of the docks a number of square manhole covers with brick surrounds were recorded. These were thought to be associated with this culvert. This culvert was considered to be part of the original dock construction, dated to the late 1870s.
