EYNHALLOW, ORKNEY
SURVEY 2007

DATA STRUCTURE REPORT

By James Moore & Antonia Thomas
Department of Archaeology
Orkney College UHI

February 2008

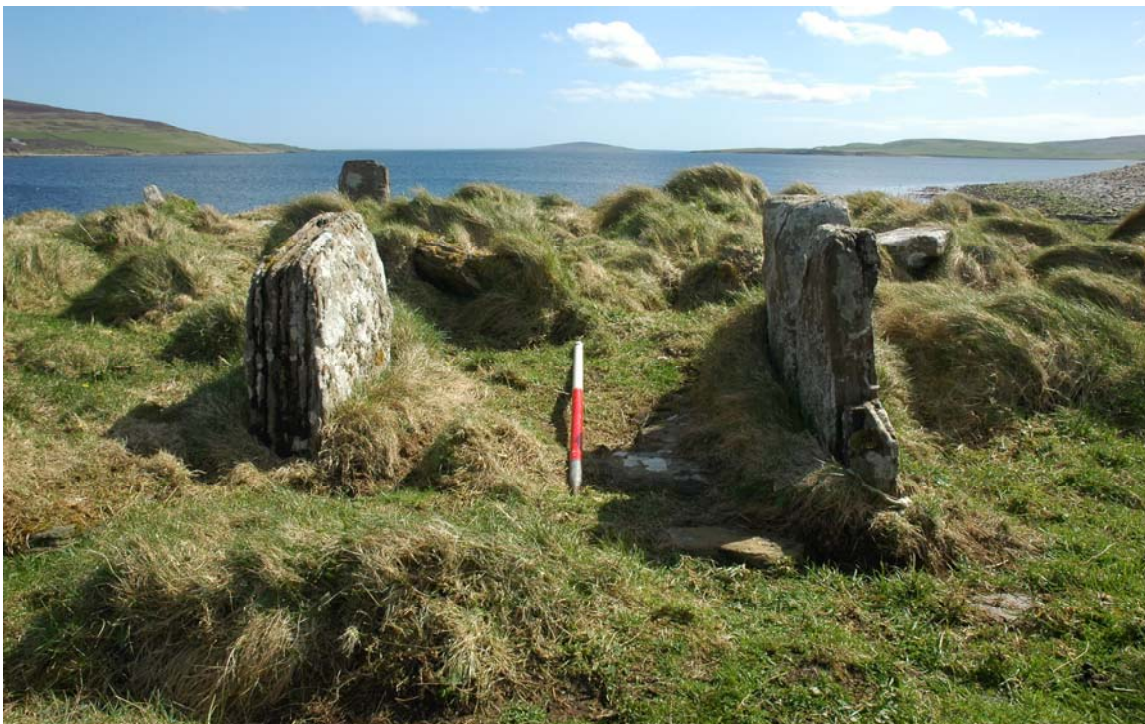
Plate 1: Site 010, with Gairsay in the background, looking west.

Two sites situated on the east coast, however, are almost certainly prehistoric and may be funerary monuments. The site excavated by Mooney at Monkerness (**Site 010; SMR: OR770; NMRS: HY32 NE28**) was identified but is partially obscured by vegetation (see Plate 1 below). However, enough of the structure was visible to question his interpretation of the remains as a hut-circle or roundhouse. The slag-like material noted by Mooney (1923, 31) is bog-iron (Julie Gibson, pers comm.) and the coastal section yielded only a single unidentified fragment of bone, with no evidence of accumulations of midden material. Mooney's photographs of the site also show that the walling is crude, unlike the carefully coursed masonry that is typical of prehistoric structures in Orkney. The second site is situated approximately 100m inland and was initially noted as a pair of low orthostats (**Site 019**); these are positioned in the centre of an area of stone measuring approximately 5m in diameter. The similarity between the two sites suggests that they are associated, but further work will be required to confirm this and also to ascertain the nature of the structures. Also of interest is the rather indeterminate remains (**Site 009; SMR: OR775; NMRS: HY32 NE40**) situated close to the eastern end of an ephemeral stretch of dyke (**Site 052**). The current survey only located an apparently isolated orthostat here but earlier visits (**RCAHMS 1982**), recorded a second orthostat at right angles to this.

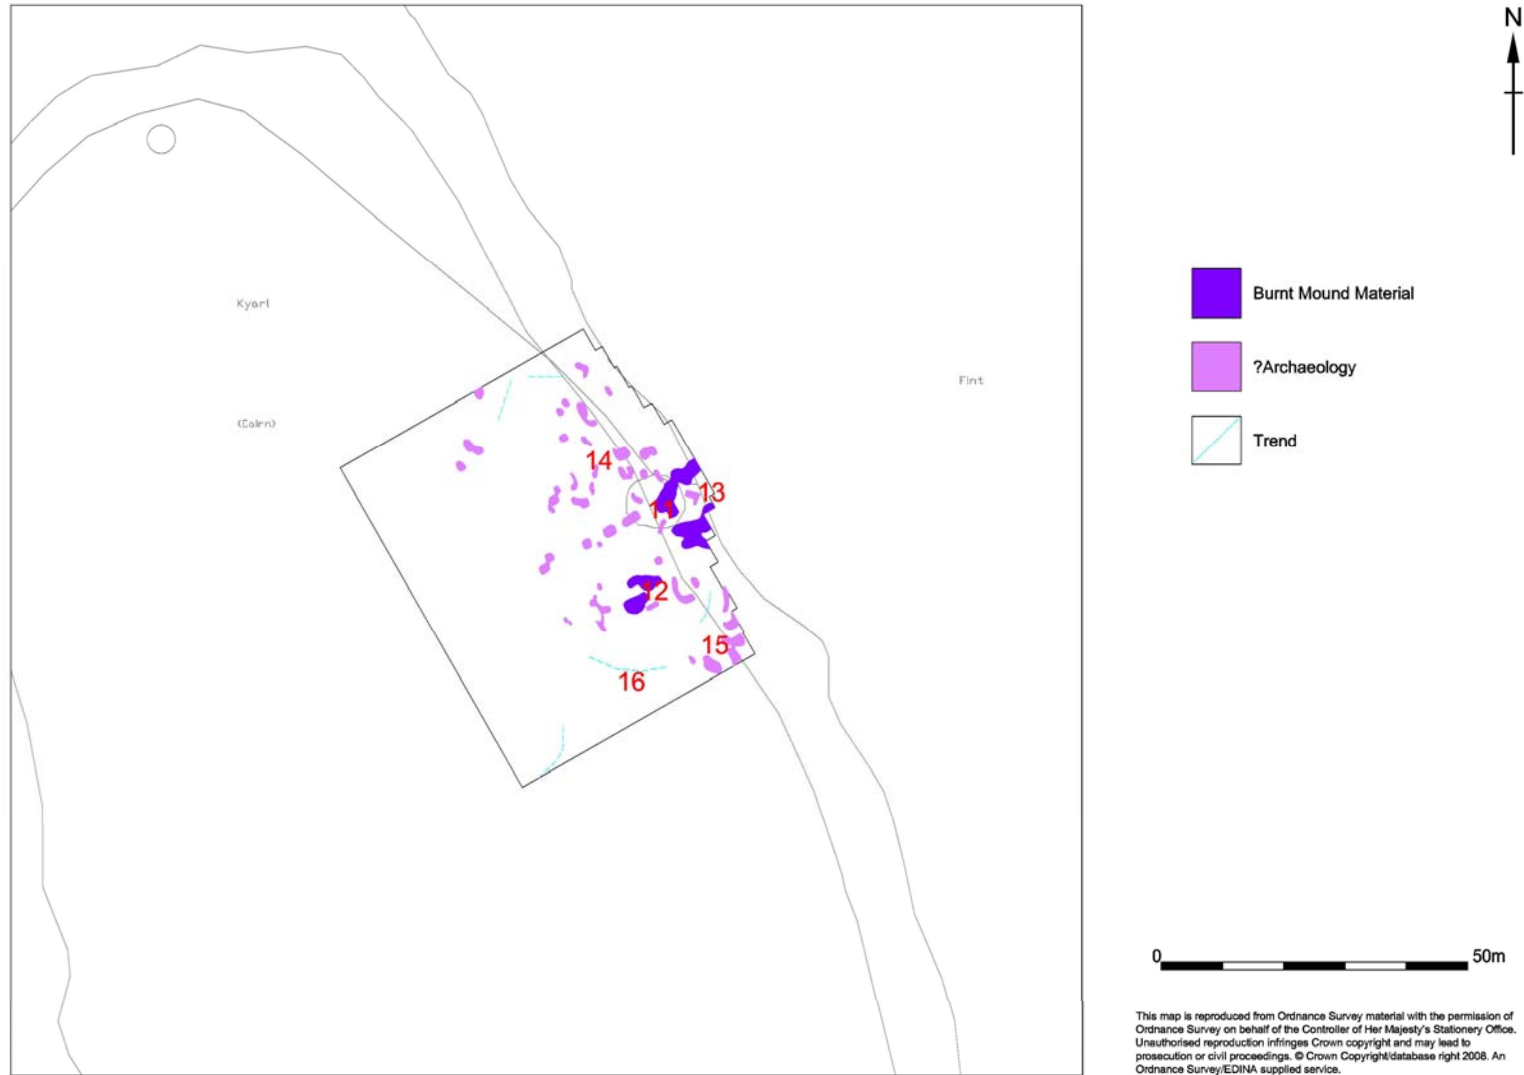
Figure 4: Gradiometer survey of Site 012, summary interpretation

On the coast at Fint are two mounds (**Site 012; SMR OR771; NMRS: HY32 NE29**), the larger of which measures approximately 12.4m x 9.6m and has a distinctive kidney shape, which are surrounded by a boggy area and situated immediately north of a small burn. This is the 'enigmatic' crescent-shaped mound described by Butler (2004, 43-45) and although some local people knew of this site (Sandy Firth, pers comm), it has previously been recorded as a probable roundhouse. During the survey, the site was interpreted as a probable burnt mound, a hypothesis that was tested through the application of gradiometer survey. This confirmed the presence of large concentrations of highly magnetised material in a form highly suggestive of a burnt mound, and similar in nature to other known burnt mounds surveyed within Orkney. A number of extremely strong magnetic anomalies dominate the data; the largest anomalies (**Figure 4; anomaly 11**) correspond to the mounds noted during the walkover survey, whilst a small mound to the west also corresponds to strong magnetic anomalies (**12**). In the centre of the larger anomaly is a small roughly rectangular highly magnetic response (**13**), measuring approximately 1x1.8m and which may be the tank often associated with these sites.

To the northwest of the strong anomalies is a concentration of small pit-like anomalies and weak magnetic linear trends (**14**), which may suggest additional activity beyond the immediate site. Similar anomalies (**15**) are also visible to the southeast of the burnt mound, although the limited area of these responses revealed due to the small survey area, makes further interpretation difficult. The very weak curvilinear trends (**16**) visible in the data correspond to the location of a small burn that runs to the south of the mounds. Whilst these magnetic responses may be the result of topographic variation, it is important to note the presence of the burn as it is likely that it is the reason for the mounds being sited in this location. Although only covering an area of 0.3ha this survey was highly successful. The distinctive form and strength of these anomalies confirm the presence of large concentrations of burnt material typical of burnt mounds seen elsewhere in the Northern Isles, being similar in form to Lambhoga, Fetlar (Moore & Wilson 1999, 208-209).

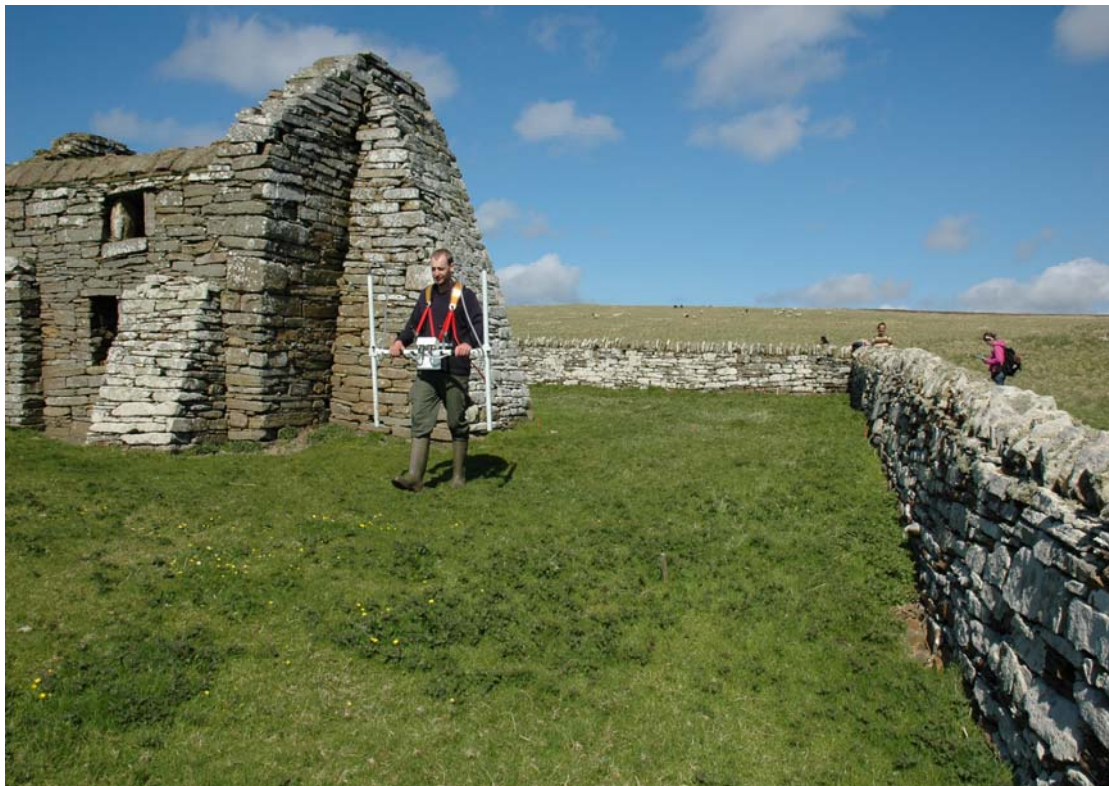
Plate 2: James Moore conducting a gradiometer survey at Site 038

The walkover survey was enhanced by the use of targeted geophysical (gradiometer) survey on two areas, using a Bartington Grad 601-2 gradiometer comprising two fluxgate sensors mounted 1m apart on a vertical axis. Each sensor measures the earth's magnetic field, in nanoTesla (nT), and the instrument records the difference between the observed readings for each sensor. By doing so the instrument is capable of recording subtle changes or anomalies in the earth's magnetic field caused by material in the top metre or so of the earth's surface, whilst variations due

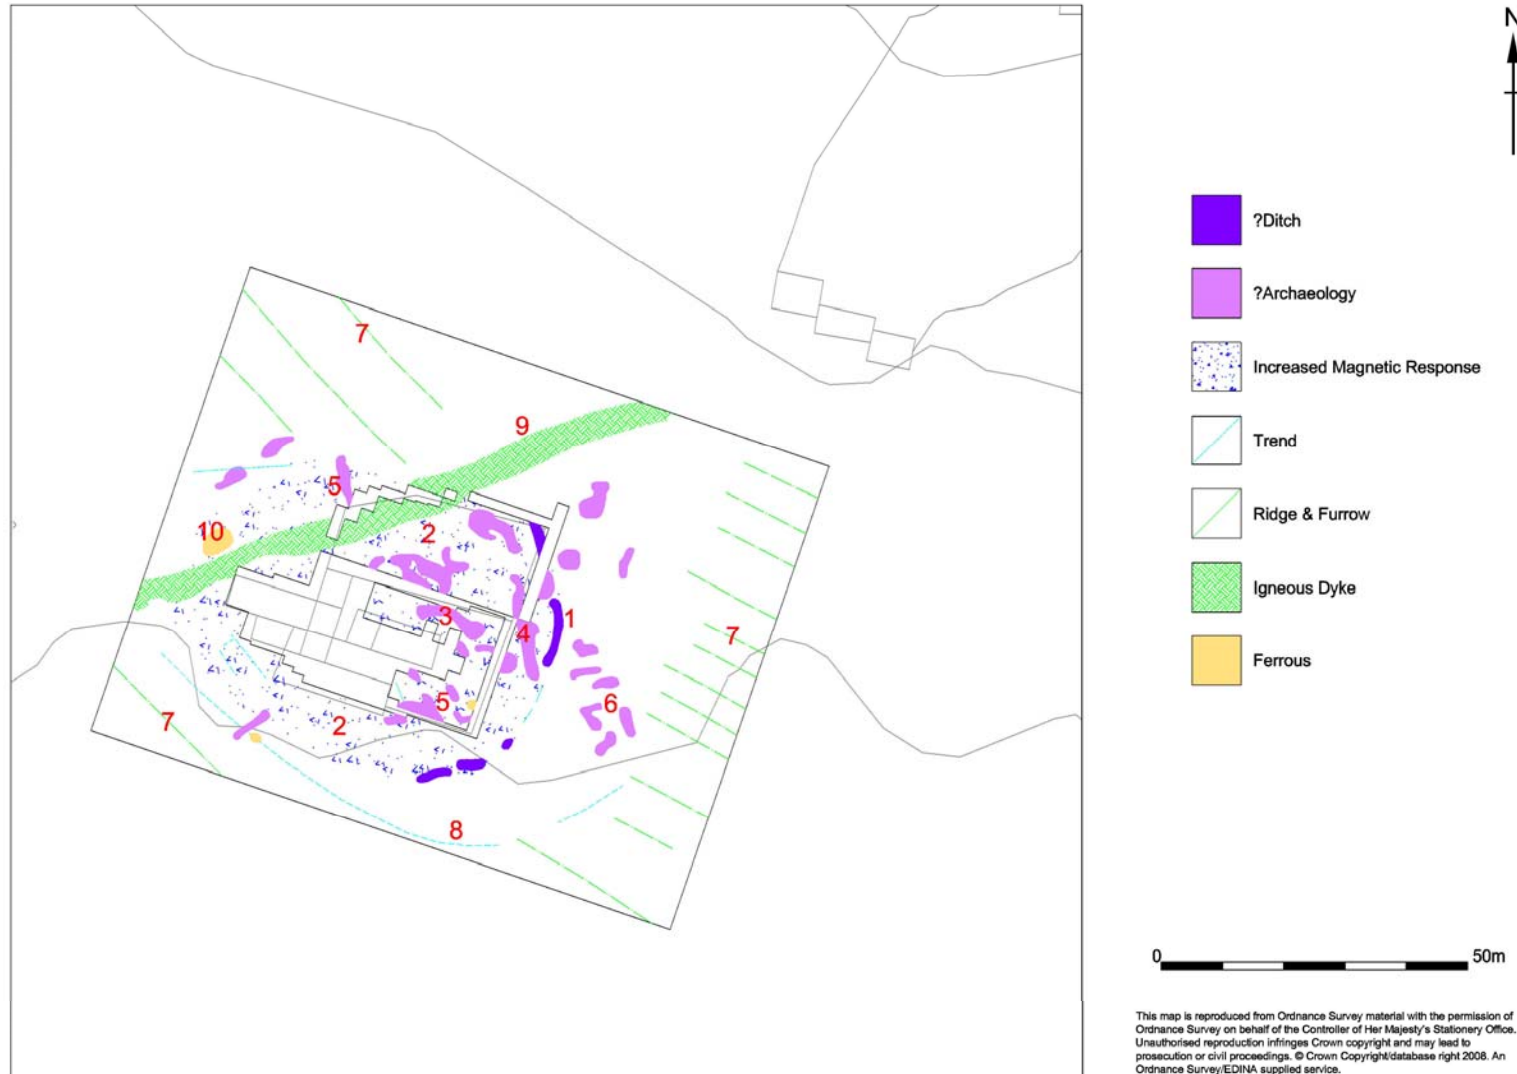
Figure 6: Gradiometer survey around Site 038, summary interpretation

This survey revealed a number of anomalies of clear archaeological interest (Figure 6). At the eastern end of the boundary wall, a strong curvilinear anomaly **(1)** is visible and is likely to be a ditch-like feature. The line of this feature also marks the limit of an area of increased magnetic response **(2)**, which indicates occupation or other anthropogenic activity. Within this area are further anomalies of probable archaeological interest. The short, slightly curving anomaly **(3)** to the north of the building may relate to a later phase of the structure, specifically the porch that is still partially visible in the fabric of the building. There are also several clear linear responses in this area, most notably **(4)**, aligned approximately north south and which may be either a ditch or an accumulation of enhanced soil or midden material banked against a built feature. The alignment is shared by a number of other linear responses **(5)** within the area that may suggest buried structural remains, and also the concentration of narrow rectilinear anomalies **(6)** to the southeast of the monastic complex. These may represent further structural remains.

To the east and west of the buildings, a number of clear parallel linear trends visible in the data **(7)** are indicative of ridge-and-furrow ploughing and closely correspond to the cultivation pattern noted on the ground and transcribed from aerial photographs.

It is interesting to note that the anomalies to the southeast of **Site 038** are much more narrowly spaced than those to the northwest. The patterns and morphology of rig and furrow can indicate social and chronological factors in addition to informing about patterns of land use and tenure (Barber 2001, 7). As with other features noted during this first phase of fieldwork there appears to be several phases of reworking and redesign of the infield area. To the south of the complex of buildings is a narrow curvilinear response **(8)**, which defines a magnetically quiet area. This anomaly corresponds to the boundary wall recorded by RCAHMS and to the approximate limit of the mound upon which the buildings are situated. The rig and furrow and other features within the infield area are discussed in more detail in the following section.

The data are dominated by a northeast – southwest linear anomaly **(9)**, characteristic of an igneous dyke. Similar responses have been detected on numerous other sites within Orkney, including on the nearby island of Wyre (Thomas 2006). Unfortunately, the strength of this anomaly has obscured any responses of archaeological origin in the area. A number of ferrous anomalies were also noted, including at the western end of the structures **(10)**; these may be associated with the removal of the roofs of these buildings in the nineteenth century. Although limited in scope the survey was highly successful and appears to have identified a clear area of activity around the monastic complex. The nature of geophysical survey data makes it impossible to date these features but the roughly north-south alignment shared by a number of these potential structural anomalies is clearly different to that of the extant structures and as such it would seem that pre-monastic remains have been revealed on the site. The area around the monastic complex will be further investigated in the second season of fieldwork in 2008.

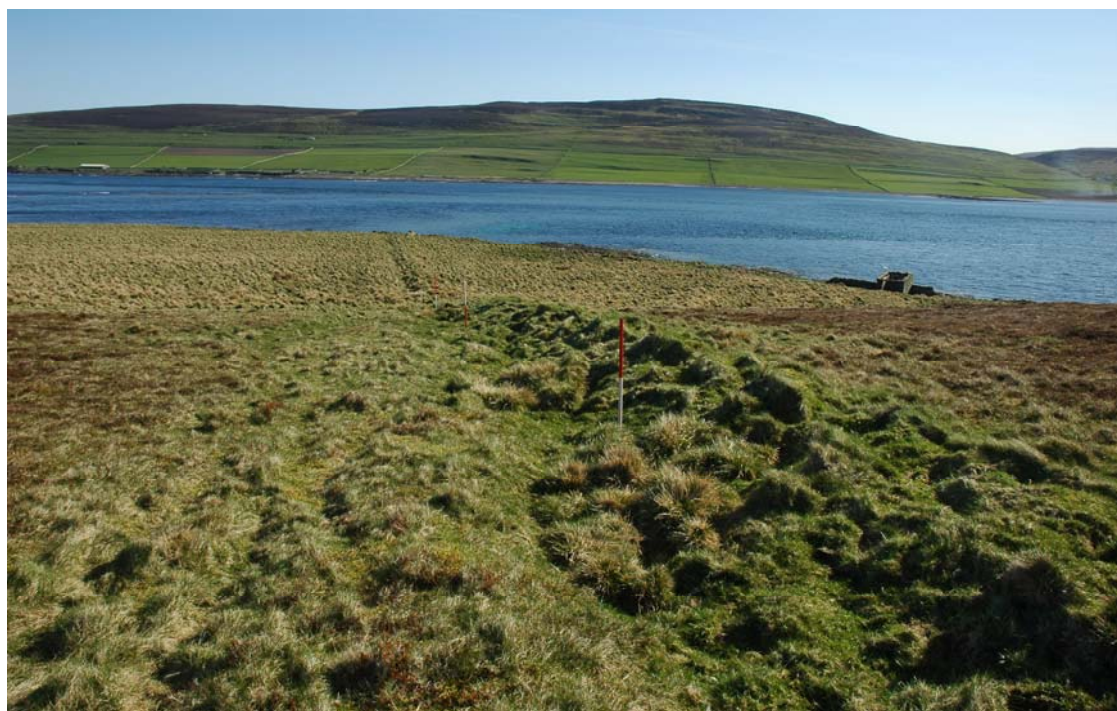
Plate 3: The dyke 048, with Rousay in the background, looking east

In addition to the infield boundary, there is a considerable network of dykes of various periods transecting Eynhallow. **Sites 048/055/056** were recorded in three separate stretches but together these form a large hill dyke, roughly oriented east-west and bisecting the island. This was known as the 'old dyke' in the 1820s (Butler 2004, 35); a charter of 1700 refers to the island in two halves (Butler 2004, 57) and may relate to the two areas divided by this dyke, but it is not marked on MacKenzie's map of 1750. However, hill dykes formed a seasonal separation of the townland from the common grazing of the hill land in the summer time and was not a dividing line as such, rather representing the link between different parts of the township (Fenton 1978, 89). The variations in this dyke's form would suggest that it has been maintained and reworked over a considerable period and its size suggests that this may well be an early and significant landscape feature. The 100m section between **HY 36009 29065** and **HY 36104 29050** has been significantly reworked and although a full understanding of the phasing was not possible within the limited scope of the current work it seems to form a focus for a number of other presumably later boundaries.
