Clyde-Built: A Study of the Clyde Shipbuilding Industry as  
Represented by Shipwrecks within the Clyde River and  
Estuary

Historic Scotland

CA Project: 770001

CA Report: 15133

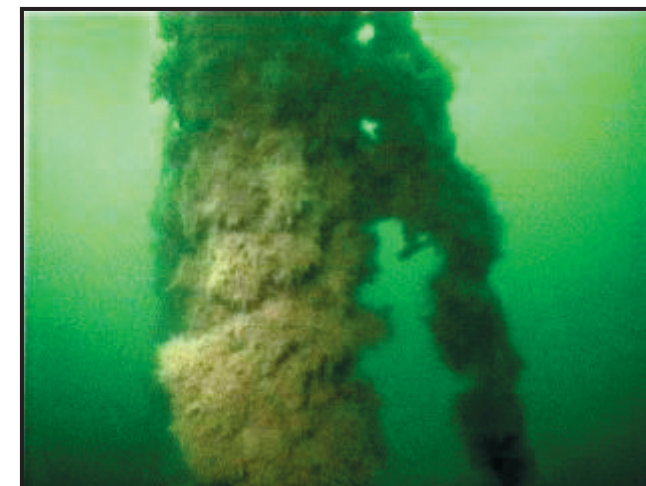
FIGURE TITLE  
 Wreck of the Clyde Puffer 'Tuscan'

Base of funnel

Diver port side of engine casing

Tuscan door to engine room

Mast

- 5.3.14. Within those identified as Clyde Puffers a number survive in good condition (see Appendix B, Wreck Sheets 16.2- 16.11). Figure 4 shows an example of the surviving remains of one of

the Puffers, the *Tuscan*, which include the vessel's mast. Of the Clyde Puffers the *Margaret Niven* has been selected for a detailed assessment of significance. This selection is based not only on the good condition of the wreck, but is also due to the ability of the wreck to represent the development of the Clyde Puffer (Appendix B Wreck Sheet 16.10 and Figure 5).

- 5.5.3. The different locations of other Clyde Puffers within the dataset mean that different individuals can connect with the vessels. *Kaffir* for example is accessible from the shore, and can be seen above the water, while there are many others which survive in an apparently good state of preservation below the water, including *Glenhead*, *Briton* and *Tuscan*, the latter of which has been noted by divers to be the best preserved (underwater) example of a Clyde Puffer (Figure 4).

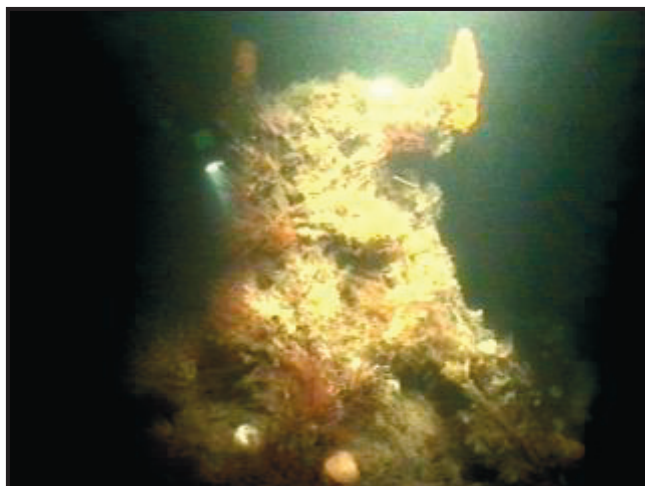
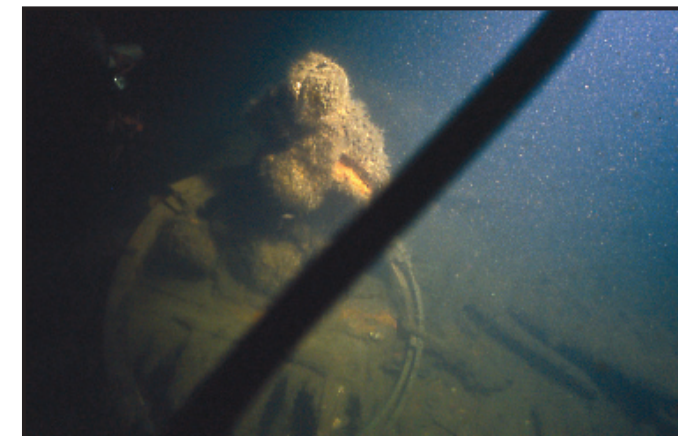
FIGURE TITLE  
 Wreck of the 'Beagle'

Bow

Beagle emergency steering post

Beagle main wheel

- 5.9.1. *Intrinsic Characteristics:* In 1976 the UKHO reported a wreck lying intact and on an even keel, off Great Cumbrae island. Subsequent diver reports indicate that the wreck remains include the hull, however the superstructure has collapsed (Appendix B, Wreck Sheet 16.17, Figure 6). The bow post and emergency steering position at the stern form the wreck's high points. Other features noted include the boiler stack, engine room, anchor and steam winch (toward the bow), propeller and rudder. Aft of the cabin there is a large empty space. An anchor is visible toward one end of the wreck (possibly the bow). Railing is also present, and a section of the railing is missing near the port side toward the bow. Collision damage is visible and a large section of the hull is missing on the port side. The cross-decking and support structure has largely deteriorated and the aft bulkhead has disintegrated. A series of objects have also been reported to the Receiver of Wreck including a Bronze or brass signal cannon, two cast iron sides of carriage, portholes (one with a deadlight), pottery and cutlery. Divers have noted that the wreck had high quality features including a cast iron

- 5.9.2. It appears therefore that the wreck survives moderately well although some features recorded by earlier surveys are no longer present on the wreck site, or have deteriorated (such as the decking). The ship's bell indicated that this vessel is the *Beagle*.

- 5.9.6. The high quality fittings noted by divers indicate potential interest of the wreck in terms of its aesthetic attributes. However, it appears that many of these fittings no longer survive on the wreck site, and numerous fittings including bronze or brass signal cannon, two cast iron sides of carriage and portholes have been reported to the Receiver of Wreck. It is thought the cast iron stand formed of two dolphins, in which the ship's bell fitted, also no longer survives on the wreck site. Thus the surviving aesthetic attributes may be limited.

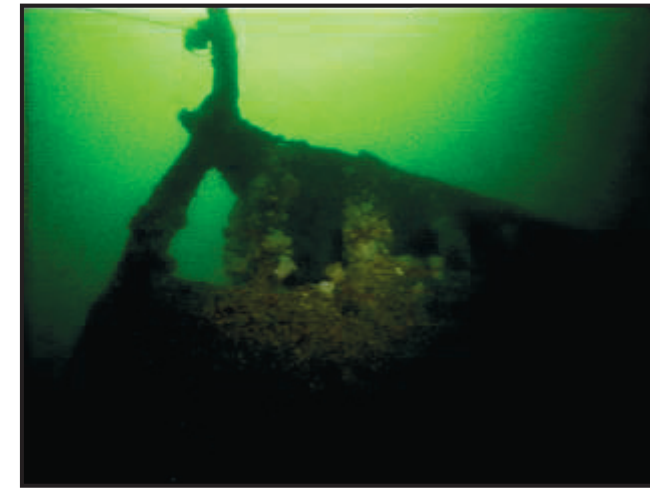
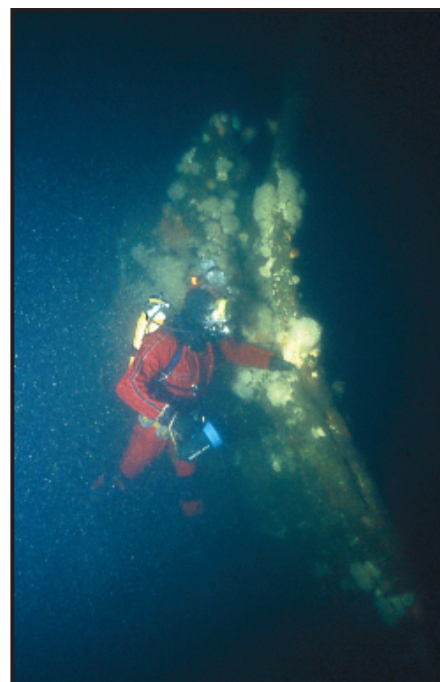
FIGURE TITLE  
 Wreck of the 'Kintyre'

Bow

- 5.10.1. *Intrinsic Characteristics:* A wreck lying virtually intact, with some superstructure also present aft of the forward hold, was first recorded by divers in 1982 (Appendix B, Wreck Sheet 16.16, Figure 7). Recent reports indicate that some deterioration has occurred,

however the wreck remains are reported to consist of the hull (relatively intact on the port side, and with a large gash in the starboard side thought to represent a collision scar). While the plating is present in some areas, it has fallen away around the bow leaving the exposed ribs. The bow itself has a distinctive clipper form and the bowsprit survives. In the amidships area three toilets have been noted. The stern of the vessel lies at a depth of c. 50m. Features recorded in this area include a bollard, and the stern structure itself which has reportedly seen some break up. The engine room has also been recorded, with the roof missing allowing views of the large boiler within. Other features noted include a winch, and brass toilet fittings. However brass cannon, the ship's bell, portholes and brass rims, passageway edges and toilets have all been removed since the 1980s. The wreck has deteriorated down to deck level, and the bow and deck are silting up.

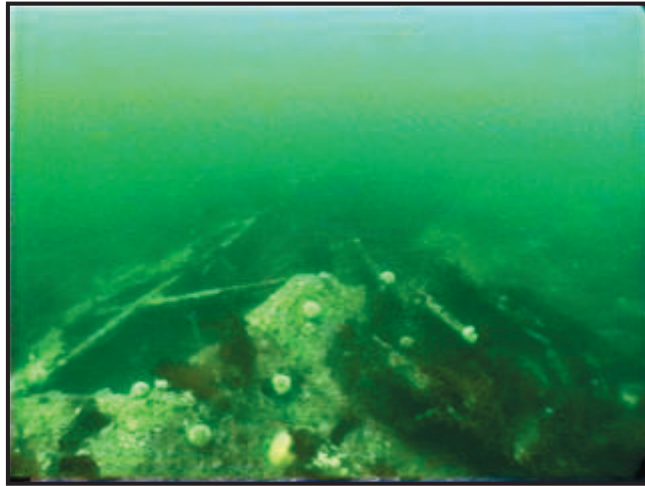
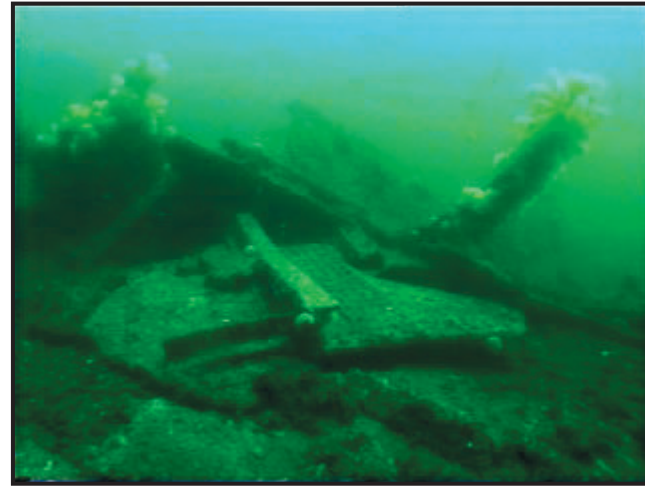
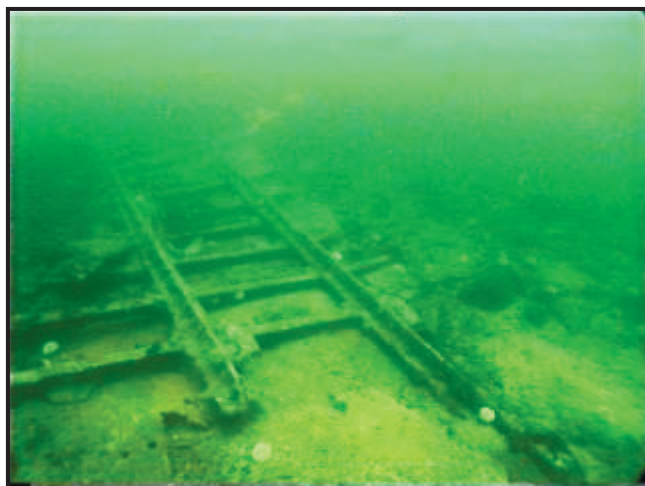
FIGURE TITLE  
 Wreck of the 'Lady Isabella'

Hull structure

Hull

Ribs

Structure

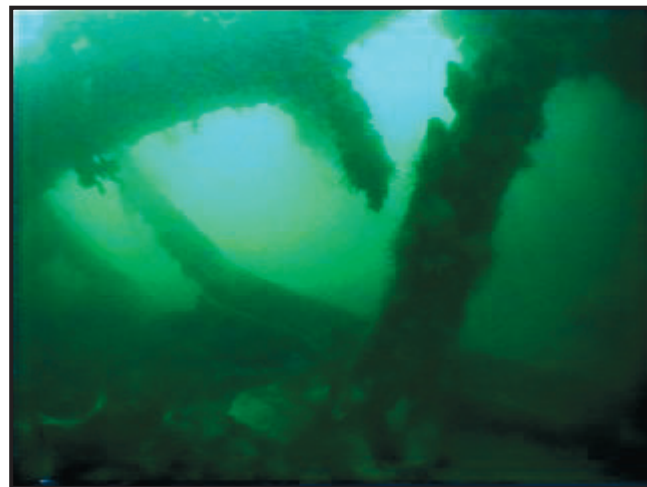
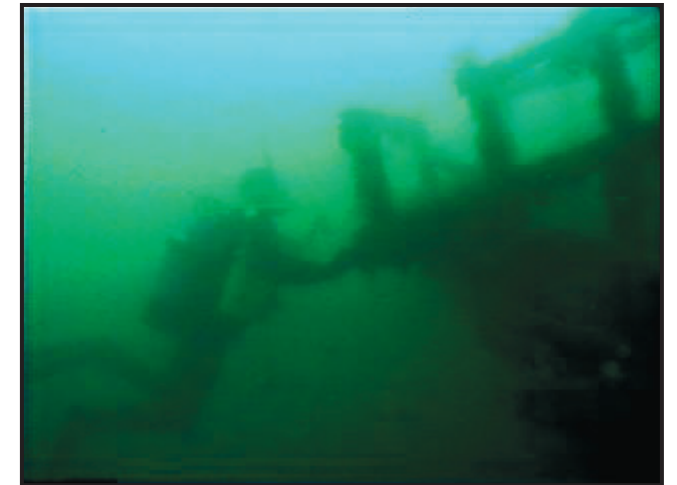
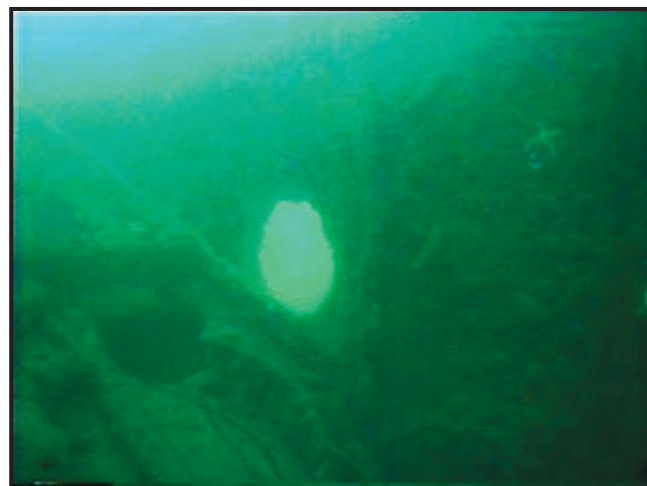
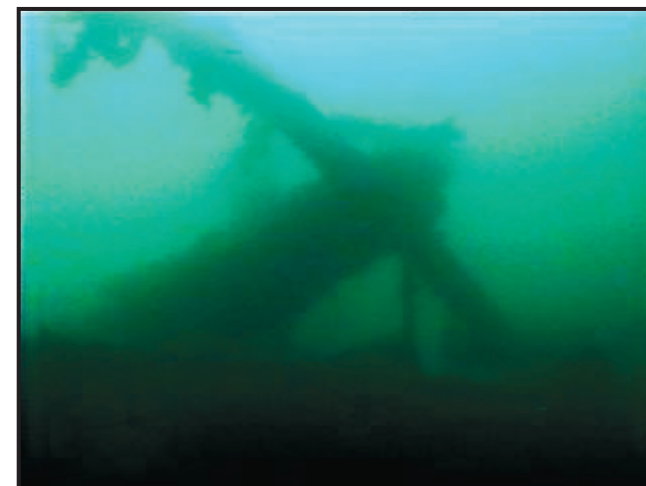
FIGURE TITLE  
 Wreck of 'HMS Breda'

Debris

Deck structure

Diver under stern

top of rudder quadrant

Hull

Structure

Top of stern

Porthole

Rudder
