Survey and Recording Section: Architecture and Industry

Birkhill Fireclay Mine Clay Preparation Buildings FALKIRK

NS97NE 83 (NS 9650 7896) Canmore ID 47866

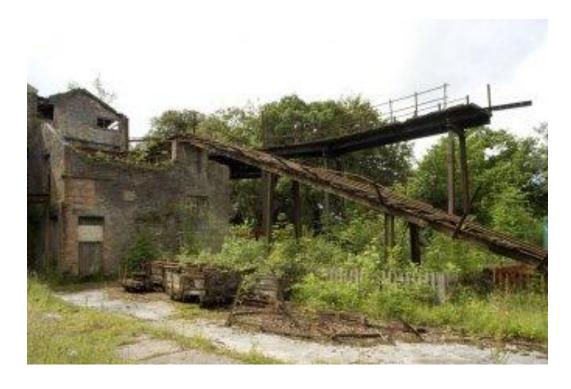
Birkhill Fireclay Mine, mine surface buildings. View of haulage gantry and 'run of mine' wagon rail gantry, from south. These structures have since been demolished. RCAHMS, 2007 [DP028368].

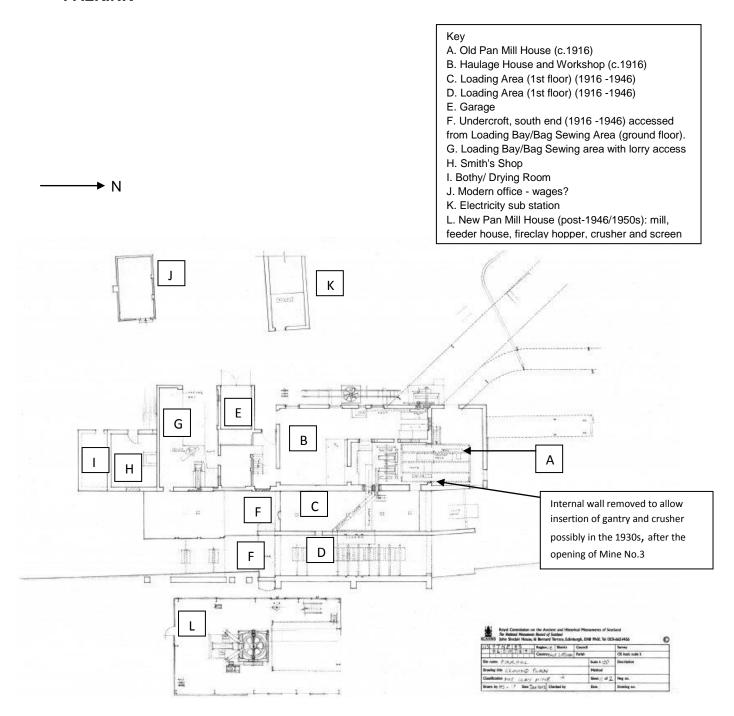
Birkhill, fire clay mine, ground plan of processing plant. RCAHMS, 2011/12 [SC1361815]

'Old' Pan Mill House, see SC1361815, A

The 'old' Pan Mill house (c.1916)¹¹ is a remodelled, brick-built structure which, along with the haulage house, appears to have formed the original core of the processing buildings (of c.1916). The Pan Mill House was originally two compartments, forming an L- shape. The Haulage Building (see SC1361815, B) was wrapped around its south and east sides. It would appear that the opening of Mine No.3 (see SC 1256004 above) accounts for modifications to the 'old' Pan Mill House. The double-pitch roof was removed from the 'old' Pan Mill House and a steel-framed structure was inserted (pre-1946 and probably around the time of the opening of Mine No. 3 in 1932) to allow the creation of what could be called a 'charging' and clay distribution level. From this floor, material from the mine wagons accessing it from the mine incline was tipped into a crusher below which in turn fed the Pan Mill on the ground floor. The north east corner of building A has been rebuilt with concrete lintels inserted above the doors (see distribution platform top of incline windows), contrasting with the wooden window frames and lintels in the northwest and west walls.

Haulage House and Workshop (SC1361815, B)

Looking at the plan of the ground floor, this appear appears to closely date with A, although it is clear that the south or rear wall has been rebuilt presumably as a result of modification to the hopper area (SC1361815 C and D). The haulage house contained concrete, plant-supporting plinths, the machinery for which was in pieces or missing on the date of survey. The haulage would also possibly have been inserted when Mine No. 3 was opened in c.1932 at which time Building A was remodelled.

An almost intact, cable-hauled incline survived at Birkhill (in 2011). It is difficult to establish if, in its first phases (pre-1932), there was indeed the developed incline and haulage system. It may have been that material was hauled up from Mine 1 on an earlier incline and barrowed in at ground level to the 'old' Pan Mill. The structure for haulage and distribution surviving in 2011 probably dates from the opening of Mine No.3 as there is evidence of the haulage system being inserted and the top of the incline area sits as a separate platform with concrete window lintels, and so later than the 'old' Pan Mill House (SC1361815, A) and Haulage Building (SC1361815, B). It seems possible, therefore, that

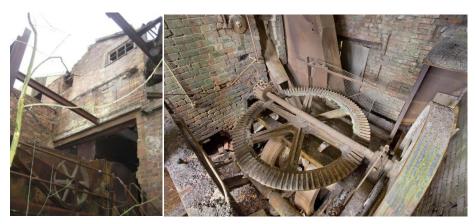
Above left: Old Pan House. The slapped through wall clearly is visible and the steel structure carrying the crusher which fed the Incla Mill. The gable above is clearly later (possibly the 1930s). Image: M McDonald, 2011
Above right: Old Pan House, Incla Mill. Note the bucket elevator behind with the return chute from the sieve to the left of it. The drive wheel is visible extreme right. The space was extremely cramped unlike the purpose built New Pan House (pre-1946), RCAHMS, 2011 [DP111699]

The east wall of the Old Pan Mill House has been rebuilt, presumably when the hopper area (C and D) with its undercroft was built (sometime between c.1916 and 1946) and later modified (between c.1932 and 1946). It may be that around this time, and more probably during the 1930s, the east wall has been roughly slapped through to insert the bucket elevators from the Old Pan Mill to the screen above Hoppers C and D along with the return chute from the screen for re-milling of fireclay which would not go through the sieve. The remodelling of the Old Pan House building probably around the time of the opening of Mine No.3 (1932) may have precipitated the removal of the internal wall to allow the gantry for the crusher to be inserted (see 'Ground Plan of Processing Plant' above).

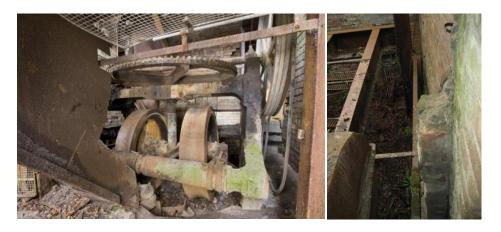
Above, left: Old Pan House with Incla Mill, from north. Chute on left from crusher on steel frame. The space was extremely cramped unlike the purpose-built New Pan House, RCAHMS, 2011 [DP11170]. Above centre: Old Pan House. The slapped through wall is clearly visible and the later steel structure carrying the crusher, which fed the Incla Mill, is to the left. Image: M McDonald, (2011).

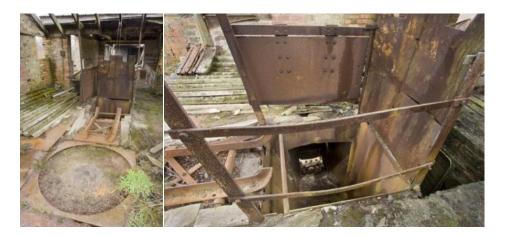
Above left: View from west of tipping area for tub into crusher for Pan Mill below [DP111682]. This has been inserted into an existing floor. Above right: Detail of tipping area with crusher jaws visible on frame below from south. The Pan Mill is directly beneath the camera [DP111681]

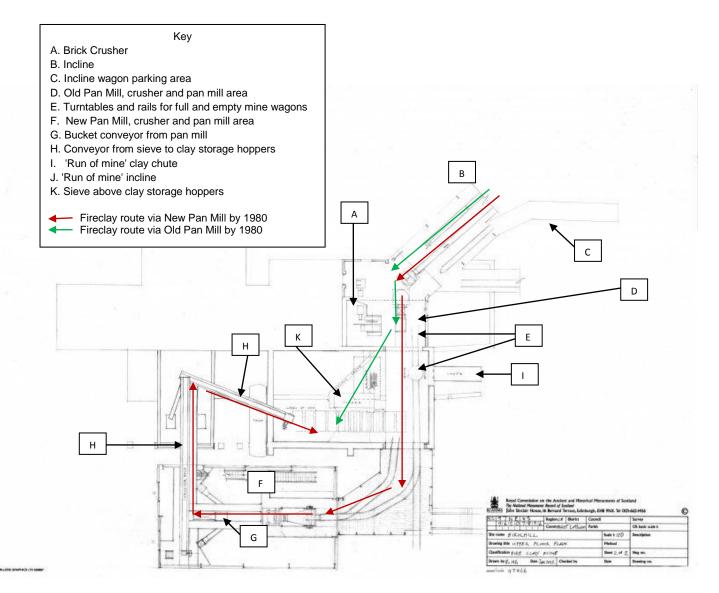
Birkhill, fire clay mine: Plan of upper (1st) floor plan, processing plant. RCAHMS 2012 [SC 1361816]

Distribution area (Upper Floor, SC1361816)

The distribution area overlies Building A and the Hopper area above Loading areas (SC1361815, C and D). From this level the crusher for the Old Pan Mill in Building A can be accessed. There is a brick crusher (SC1361816, A) on this level whereby crushed brick can be added to the clay prior to crushing in Building A or sent to the New Pan Mill (SC1361816, F).¹²

New Pan Mill House (see SC 1361816, F) was built after 1946. It was a steel-framed, corrugated iron and asbestos building with open steel mezzanine areas, incorporating (ground floor) pan mill and portable worm screw for feeding crushed clay into the pan mill (maker: Fawcett); first mezzanine, crusher; second mezzanine storey, access rails to distribution area on the top floor which allowed the one ton wagons to tip into the crusher hopper semi-automatically; third mezzanine level, south end of the building allowed access to the elevator buckets and the clay dust screen and conveyor. This conveyor then crossed into hopper area (SC1361816, H) storage area prior to dispatch by train and latterly by lorry.

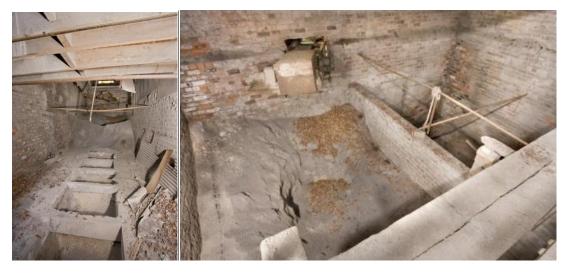
Above left: View of Hopper (SC1361816, D) above loading area from north, RCAHMS, 2011 [DP111695]. Above right: Hopper (SC1361816, D) above loading area, south end. The conveyor from the New Pan Mill House (post -1946) screens has been slapped through the south wall. RCAHMS, 2011 [DP111693]

- Hopper D (SC1361815, D): This post dates the Old Pan Mill House (its east wall has been slapped through to allow the Old Pan Mill conveyor access to the sieve and hopper area, see SC1361815, A) and pre-dates the New Pan Mill. It may therefore date to the development of Mine No. 3 after 1932. The south wall of the hopper area has also been rebuilt indicating that it is maybe later than the Old Pan Mill House and Haulage buildings (SC1361815, A and B). This hopper contained clay dust and was fed from not only the screen above from the Old Pan Mill House (SC136815, A) but also from the conveyor belt from the screen in the New Pan Mill House (see SC136185, L and SC136186, G).

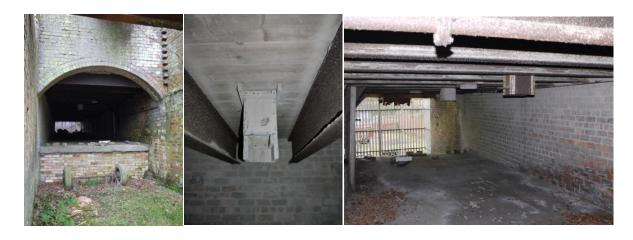
Above left: View of Loading Bay below Hopper C from south. This was originally served by railway wagons but was converted to allow bagging and loading into lorries. Image: M McDonald, 2012 Above centre: Funnel from modified hopper above to allow bag filling. The bags were then manhandled into the bag sewing area and loaded onto lorries. Above right: View from north of platform and funnel for filling bags with dry clay dust from modified hopper floor above. Image: M McDonald, 2011

- Hopper C (SC1361815, C): This may post-date the Old Pan Mill House of c.1916 (its east
 wall has been slapped through to allow the Old Pan Mill conveyor access to the sieve and
 hopper area, see SC1361815, A) and pre-date the New Pan Mill (post-1946). Hopper C has
 been remodelled: the chute areas have been closed off (date unknown) but presumably when
 rail access was no longer needed and the platform for lorry dispatch was built.

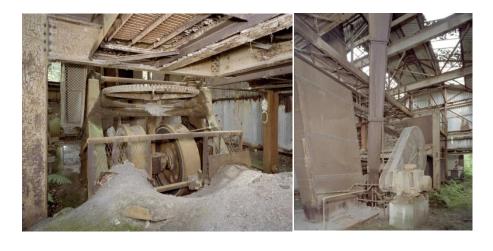
Far left: New Pan Mill House (post-1946), Pan Mill with the access mezzanine to the clay crusher above. RCAHMS, 2011 [SC1082490]. Left: View from south of New Pan Mill House. Bucket elevator and clay pit (left) return chute from screen sieve (centre) and drive motor (right). RCAHMS, 2011 [SC1082488]

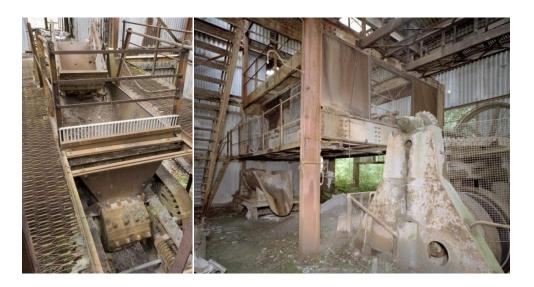
Above left: The tippler which tipped the clay wagon contents into the crusher below. RCAHMS, 2011 [SC1082489] Above right: View of the housing for the motors which drove the crusher and pan mill. The portable worm screw which pushed the crushed material from the crusher into the pan mill can be seen to the left. RCAHMS, 2011 [DP111671]
