Castlelaw and Dreghorn Training Area

An archaeological survey by
the Royal Commission on
the Ancient and Historical
Monuments of Scotland

An archaeological survey

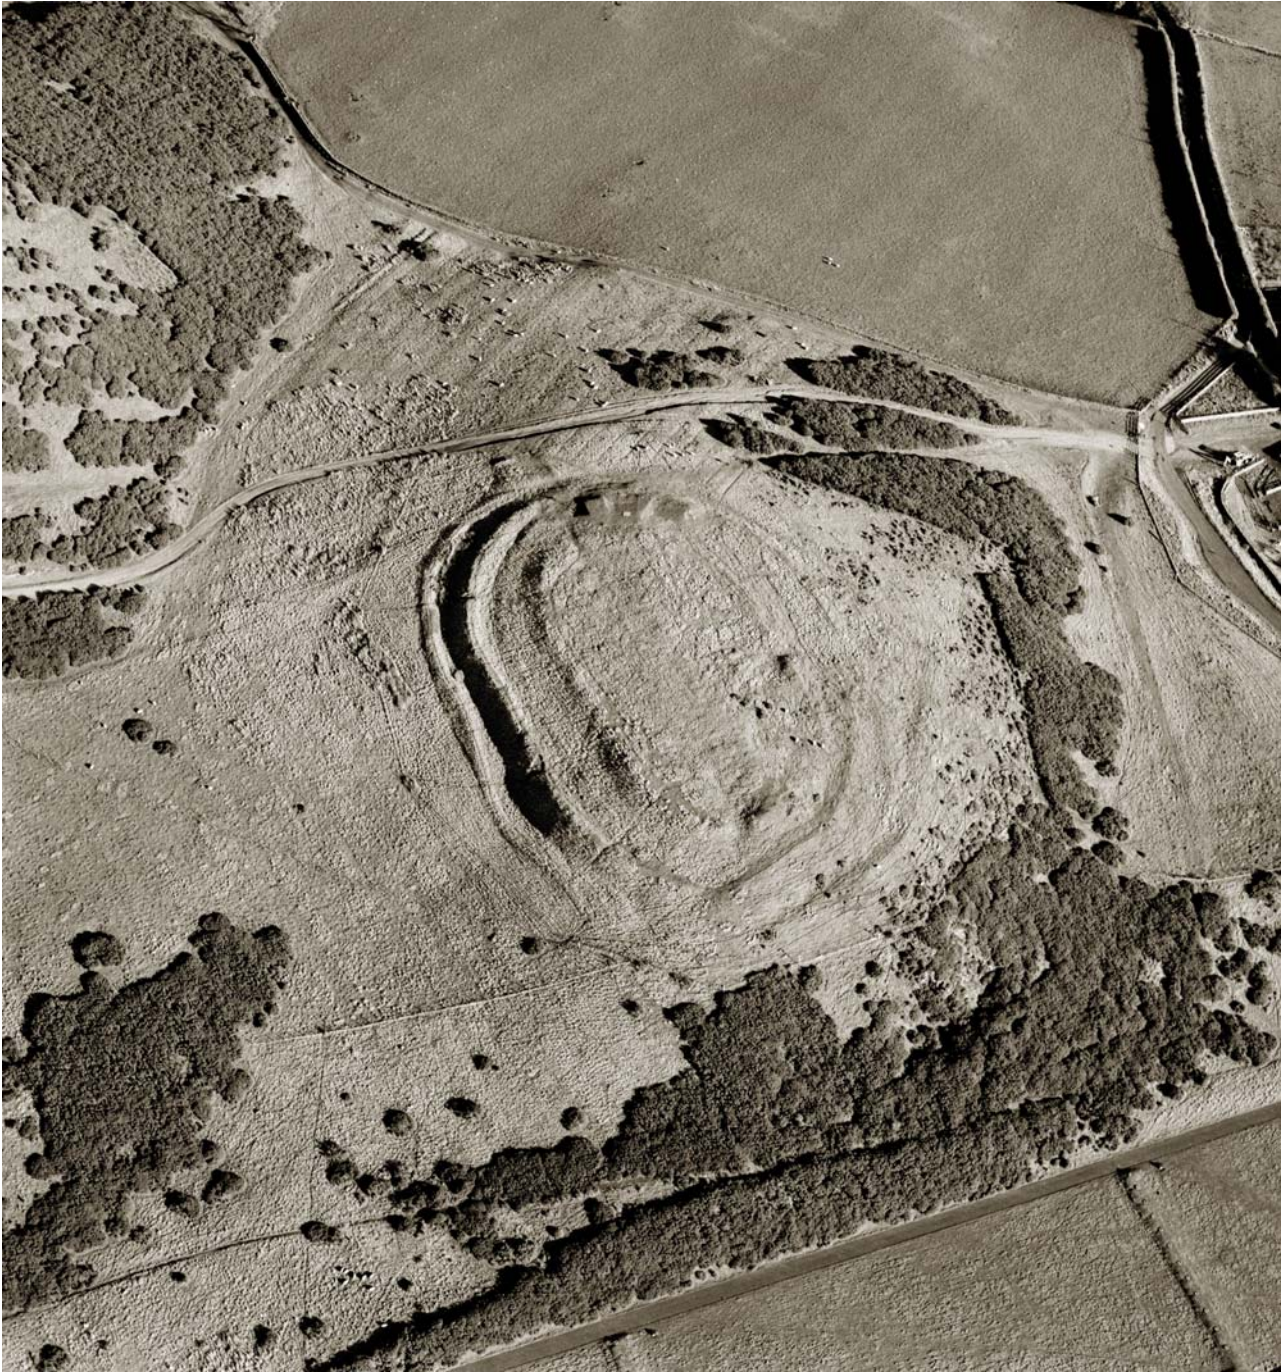
Illus 1. Castlelaw. Oblique aerial view centred on the remains of the fort and settlement, taken from the W (SC993181).

Within zone two the only monuments that survive from an earlier period are the Castlelaw fort (51871) and the palisaded enclosure on Castle Knowe (51873). The fort has been heavily damaged, particularly on its S side, where the ramparts appear to have been cast down in the formation of cultivation terraces, but also in the interior, where cultivation has removed all visible traces of any contemporary round-houses. The palisaded enclosure has fared better, the rig only overlying its ENE end, but it is probably little more than luck that the cultivation has not been extended across the knoll from this end or from the NW, where there is a further plot of rig only 30m away.

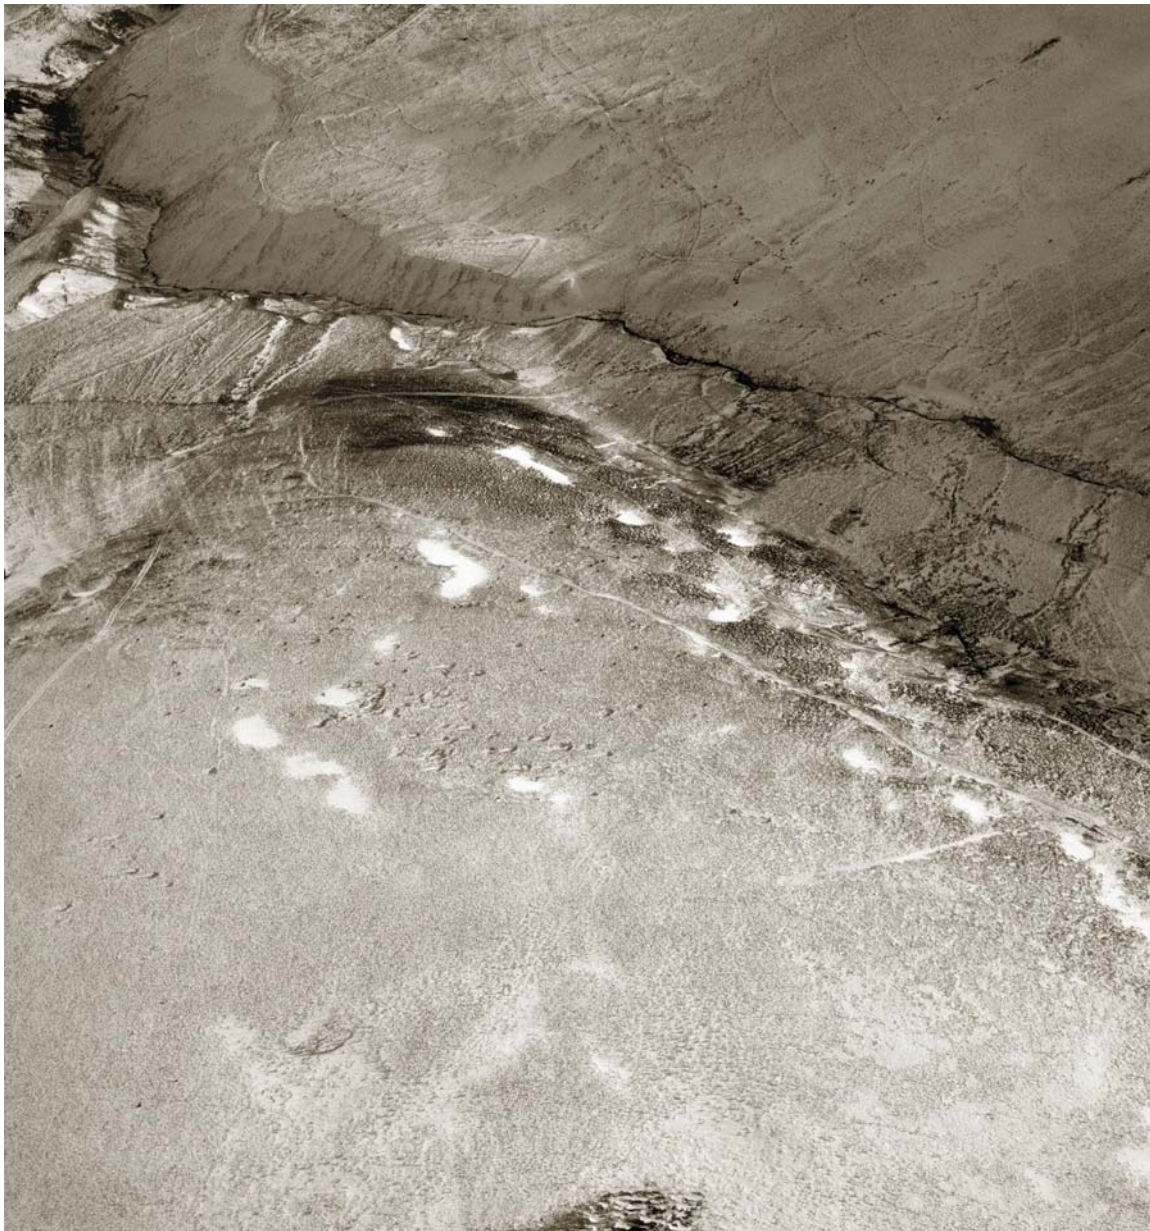
Illus 9. Capelaw Hill. Oblique aerial photograph of the unenclosed platform settlement viewed from the NNW. Snow has collected in the depressions formed by the platforms. (SC993180).

This unenclosed platform settlement is situated on the S flank of Capelaw Hill, above a natural terrace to the W of Kirk Burn. It comprises at least ten platforms (CDTA05 32-34, 37-8, 40-43, 193) disposed in two strings, one above the other about 40m apart. Two further possible platforms (CDTA05 251 & 252), which are situated in the upper string between CDTA05 37 and 193, are marked only by low front scarps. The platforms measure between 6m and 11m in diameter, and have been levelled into the slope to a depth of up to 4m; with the exception of the two possible platforms, all have well-formed back and front scarps.
(CDTA05 32-34, 37-8, 40-43, 193, 251-52)
Visited by RCAHMS (AGCH) 25 May 2005

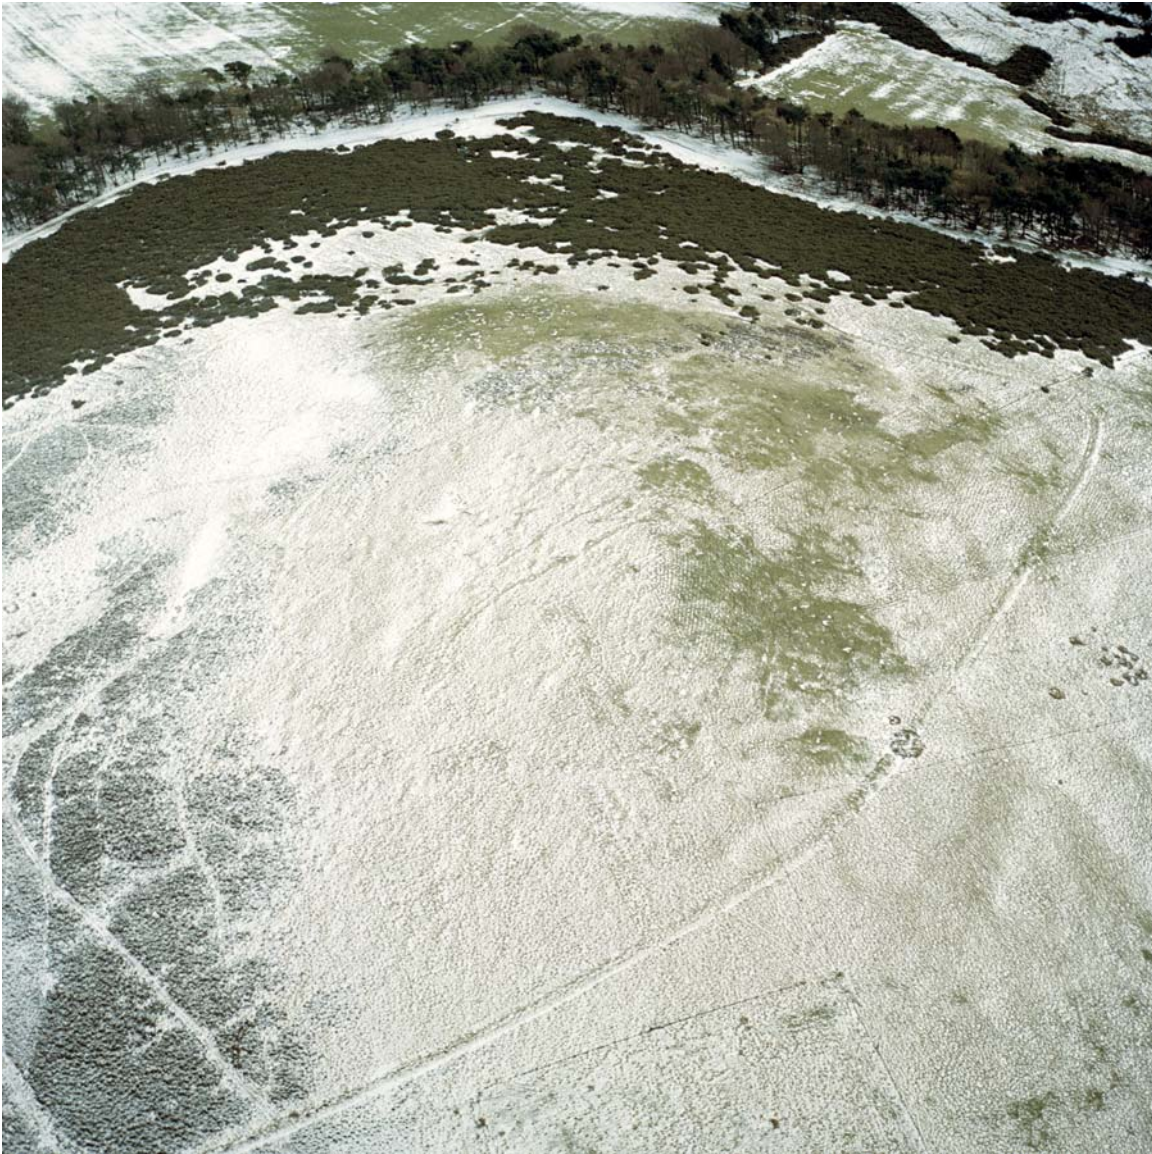
Illus 10. Woodhouselee Hill. Oblique aerial view of the palisaded enclosure, taken from the NNW. The banks and palisade trenches are in the centre of the photograph, which is crossed from bottom left to top right by what is probably an eighteenth century plantation bank (SC993179).

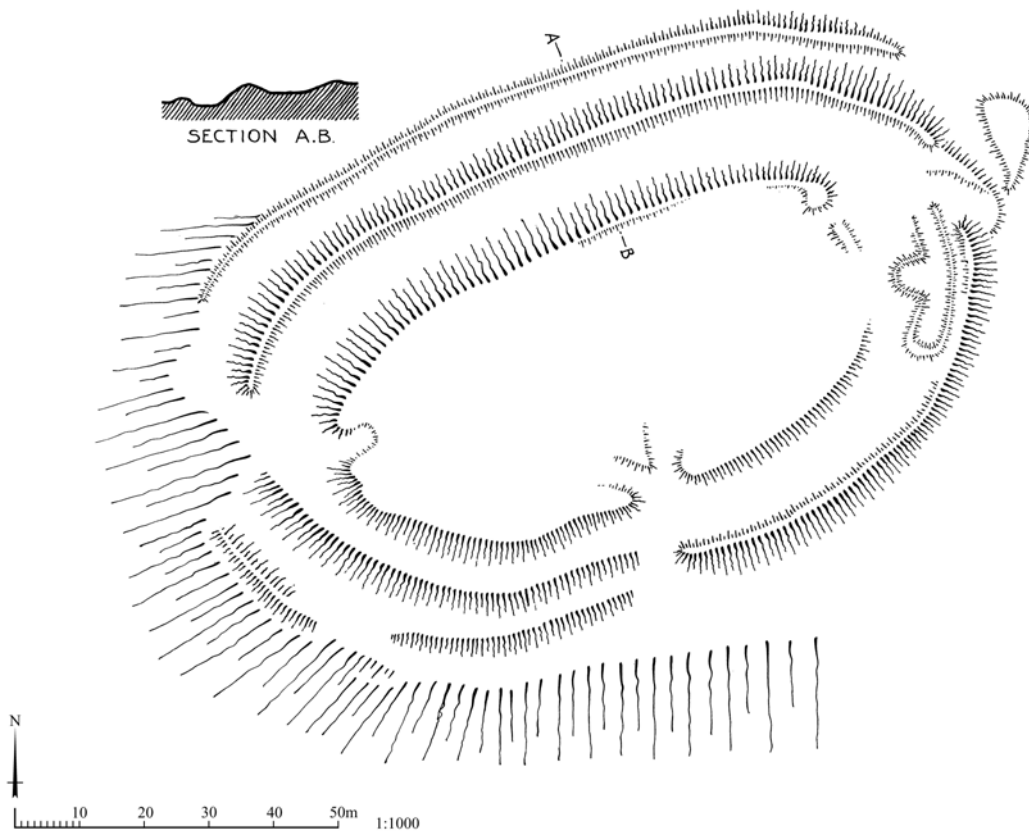
Illus 11. Castlelaw Fort. This illustration is an inked version (MLD/13/1) of a pencil-on-paper plan (MLD/13/2) of the fort undertaken by RCAHMS on 30th July 1915, using an alidade and plane-table (SC1006132).

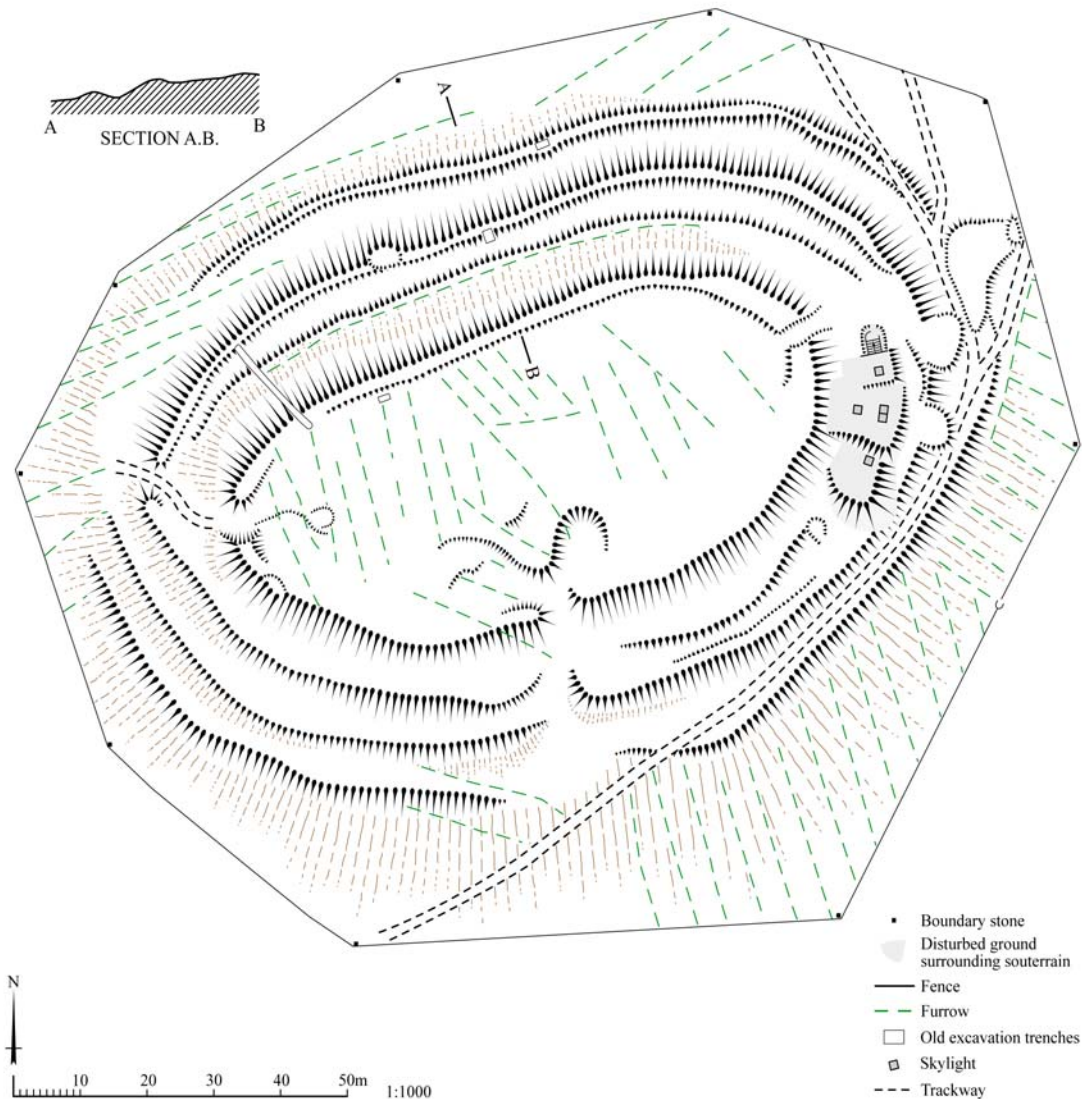
Illus 12. Castlelaw Fort. Recent survey by RCAHMS has demonstrated the extent to which the fort has suffered from cultivation. Evidence for encroachment by rig-and-furrow onto the margins of the earthworks has long been obvious, but it is now clear that the ramparts and ditches on the S side of the fort have been converted into cultivation terraces, and that the whole of the interior has also been cultivated (DP006983).

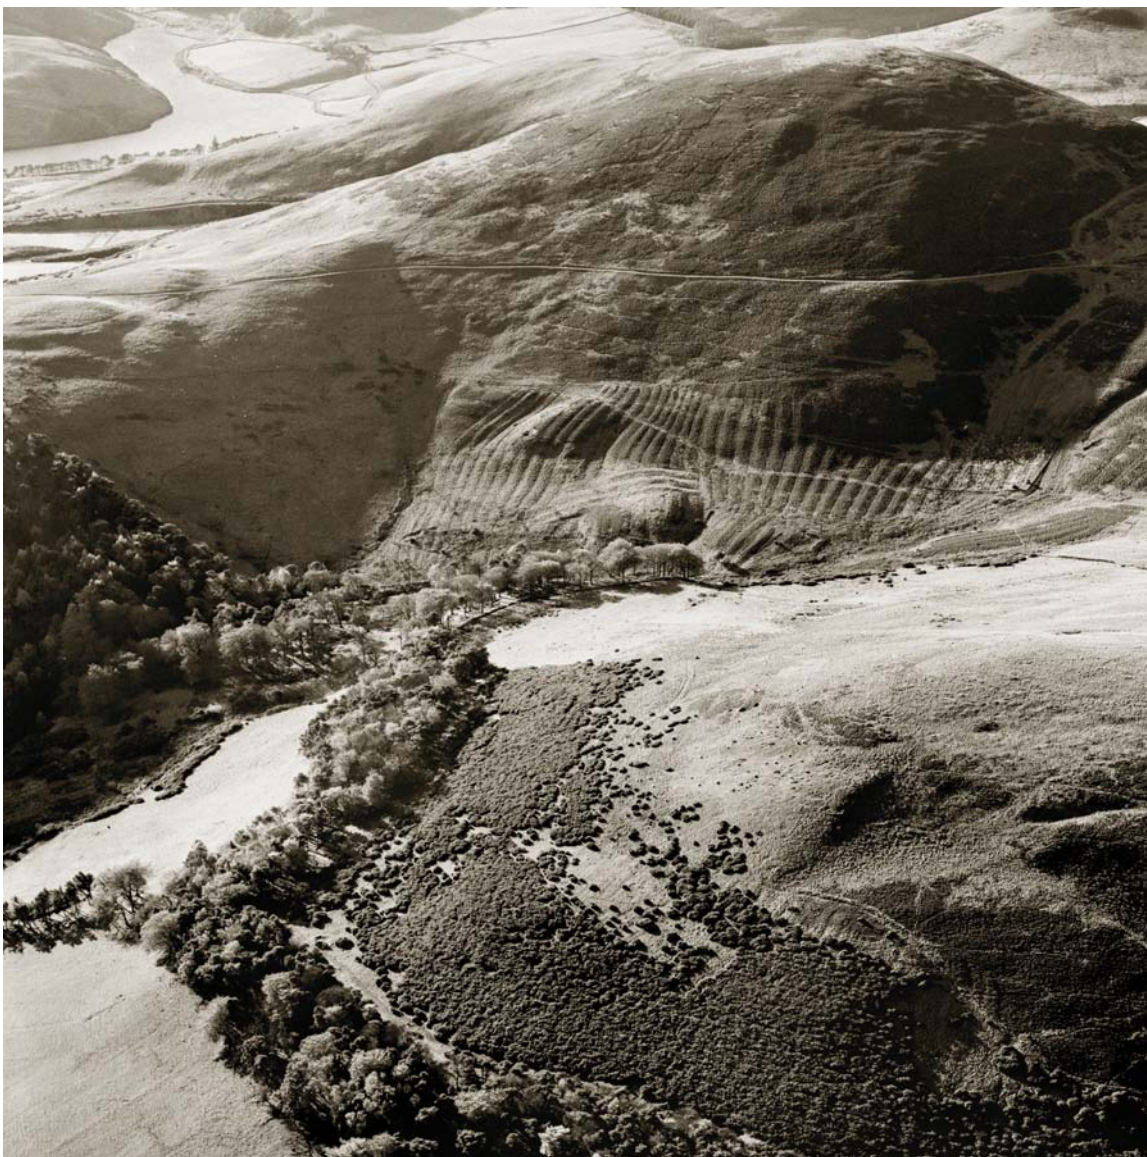
Illus 14. Castlelaw Hill. Oblique aerial view of the well-preserved rig-and-furrow on E flank of hill, taken from the ENE (SC993183).

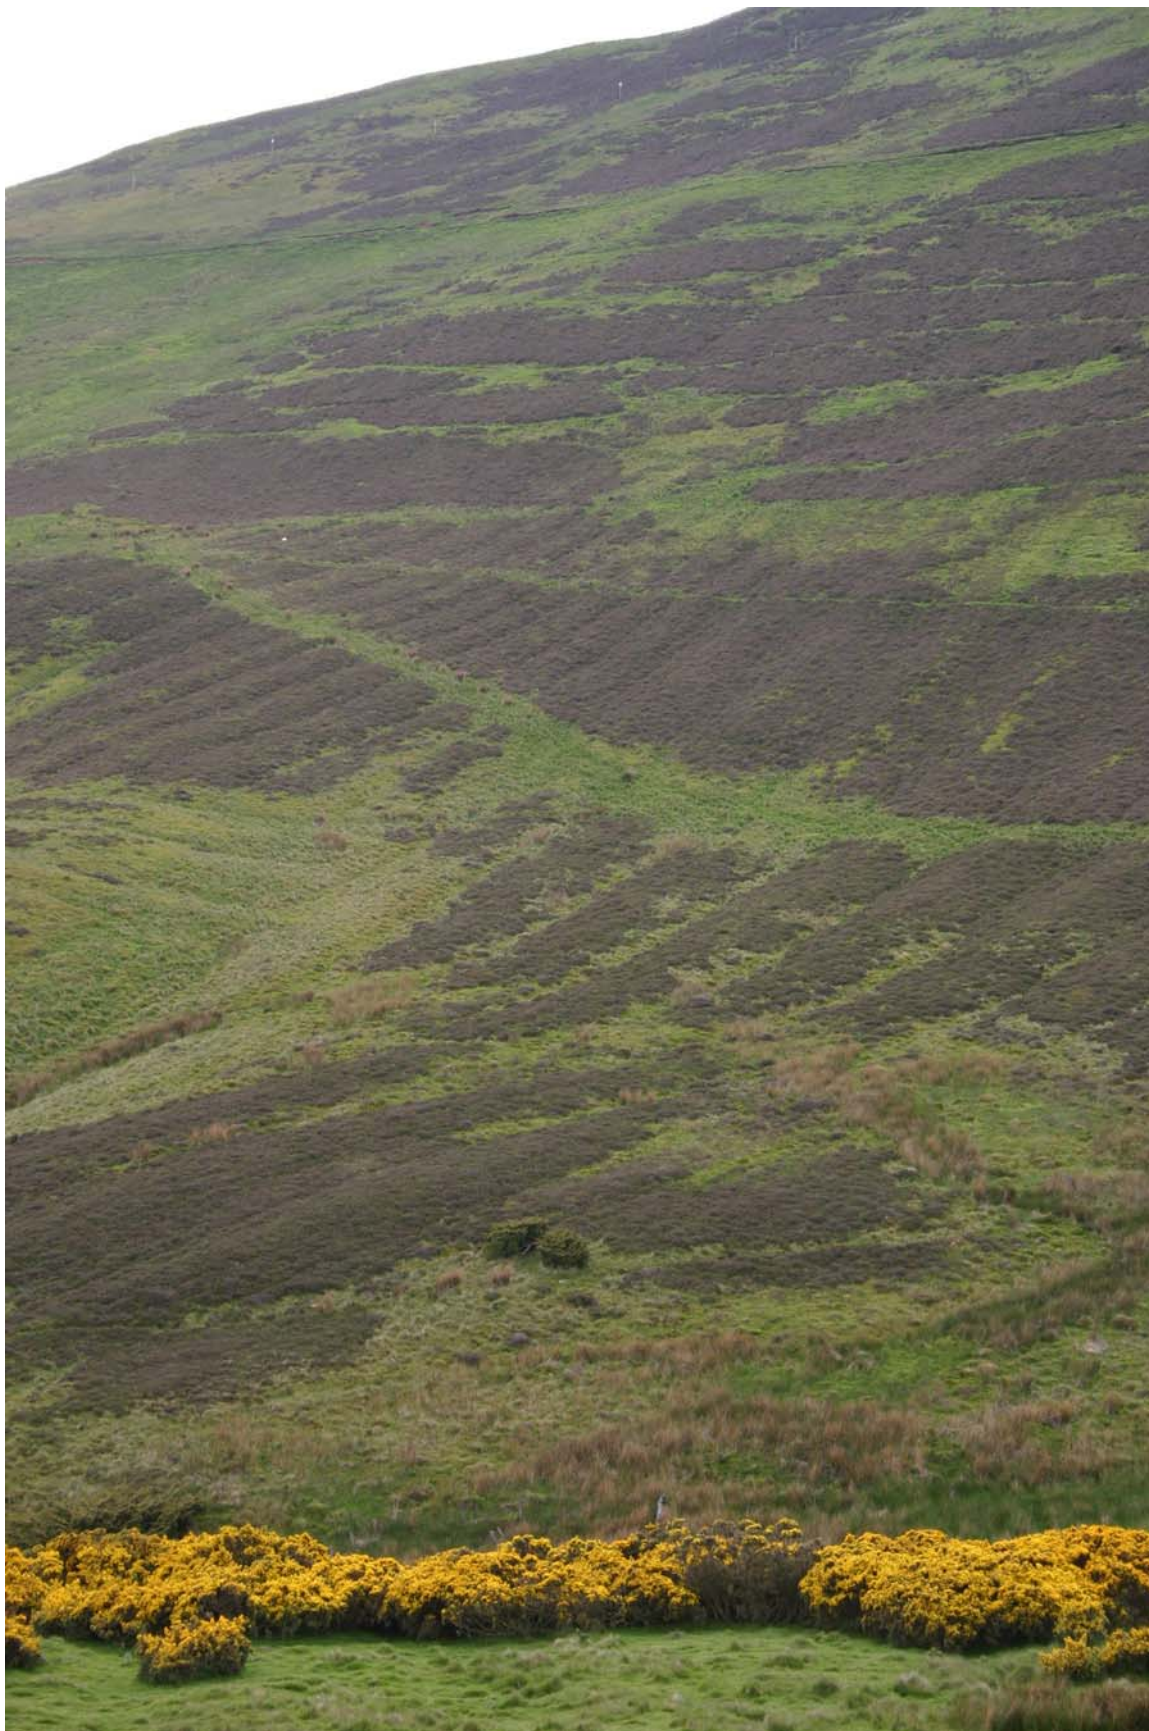
Illus 15. Castletaw Hill. View of rig-and-furrow on the E flank of the hill. The survival of well-preserved areas of rig such as this is a result of a change in land-use from arable to pasture over 200 years ago (DP006639).

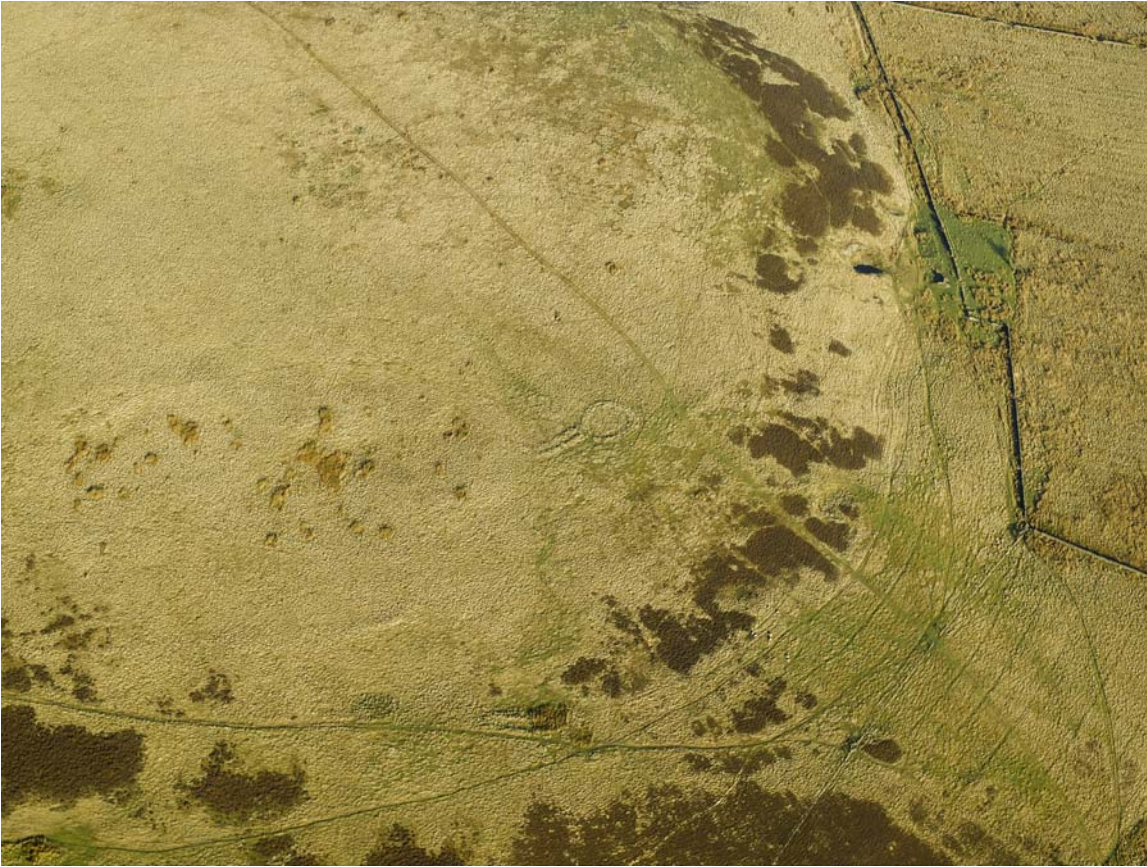
Illus 16. Capelaw Hill. Oblique aerial photograph centred on a rectangular sheephouse and circular fold, taken from the S (DP006971).

The reversion of large parcels of land to pasture is particularly attested in the valley of the Kirk Burn and on Capelaw Hill, where the number and variety of the sheepfolds suggest that sheep rearing has enjoyed a long history here. The two stone-built circular folds are contemporary with the early to mid-19th century occupation of Capelaw, but there are also two circular turf-built folds that were already disused by 1854, one at least of them overlying straight rig. Two rectangular structures (277203 & 277237) on the S-facing slope above Capelaw, one of them set end-on to a circular turf fold, are probably sheepbuchs, low buildings that provided covered shelters for sheep (Illus 16).

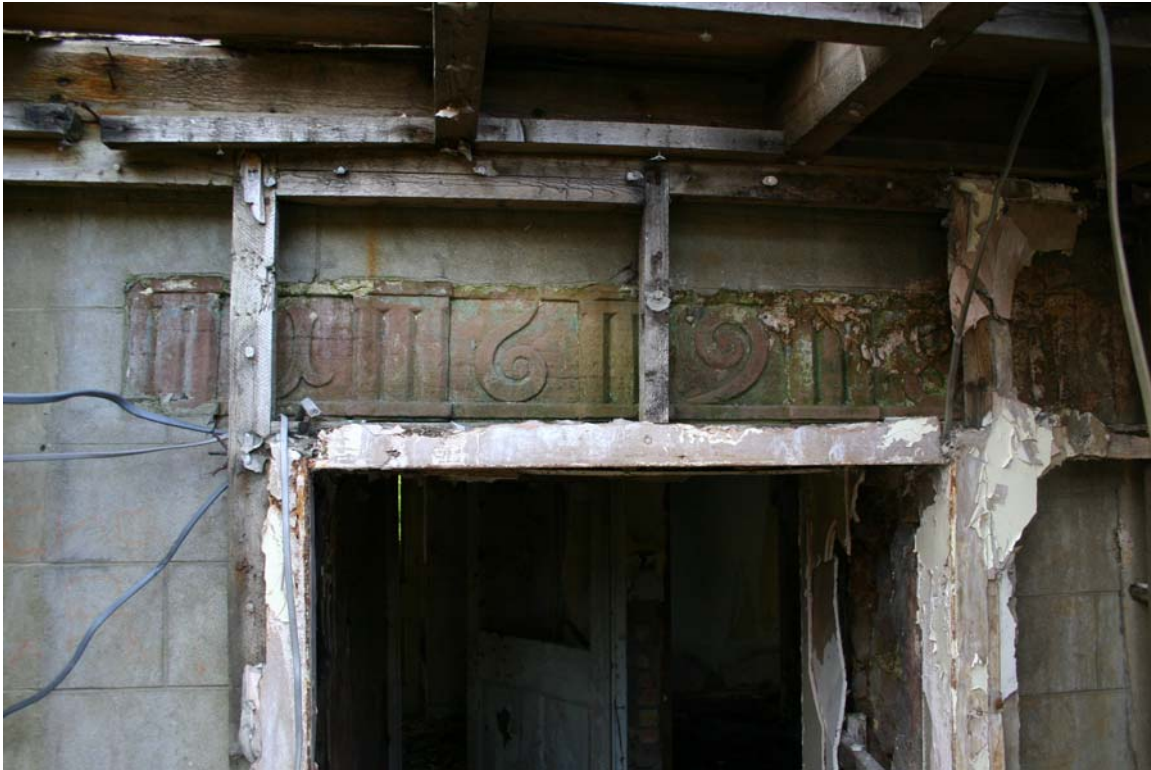
Illus 17. Dreghorn Mains. View of dated lintel over door in W elevation of farmhouse (DP006496).

In the 18th century there were four main farmsteadings within the CDTA -- Dreghorn Mains in the N part of the area, Capelaw in the SW, and Castlelaw and Woodhouselee in the S, but in each case the foundation of the farm is much earlier. All appear on John Adair's map of about 1682 in the late 17th century, and a late medieval tower-house, Fulford Tower, stood at Woodhouselee. The earliest surviving structure is at Dreghorn, where the northern part of the house is late 17th century in date (Illus 17 & 18).

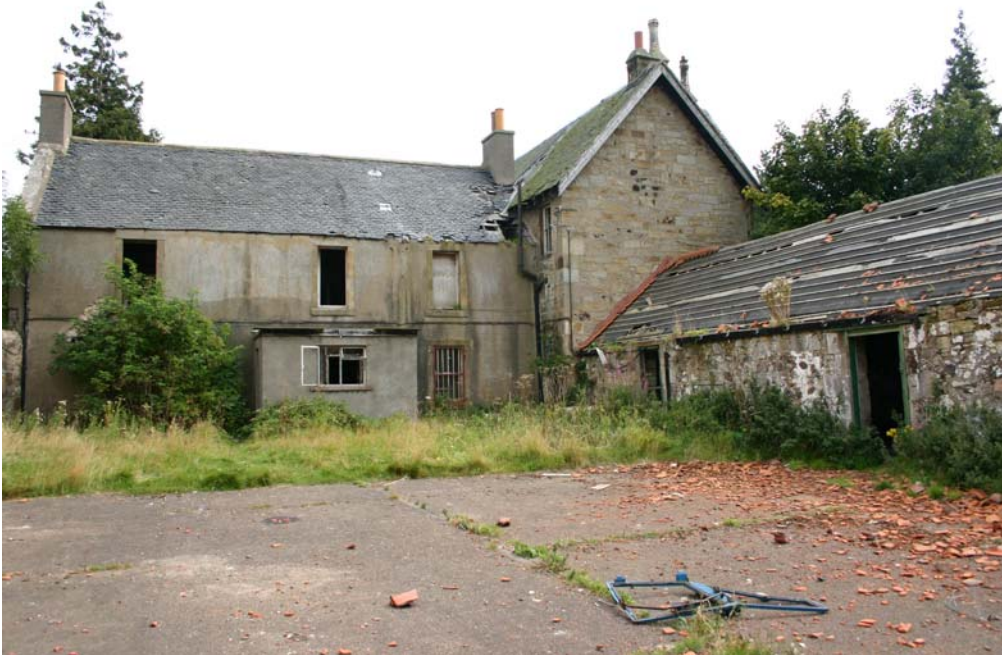
Illus 18. Dregghorn Mains. View of farmhouse and byre from W (DP006596).

One of the cart-sheds here is probably of 18th century date but the remaining buildings all appear to belong to the 19th century and later (Illus 18-21). Capelaw has long been abandoned and the buildings, largely reduced to footings, are probably of late 18th or early 19th- century date. At Castlelaw, none of the buildings appear earlier than 19th century in date.

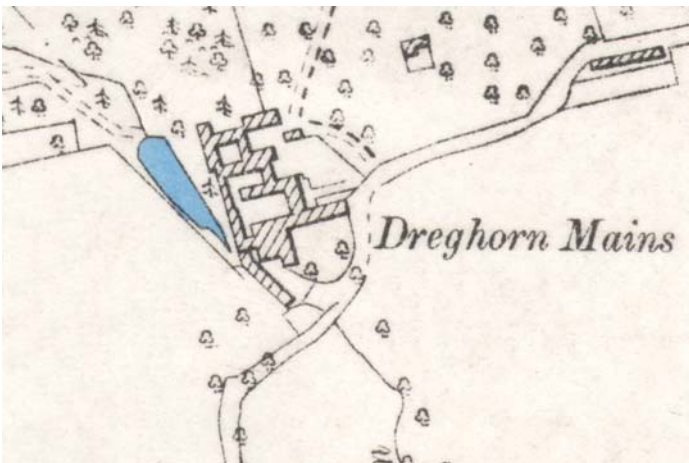
Illus 20. Depiction of Dregghorn Mains of the 2nd edition of the OS 6-inch map (SC1006094).

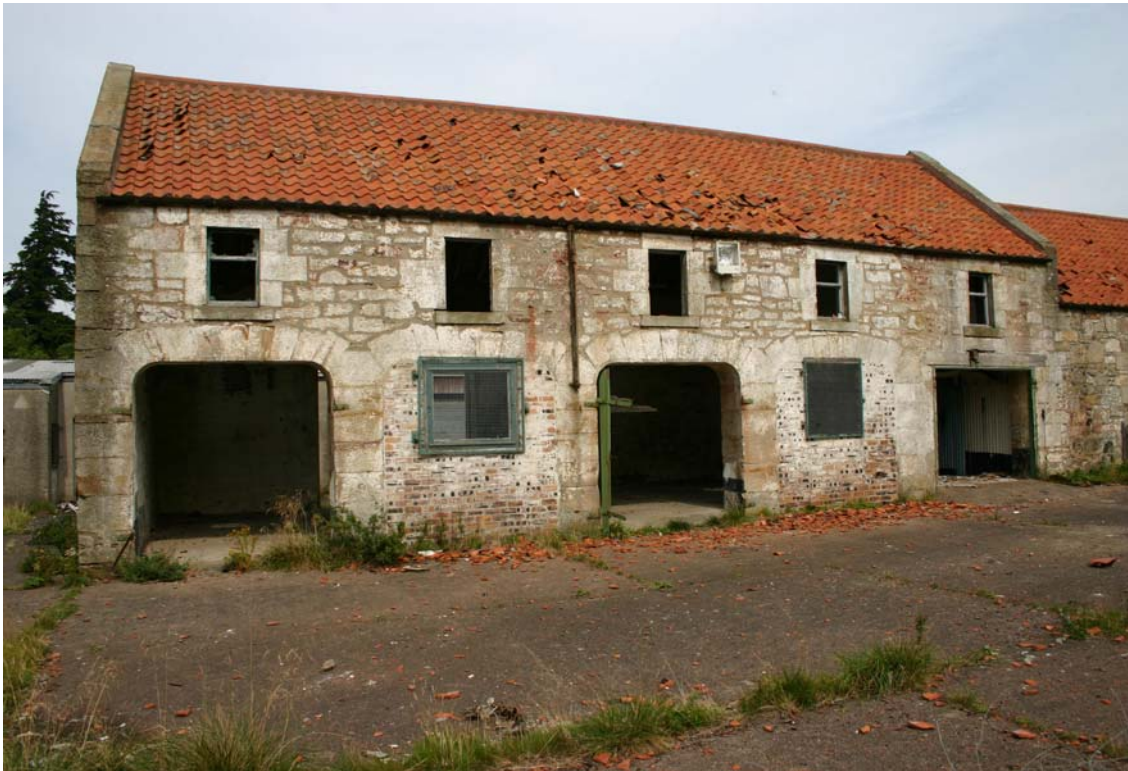
Illus 21. Dreghorn Mains. View from S of cart shed in the N range (DP006601).

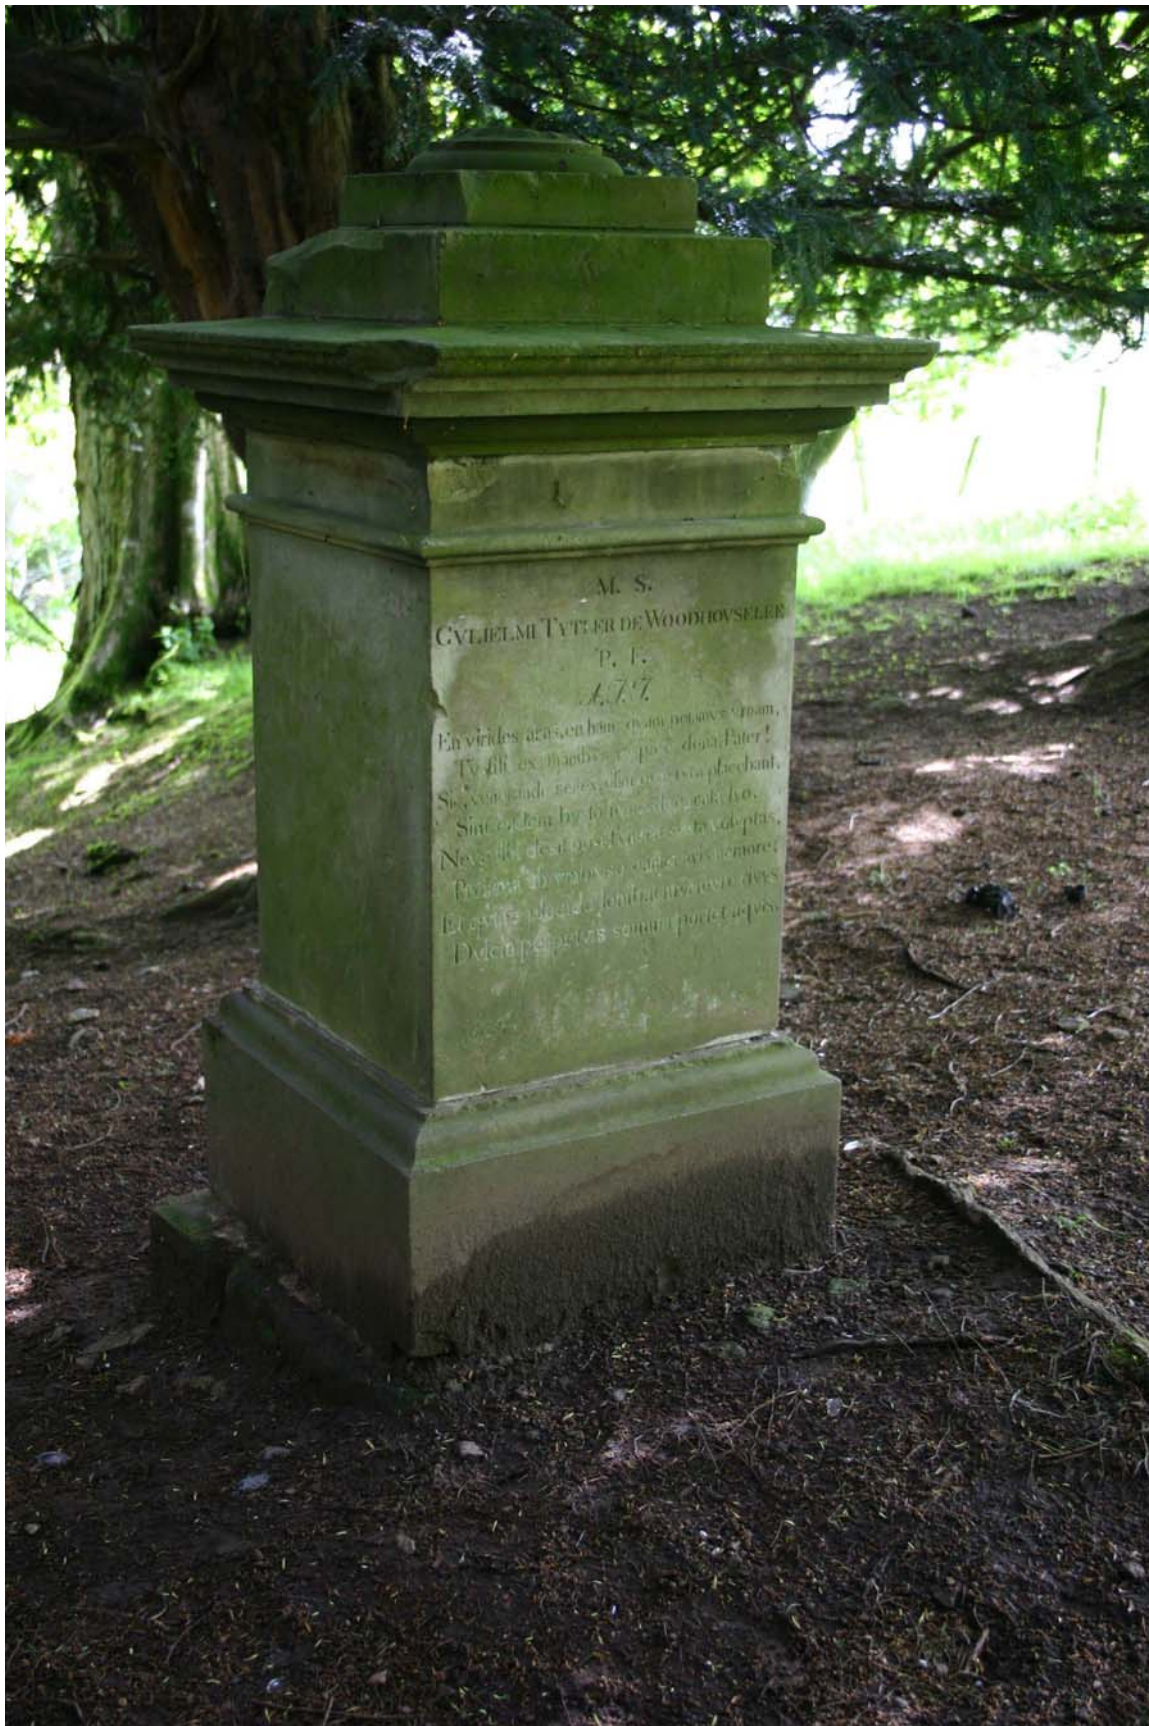
Illus 22. Woodhouselee. View of the W face of a late-18th century pedestal in the old policies (DP006627).

At Woodhouselee (NT26SW 4.00) nothing is now visible of either the late-medieval Fulford Tower or the mansion that replaced it, which was demolished about 1967. However, much of the designed landscape around the house still exists, if mainly lying outside the CDTA. Thus, the site of the house, its garden, adjacent farmstead, and most of the land to the E of the house fall outside the survey, but areas of relic parkland, woodland and fields enclosed by shelter-belts have been recorded on the flanks of Woodhouselee Hill. The designed landscape around Fulford/Woodhouselee was relatively modest, and a great deal of it appears to have been established by 1766, when the estate is depicted on Laurie's map. The fully-developed Victorian policies are depicted on the 1st edition of the OS 6-inch map (Edinburghshire 1854, sheet 12), but of the structures noted within the policies, which included a summer house and two 'pedestals', only one of the latter now exists (Illus 22).

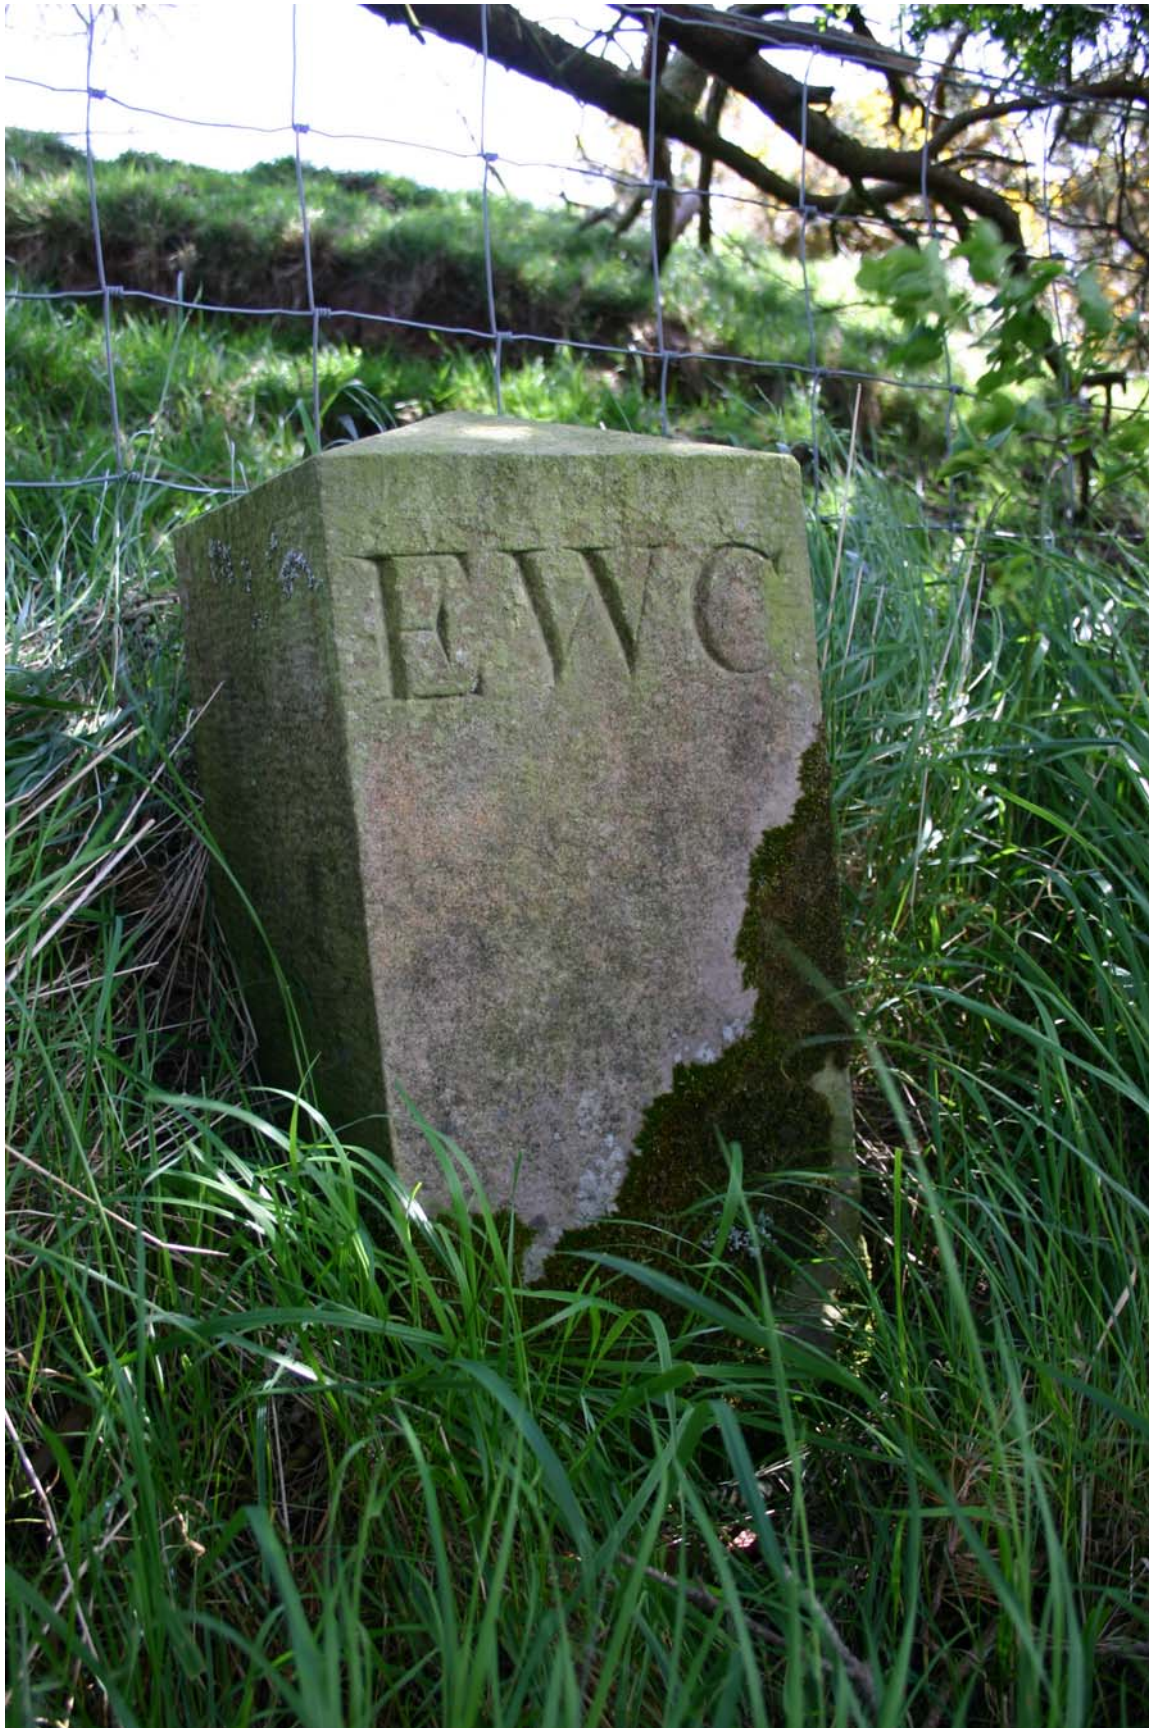
illus 23. Glencorse Reservoir. View of a boundary stone erected in 1819 on the march between land owned by the Edinburgh Water Company and Castletlaw Estate (DP006773).

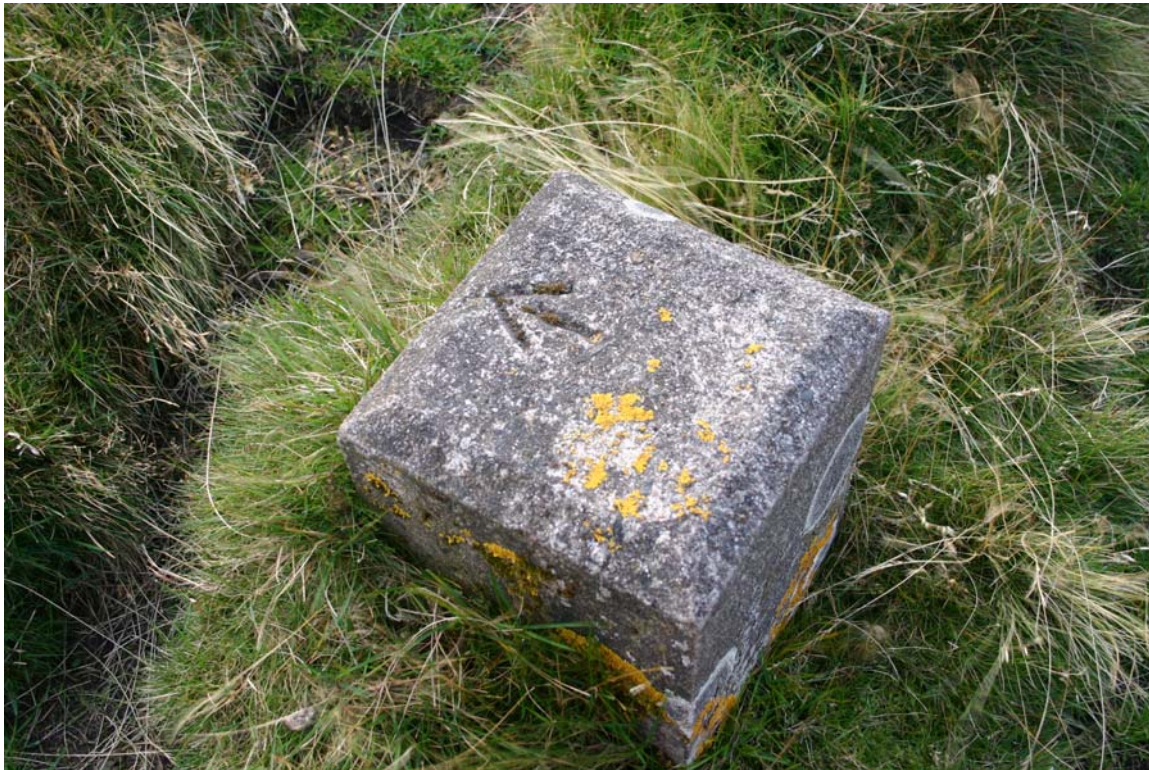
illus 24. Castlelaw Fort. View of the top of one of the nine boundary markers around the guardianship area (DP006759).

Nine boundary markers define the Guardianship area around the Castlelaw fort (Illus 12) and include three distinct forms, reflecting different periods in the definition of the boundary. The earliest markers are two short sandstone blocks, measuring only 0.14m square in section, which stand on the E and WSW sides of the fort respectively. Both stones bear an incised arrow pointing towards the centre of the fort on their flat top and probably date to about 1924, when the site first came under Guardianship protection. However, although the WSW stone is probably on or very close to its original position, the E stone is not. A Ministry of Works plan, dated August 1955 (4/08/4SK; NMRS MS: MLD/13/5), depicts the fence-line around the E side about 12m within the line of the present boundary. The plan depicts a 'marker block' lying uprooted outside this fence-line, so it was probably re-used when the current boundary was established about 1964.

The three remaining markers at Castlelaw are little more than crude blocks of concrete which barely rise above the level of the surrounding turf. There are two on the N side and one on the S, and they were probably inserted into the circuit when the guardianship area was enlarged about 1964. Like the other markers, these ones have impressed arrows on their flat upper surfaces.

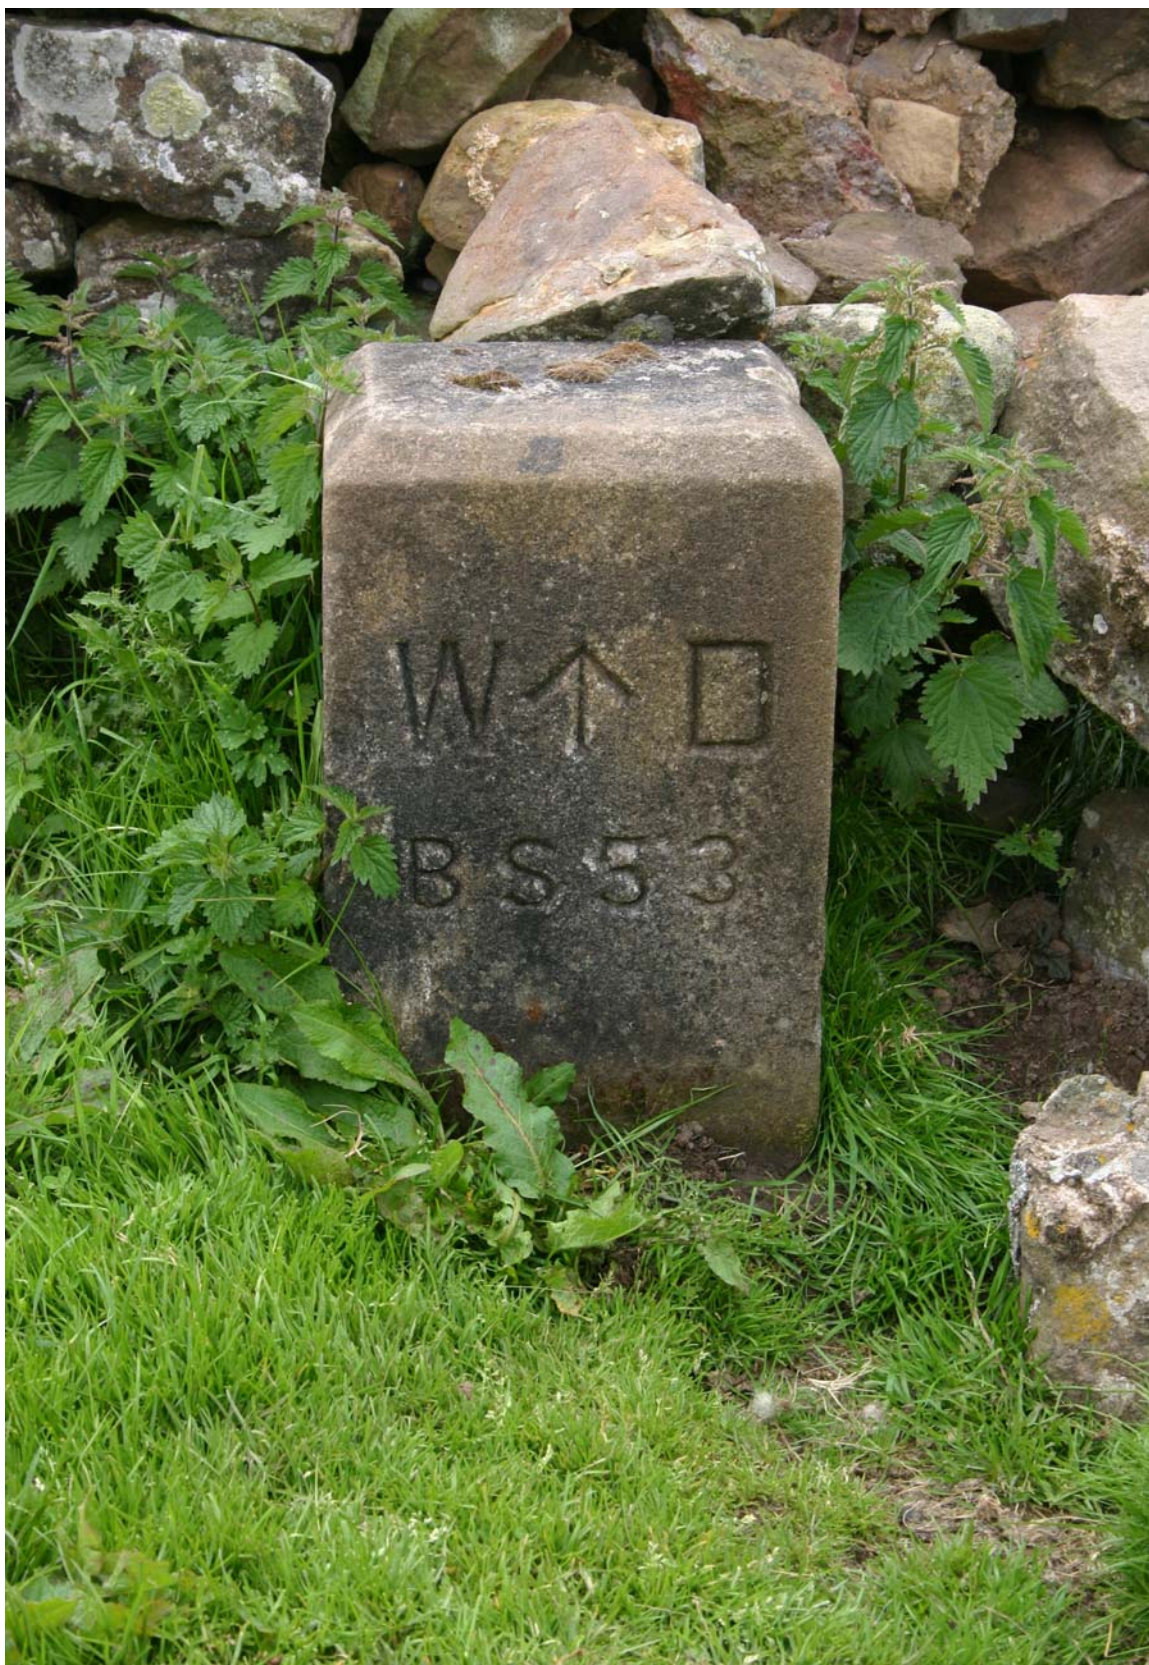
Illus 25. Capelaw Hill. View of NW face of one of the War Department boundary markers (DP006354).

Another series of markers (NT26NW 452 & NT26SW 129) defines the boundary of the military land that stretches from Redford Barracks (73614) and Dreghorn Camp (135087) in the N to the Castlelaw Ranges (110879) in the S, and includes the CDTA. This series offers an interesting contrast to the 1819 stones. Here their function was to provide a series of permanent markers, each with its own identity number, around a very large area. These markers have been cast in concrete, in moulds that allowed the shape and form of each marker to remain constant, but permitted the identity number of each to be different. The markers bear the letters W and D for War Department, flanking an upward pointing arrow, below which is the unique number of the boundary stone, e.g. BS 53 (Illus 25). Each marker seems to have been formed without the addition of any bulky aggregate, which has ensured an even surface that has weathered to give the appearance of sandstone. It is not known whether this effect was intentional. The quality of the markers is also such that few now show signs of major erosion. Three of the markers on the boundary of the CDTA appear to have been totally removed, but the remaining nineteen display a sharpness of detail that is testament to the skill of their makers.
