Castlelaw and Dreghorn Training Area

An archaeological survey by
the Royal Commission on
the Ancient and Historical
Monuments of Scotland

An archaeological survey

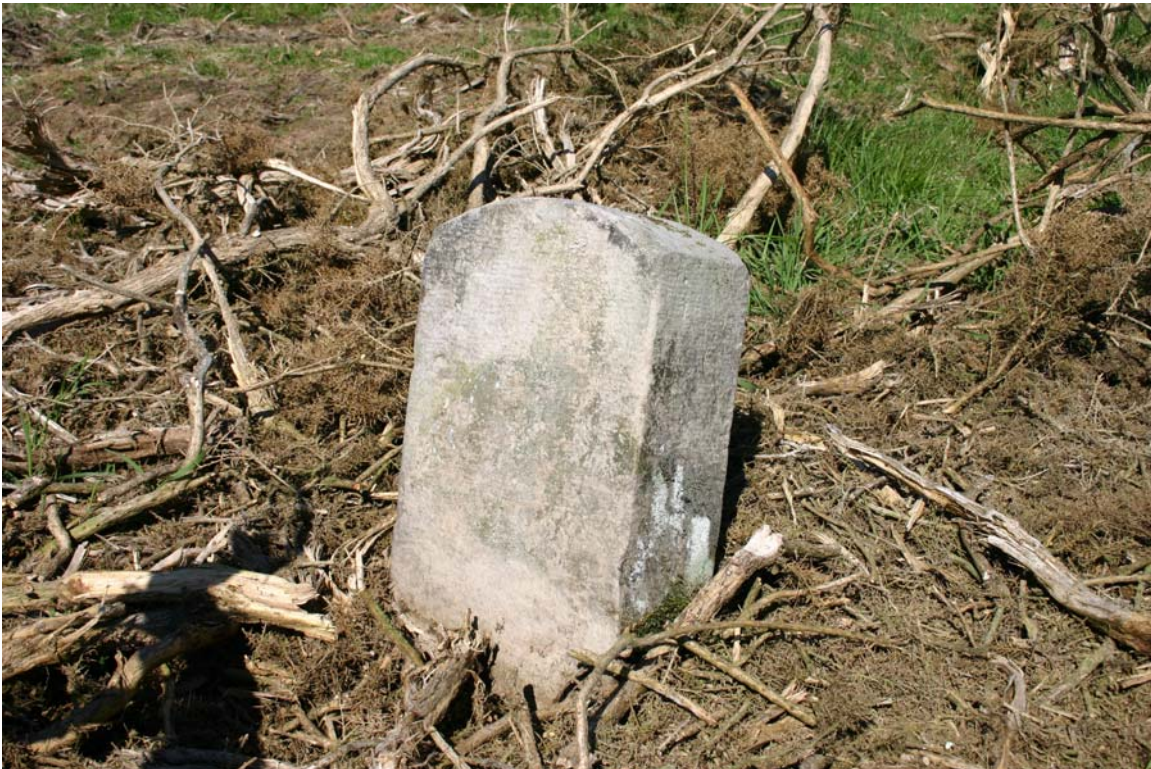
Illus 26. Dreghorn. View of one of the round-headed marker stones on the line of the Bonaly to Edinburgh water pipeline (DP006682).

The course of the pipeline can still be traced on the ground by following the marker stones. Of the twenty stones that are known to have existed, nine are still visible. Seven of them (CDTA05 148, 151, 153-5, 158-9) are still standing and two (CDTA05 152 & 156) that have been displaced lie close-by. A number of stones have suffered damage from gunfire directed from the adjacent rifles ranges, and in some cases the impact of multiple bullet strikes has caused severe damage. With the exception of three stones (CDTA05 159, 206-7), all the surviving marker stones are uninscribed sandstone pillars, square in section and rising to a shallow pyramidal top at a height of about 0.6m.

The exceptional stones are finely-dressed round-headed slabs, one of which (CDTA05 159) stands 40m SW of a cistern or well-head (CDTA05 125), at a position indicated by a small open square on the 1st edition of the map. This stone is uninscribed but the stones to the W were marked with numbers on their E faces. Stones 1 and 2 have been removed, but 3 and 4 survive; stone 5, which stood near the W boundary of the CDTA, could not be found on the date of visit, and stones 6 and 7 stand outside the area.

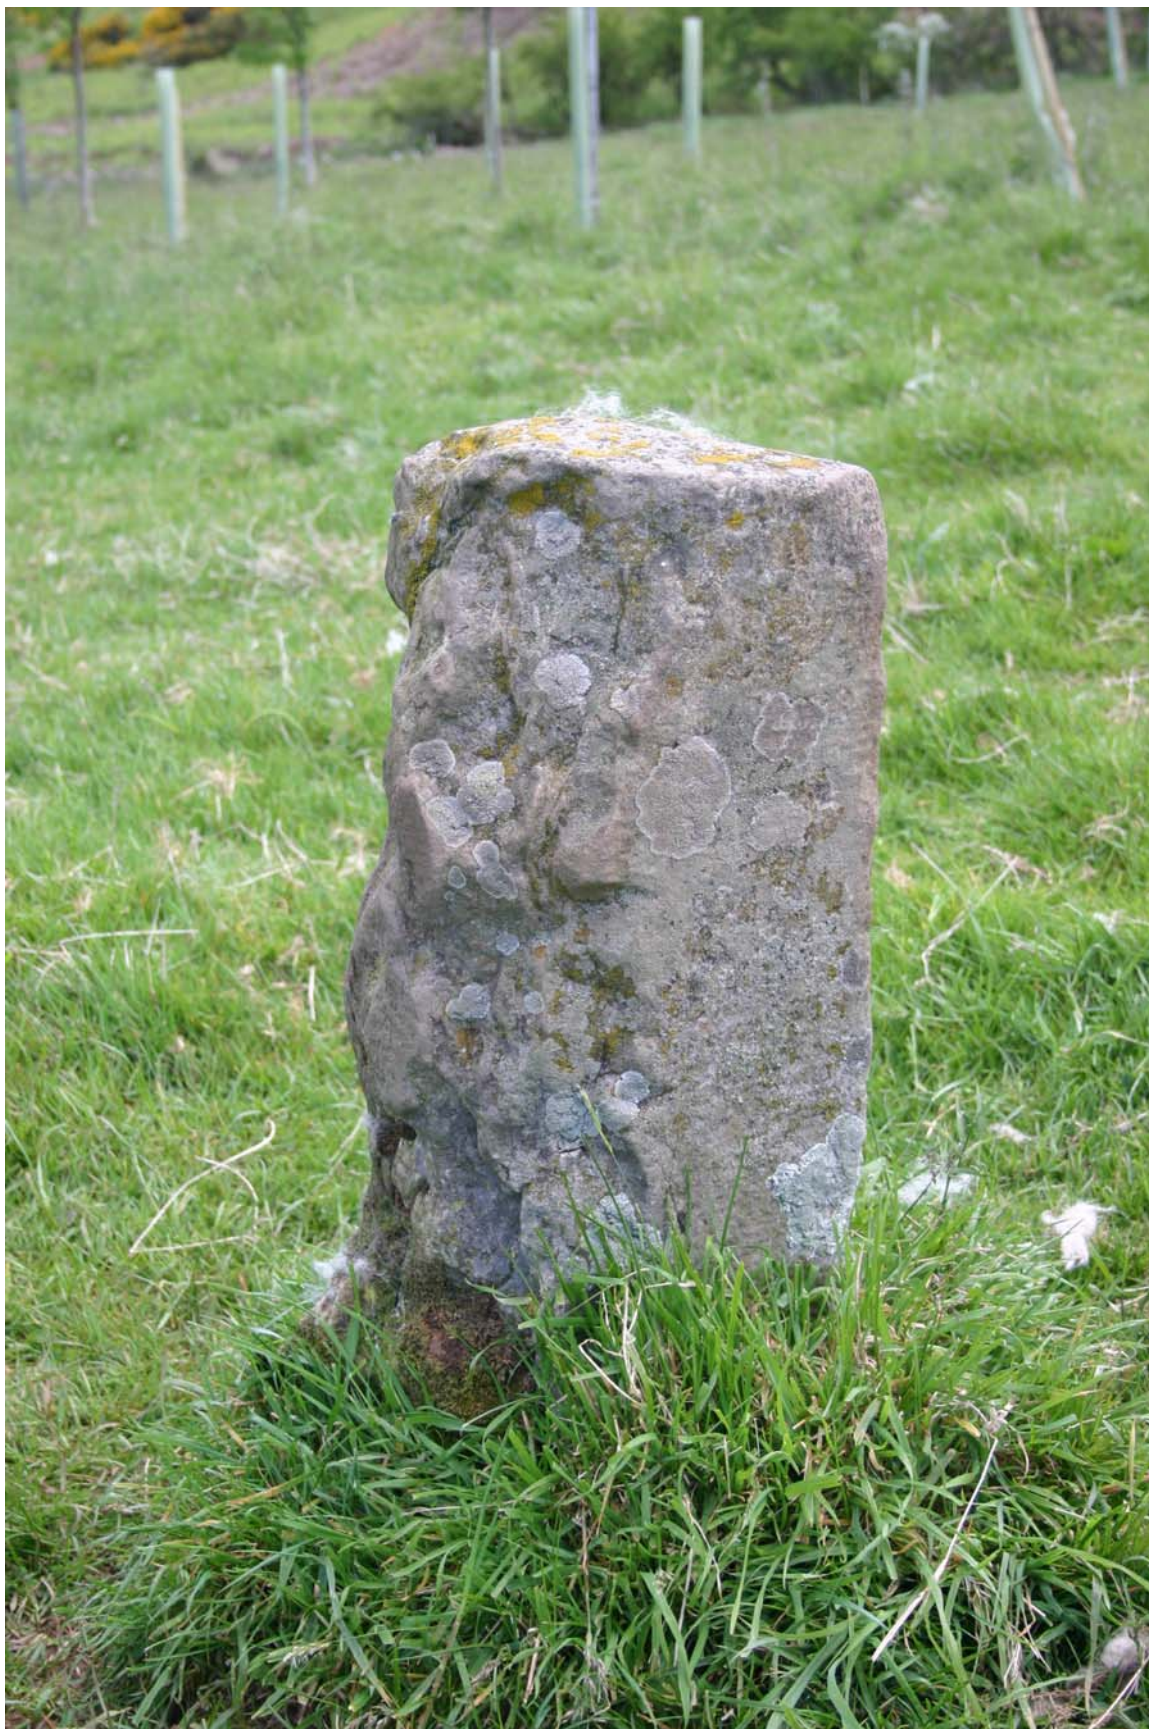
Illus 27. Dreghorn. View of one of the marker stones on the line of the Bonaly to Edinburgh water pipeline. Probably erected in the late 18th or early 19th century, this stone has been damaged by gunfire from the adjacent rifle-range (DP006704).

Eleven are still visible, nine of them still standing and two lying displaced. A number of stones have suffered damage from gunfire directed from the adjacent rifles ranges, and in some cases the impact of multiple bullet strikes has caused severe damage (Illus 27). With the exception of three stones, all the surviving markers are uninscribed sandstone pillars, square in section and rising to a shallow pyramidal top at a height of about 0.6m. The exceptional stones are three finely-dressed round-headed slabs, one of which (illus 26), stands 40m SW of a cistern or well-head (276007), at a position indicated by a small open square on the 1st edition of the OS map. This stone is uninscribed but the stones to the W were marked with numbers on their E faces. Stones 1 and 2 have been removed, but 3 and 4 survive; stone 5, which stood near the W boundary of the CDTA, could not be found on the date of visit and stones 6 and 7 stand outside the area. There is no obvious reason why the stone markers to the E and W respectively of the Green Craig cistern should be of different forms.

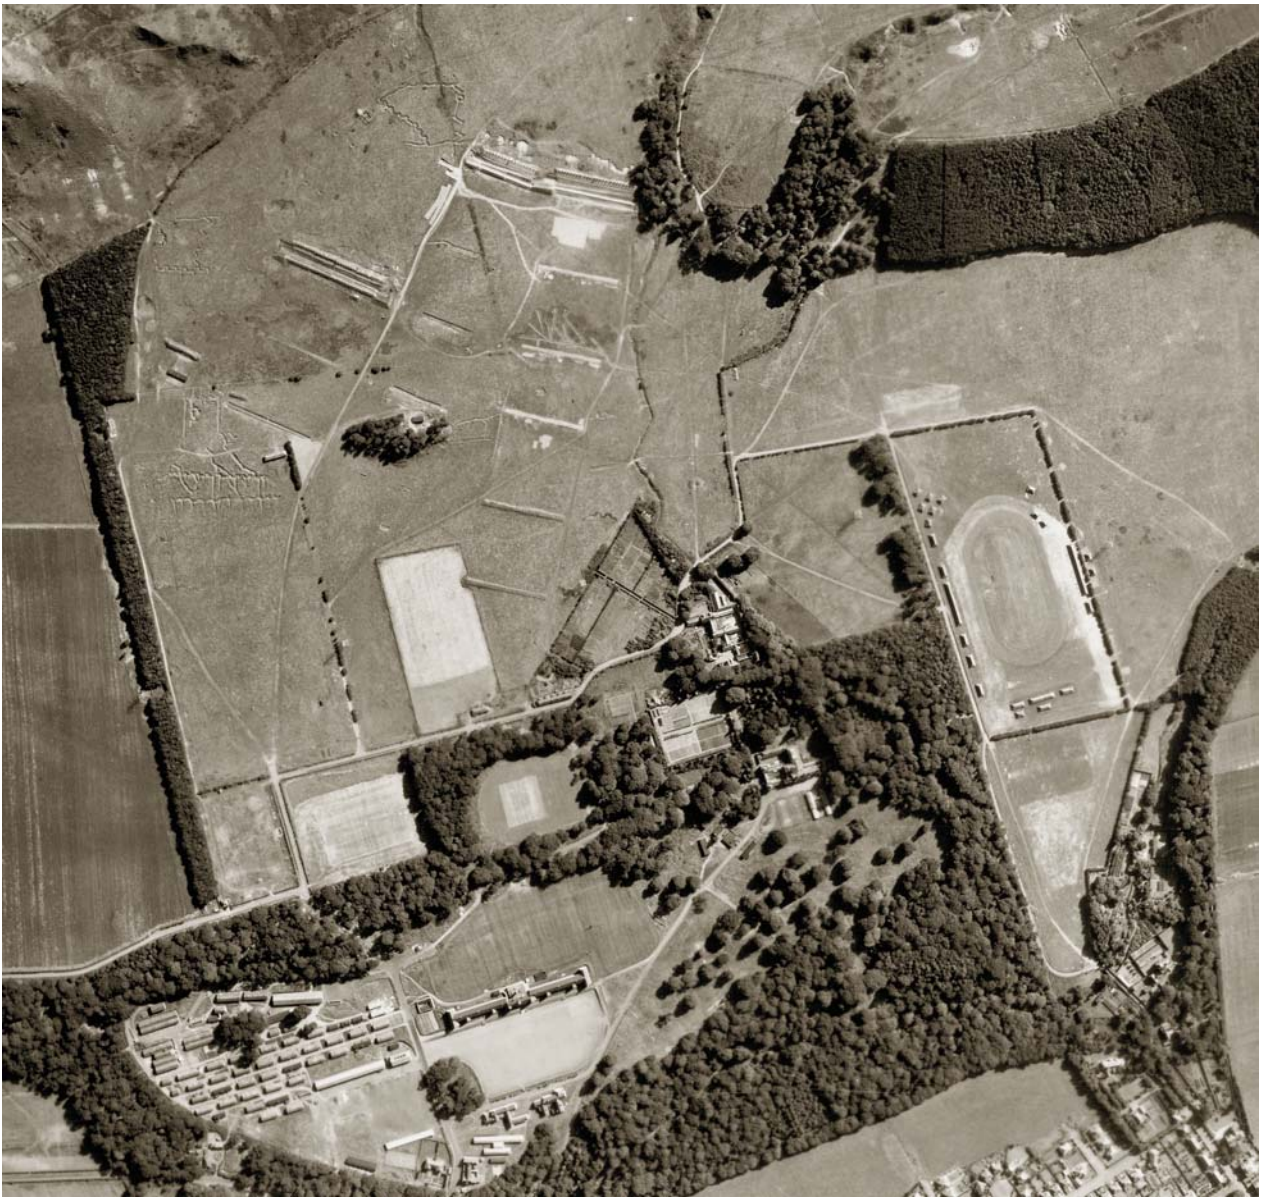
Illus 28. An RAF vertical aerial photograph (CPE/SCOT/UK 277, 5266), taken in 1947, centred on Dreghorn Castle, showing Dreghorn Mains farmsteading, the military small-arms ranges, practice-trench systems, sports facilities and barrack blocks (SC993232).

There has been a military presence in the Pentlands for about ninety years, following requisition of the Dreghorn Estate by the War Department in 1914. The two ranges at Dreghorn (277390) and Castlelaw (110879) allowed training in small-arms, and the remainder of the rugged hill ground was ideally suited to numerous other aspects of military preparation and exercise. The Dreghorn ranges (three rifle-ranges and a pistol-range) were decommissioned and bull-dozed flat about 1985, and small-arms training was concentrated at two new ranges, which replaced the old single range, at Castlelaw.

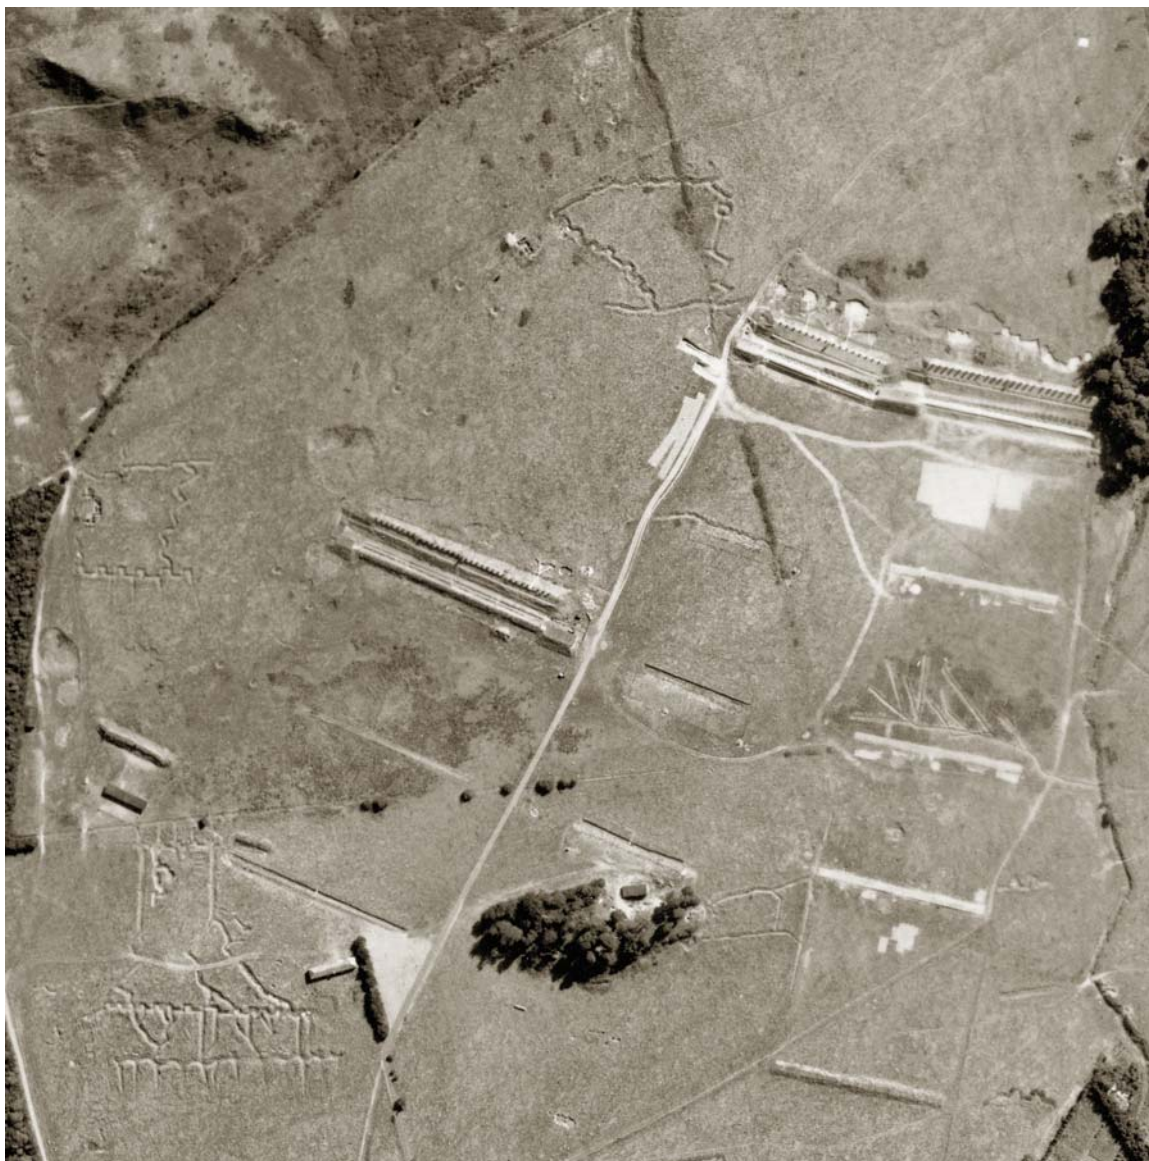
Illus 29. Detail of an RAF vertical aerial photograph (CPE/SCOT/UK 277, 5266), taken in 1947, showing the practice trenches at Dregghorn. The trenches in the bottom left corner of the photograph typify a front-line design, comprising a supervisor trench on the N (bottom of image), which is linked to a 'trench and traverse' line with angled and straight communication trenches leading S. Further S still are what appear to be angled sapper's trenches leading into a short stretch of 'trench and traverse'. The trenches shown about the centre of the left side of the photograph define a roughly rectangular area and has a different style of trench on each side. These include 'trench and traverse', 'tenaille' and 'curved without traverses'. The trench-system at the centre of the top of the photograph also includes these three types of trench, together with two forms of communication trenches, known as 'zigzag' and 'island traverse' (SC993232).

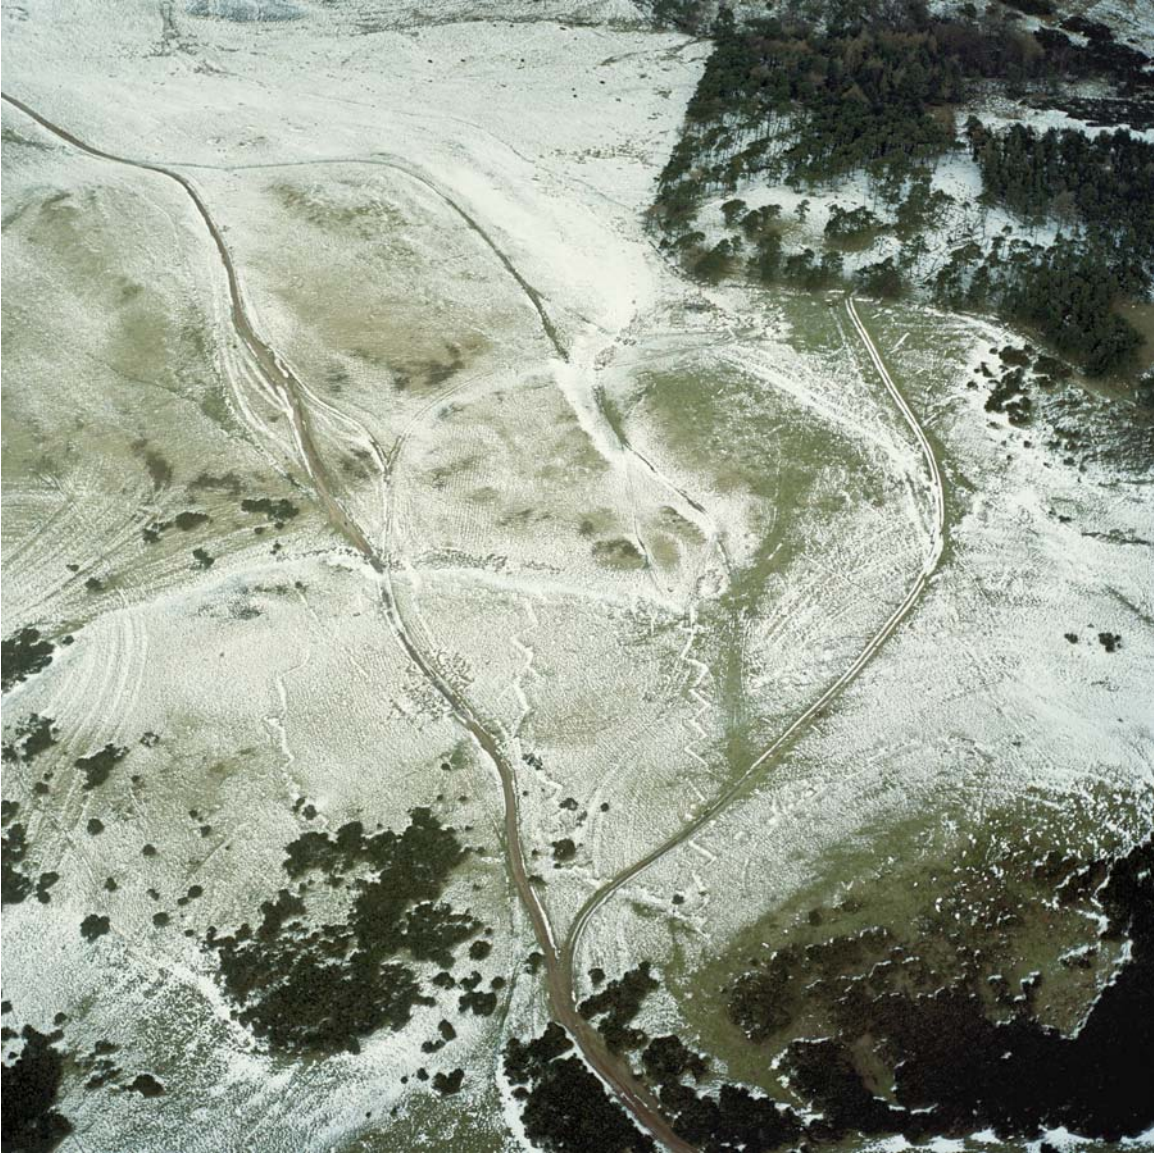
Illus 30. Castle Knowe. Oblique aerial photograph centered on the system of practice-trenches on Castle Knowe, taken from the SSW. Enclosing a roughly square area up to 120m across, the trenches are now visible as hollows little more than 1m in breadth and 0.2m in depth. The trenches forming the NE and SW sides of the area form an 'equal trench and traverse' pattern, with further, short runs of trench branching off. These may be interpreted as practice front-line and support trenches. The trenches forming the NW and SE sides of the square, together with a third which runs across the middle of the area from NE to SW, are zigzag 'tenaille' on plan, and they too have short branches springing off them (SC 993165).

Today, the Castlelaw ranges are still used by the military and a broad range of civilian groups, including the police, and the remainder of the CDTA is used for dry-training. Perhaps the best representation of the extent and variety of the military installations that once existed within the CDTA is provided by vertical aerial photographs. One (Illus 28), taken in August 1947 (CPE/SCOT/UK277, 5266), shows the full extent of the army holdings at Dregghorn Estate before it was bisected by the Edinburgh bypass in 1986. Dregghorn Barracks, Dregghorn Castle (demolished in 1955), and Dregghorn Mains, are all shown, as are the small-arms ranges, an oval running track, a cricket pitch and a remarkable collection of practice trenches, presumably dug by trainees in anticipation of undertaking real trench warfare. Most of these trenches have been removed, but the 1947 photograph provides graphic evidence that they were dug on the basis of designs set out in the volume *British Trench Warfare 1917-1918*, published by General Staff at the War Office. The practice trenches at Castlelaw are better preserved and include an example on Castle Knowe (263926) where practice frontline-, support- and communication trenches are all still visible (Illus 30).

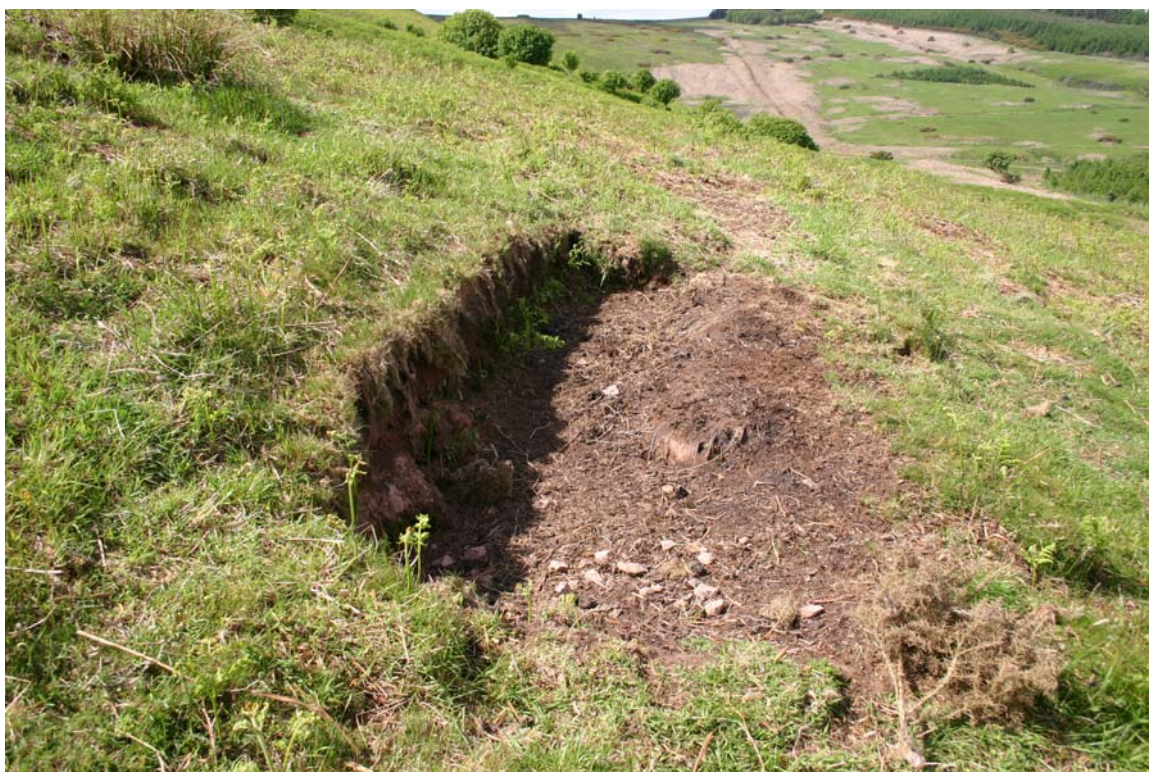
Illus 31. Green Craig. View from E of fox-hole (DP006744).

Other features within the dry training area include the remains of a grenade range (275484) and an enigmatic structure of unknown purpose (275818), both at the foot of the N flank of Fala Knowe. There are also several platforms and the sites of probable buildings throughout the area, but the most ubiquitous feature of the CDTA are the hundreds of small areas where shallow excavations have been dug as fox-holes or bivouacs. These features, which generally range in length from 1.5m to 3m by less than 1m in breadth and are usually no more than 0.2m in depth, have probably been dug throughout the life of the training area and continue to be dug by the troops training there.

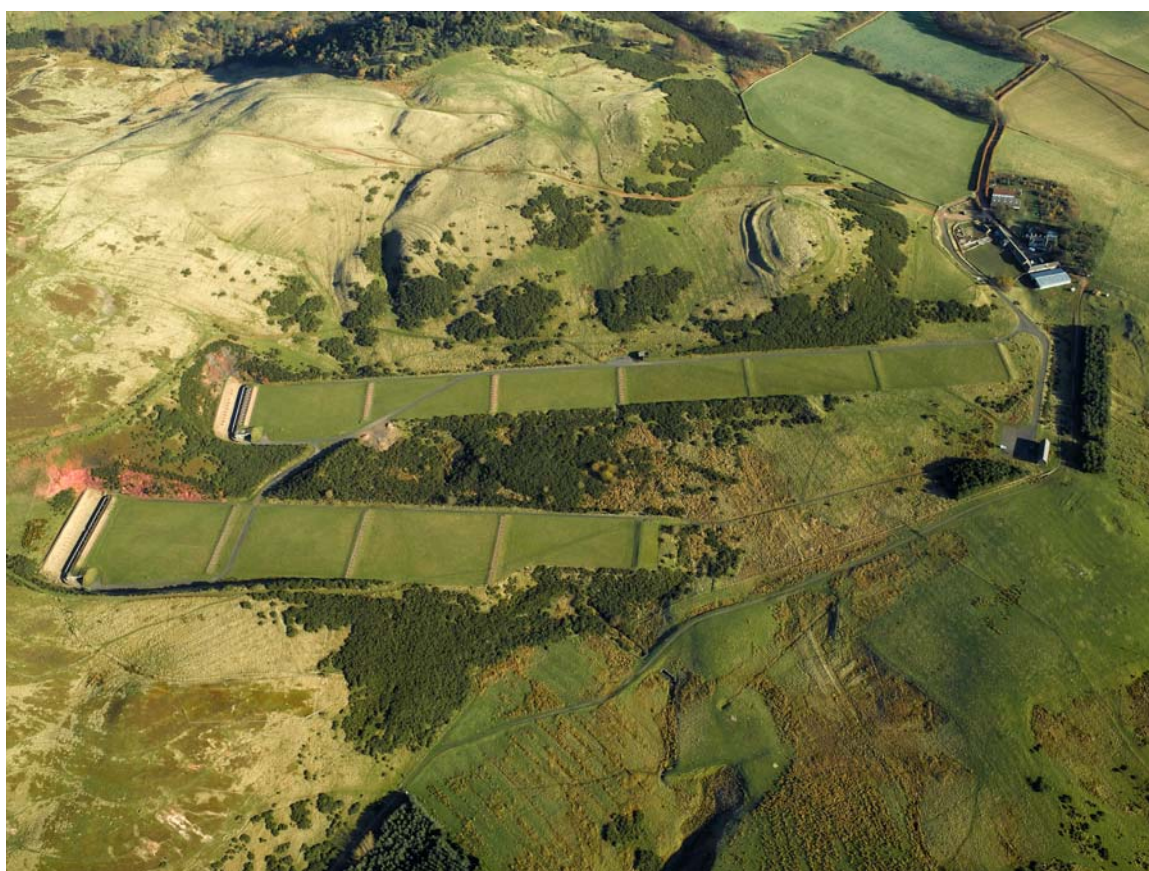
Illus 32. Castletaw Range. Oblique aerial photograph taken from the W (DP006972).

The two new small-arms ranges completed in 1985 at Castlclaw, are 400m and 600m in length respectively, and replaced a single range of 600 yards. The latter incorporated a tramway for parallel and oblique moving-target practice, and details of this and other features of the range are recorded on an RAF vertical aerial photograph taken in 1947 (CPE/Scot/UK 281, 5322). Most of this range was removed during the construction of the present range, but among the features that are still visible within a pasture field to the S of the range warden's hut are the original 500 yard and 600 yard range markers (Illus 33) and a number of concrete markers for electricity and telecommunication points (Illus 34).

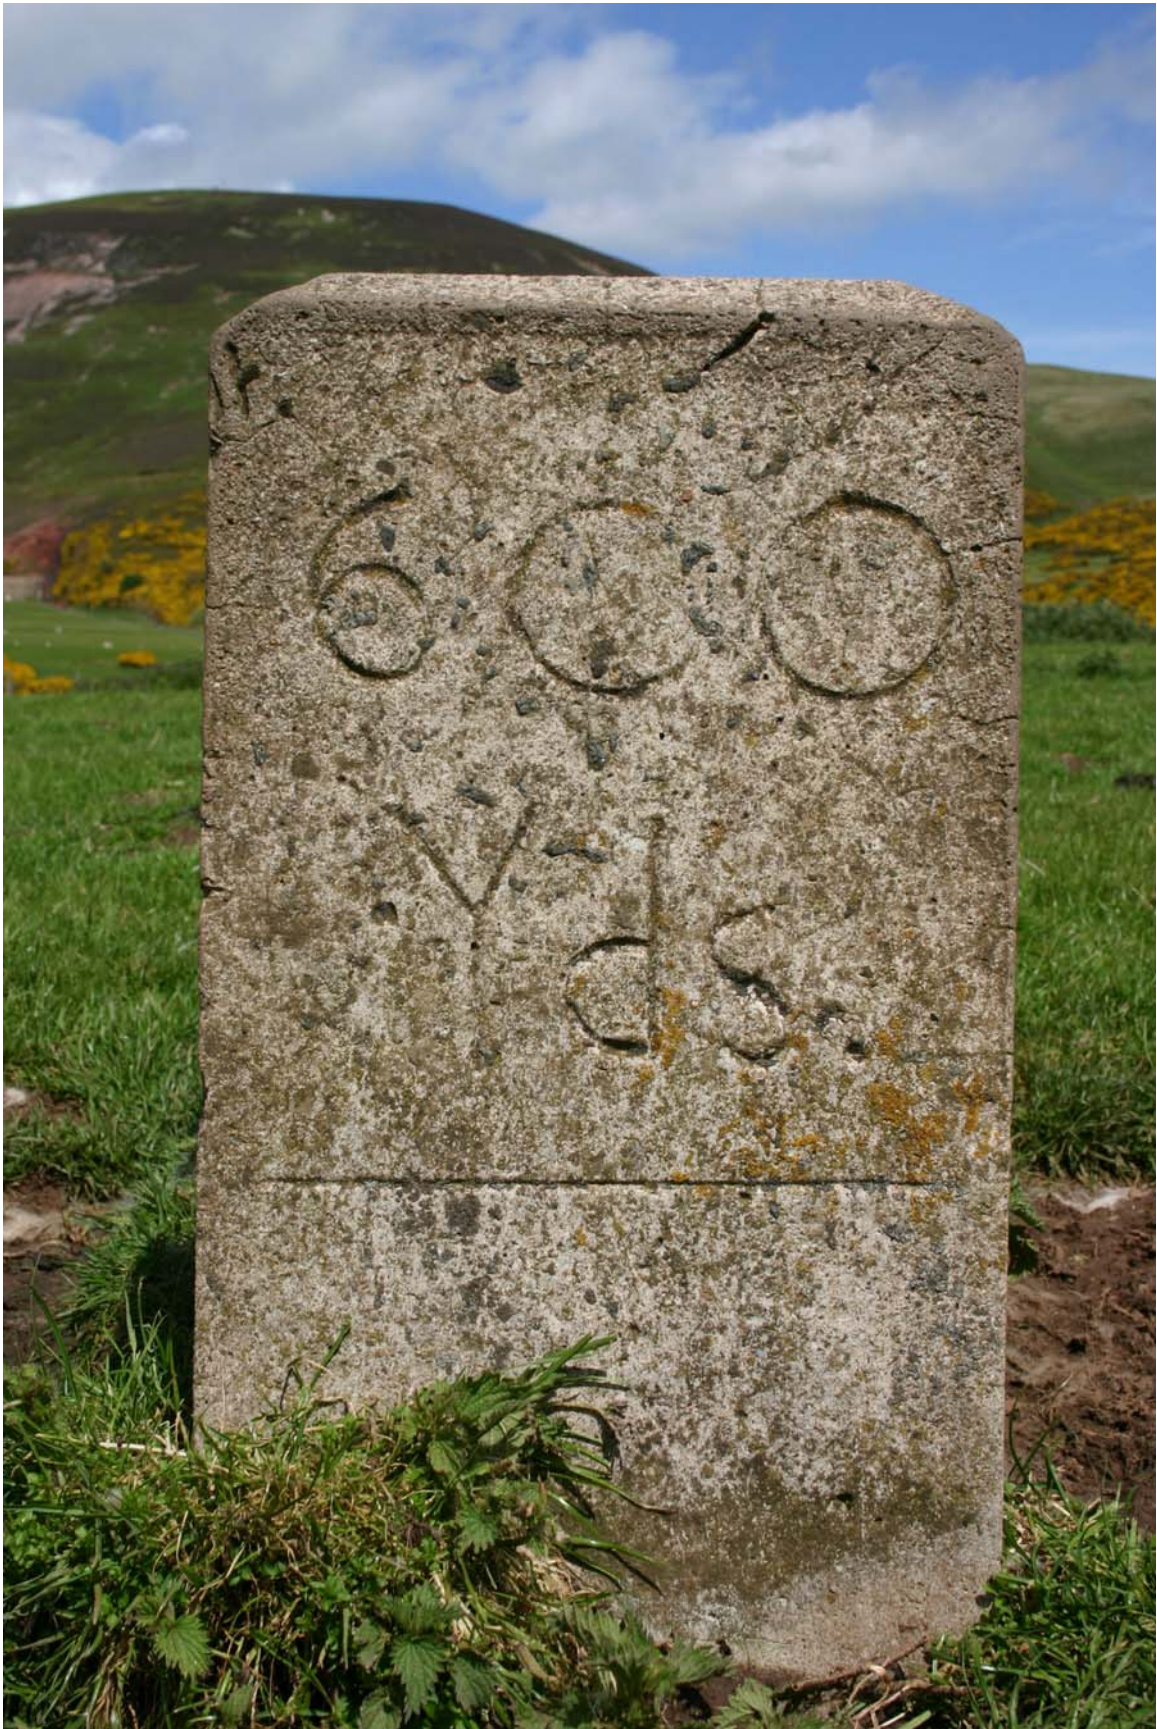
Illus 33. Castlelaw Range. View of the S face of the marker for the 600 yard firing line of the original range (DP006844).

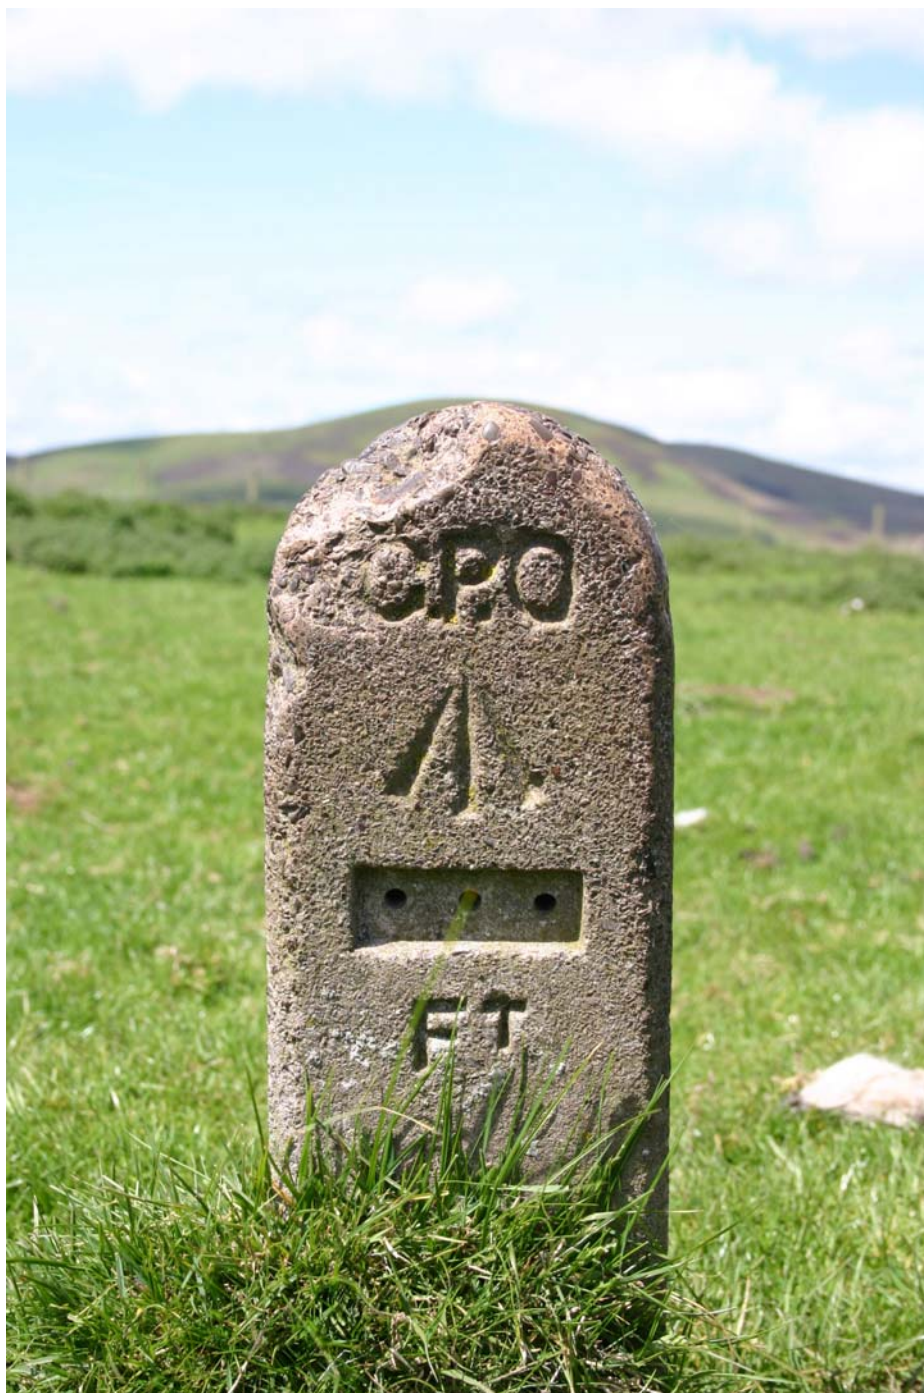
Illus 34. Castlclaw. A disused telecommunications marker. One of the relicts of the original firing range (DP006767).

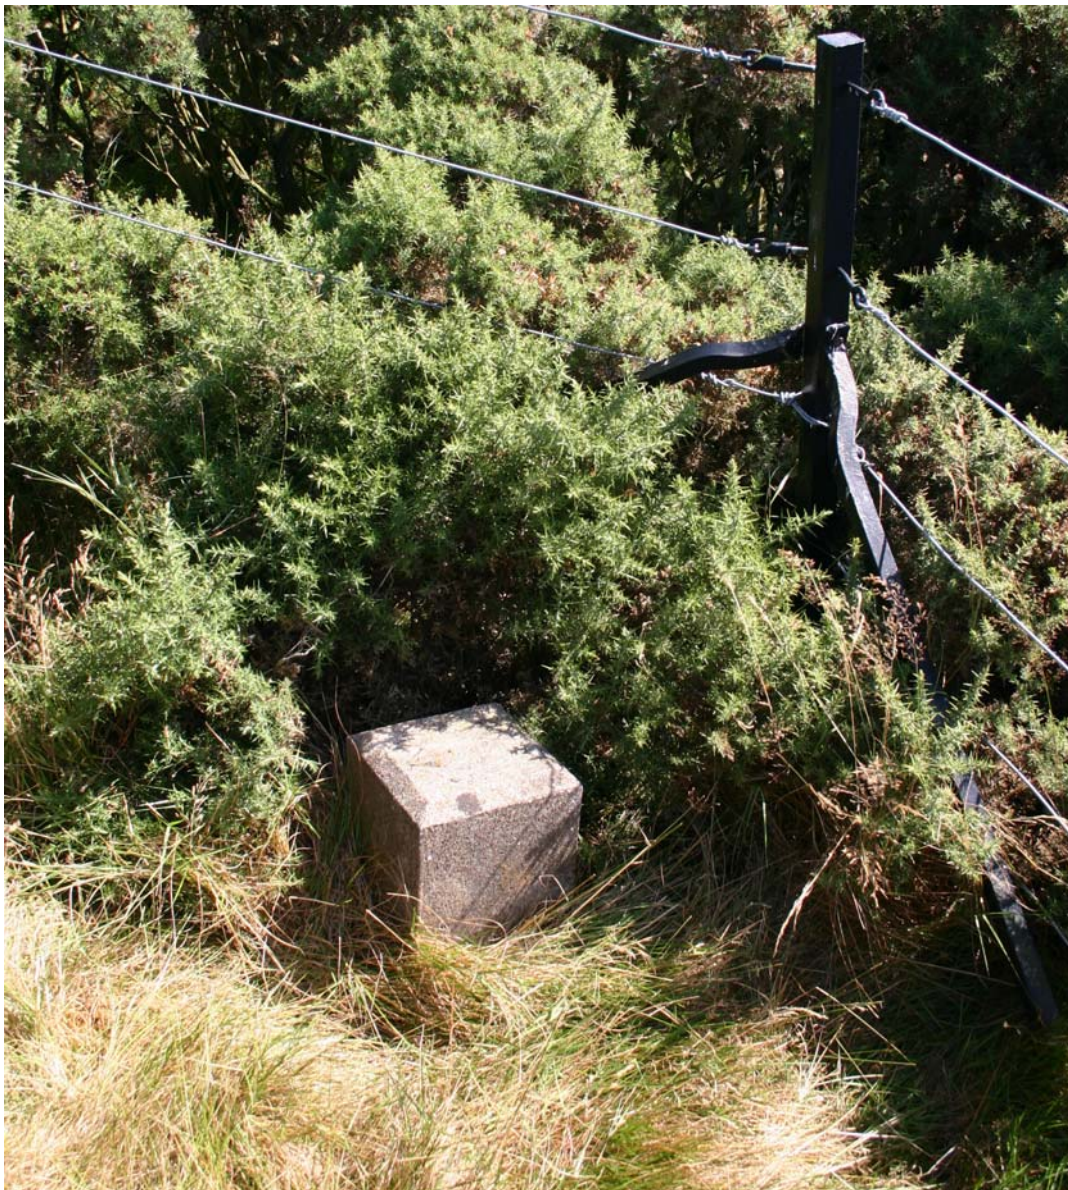
Illus 35. Castlelaw Fort. An example of encroachment by gorse on one of the marker stones that stand on the boundary of the guardianship monument (DP006764).
