The National Trust  
for Scotland

## **St Kilda Archaeologist Annual Report 2002**

**Susan Bain  
December 2002**

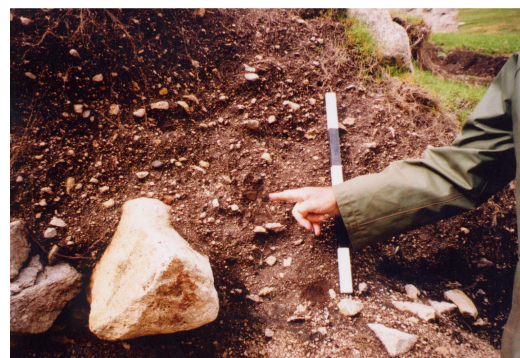
*A fragment of hand-made pottery*

Two sherds of handmade pottery (STK02/21) were recovered from section B; a layer of burning was also noted in this exposed section.

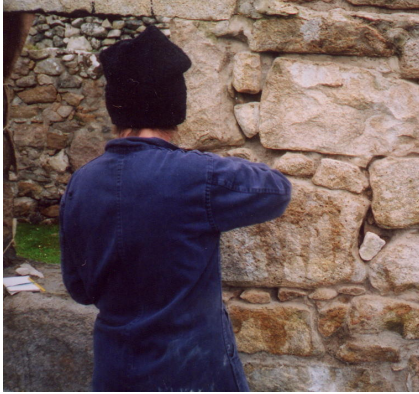
i) Sections of walling were repaired including: the dyke to south and north of cleit 2; planticrue 3, cleitean 15, 18, 31, 36, 94 and the enclosure behind house 3. A number of artefacts were noted during these repairs.

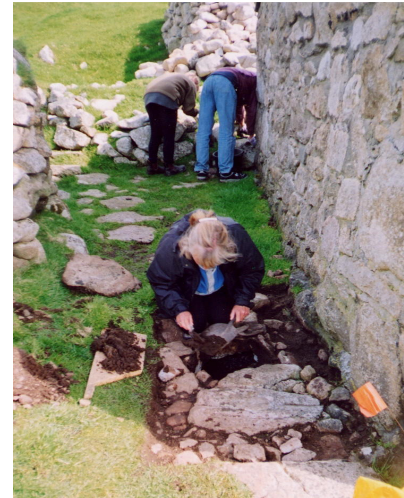
v) Damp problems have been regularly reported over the last few years along the base of the north wall of the church. The opportunity was taken this year to investigate them. As part of the investigation a small exploratory trench was dug under archaeological supervision along the north wall. This revealed that there is no drain along the north side gable of the church. Appropriate drainage works may be required for this building too.

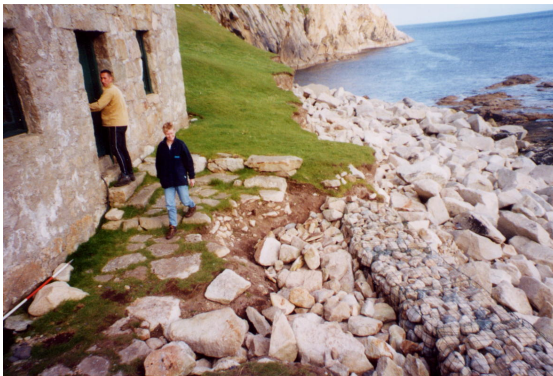
The cliff face immediately in front of the Store had suffered extensive erosion over the winter months. In order to minimise the effects of potential future storms, and as a temporary

measure until a full assessment of coastal defences can be prepared, three gabion baskets were placed immediately in front of the Store.

These baskets were placed on the stone foreshore and filled with loose stones and boulders recovered from the slipway area. The area behind them was filled with loose stones in order to avoid scouring. This work was carried out by the St Kilda Archaeologist and Warden and is intended merely to absorb some of the impact of winter storms this year. It
