The National Trust
for Scotland

St Kilda Archaeologist's Annual Report 2003

Susan Bain
October 2003

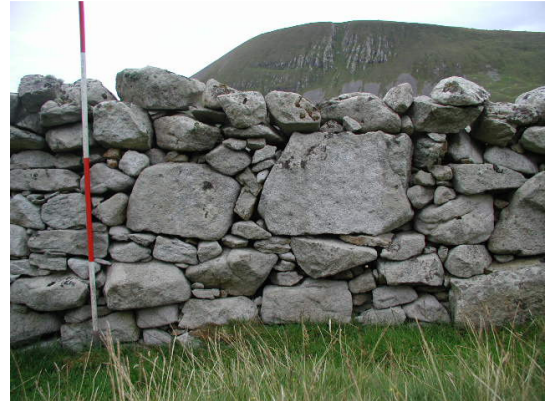
A section of the head dyke, recorded as part of the Village dyke survey

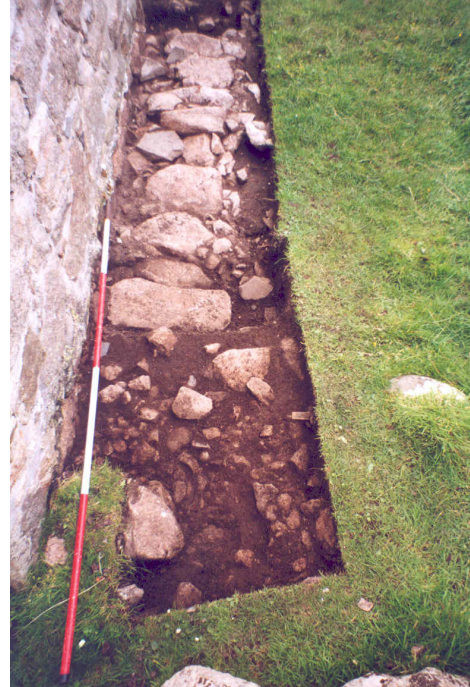
The box drain was completely silted-up and substantial midden deposits had accumulated over it. At the southern end of the drain both the cap and side stones were missing and the area was filled with midden material. The midden material all appears to be contemporary with the occupation of the house. The small trench excavated against the back wall also contained material and deposits that may be contemporary with the occupation of the house.

The capstones of the box drain for house 6

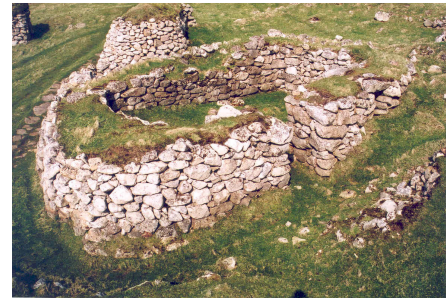
However, clay was definitely used either as a bond and/or draught proofing material in the interior elevations of Blackhouse X and in several other 1830s houses in the village, and is still clearly visible in patches.

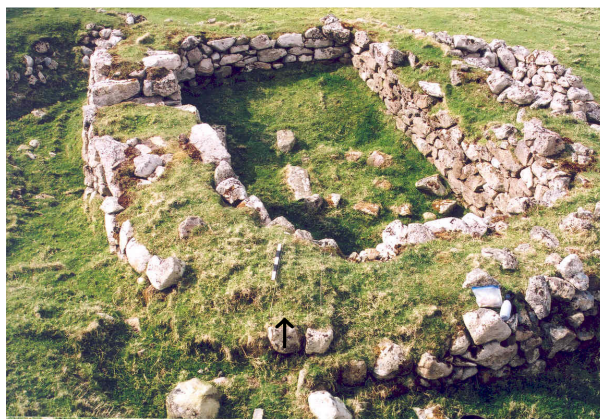
Location of slot trench

A maximum of 250mm of material was removed from the wall-head, composed of a humic topsoil overlying a dark-brown friable peaty layer. This overlay a more compact dark-orange/brown gritty soil with visible patches of ash and burnt clay confined to the centre of the trench and interpreted as the wall core. Several stones were embedded within this layer although some of the smaller stones were quite loose with voids around them.

No evidence for a clay cap was noted at this point in the wall head but it cannot be inferred with certainty, from such a small excavation, that no clay cap existed.

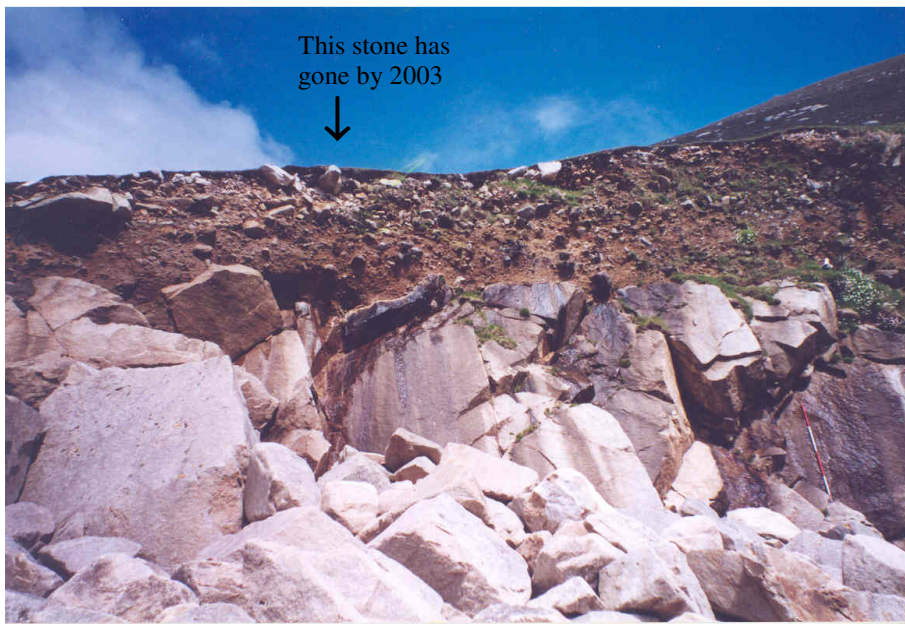
Section A suffered very little noticeable erosion since last year. Only one stone was noted as having disappeared. The distance from the cliff edge to the timber pegs was unchanged since 2002 viz:

Coastal erosion Section A -2002 (STK02 10/4)

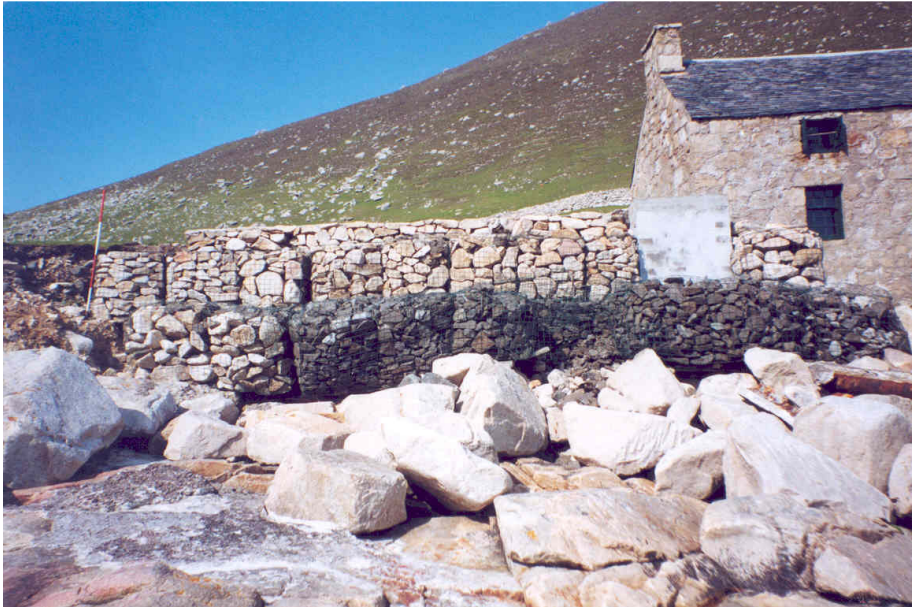
The gabion baskets around the septic tank had been damaged by storms in the winter of 2001-2002 and had been repaired by the summer of 2003.

Coastal erosion Section C – 2002 (STK02 9/22)

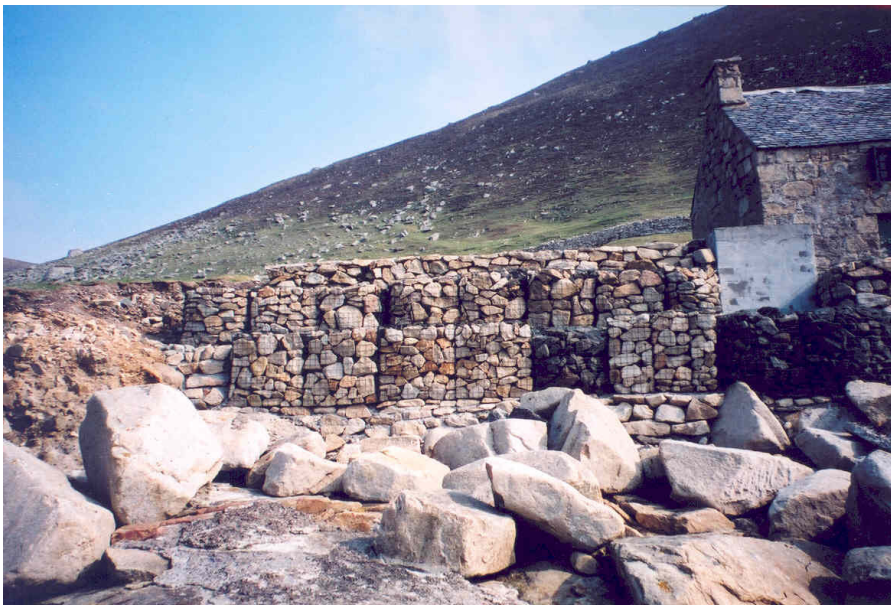
Coastal erosion Section C – 2003 (STK03 3/9) The repaired gabion baskets

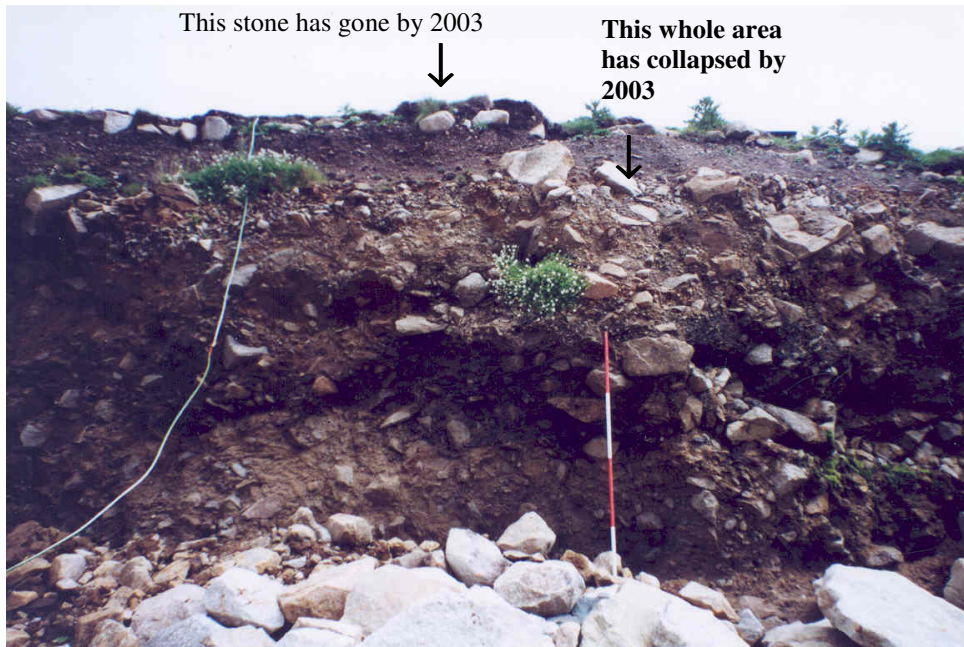
Changes were noted in section E. Section E is directly to the west of the main gabion baskets and stretches as far as the Abhainn Illishgill. The loss of soils and undercutting had been noted in 2002 but changes noted this year included the loss of one stone from the seaward dyke, collapse of overhangs and loss of vegetation at two locations.

Coastal erosion in section E 2002 (STK02 11/7)

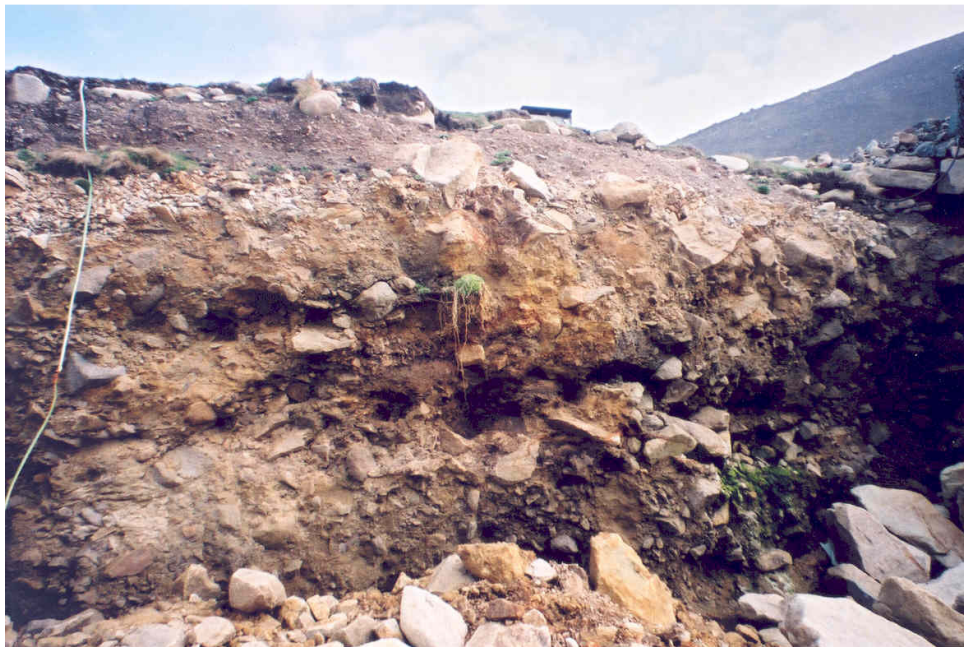
The same section in 2003(STK 03 3/10) The overhang has collapsed and a stone has fallen from the top

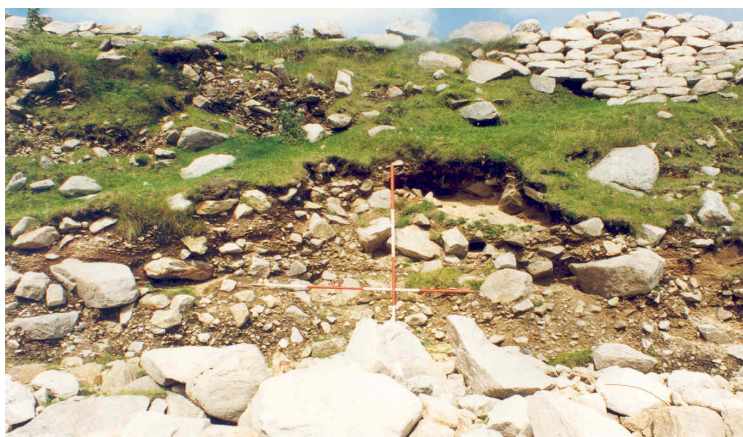
In 1996 there is good vegetation cover

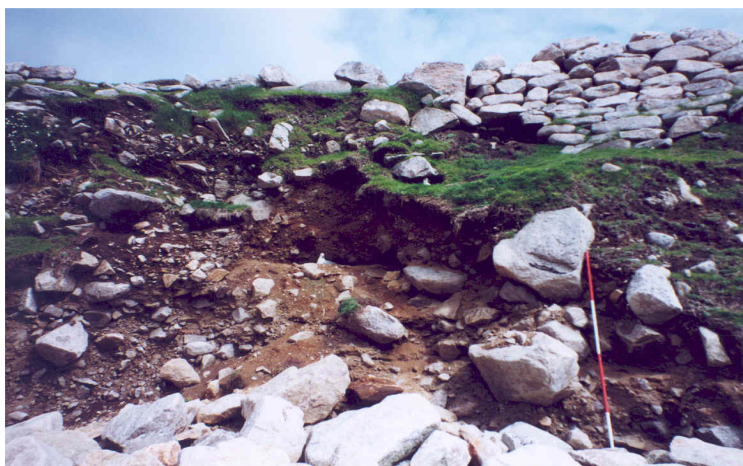
In 2002 the vegetation has decreased dramatically

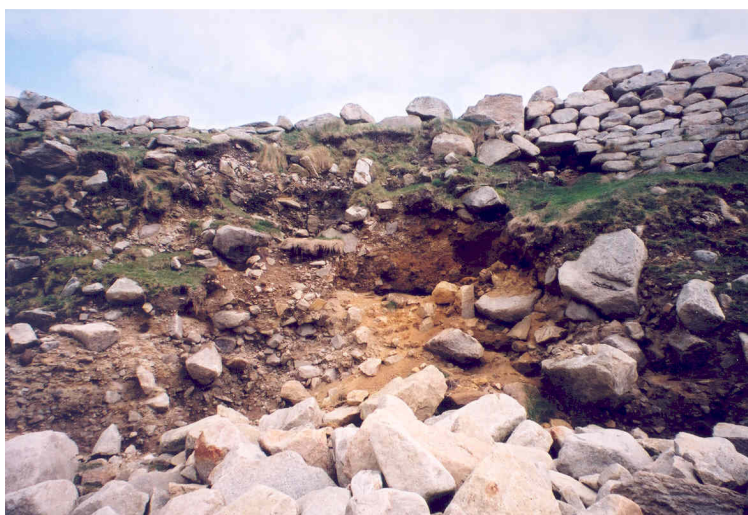
In 2003 the overhang has collapsed with further loss of vegetation

The coastal erosion survey of Village Bay this year showed only minor changes since last year. The main areas of change were in section E where overhangs noted last year had collapsed and stone from the seaward dyke had fallen. The winter of 2002-2003 was mild with few storms driving into the bay.
