The National Trust
for Scotland

St Kilda Archaeologist's Annual Report 2006

**Samantha Dennis
October 2006**

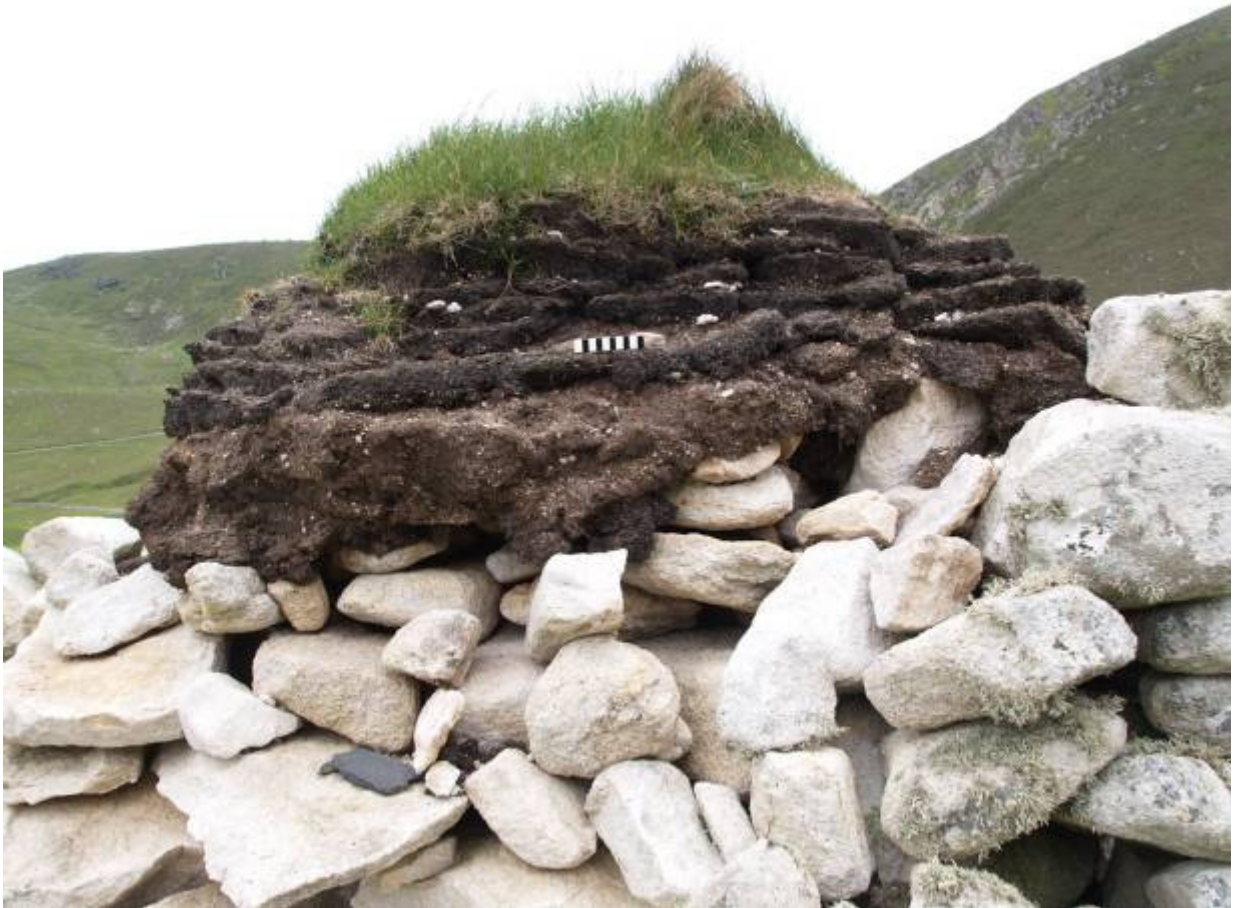
Cover plate:

The deterioration of a cleit wall and turf roof in Village Bay, Hirte

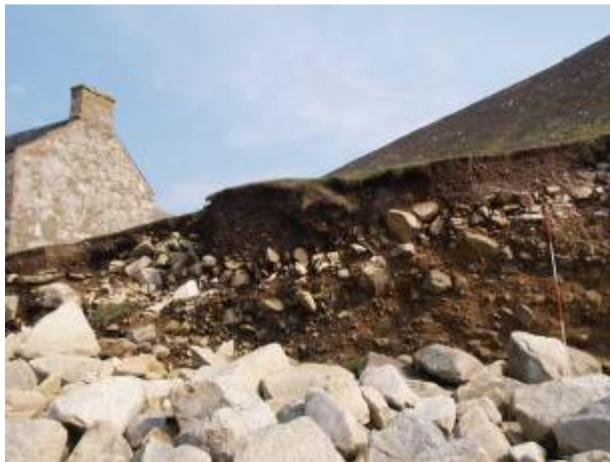
In summary, the eastern end of the Bay has undergone the most change, including fallen stones and soil from the cliff edge. The continual erosion in this part of the Bay is of grave concern in relation to the potential damage to the Store from further coastal erosion. The western end of the Bay, in contrast, is stabilising with only minor collapses noted.

Coastal erosion observed at east end of Village Bay

In late summer a new temporary gabion basket was constructed in front of the Store and one of the old temporary gabion baskets was repaired.

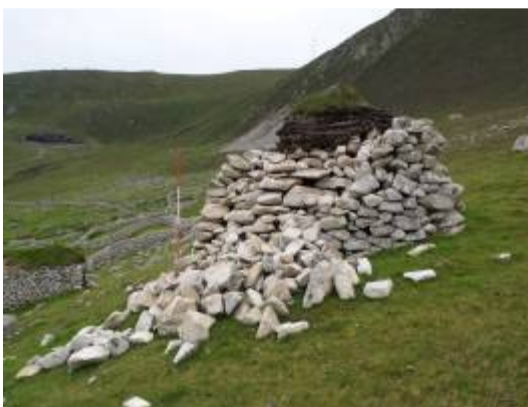
Photo of the major collapse of cleit 168, just beyond the head dyke, taken before its repair in July 2006

- i) Wall repairs were carried out to enclosures by cleit 154 and near cleit 166, and to the consumption dyke near cleit 87. Repairs to the walls of cleits 168, 105 and 40 were attempted. Repairs to cleit 105 were abandoned because of its unstable and dangerous nature. Repairs to the Dry Burn were carried out under the supervision of a drystane dyker, Jim Ramsay.
- ii) Turf roof repairs were done on cleits 22, 34, 45, 56, 69, and 71. Unfortunately repairs could not be carried out on cleits 101 and 63 because of nesting fulmars.

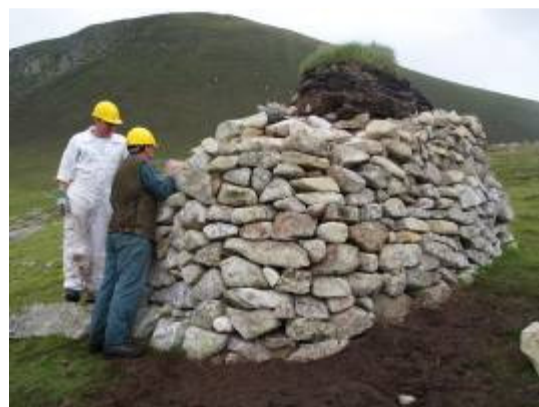
Cleit 168 being repaired by drystane dyker and Work Party member

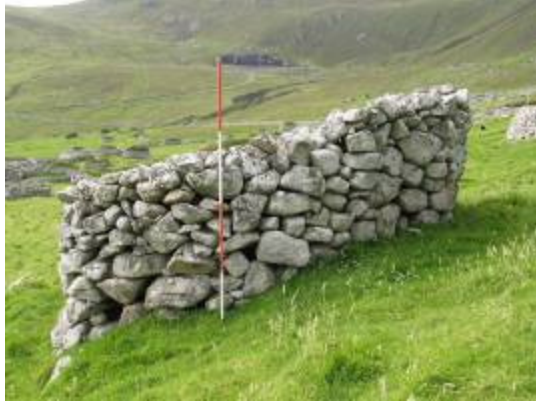
Planticrue (P-03) located within head dyke

condition were recorded for each structure and entered into a database. In addition, digital photographs were taken from four angles, including both interior and exterior views.

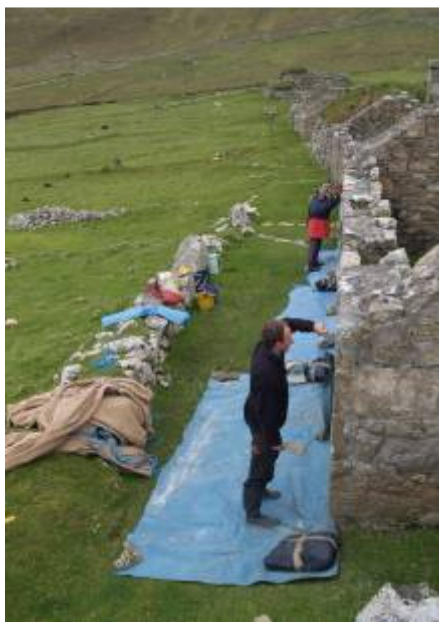
Lime pointing the façade of House 12

- iii) The graveyard gate, constructed in the summer of 2005, was hung.
- iv) Repointing was carried out on the front facades of Houses 12, 13, 14 and 15, supervised by Iain Small (NTS Stonemason, Culzean Castle).
- v) The drains were cleared by Houses 1, 3 and 12, blackhouse R, and through the camping enclosure by cleit 8.
- vi) The Gun was recoated with a protective layer of bitumen.
- vii) Other work included mending the church rones, painting the Factor's House downpipe, and pitching the roofs on Houses 4,5, and 6.
- viii) work not carried out included further work on the drain of the church.

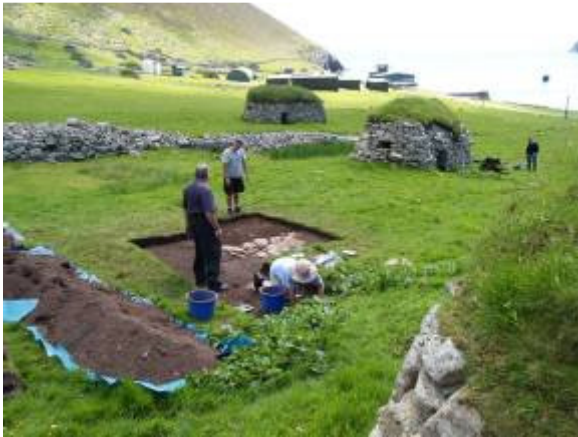
Excavations south of the Village street

Archaeological research within the Village was conducted under the supervision of GUARD between June 23rd and July 22nd, 2006.

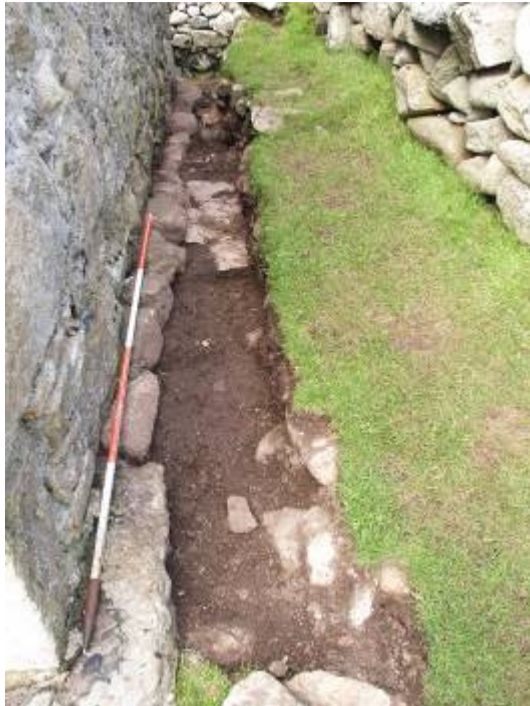
Excavation along the east gable of House 6 in preparation for a new drain

The Archaeologist excavated the drain with the assistance of Work Party members. The excavations revealed the remains of a simple drain lined on the sides by stones. There was no indication of lining along the base. The drain had silted up and been used as a dump in the 20th century. The material was cleared this summer and the new soak-away drain was constructed. The soak-away already in place at the rear of the house now connects with the new drain running along the east gable, similar in design to that around House 3.

Following the excavations carried out in previous years relating to the drainage system around House 6 (Bain 2002, 2003, 2005; Dennis 2005) a new drain was cut along the east gable of the house. It is hoped that this will solve the winter flooding problems.

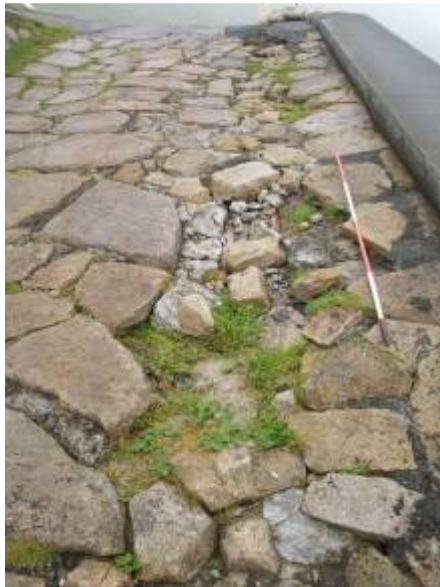
The Archaeologist repaired the slipway leading down to the jetty, outside the Scheduled Area. The slipway had been damaged in the severe winter storms in 2005 which resulted in the gradual exposure of underlying electric cables.

Jetty slipway before repair

A stretch, approximately 2.5m long and 1.5m wide, of paved stones had become dislodged leaving a cavity. This was cleared of vegetation, levelled off using sand, and filled with large stones embedded in lime mortar.

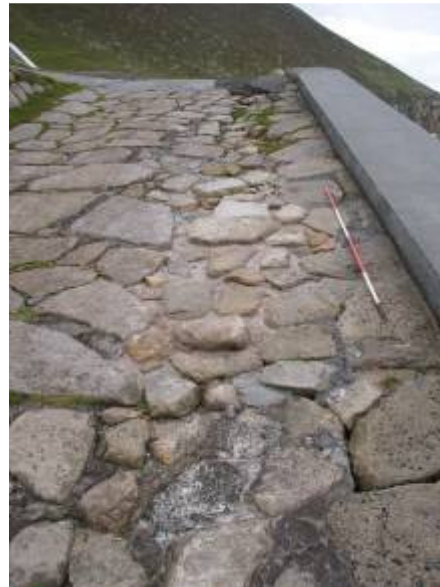
Jetty slipway after repair
