This report summarises the work undertaken by the National Trust for Scotland's St Kilda Archaeologist (SKA) from April 2010 - April 2011.

3.0 On-island work: April – September 2010

3.2 Coastal Erosion Monitoring

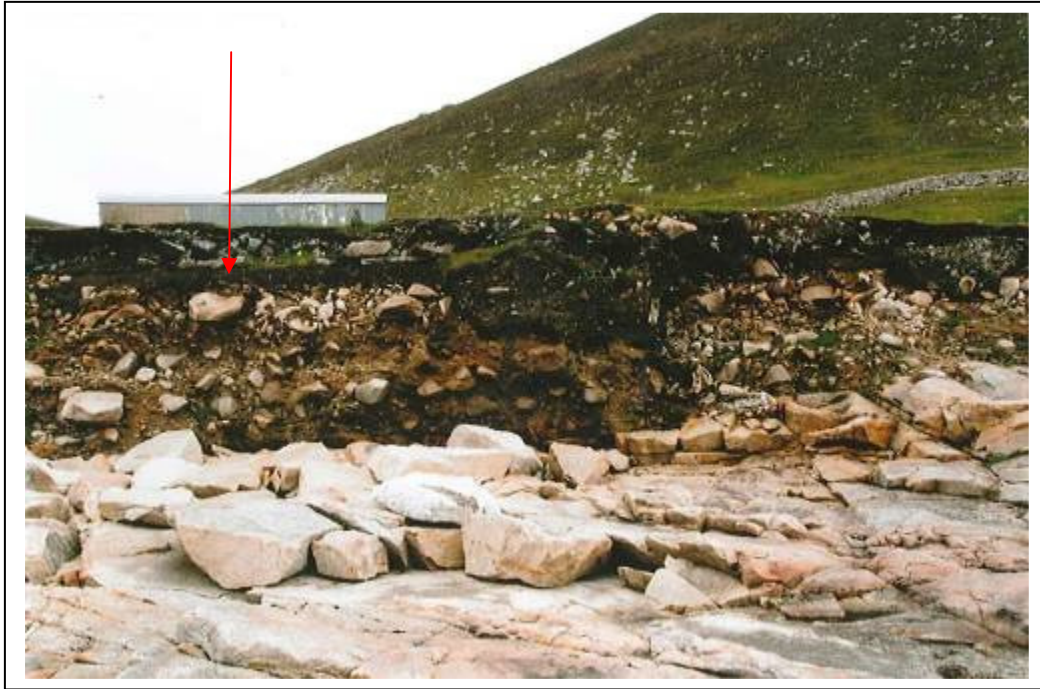
Figure 2a: Photograph CEP 15, area C in 2008

There were only two photographs in which change could be observed: CEP 15, see Figures 2a and 2b below, where a large stone had fallen out, and CEP 44, Figures 3a and 3b below, where the erosion scar looks bigger, although it is difficult to be sure and the impression may be a misperception resulting from higher vegetation in 2010. However, the discovery of probably prehistoric pottery (SFs 6,7,8) here would support the former interpretation, as these eroding sections were checked by Strat Halliday in 2009 whilst carrying out the recent RCAHMS survey (pers comm) and would therefore seem to have eroded since then.

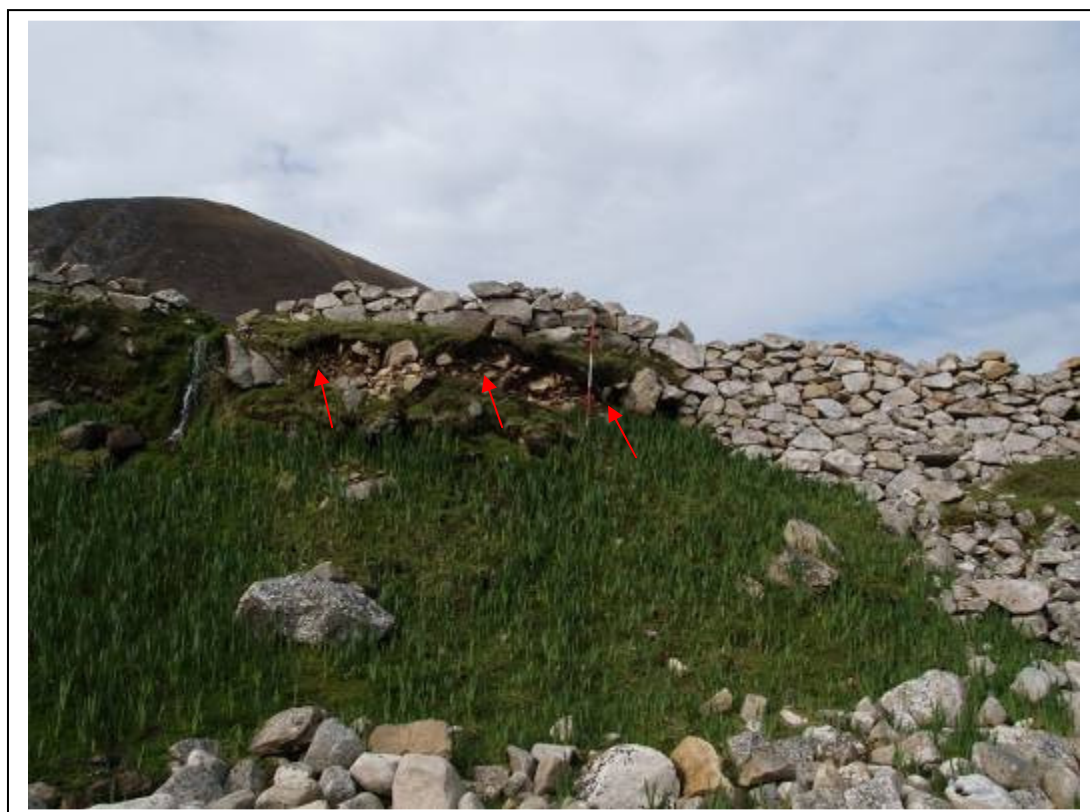
Figure 3b: the same area in 2010 - does this represent gradual erosion? Findspots of SFs 8, 7 & 6 shown left to right

Surprisingly, the rest of the monitored coastline did not appear to have noticeably eroded. This seems unlikely given the environment, and when the difficulty in interpreting photos 3a and 3b is considered, as well as the total absence of visible change at area A despite pottery being uncovered, it seems sensible to question the efficacy of the current methodology. This issue will be discussed in the recommendations section below.

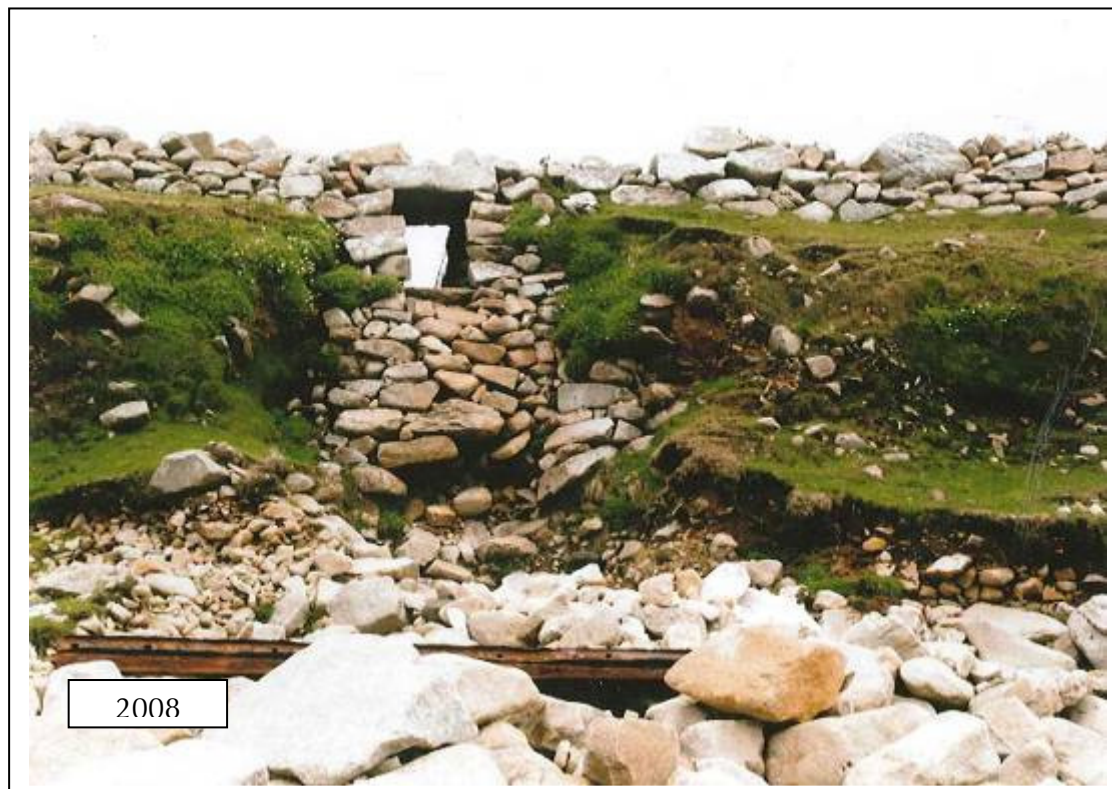
Figure 4a: The Abhainn Illishgill outlet to shore, 2008

Another issue which has and will continue to cause concern is the condition of the outlet of the Abhainn Ilishgill to the shore. This 19th-century drystone structure is eroding from its foundations, most probably causing its complete collapse in the next few years if nothing is done. Careful examination of the photographs shows that no stones have slipped or slumped significantly since 2008, as far as can be told, but this would not seem reason enough to sideline the issue. If any one of the remaining foundation stones did move then the whole section – several tonnes of stone – could well collapse in one dramatic event. This danger makes any repair job very problematical, and it would seem the only available option would be to dismantle most of the overburdening wall to make it safe enough to access and repair the foundations.

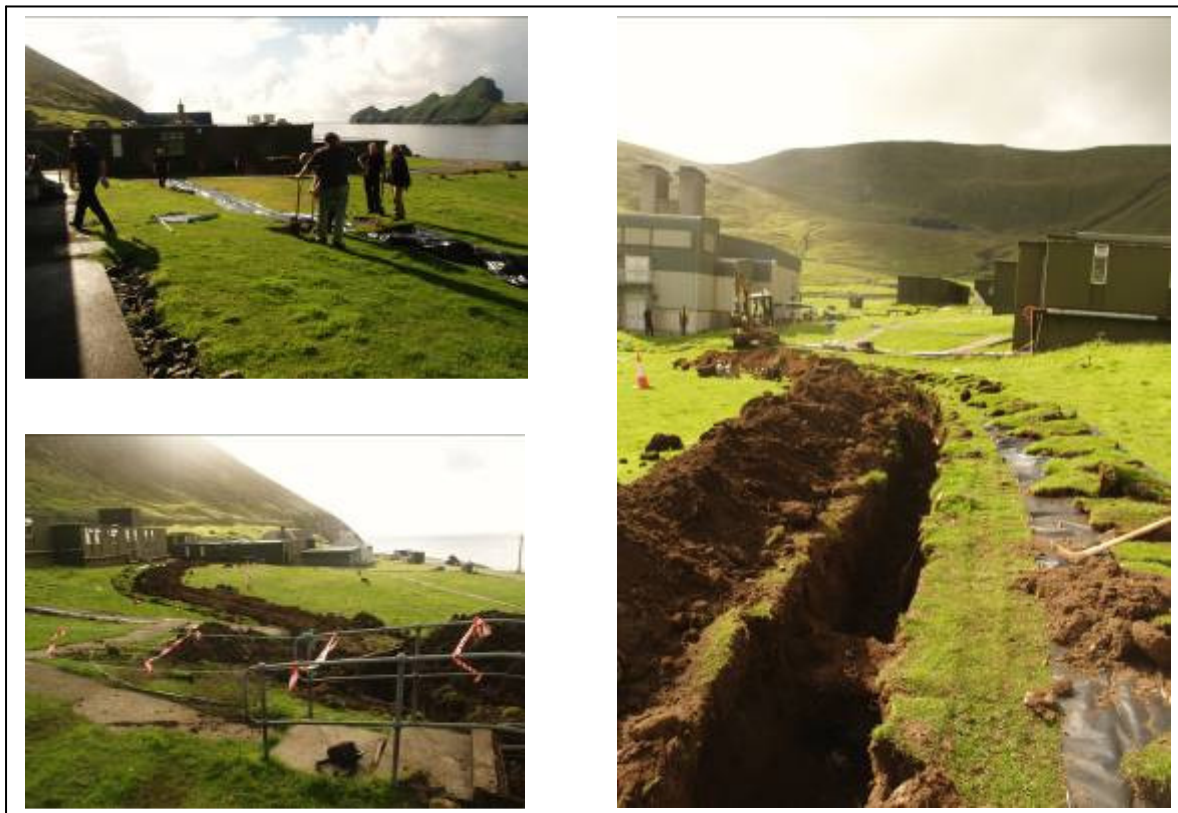
Heating ducts which formerly ran along the outside of the main building of the military base on St Kilda, immediately outside the "Puff Inn", required undergrounding. This necessitated a trench, c100m in length, 0.7m wide by 0.7-1m deep – see Figure 7, below. Most of the trench was excavated by mini-digger, and monitored by the SKA, whilst three areas required hand digging.

Deposits found beneath a 200-400mm thick turf and topsoil layer largely consisted of re-deposited rubble associated with the post-1957 military base. A concentration of porcelain, tiles and frosted glass in the southern 15m perhaps indicates the site of a washroom in this vicinity. One metre deep top soils to the north of this may be undisturbed but given the amount of activity in the area are more likely to be similarly re-deposited material from the construction of the present day Base. An undisturbed glacial deposit was observed 20m north of this, where the trench arcs towards the southwest, underlying the soils. Around 10m of this was uncovered. The last stretch of trench consisted again of re-deposited rubble associated with the base. No artefacts worthy of recovery were found.

Figure 8: The trench being excavated

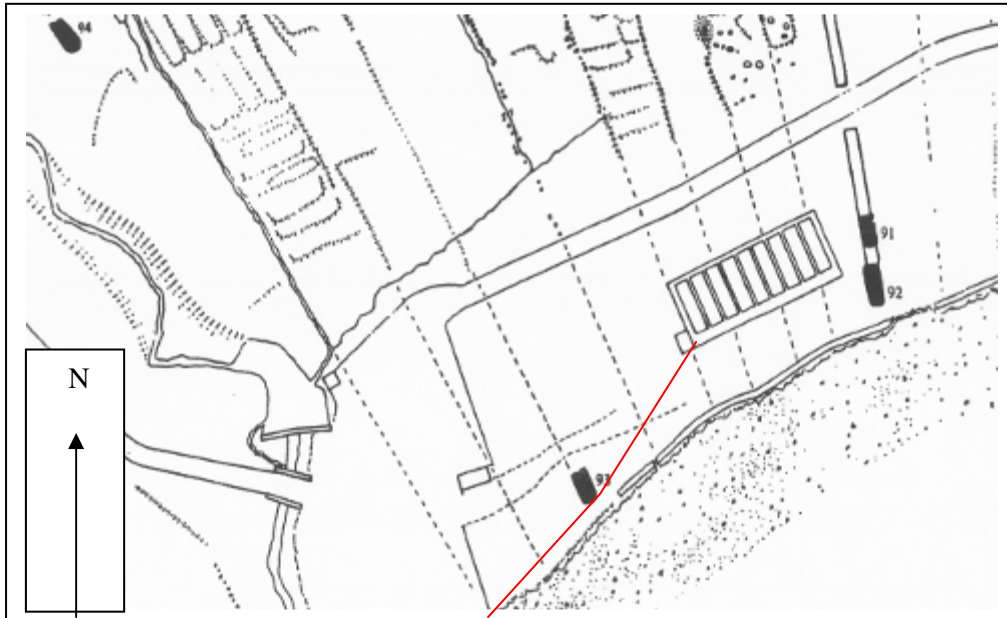
A small section of pipe, from the diesel storage tanks to the LCL ramp, had grown over and required exposing. The pipe had been laid above ground, over re-deposited material from the early stages of the creation of the fuel store, so there was nothing of archaeological interest. See figure 9, below.

Figure 10: The LCL watching brief, pipeline in red

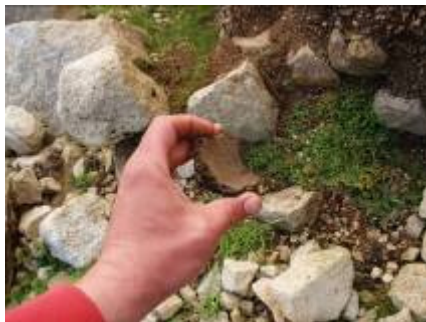
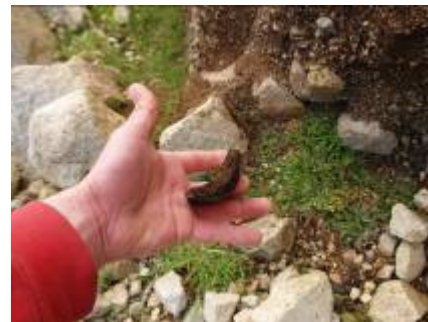
Photos 1 and 2 – the basal sherd

The first finds came from the coastal erosion survey – one of the most likely places to find things, as the ocean is eating away into soils containing traces of every age we have inhabited the island. In total, 10 sherds of (probably) pre-historic pottery were found from eroding shoreline deposits, including a beautiful big piece of base – see photo 1 or 2 below – likely to be Iron Age (c.500BC- 800AD), at least.

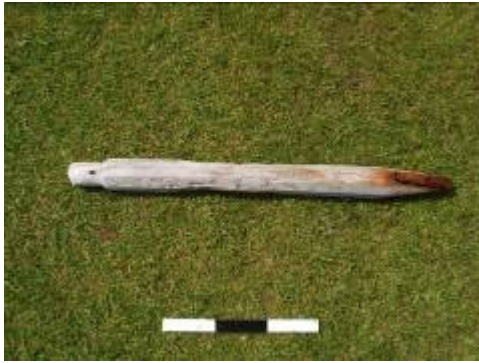
Photograph 3 – ‘stake’ handle (scale = 30 cm)

WP2 got really into it, too. In the process of clearing drains Iain Gordon and Alison Mosley found 6 sherds of prehistoric pottery – possibly some kind of record, but that was not all. On the weekend before WP2 had arrived I had been wandering around the Mullach Sgar screes and come across a strange wooden post, octagonal in section with a point at one end, covered with a strip of rusty old iron – see photo 3, below. I called it a stake handle at the time as I had to call it something. Nobody seemed to know what it was and there was no record of anyone else finding them - It was a mystery. I showed Work Party 2 and we had a brain storm about what it could be – everything from a ploughshare to abseiling anchor was mooted. We even asked the entire Puff Inn on a quiz night if they had any ideas - not mentioning that we hadn't a clue ourselves...

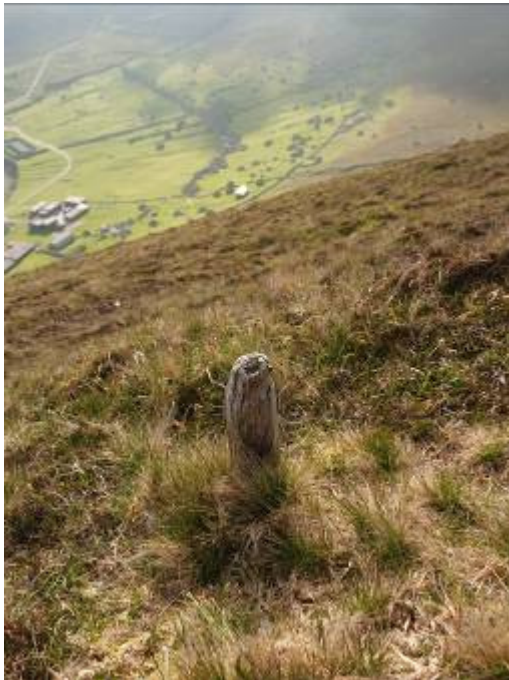
Photo 4 – Erica Honning’s Oiseval example

Shortly after this, WP2 member and Kildan descendant Murdo Mclean found two more stakes, both exactly like the first, and again from the screes. Over the next few days we found five more, three from the screes and two on the way up to Mullach Geal. Then one evening WP member Erica Honning found yet another, this time near the top of Oiseval, causing great excitement, see photo 4, below. These locations had to be the key to figuring out what these things were.

The Oiseval example did turn out to be the key, as we knew that there had been a look out post there during the 1st World War, as there was on Mullach Geal. A check through James Mackay’s “Soldiering on St Kilda” confirmed that there had also originally been a look out on Ruaival. These look outs had started out communicating with the village by semaphore, but this was unpractical in bad weather and so cables were laid to each. At first they were going to lay a cable to Ruaival, but then decided to move it to Mullach Geal instead. Cables on Hiort are to this day laid out and anchored using wooden stakes – although today the stakes are a rather simple affair compared to these deluxe 1st World War models, which is interesting in itself. It was possible they had laid out the stakes in preparation for a cable to Ruaival which was never actually laid. Shortly after these tentative interpretations, Mary Harman, oracle of Kilda knowledge, got back from holiday and got in touch to say that she thought they were probably 1st World War stakes for laying cables, and that she had seen them but never written about them. Case closed! We had all had fun with the experience of their being new (well, new to us) finds out there to be found and especially the consequent process of detective work to figure out what they were.

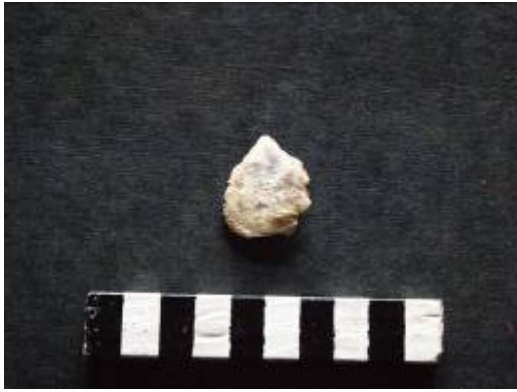
Photograph 5, Graeme's worked stone

Most spectacularly, on a walk to Ruaival Graeme Carter (WP2) spotted what he thought might be an arrowhead – see photo 5, below – and he might not be far off the truth. It is at least ‘worked’, as in shaped, and is of a sort of siliceous looking quartzite which certainly holds an edge. This means that is likely to have been a tool of some sort, used thousands of years ago. Further studies will be done and hopefully teach us much more about this discovery. Well done Graeme!

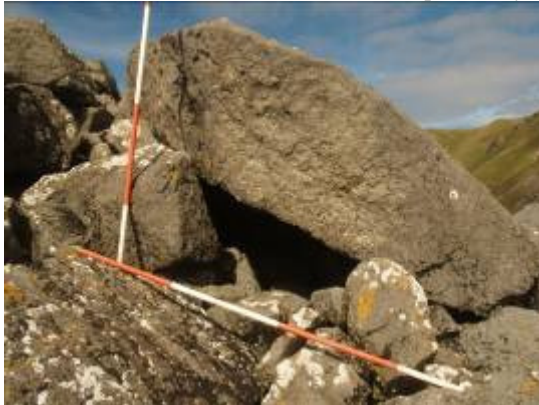
Photo 6 – The real Uamh Cailleach Beag Ruaival?

It was with great excitement then that I read of a different location for the cave in Donald John Gillies book "The Truth about St Kilda", which was launched this summer. Donald John describes a place on the east side of Ruaival, with an excellent view of the sea approach to Hiort, and also of the village. He describes taking tourists there in his youth, before the evacuation. The cave marked upon the OS maps as Uamh Cailleach Bheag Ruaival would certainly not fit this description, so I determined to search Ruaival for Donald's cave. Sure enough a rock shelter (a space under a large rock which has been given rough walls) was located which fits the description admirably. Inside there were cut peats, providing evidence that this shelter was definitely used at some point. There are many such shelters on Hiort, but this one was not previously known or recorded. We are indebted to Donald John.

However, the story doesn't finish there. Shortly afterwards the Royal Commission surveyors came out to the island. They have recently finished surveying Hiort to provide an accurate and definitive record of everything there, so they were interested to see one they had missed. One member of the party got behind on the way up, and consequently was not shown where the shelter was. We tried to explain to him when we passed him on our way down, but it was quite difficult – as I'm sure many readers know Ruaival is an exceedingly large pile of big rocks. Later that evening, we met up and he explained that he'd found the shelter – but when we looked at the photos he'd taken it was clearly a different shelter than the one we had meant. It also had a little wall and cut peats. So, thanks to Donald John, we now know of two new rock shelters on Ruaival.

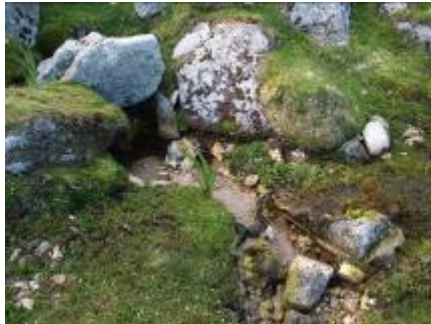
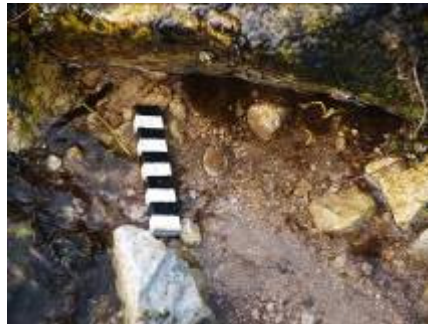
Photo 7 & 8 -The flint in the Tobar Childar

There was one other find of the summer. One fine evening myself and the Ranger were strolling around the village when we came to the spring called Tobar Childar – the main water supply for the village in the past. Gazing idly into its crystal waters I saw the unmistakable hue of a piece of flint, sitting on the bottom amongst the gravel. I reached in to retrieve it, momentarily obstructing the view and causing a panic that it might disappear back into the gravel if I picked up the wrong stone by mistake... but I grabbed it and pulled it out and there it was; a beautifully coloured yellowy brown flint flake, hewn from a rounded pebble and reworked around the edges, probably during the creation of a tool such as a scraper.

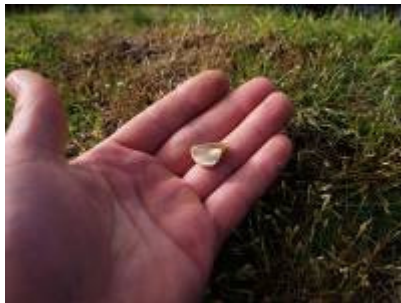
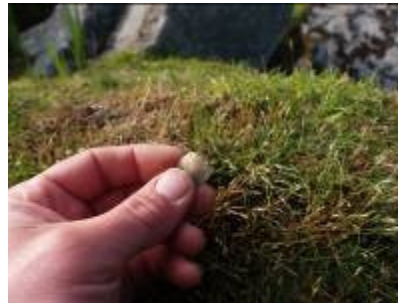
Photos 9 & 10 - The flint

Although use of flint carried on in some places into the Iron Age (c.500BC-800AD) and later it is likely to be much older – generally speaking flint use declined after the adoption of metal in the Bronze Age (c2000-500BC). We will have a better idea of its age after we get it looked at by a specialist, but it is likely to be either Neolithic (c4000-2000BC) or Bronze Age. Pebbles of flint wash up very occasionally along the west coast of the Hebrides, originating from sediment deposits dumped upon what is now the continental shelf by the last ice age. However, as St Kilda is in deep water close to the edge of the continental shelf it is unlikely to have washed up here – it is more likely to have been brought here by early settlers as part of a tool kit for survival. These pebbles are usually quite small and unsuitable for creating an arrowhead, so it seems more likely that this flake was struck off during the creation of a scraper. This particular tool is generally used for preparing hides to be used as clothing, so the flint also implies that there was already livestock such as sheep on the island – Soay sheep perhaps? There has always been debate as to whether these sheep were brought over by native Hebridean people (perhaps as early as the Neolithic as they are thought to be a ‘Neolithic’ breed) or introduced by the Vikings (c800-1266AD), as ‘Soay’ means sheep island in Norse. The flint doesn’t prove anything but certainly helps to build the case for early introduction by Hebridean people.
