The Development of the Gardens and Designed Landscape at CARFIN & CROSSFORD PARK, CLYDE VALLEY

Carfin & Crossford Park, Clyde Valley

Report on the development of the designed landscape

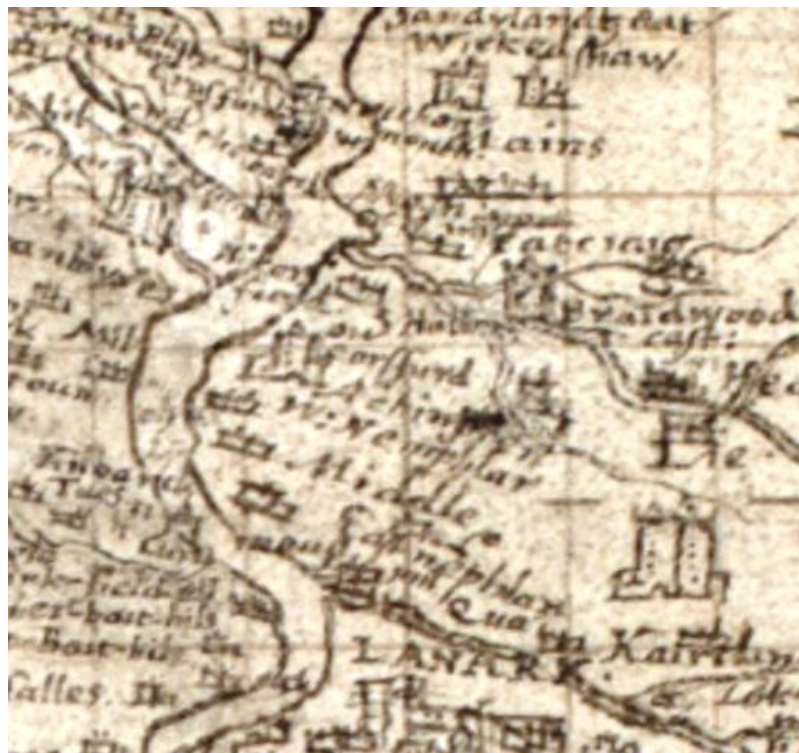
Illus 2: Pont's Glasgow and the county of Lanark (Pont 34) (1593-96).

The town of Lanark is clearly visible on Pont's map, as are the River Clyde and a number of other recognisable names still current in the area today, for example 'Corsford' (Crossford).

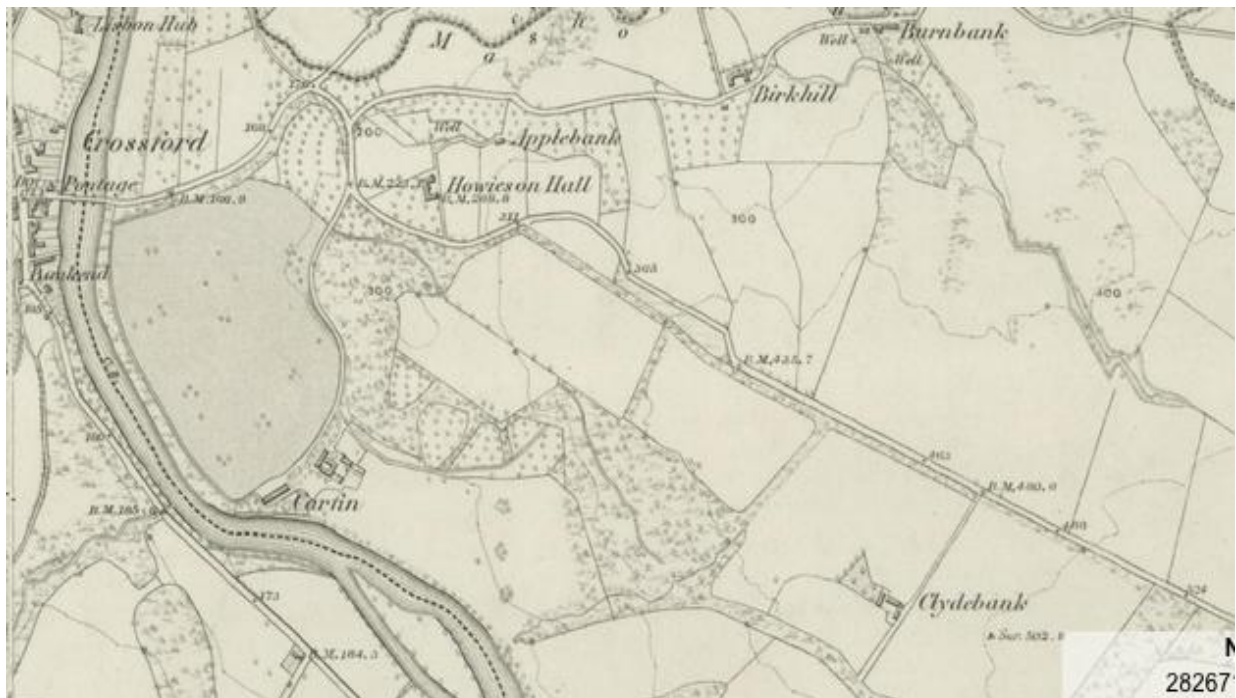
Illus 5: Ordnance Survey 1st edition six-inch map, Lanarkshire XXV. Surveyed 1858-9, published 1864.

This map was surveyed just over 40 years after Forrest's map and depicts the estate in much greater detail. Carfin mansion house is shown as an elongated rectangular structure. The Courtyard Stables and Walled Garden are also now clearly visible.

The Holm Park remains open parkland, probably used for grazing. The Pleasure Walk or drive along the river is still there, with other clearly defined pathways around the estate. The top north-east corner of the Holm Park has been planted as orchard, as have several areas in Aaronshill Wood (See p.5). There is now a road bridge over the river at Crossford, replacing an earlier ford. The land to the south-east of the house appears to be used as grazing as is the case with the fields running alongside the boundary of the North Park.

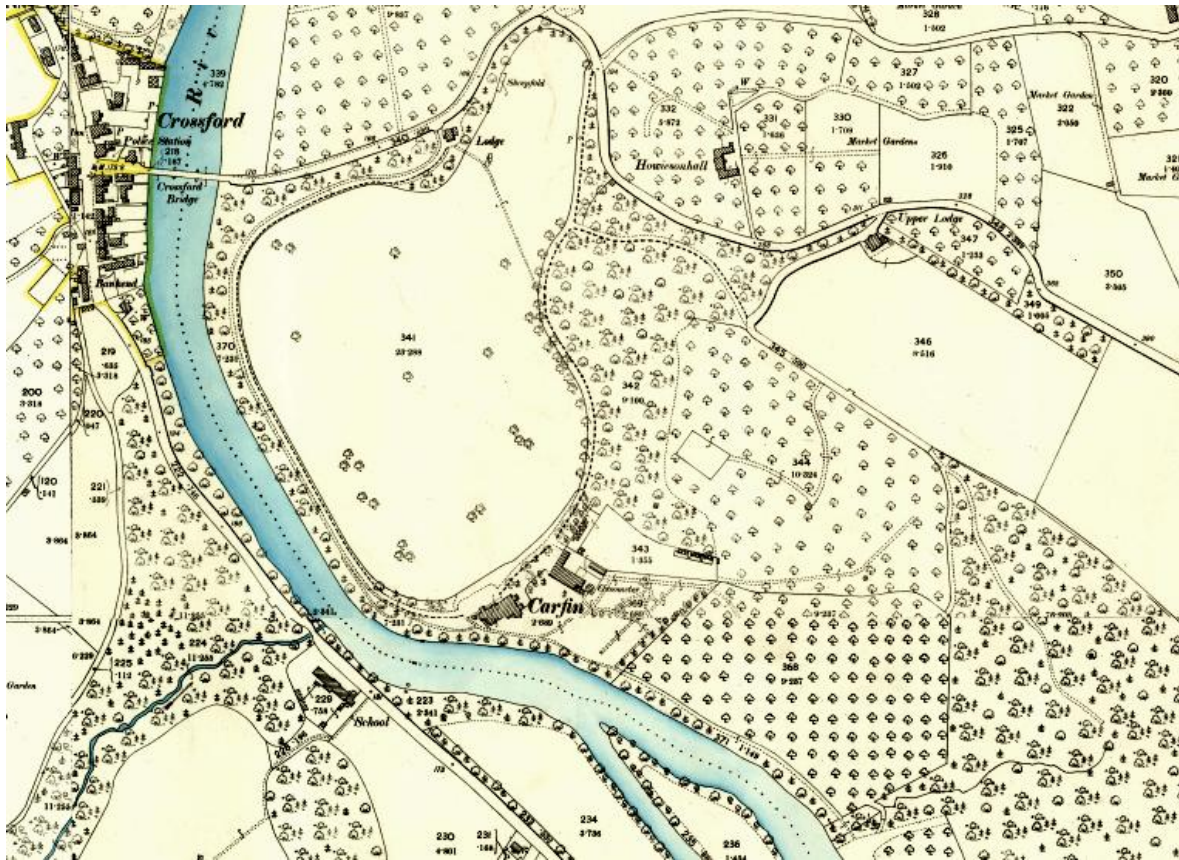
Illus 6: Ordnance Survey 2nd edition six-inch map, Lanarkshire XXIV. Surveyed 1896, published 1898.

The mansion has been extended, and additions have been made by 1896. The drive or walk along the riverbank has been opened up to the road leading to the new Crossford bridge and is possibly the main entrance to the house at this time. The Walled Garden now extends further east and has become sub-triangular in shape. A line of glasshouses has been erected on the south-facing north wall. There are also glasshouses outside the walled garden to the north-west. The area to the south-east of the house and stable block has been developed with gardens and pleasure walks. There has been a significant increase in the amount of land given over to productive orchards including Aaronshill Wood, North Park and East Park. The two lodge houses on the main drives have been built, and the folly is depicted. The orchard in the north-east corner of the Holm has now been returned to park land. A rectangular clearing has been made in the orchard in what was the North Park. By its shape, it could be a tennis court.

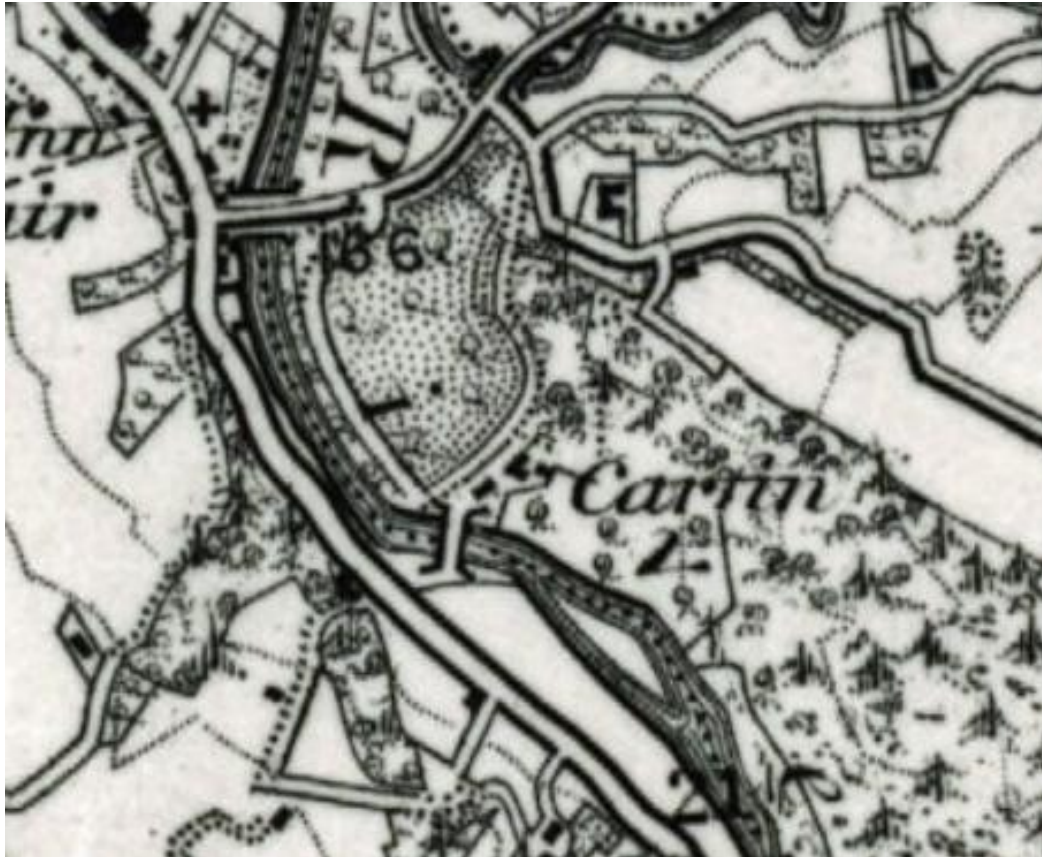
Illus 7: Ordnance Survey one-inch 3rd edition. Sheet 23 Hamilton. Revised 1901-1902, published 1905.

The ornamental iron Carfin Footbridge, which was built in the 1890s, is shown on this early 20th century OS map. This bridge connected the Carfin estate, and more specifically the house and pleasure walks, to the west bank of the river. The map also shows the upgraded entrance to the property, leading now from Carfin Lodge near Crossford Bridge, shown on the OS 1st edition map (See p.12) as a riverside pleasure walk or drive. Most of what had previously been shown as orchard in front of the house has become mixed woodland, although there still appears to be a small enclosed section next to the river and the Riverside Walk.

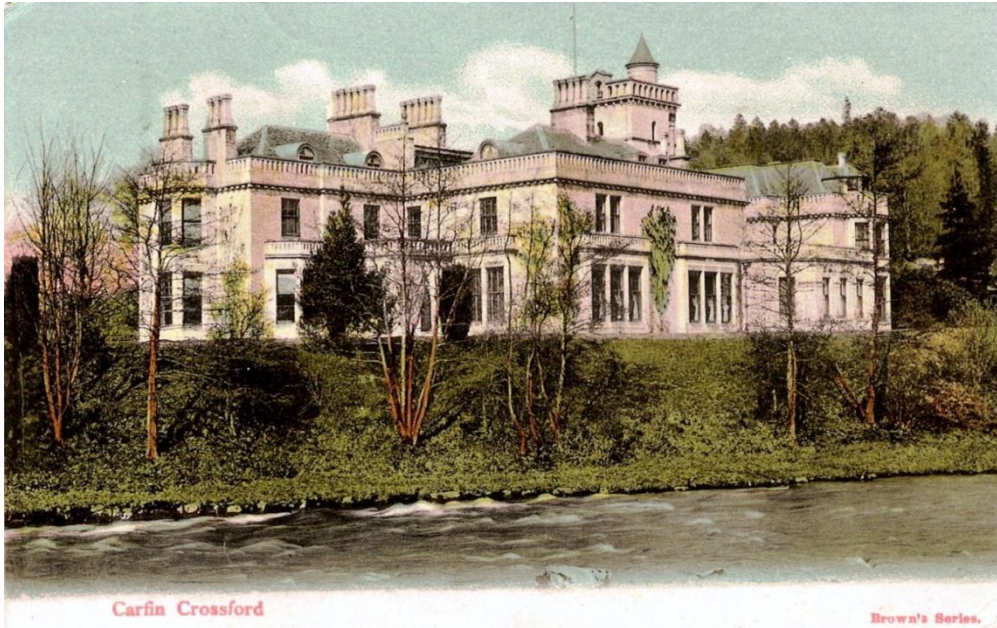
Illus 9: A postcard showing Carfin House from around the turn of the 20th century.

The front of Carfin House faced south-west and up river, with ornate balconies along the wall heads. It is possible that these were added by Graham to give the classical mansion a Portuguese flavour, a reference to the source of his wealth.

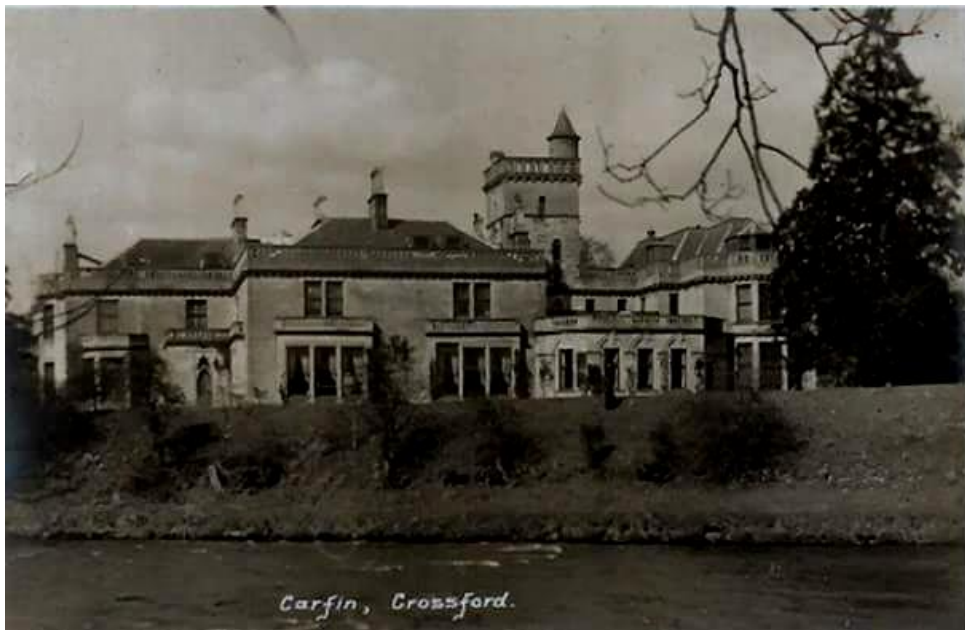
Illus 10: Carfin House (date unknown but probably early 20th century) showing to the right of the house the Wellingtonia which survives to this day.

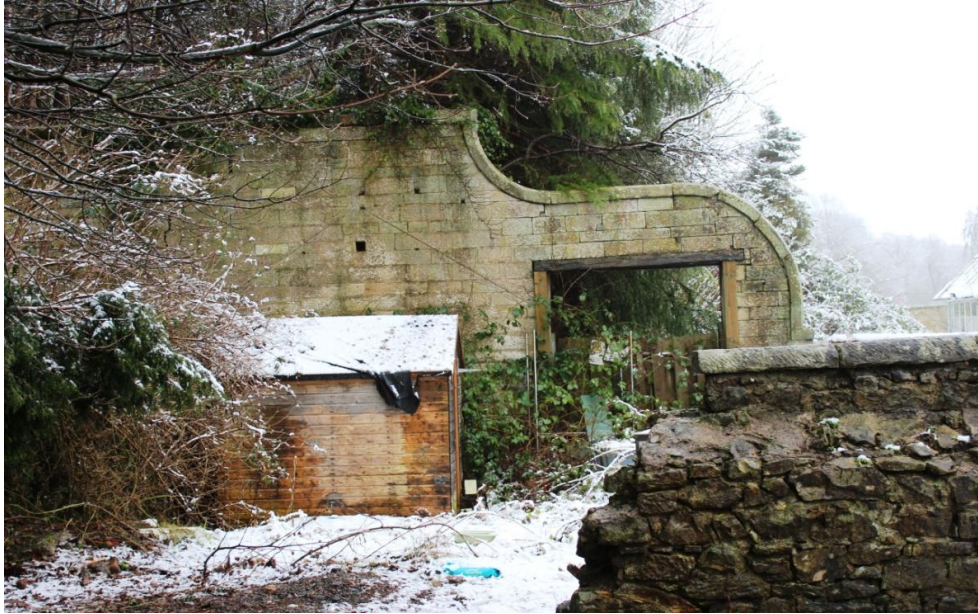
Illus 13: The west entrance to Walled Garden, near the head of North Drive.

Walled Garden (Illus 13, 14, 15)

Today, the Walled Garden at Carfin is extensive and structurally it survives very well. It is built of large, blonde sandstone ashlar masonry; the walls average about three metres in height. It contains three distinct areas defined by stone steps and walling; these appear to correspond to the three glasshouses shown on the 2nd edition OS map. Pins and small joist holes in the south-facing wall indicate where espaliered fruit trees grew. Trees and shrubs (including laurel and yew) grow in the north-west part of the garden.

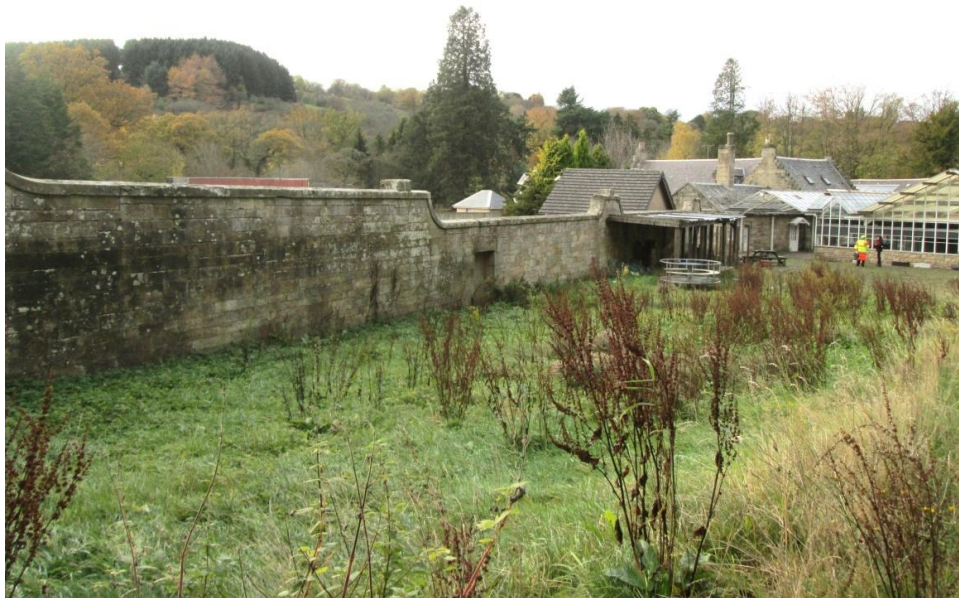
Illus 14: The Walled Garden, looking towards the Courtyard Stables and the Wellingtonia at the site of Carfin House.

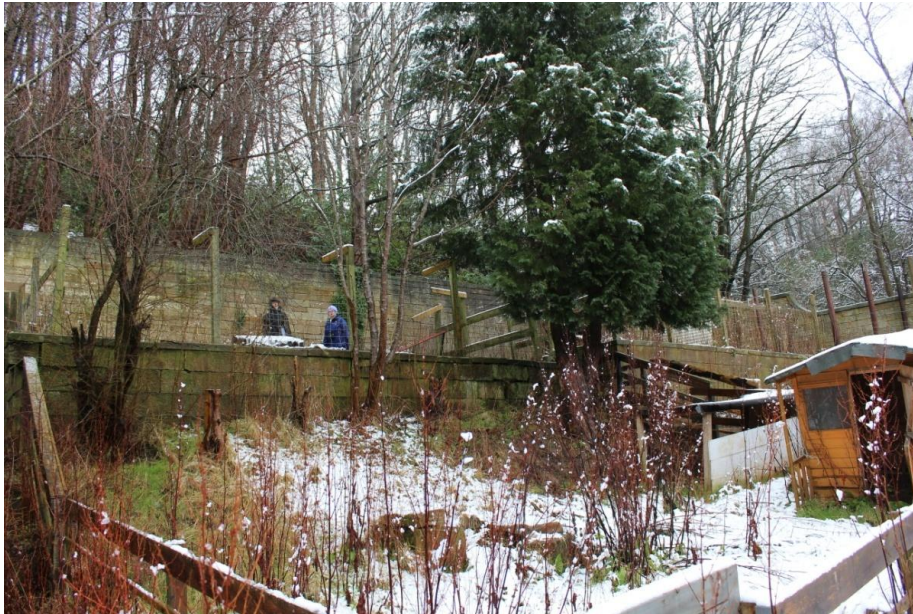
Illus 15: Interior of the Walled Garden, with stone-built terraces on which stand disused wooden shelters and fences for the former petting zoo.

The eastern interior housed a petting zoo in recent years and there are remains of old shelters, cages, benches and fences, along with several large stone blocks. There is an original entrance and makeshift wooden door in the north-east wall and another (blocked with timber) in the south wall. The west part is mono-blocked and contains a large, abandoned glass conservatory that was previously used as a shop, along with an old roundabout and a considerable amount of debris. Part of the western wall and south-west corner were dismantled to construct a modern garden centre.

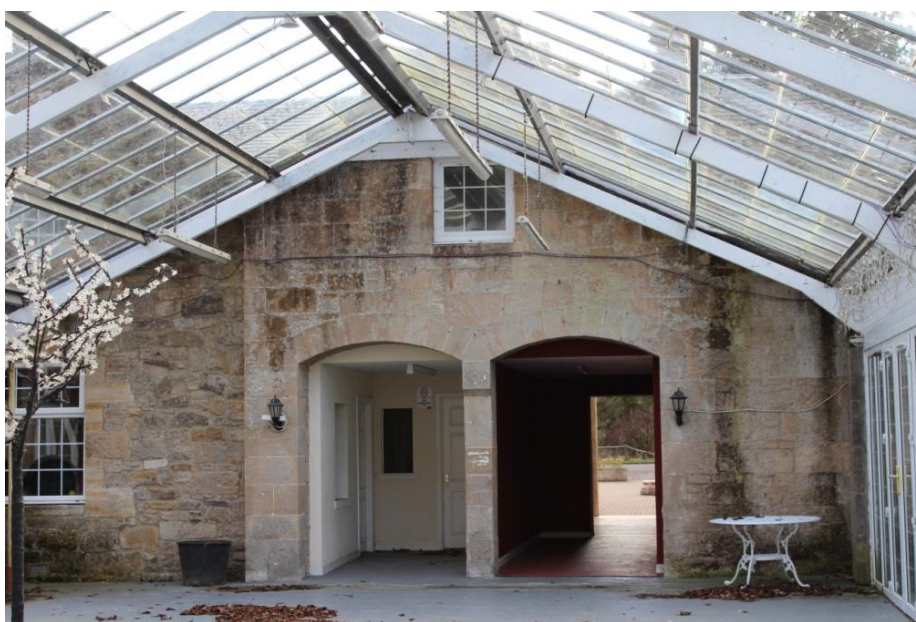
Illus 16: Interior of the Courtyard Stables, showing north-facing wall with reconstructed archways under the modern glass and steel canopy.

The interior today is in a much altered state. A modern garden centre and café (now closed) have been built on the north side and there is evidence of alterations to the masonry around the courtyard walls. Large apertures around the courtyard would have given horses access to stables; along the east, these are now covered by glass and metal doors for former shops, but upper and lower iron hinges remain from their previous use. Large, modern glass units for former offices and a restaurant fill much of the interior space. A metal and glass canopy covers the entire courtyard and a concrete base covers most of the floor. A narrow, double stone cornice runs around the courtyard wall above the level of the doorways, and there are square and circular windows set into the crow-stepped gables. Other earlier features include a refurbished gas lamp set in one wall and an area of encaustic mosaic tile flooring.

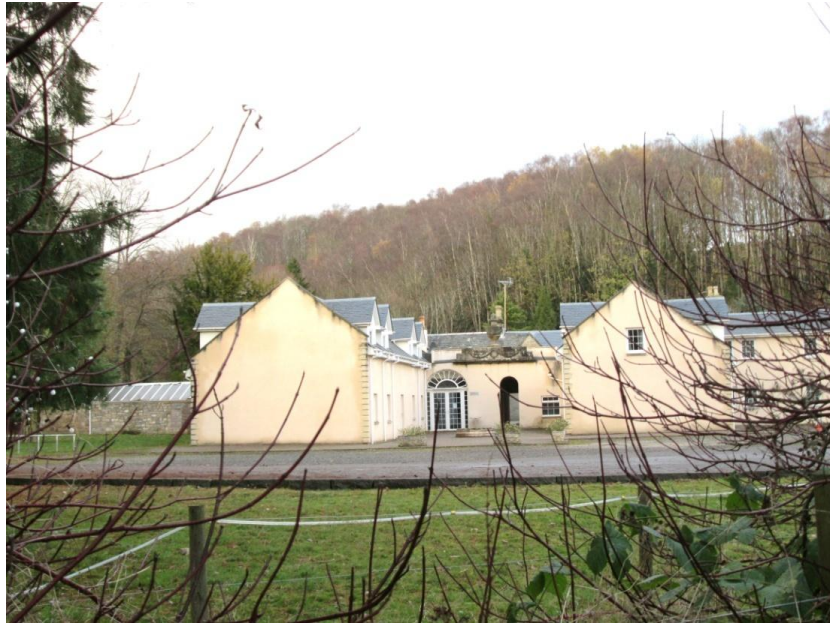
Illus 17: Courtyard Stables, with the modern hotel complex built against the original façade and Aaronshill Wood in the background.

Outside, the former coach house has been modified with a large extension faced with re-used stone blocks; until recently it was the Coach House Restaurant. Two other modern, two-storey extensions on the east were formerly a hotel. Some small stone buildings to the east of the Stable Block may have originally been an estate office and gardener's cottage, but they are much modified and in poor condition. Areas of the surrounding ground lie under decking, crazy paving and gravel. Several holly and Lawson cypress trees stand outside the Courtyard Stables on the south.

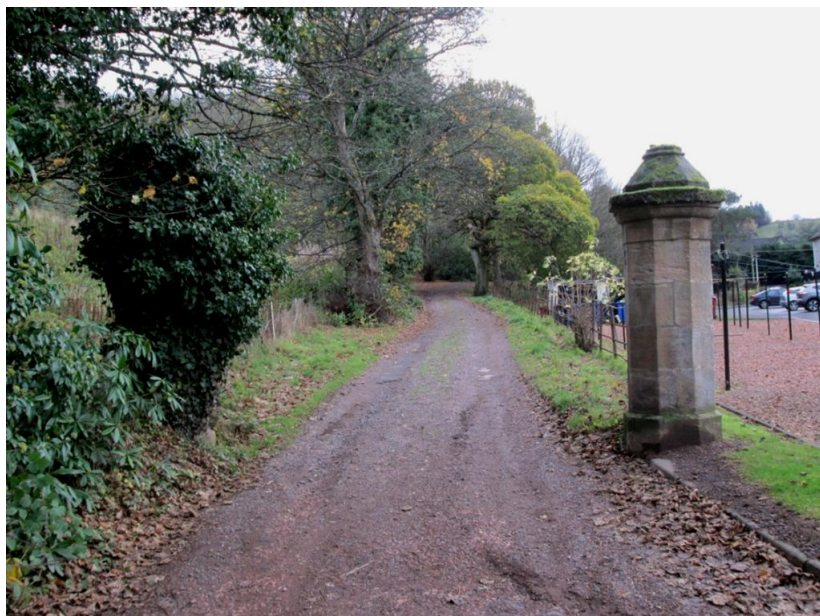
Illus 18: North Drive.

The North Drive is a continuation of the Main Drive that sweeps past the site of the mansion house. It exits the estate onto Nemphlar Moor Road between two sandstone gate posts. Like Main Drive and Forestry Road, it is first depicted on Forrest's (1816) map, and was probably historically a service drive. It is bordered on the east by policy woodland, while on the west the ground slopes down towards Holm Park. Sections of concrete and iron strap fencing are visible along sections. Scattered along the west side are sandstone blocks from stone pillars, many decorated with a Greek key pattern. The drive is unsurfaced and in reasonable condition, although there is evidence of erosion and land slippage at various points along the east side. Ivy, ferns, rhododendron and holly grow along it, as well as (in spring) snowdrops and daffodils.

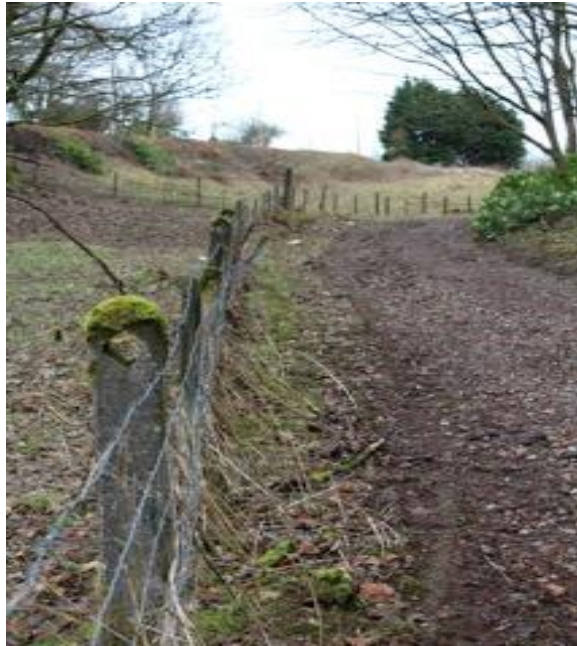
Illus 19: Forestry Road.

This is first depicted on Forrest's (1816) map. Today it is a single-track road leading east from North Drive along the north-east edge of Aaronshill Wood. The surface is very rough and overgrown, and metal gates close off both ends.

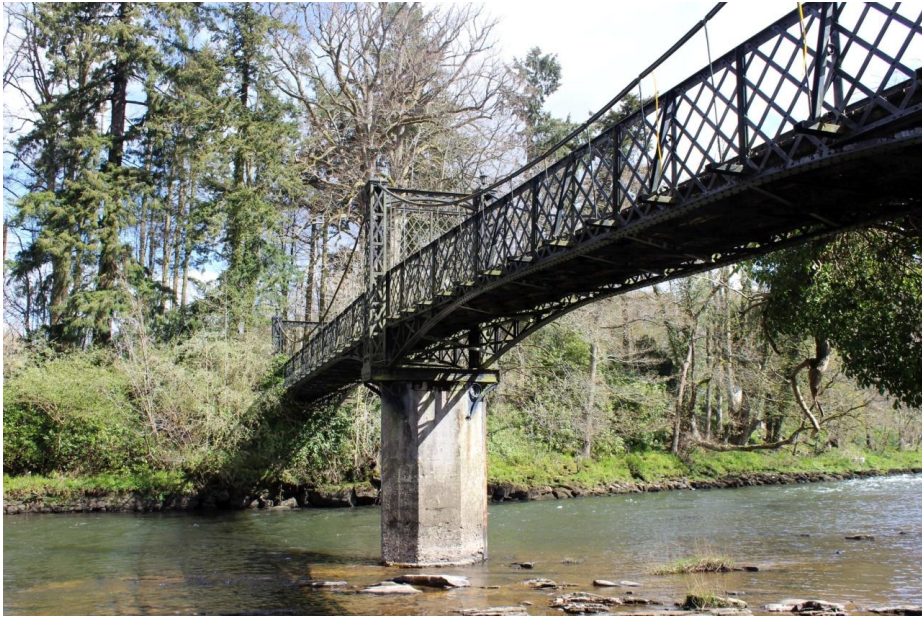
Illus 21: Carfin Footbridge.

Mr Graham had this ornamental iron footbridge built in 1897 to connect the south and north banks of the River Clyde and provide a fine pedestrian approach to Carfin House that offered splendid views of the river. The bridge is a trellis ironwork structure with three sets of towers, topped by electric lanterns, and a full-height iron gate halfway along it. The bridge is supported by a stone pillar in the middle of the river. Until fairly recently, it was used by local residents to access the estate and the river walkway, but it has fallen into disrepair and has been closed off.

James Graham had the ornamental suspension footbridge across the River Clyde built in the 1890s. It led into the Carfin estate opposite Underbank school and had a gate midway along it. A footpath along the south-western bank of the river was often used by the public for Sunday afternoon walks, and the gate was to prevent people from crossing the bridge from the path and entering the grounds of Carfin House (ibid). The bridge was fabricated by P & R Flemming & Co of 29 Argyll Street in Glasgow. Its restoration in the 1990s (Liddel & Young 2010) was awarded a Certificate of Approbation by the Commission for the Restoration of Rural Scotland and a Saltire Conservation Commendation from the Saltire Society, both in 1993. Today, however, it is again falling into disrepair.

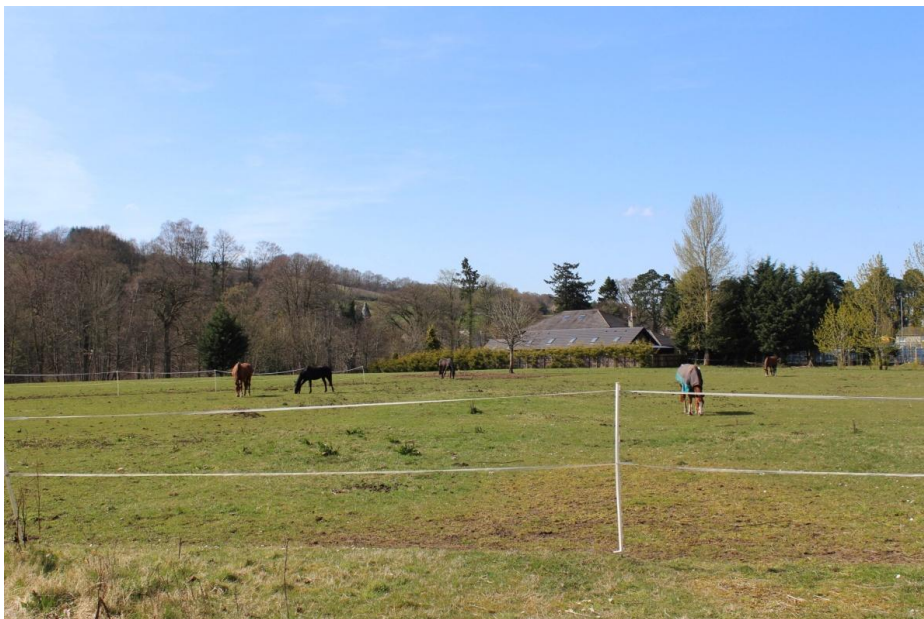
Illus 22: Holm Park, looking north-west towards modern housing.

Today, much of it remains open parkland under grass, shrubs and young trees, with early 20th-century iron strap fencing around it. It is used to graze horses. There are blocks of council housing with a recreation area at its western edge, and a small housing estate at its south-east corner. Above the parkland to the north can be seen a substantial modern house, which is actually situated among others at the top of the North Drive. At present the remaining parkland is used for grazing horses. There is evidence of the original strap fencing from the time of the Grahams all around the Holm boundary.

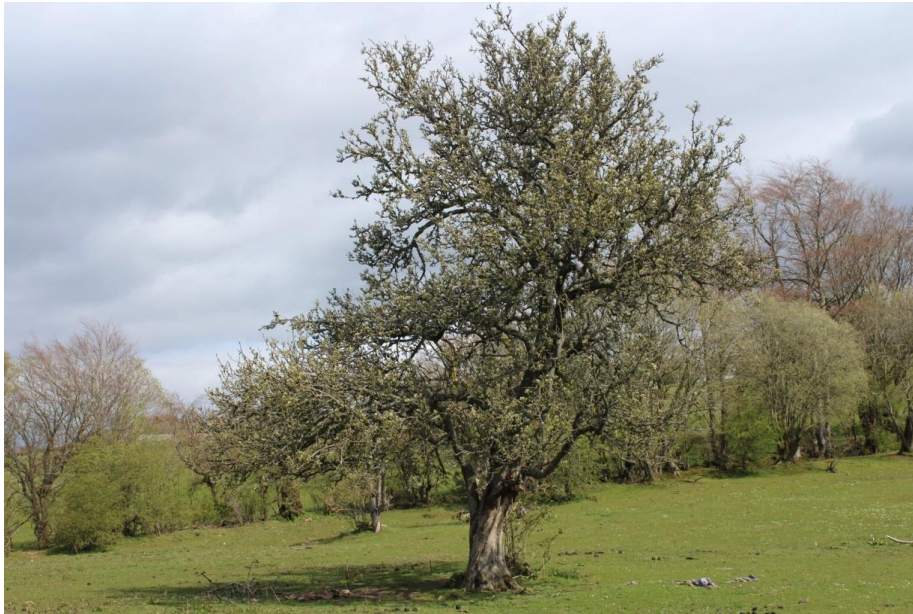
Illus 23: North Park, with an old apple tree remaining from the orchards.

Today the area is under grass, sloping gently south to north and undulating east to west, and is accessed from the Forestry Road. It is bordered by North-east Drive and Upper Lodge. It is currently used for grazing ponies and is rather neglected, but in the past (1970s and 1980s) it was used for grain cultivation. One very old apple tree remains in the parkland from the former orchards. The northern part contains a small, knee-high brick structure that covers a cistern. According to a local source, this was one of several cisterns established on high ground to collect rainwater for the Walled Garden.

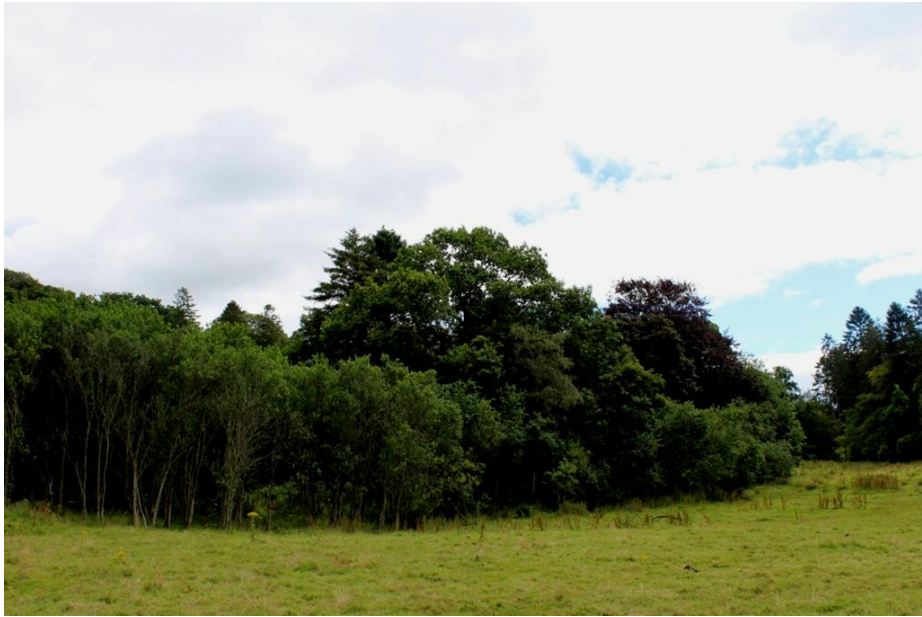
Illus 27: An area of woodland in East Park, looking east.

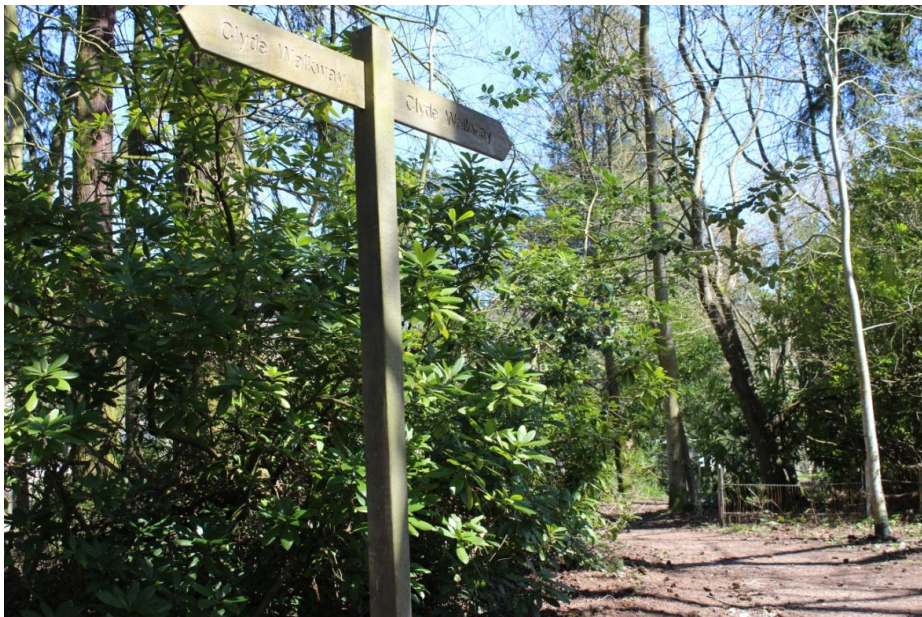
Illus 29: Riverside Walk with Clyde Walkway sign.

A pleasure walk along the riverbank was established before 1896, as it first appears on the 2nd edition OS map. It now forms part of the Clyde Walkway and is surfaced with hard core. It is bordered on both sides by mature specimen trees, including oak, Scots pine, beech, Corsican pine, lime, Norway spruce, laurel and rhododendron. The path runs past Carfin Footbridge, where a low gate leads towards the site of the house. Many of the trees along the path bear numbered metal tags which are growing into the surface of the trunks, indicating a tree survey was carried out in recent decades; many of the trees are decayed and neglected. The path is under constant threat from water damage and erosion. Some attempts have been made to shore up various sections from being undermined by the river.

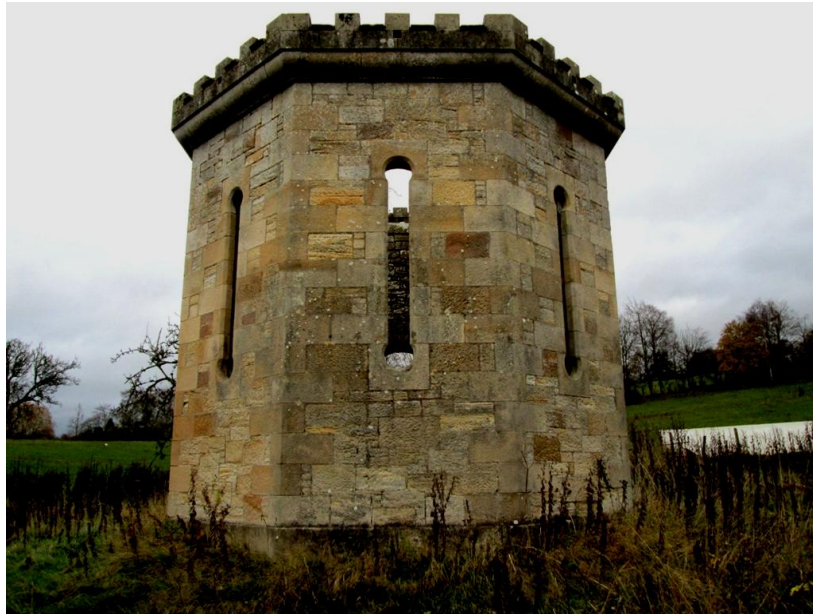
Illus 30: The Folly with its castellated parapet and keyhole windows.

The folly is an octagonal, roofless tower, constructed of blonde sandstone. Each side is approximately 2 by 6 metres with a long, narrow, keyhole shaped window. The arched entrance faces to the north-east, and remnants of a wooden doorframe (about 2.5 metre high) are still visible. One window aperture contains evidence of a wooden frame, which suggests that the windows were glazed at one time. A crenellated parapet runs along the top of the wall. Inside, halfway up the wall, are the remains of a wooden plate inserted in the wall, with joist holes below it, which would have supported a viewing platform. At present the floor is overgrown with brambles and nettles, with the rotting remains of an 0.75-metre high wooden platform and ramp. The stonework is generally in good condition and it may have been repointed in the past, but overall the structure is neglected. It is not recorded in the National Record of the Historic Environment for Scotland.
