The Development of the Gardens and Designed Landscape at KERSE HOUSE, CLYDE VALLEY

Kerse House, Clyde Valley

Report on the development of the designed landscape

April 2017

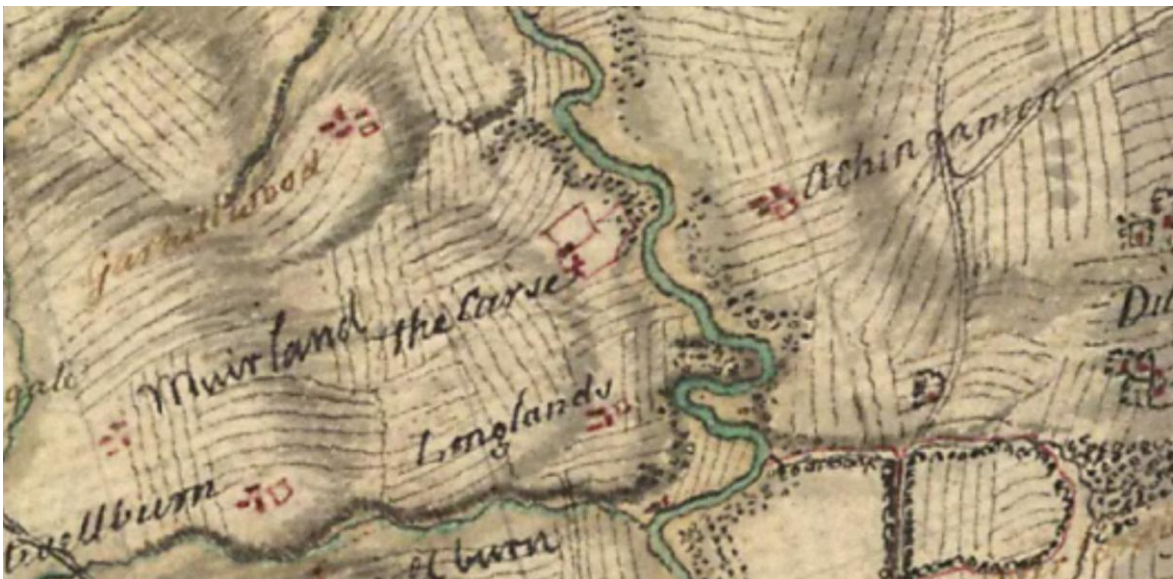
Illus 2: Roy's Military Survey of Scotland (1757) (©British Library).

Roy's map is the earliest map found to show Kerse or 'the Carse', which is depicted on the edge of one of two enclosures, the interiors of which appear not to be under cultivation. It is shielded from the Nethan Water by a tree belt. The surrounding land is under unenclosed cultivation.

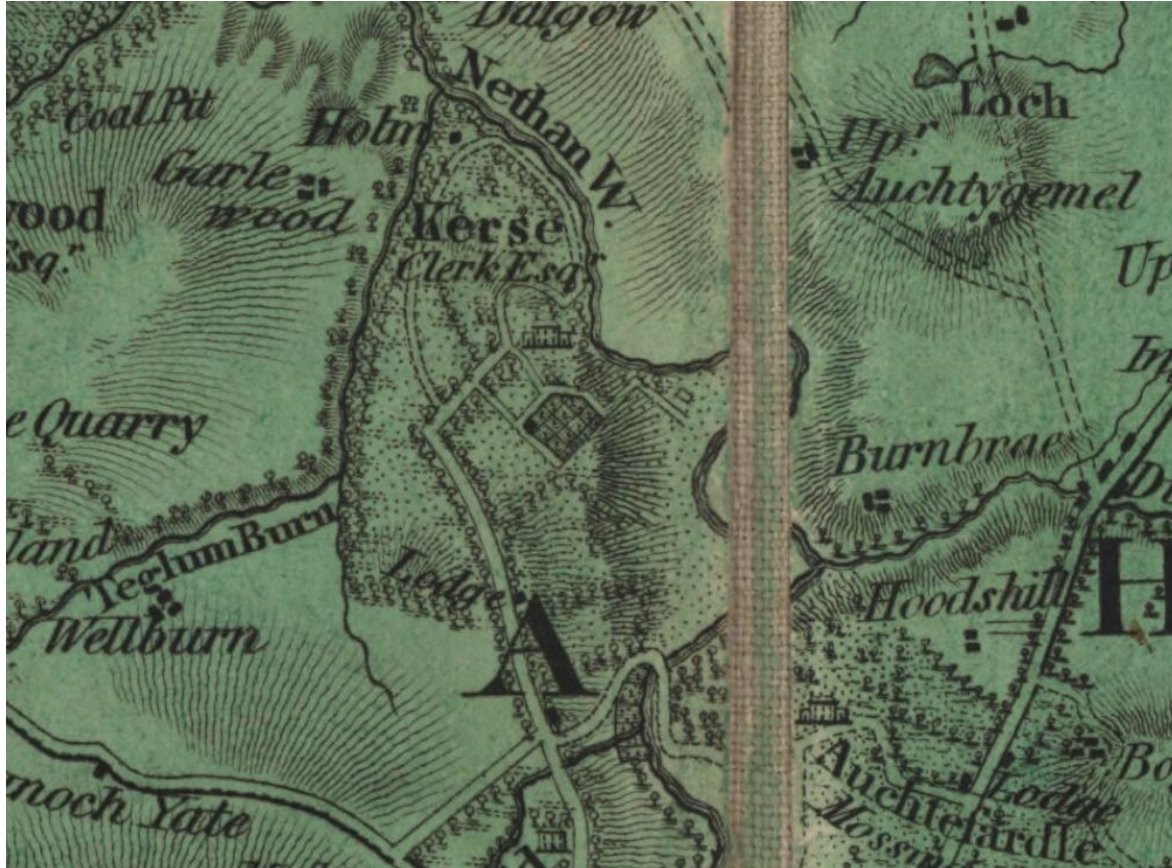
Illus 3: Forrest's map (1816) The County of Lanark from Actual Survey.

Forrest's map is the earliest found that shows any detailed features on the estate. It clearly shows an almost square Kitchen Garden to the south of the main house with a building (Gardener's House?) at its western corner. A tree-lined access road (Lime Avenue), complete with Entrance Lodge, leads to Kerse House. Paths link the garden to the access road and the house. There are further paths around three sides of the garden, one of which extends down a steep slope towards the river. Another path loops to the north (Northern Loop Path) from Kerse House down to the River Nethan and along it for a short distance before turning back to join the main access road. The residence, Kerseholmfoot (marked as Holm on the map), is located at the northern turning point on this loop path. The riverside part of the path is tree-lined. Further woodland extends along the burn at the western edge of the estate.

The main approach to Kerse (designated here as Lime Avenue) was established before 1816 (see Forrest's 1816 map, illus 3). The map shows this approach, tree-lined on both sides, passing from a lodge through policy parkland all the way to Kerse House. However from the 1858 OS map onwards the main section of the drive passed through what may have been agricultural land to reach a more formal boundary adjacent to the Home Farm, which had been built during the interim period.

Forrest's 1816 map (Illus 3) shows a path along the north-east edge of the garden extending to the area identified on the 1858 OS map as a pond and sluice, and on later editions as a Pumping Station.

Forrest's 1816 map (Illus 3) shows a path looping in an anticlockwise direction, from Kerse down to the river, along it and then returning to join the Lime Avenue near its dog-leg bend. The later OS maps also show connections to other paths around the loop's northern turning point at Kerseholmfoot, including a communication route north along the river. It is probable that the Northern Loop Paths served primarily as pleasure walks, though to some extent they would have also provided some access to the Kerse from the north. The path from the house down to the river was historically of open aspect. The riverside walk was flanked by trees along the river edge, with the northern and return sections of the loop being bounded by more heavily wooded areas. A more direct path provided communication through the Policy Parkland between Kerse House and Kerseholmfoot, while a parallel path followed a more circuitous route along the western boundary burn back to the Lime Avenue.

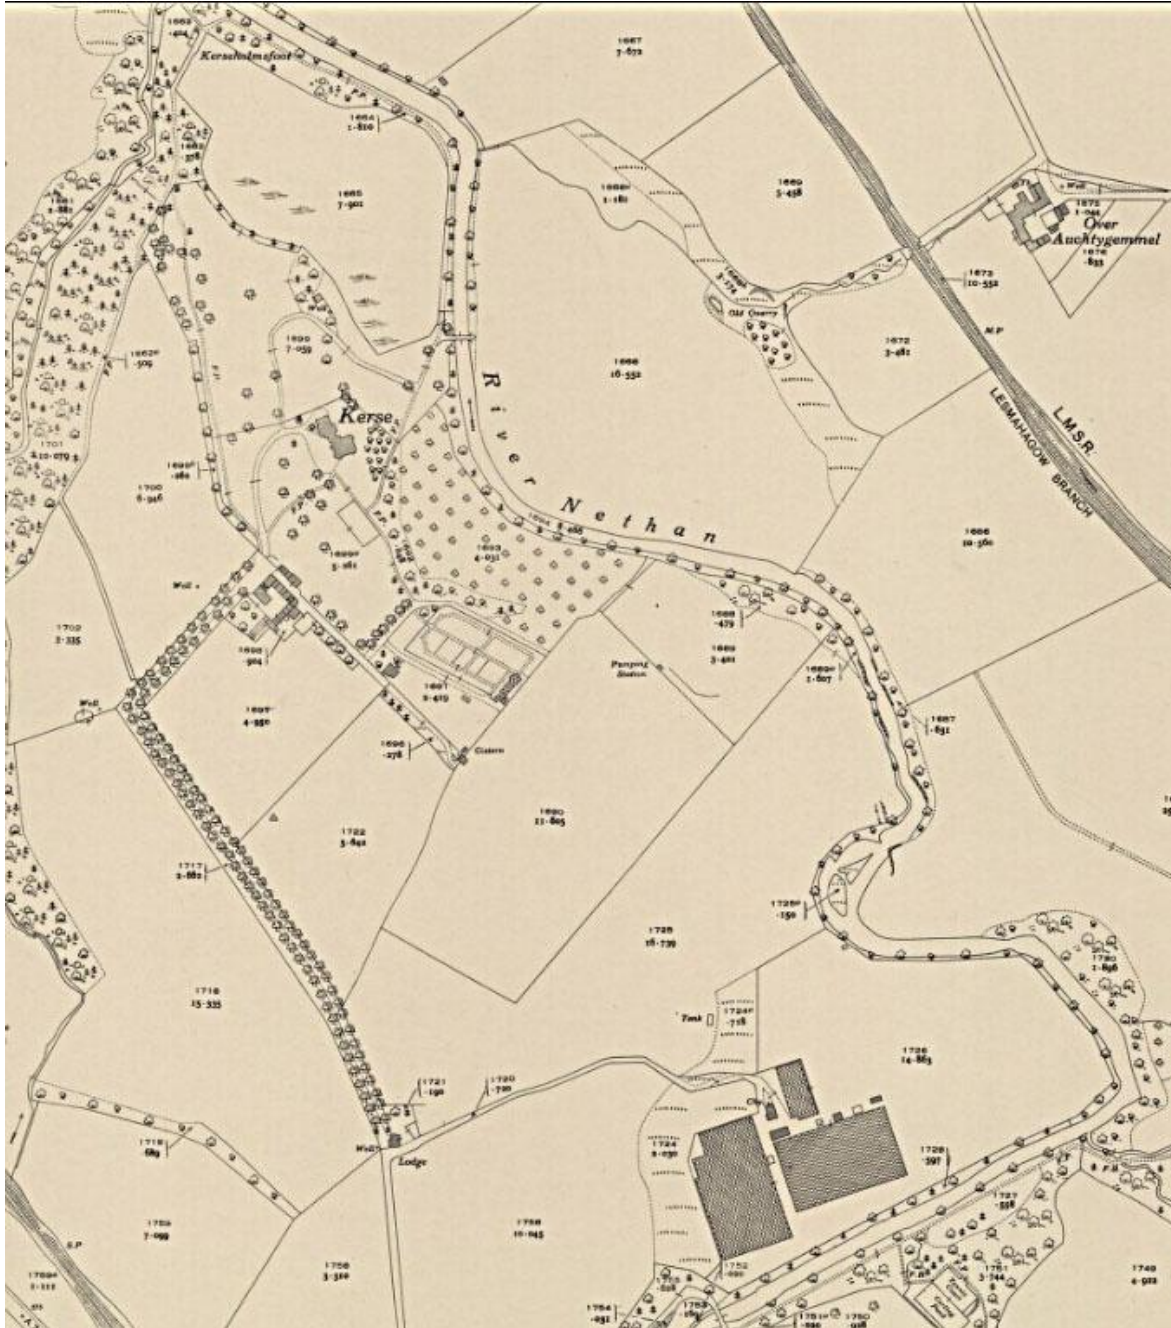
Illus 6: Ordnance Survey 25-inch (4th edition), Lanarkshire O25.11. Surveyed 1941, published 1947.

There were few further changes to the designed landscape between 1901 and 1947. The garden's internal structure appears to have been consolidated more towards its southern side, and there is a new building next to the cistern. The well by the Gardener's House is no longer shown. The area immediately west of the Riverside Walk, previously shown without any landscape detail, is now identified as being

marshy ground. The residence at Kerseholmfoot may no longer have been intact by this time, and the path along the burn is no longer shown. The only other significant changes are a new plantation near the main house and a rectangular feature (possibly a tennis court or croquet lawn) beside the path linking the house to garden, next to the site of the original house.

The map also shows a large new greenhouse complex to the south of the designed landscape, established after 1909 and accessed via the lodge.

Large greenhouses were erected at the southern end of the Kerse estate during the early 20th century (shown on the 1941 OS map, Illus 6).

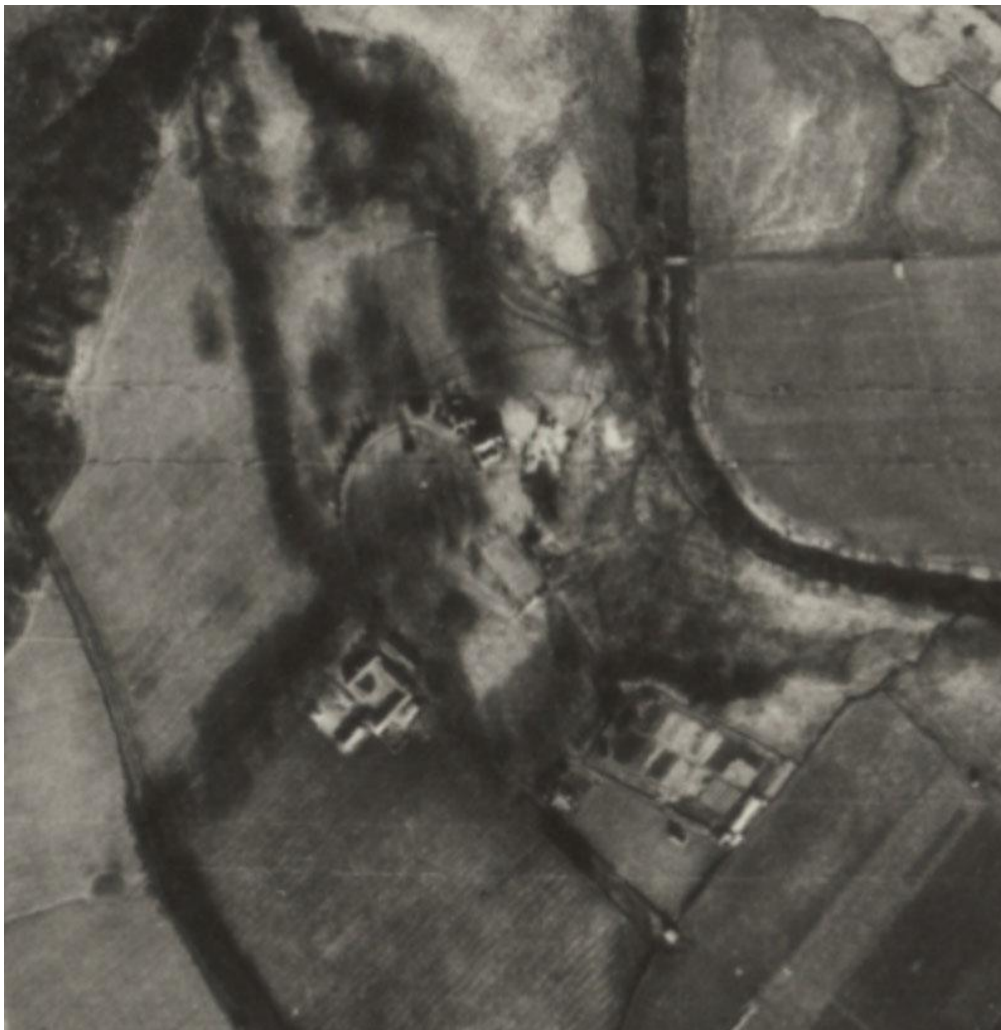
Illus 7: Aerial photo taken in 1944-50. Source: maps.nls.uk

The photo reveals internal details, not previously seen, in the garden area, and there may be some buildings in addition to the greenhouses. The rectangular feature identified on the 1941 map is also

visible, but not with any internal detail. The former plantation area to the north-east of the garden may no longer be there.

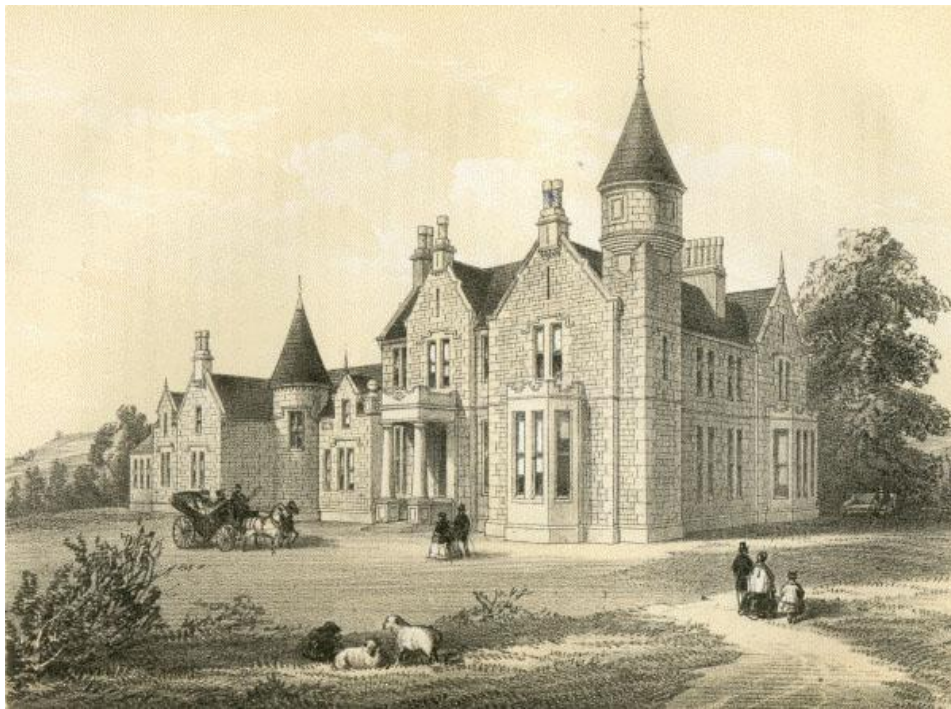
Illus 8: Kerse House, reproduced from Greenshields (1864).

The external façade appears to be in good external repair and retains the look of its portrayal in the 1864 engraving (see Illus 8). A detailed survey was not undertaken.

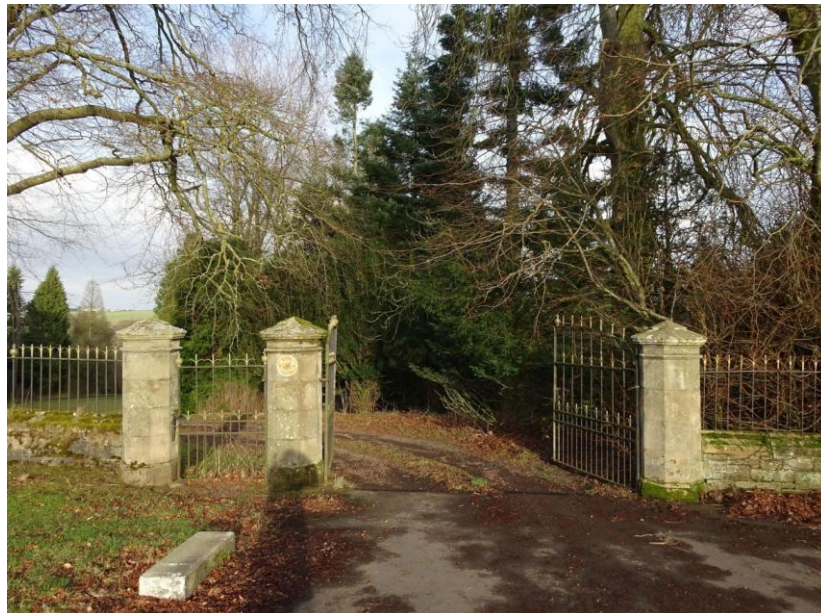
The entrance gateway to Kerse House (now renamed Little Castle) comprises three hexagonal sandstone gate pillars delineating separate vehicular and (former pedestrian) entrances. The pillars are set along a low stone wall topped with ornamental ironwork (illus 10). The internal driveway linking the entrance to the house follows the same path taken since the house was constructed, and remains unmetalled.

Illus 10: Entrance to Kerse House (Little Castle).

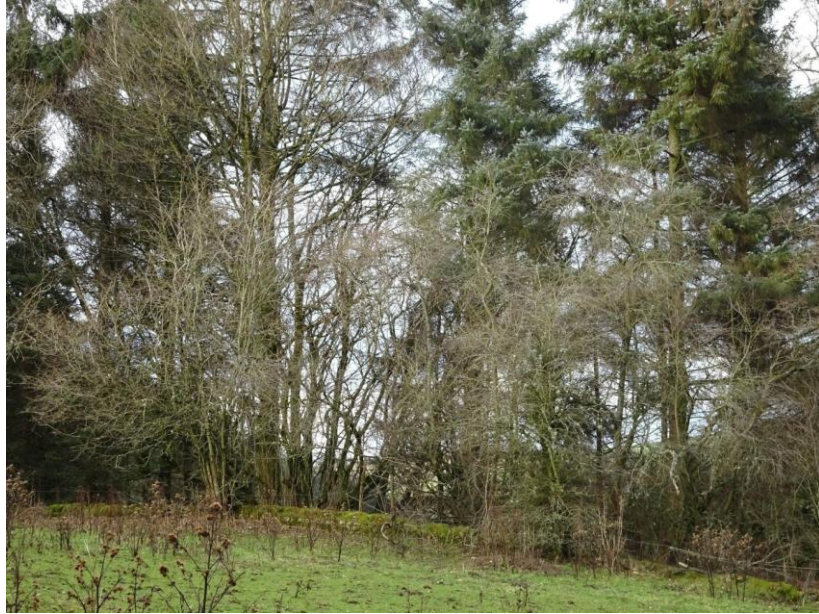
The Kitchen Garden now is largely flat, gently sloping open fields punctuated with some recent sapling growth and with trees encroaching around the borders, particularly in the south-west corner. The main part of the garden can still be discerned as a discrete entity within the boundary tree belts, but there are no obvious signs of its historical internal layout. The north-east boundary of the garden is defined by a low wall topped with the remains of iron railings.

Illus 11: Garden area and boundary wall with tree belt beyond (looking north from glasshouses).

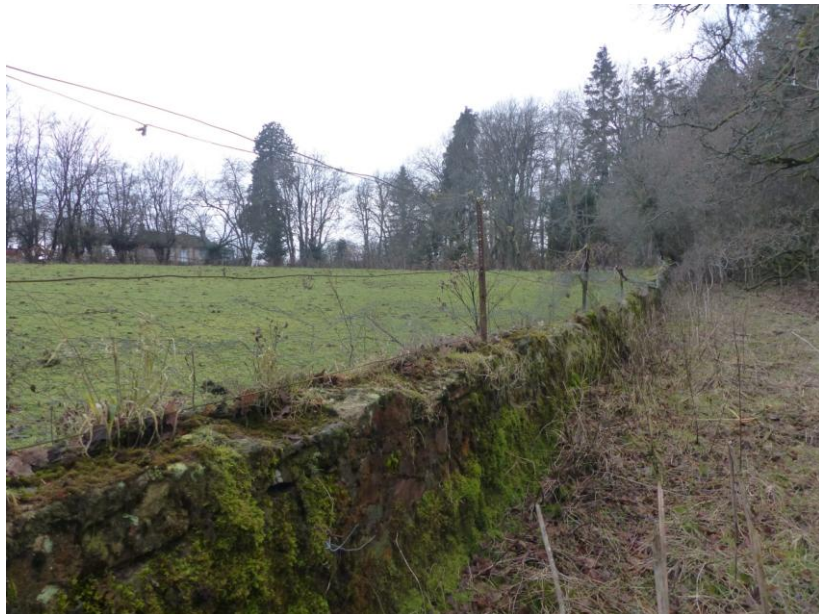
The Gardener's Cottage still stands and is occupied. It is stone-built, in good repair but awaiting renovation. A stone-built barn, possibly recently repaired, still stands to the west of the garden.

Illus 12: Kitchen Garden with Gardener's House in the distance (looking across north-east retaining wall).

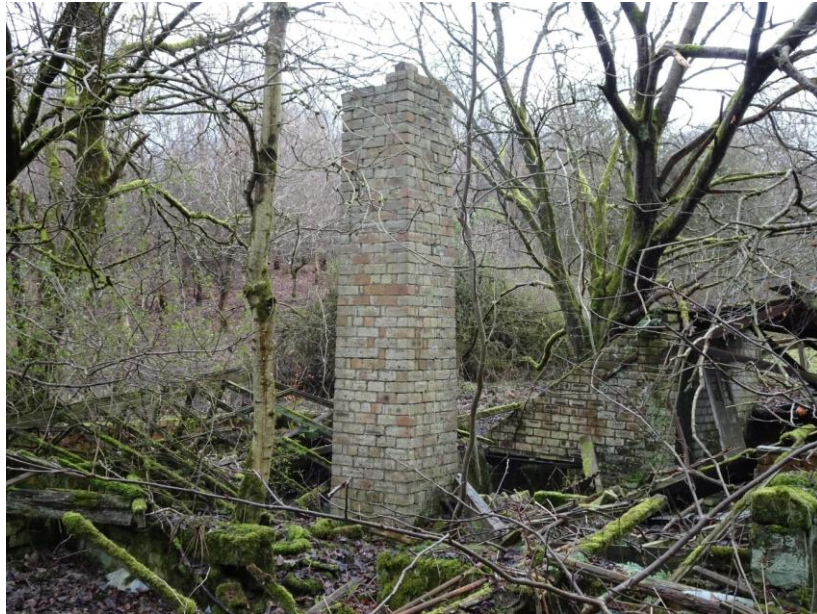
The remains of four glasshouses, comprising foundations, brick base walls and some collapsed timber roof supports, are still evident, along with some glass fragments, mechanical rods for opening windows and rusty metal troughs, presumably for watering. There are also remains of two low brick buildings within the Glasshouse Complex, possibly a shed and furnace, respectively, together with a largely intact brick chimney. Today, trees grow freely among the remains. To the north of the glasshouses there are a series of long, thin, parallel concrete structures lying prone or partially buried. Their function remains uncertain; they could be some kind of bed edging.

Illus 13: Glasshouse remains.

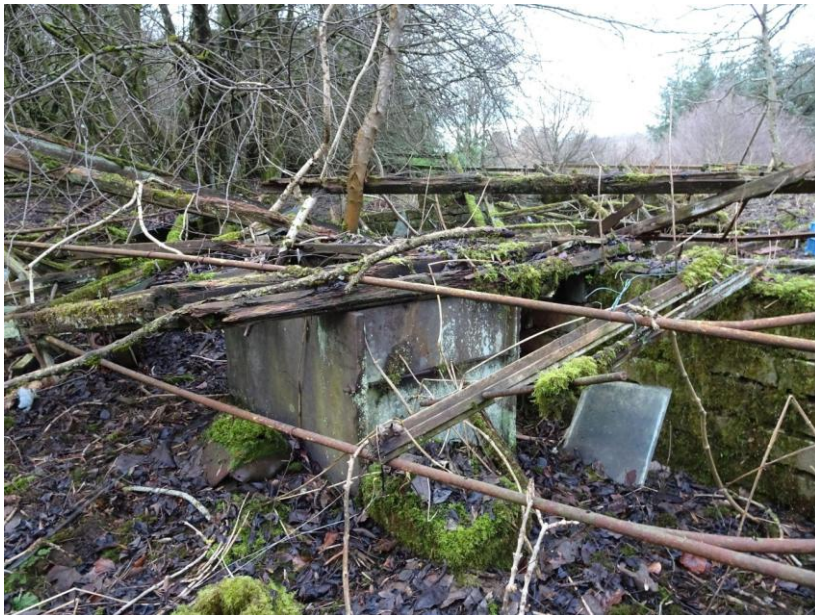
Illus 14: Window rods and tanks among glasshouse debris.

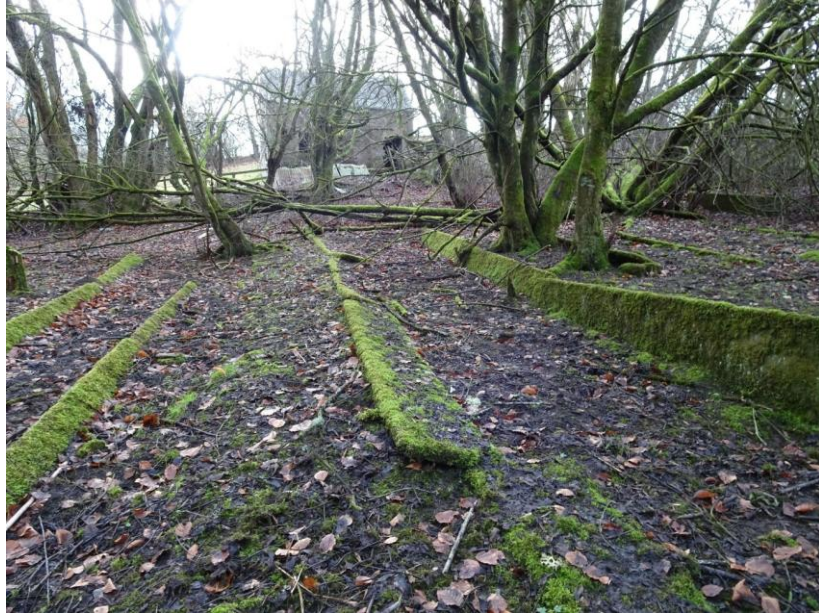
Illus 15: Linear concrete features near glasshouses.

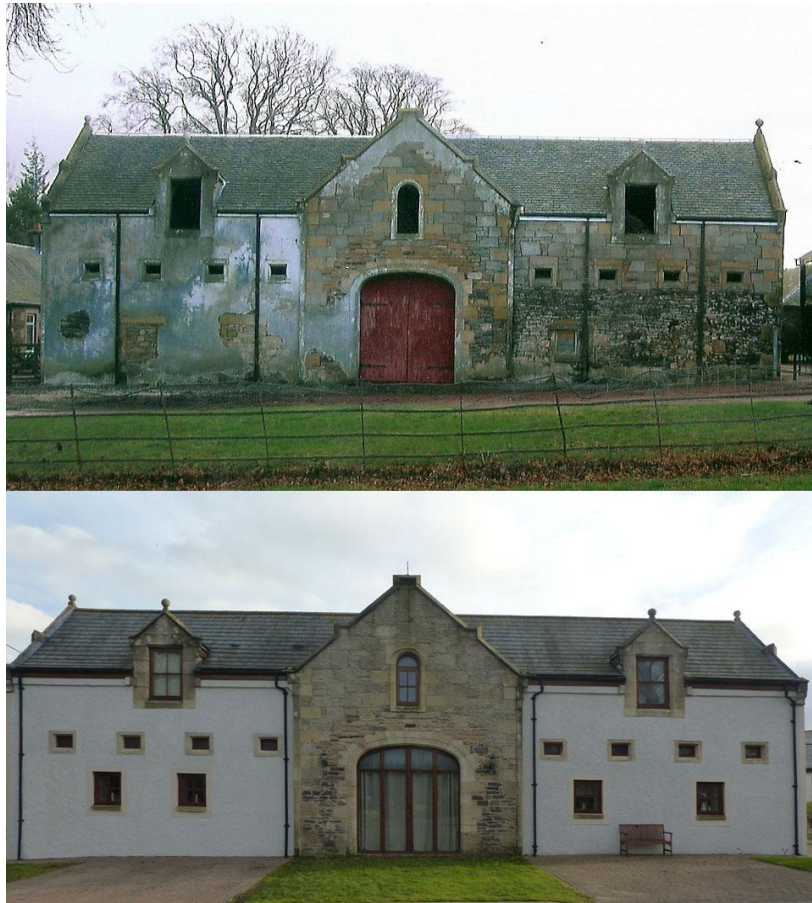
The first buildings and a yard were constructed at the Home Farm site between 1816 and 1858. The buildings were significantly extended by 1896, with multiple farm units depicted on the later maps. Units are believed to have included a stable block and coach house; they could also have housed cattle.

The Home Farm buildings underwent extensive modernisation together with new construction and conversion into dwelling houses c 2008. A two-storey building on the north-west facing side shows the former archway leading to what was the stable yard, now a courtyard. The single-storey stables on the other sides of the courtyard were also converted into residences. Illus 16 shows elements of the stables prior to and after conversion. Stone pillars for field gates to the surrounding agricultural areas still stand along the Lime Avenue and within the Home Farm Complex. The pillars are of yellow sandstone, mostly complete with the integral ironwork for gate hanging.

Illus 16: The stable block in the Home Farm Complex, before and after conversion.

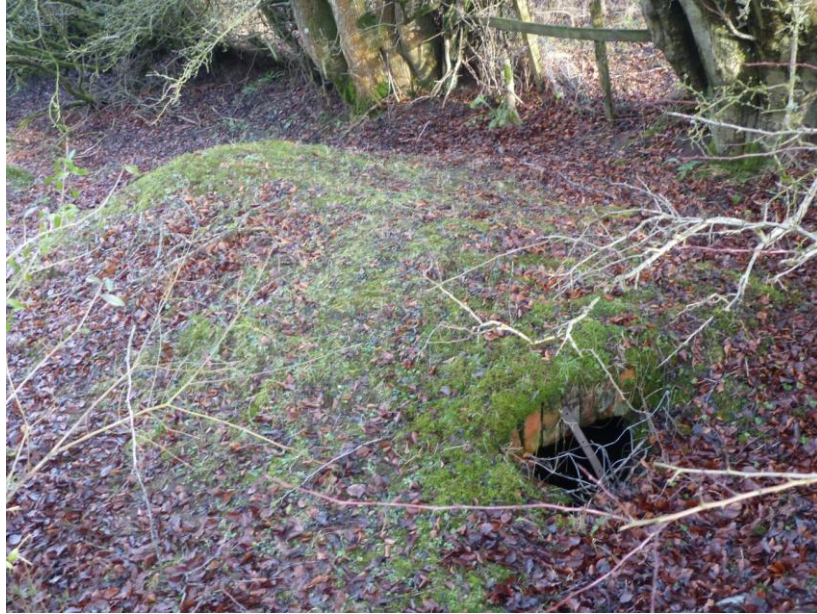
The Cistern is still evident today as a grass-covered, brick-built, barrel-vaulted chamber (illus 17). There is a spring adjacent to it and the ground is boggy at the site where the water feature was shown on the earlier maps.

Illus 17: Cistern.

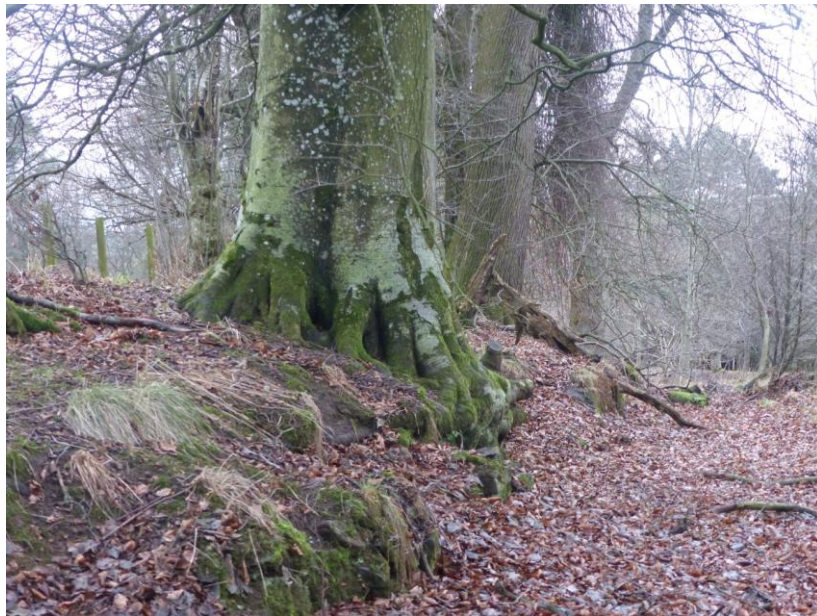
The northern tract of parkland now features some modern planting of broadleaved trees, mainly birch, giving way to older beeches and limes. Remains of a low stone boundary wall can still be seen along the western edge of the northern parkland area; it is overgrown in places by a line of mature beeches (illus 18). The remains of a building, though not the well itself, are still present at the top of the slope to the north-east. The purpose of the well building is not clear, though it is noted that the window position did provide a vista across the River Nethan.

Illus 18: Northern tract of Policy Parkland showing overgrown boundary wall marking the line of the former direct path to Kerseholmfoot.

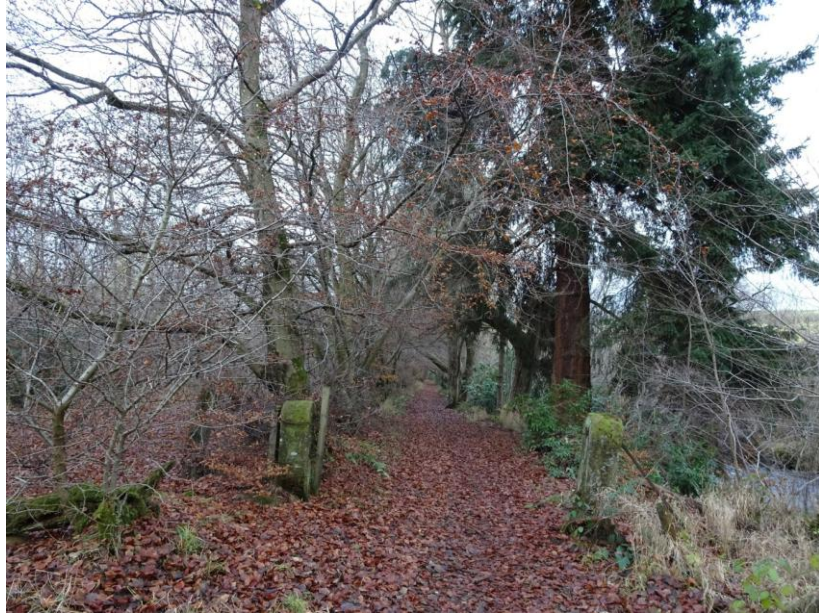
Current paths still trace the original courses of the main Northern Loop Paths. The Kerse to Nethan section, while recently maintained, provides solely private access to and from the back gate of Little Castle. The eastern section of the path now passes through a conifer plantation. The riverside walk and main return section of the loop now form part of South Lanarkshire Council's core path network. These sections link with the riverside path to the north and with a more modern pathway extension that follows the river to the south.

The riverside walk runs for around 400 m, bordered on one side by the Nethan and on the other by the remains of a wall with an overgrown beech hedge on top and some residual iron fencing. It is flanked by an avenue of large mature trees, including Douglas firs, poplars and very large Scots pine with smaller oak, beech and limes (illus 19). There are also occasional rhododendrons along the riverbank. The entrance from the Policy Parkland to the south end of the riverside walk is marked by stone gate pillars. The main Kerseholmfoot to Lime Avenue return section is a well-used, hard-packed path that starts with a very steep ascent, crosses a short, narrow ridge showing signs of erosion (illus 20), and passes through an old beech woodland giving way to a hedged garden on one side and fairly newly planted ornamental trees on the other.

Illus 19: Start of riverside walk at the southern end of the Northern Loop Paths.

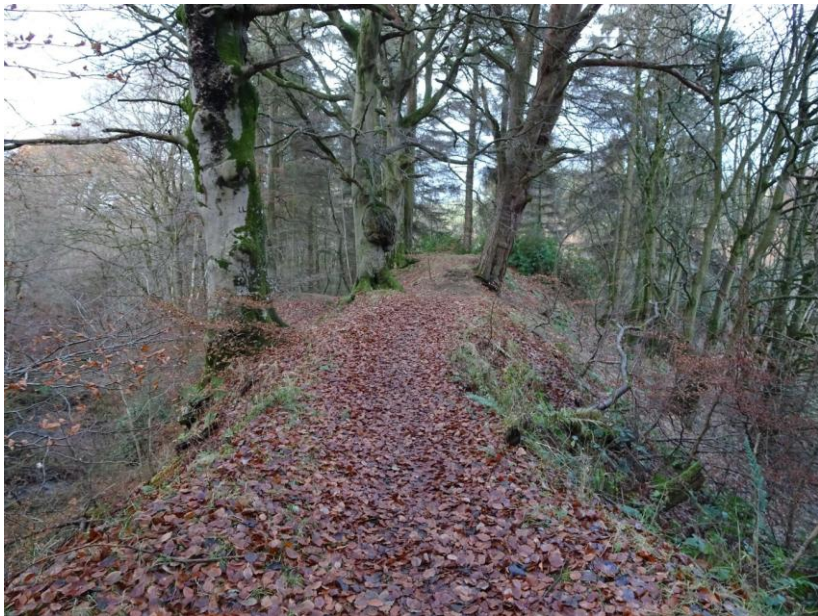
Illus 20: Narrow ridge on the Kersholmfoot to Lime Avenue path.

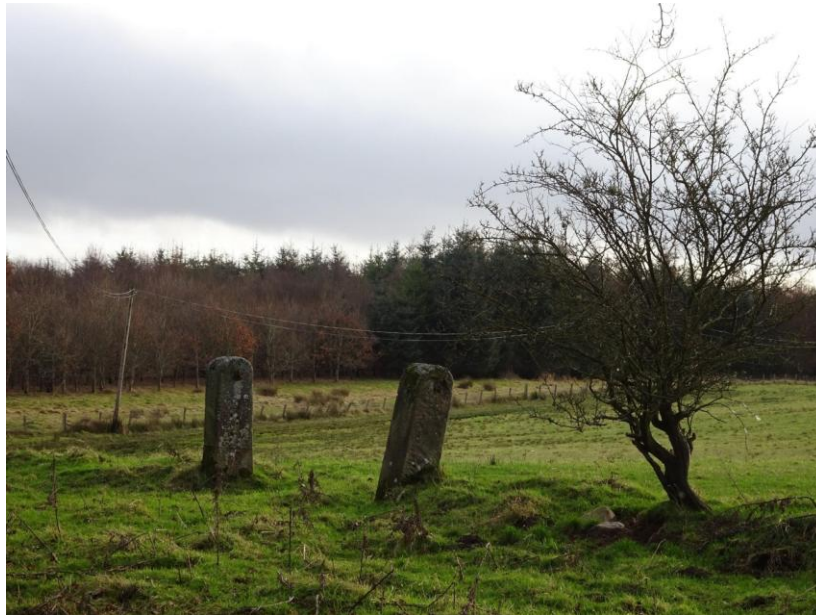
A road, initially metalled, follows the path of the old road by the coach house, through a gate where the road becomes unmetalled to the Gardener's Cottage. The road now terminates at a second gate into a field. While the road is no longer present past this point, a slight ridge in the grass alongside its old path depicts the line of the former field boundary. Two isolated stone gate pillars sit on this boundary line. The road to the north-east of the garden is no longer present, though a stone gate pillar does mark its former entrance to the fields to the south.

Illus 21: Examples of gate pillars.
