POW BURN RESTORATION, RIVER SOUTH ESK, ANGUS

Report on the results of a watching brief

16/00522/FULL

September 2016

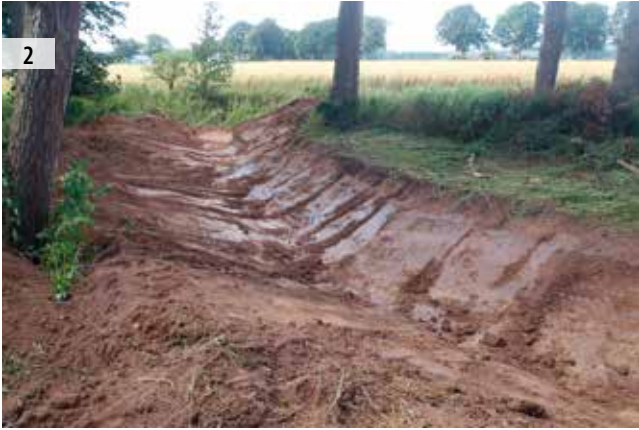
Channel 4 curved to the north-west around an area of mature trees, and measured approximately 60m in length and 6m in width (Illus 2). Where the channel met the burn, it was 1m deep, reaching up to 1.5m deep at the bend in the channel. The sequence of deposits across the excavated area was uniform, with 0.2m of silty topsoil (001) overlying 0.8m to 1m of silty-clay alluvium subsoil (002). Geological subsoil was encountered at 1.5m within the bend of the channel and was a yellowish-grey very slightly silty clay.

ILLUS 2 Channel 4 facing east **ILLUS 3** Channel 5 facing north-east

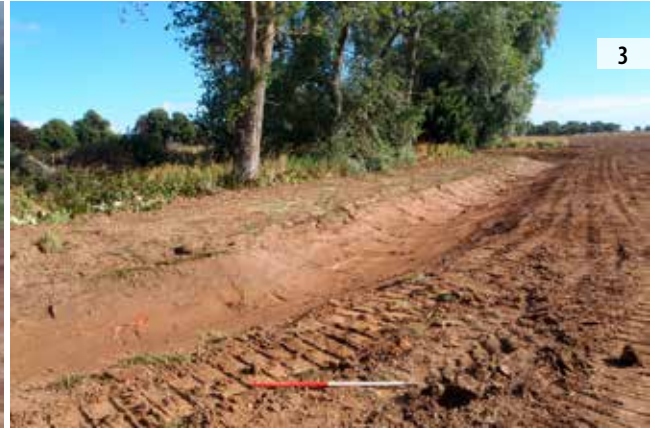
Channel 5 was located 32m to the north-east of Channel 4, and ran along the edge of a ploughed field (Illus 3). Channel 5 was straighter than Channel 4, but also turned to the northwest. It had a total length of around 68m and a width of approximately 5m. As with Channel 4, the depth was around 1m where it met the Pow Burn, deepening to 1.5m in the centre of the straight section. The sequence of deposits comprised an upper layer of silty-clay plough soil (003) 0.6m thick overlying a silty alluvium subsoil (004) up to 0.7m thick. Geological subsoil was revealed at the base of the north-east bend of the channel, 1.1m from the surface and was a yellowish-grey slightly silty clay similar to that in Channel 4.
