EARLS GATE PARK, GRANGEMOUTH

*Desk Based Assessment, Archaeological Excavation
& Historic Building Recording*

for Bericote (Ryton) Ltd

March 2012

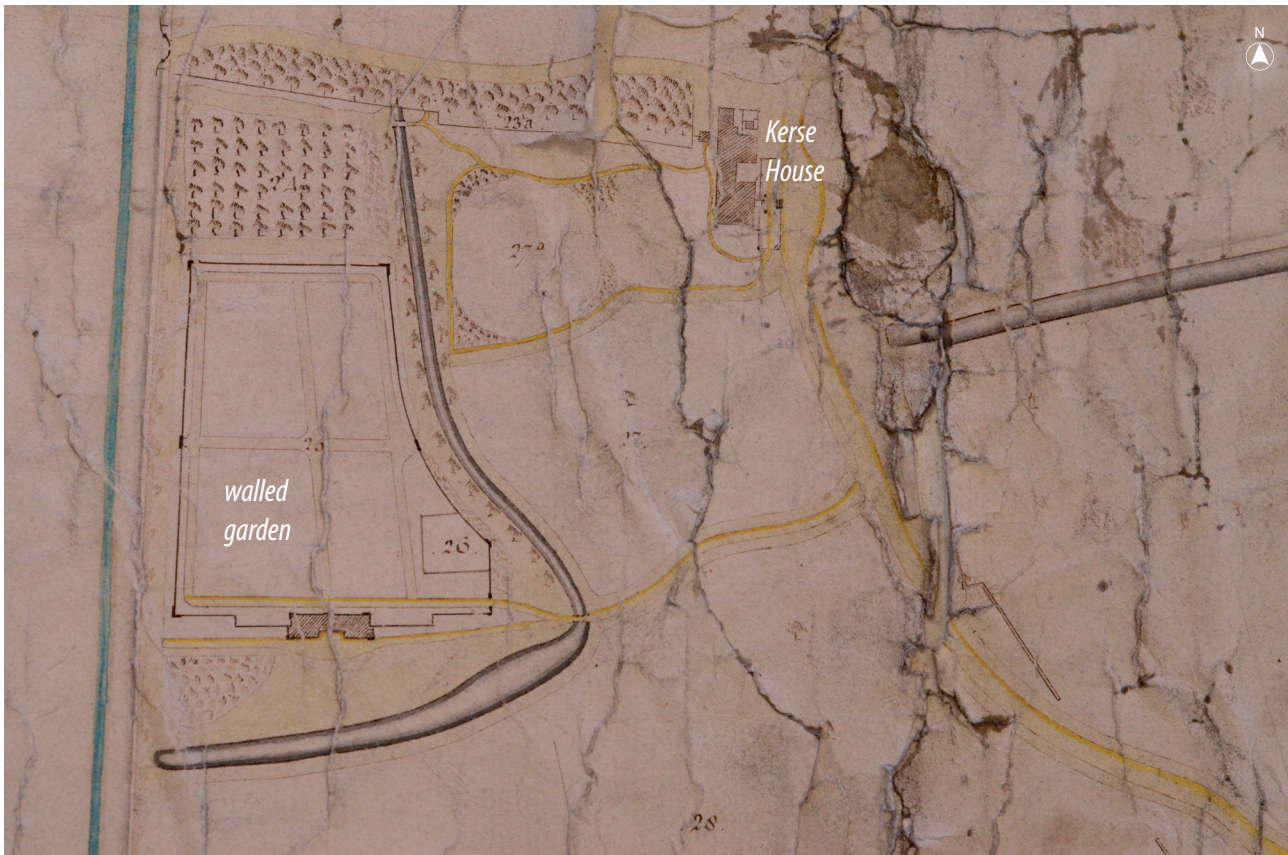
Detail of 'Plan of estate of Kerse. . .', late 18th century (RHP 48368)

Kerse House and grounds are depicted in detail on a late 18th century estate plan (RHP 48368; Illus 7). The form appears very similar to that depicted in the mid-

As shown on Illus 7 a garden wall is aligned east-west to the west of the house, while paths or roads around the estate grounds are also evident. A waterway extends eastwards at the same location as that noted on both Roy's map and the 1761 plan. A wooded area west of the house is labelled 'back park', with the open ground to the south a 'bowling green.'

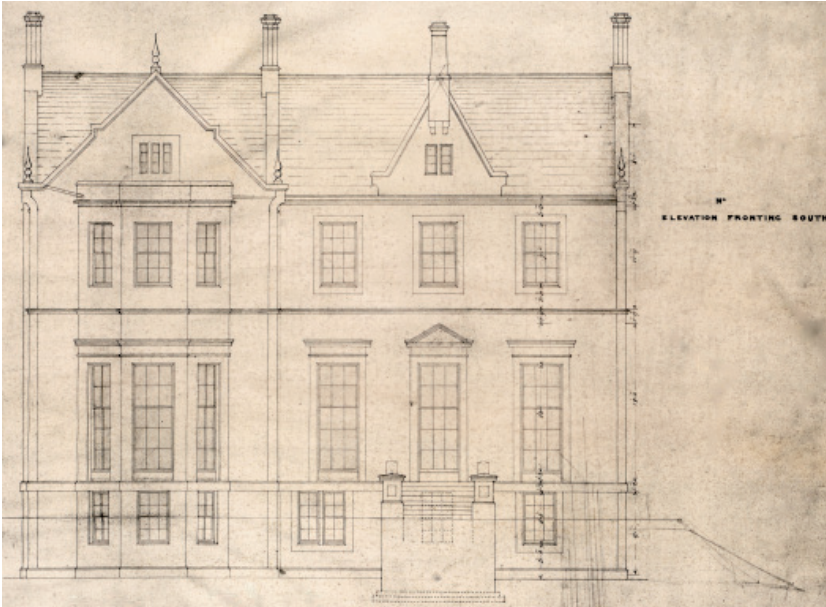
Illus 11

Architectural plan of south elevation of Kerse House, 1876 (STD/105/18)
©RCAHMS

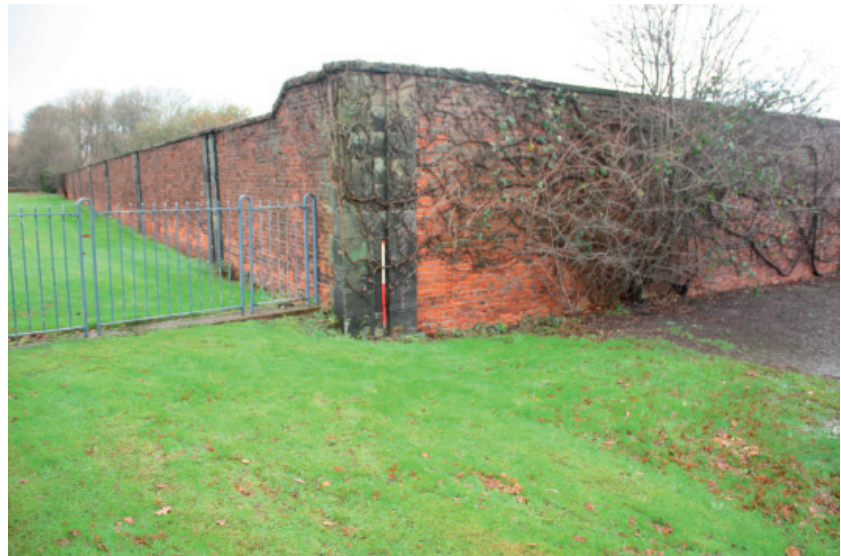
Illus 14

North-facing shot of walled garden showing stone pillar (photo 047)

The walls stood up to 3m in height and were constructed of randomly coursed, hand-made brick topped with stone coping (Illus 14). Coarse white/grey cement formed the bonding material. Indented dressed stone pillars, 1m wide, were located at intervals of 10.5m and at corners. One of the pillars on the west side bore carving suggestive of a construction date: '17.7.77'. A less legible impression appears to state 'IT 1772' (Illus 15). An entrance-way with moulded pillars was located at the southeast corner, while a heavily moulded doorway was located in the centre of the east wall, with the lintel bearing a keystone motif. This type of doorway is found from the mid 18th century onwards (Brunskil 1971; Illus 16).

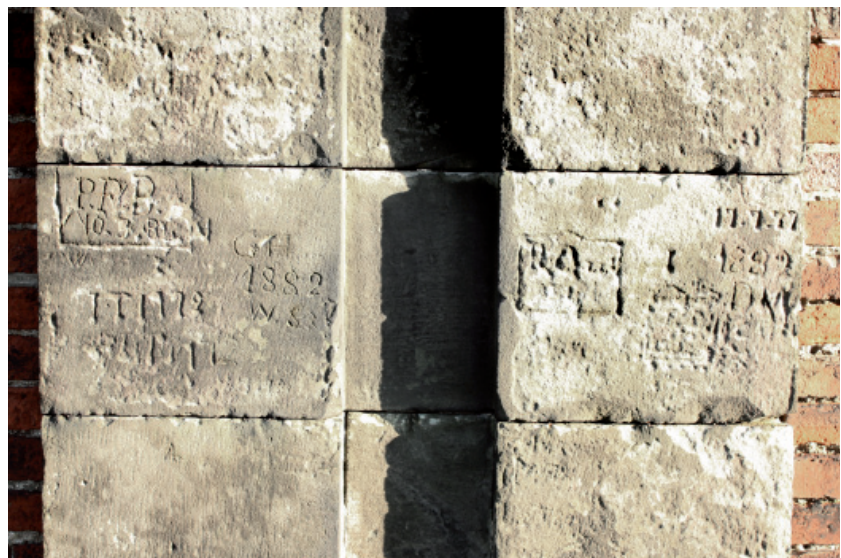
Illus 15

North-facing shot of walled garden showing stone pillar (photo 127)

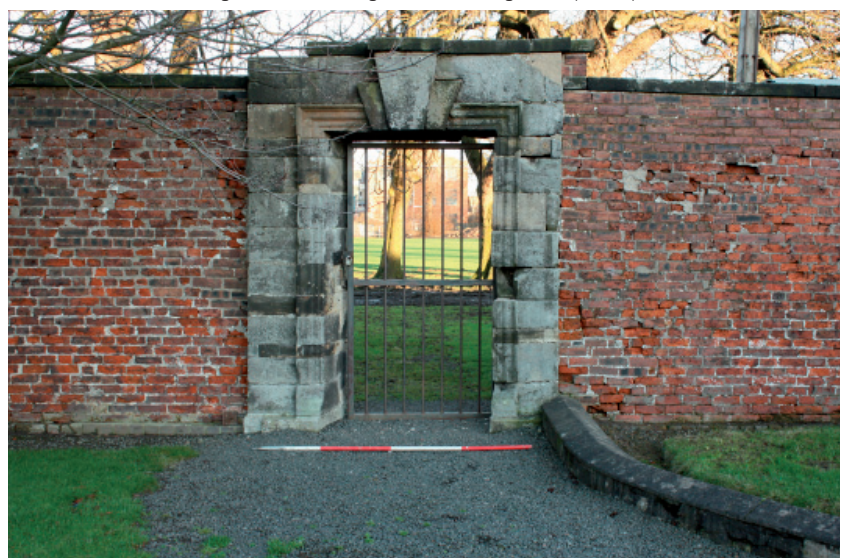
Illus 16

East entranceway with keystone lintel (photo 133)

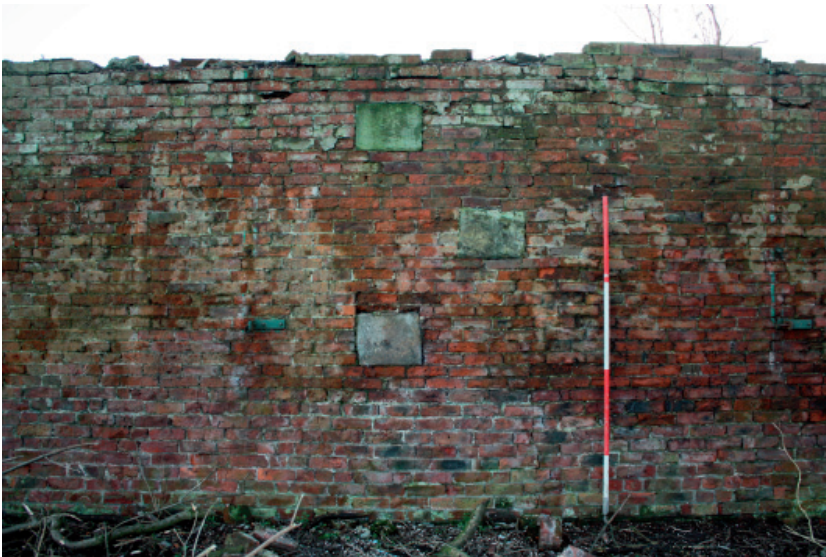
Illus 18

Sandstone blocks in north wall of walled garden (photo 148)

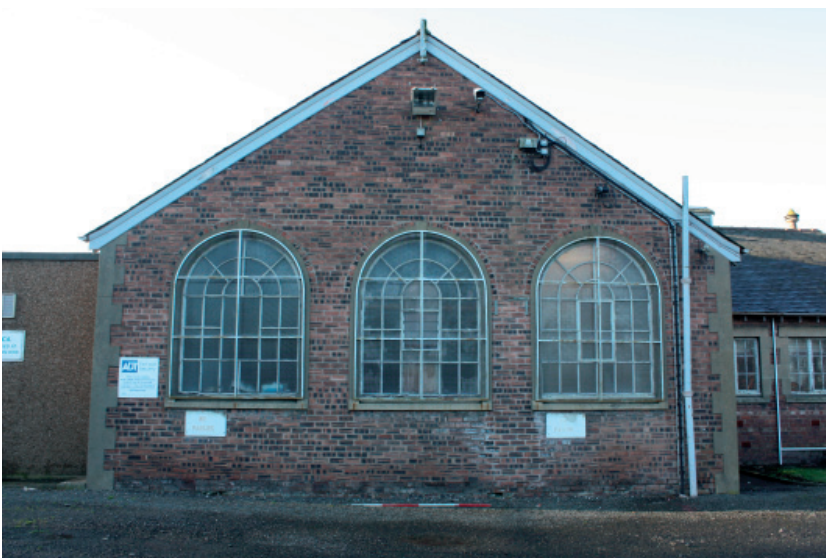
Illus 19

East gable of 'The Orangery' (photo 119)

The garden housed several brick-built, single-storey structures associated with a former recreation club which included a clubhouse, changing rooms, bowling greens and football pitch. The structures centred on 'The Orangery' located at the southern extent of the garden, which is rectangular in plan with pitched, slate roof. The gable ends each contained three windows with arched head (Illus 19). A ballustrated extension to the building projects to the south and the southern façade is harled. The buildings date only from 1930 and were not recorded in any detail. 'The Orangery' was a replacement for an earlier structure depicted in early 19th century plans (RHP 80127).

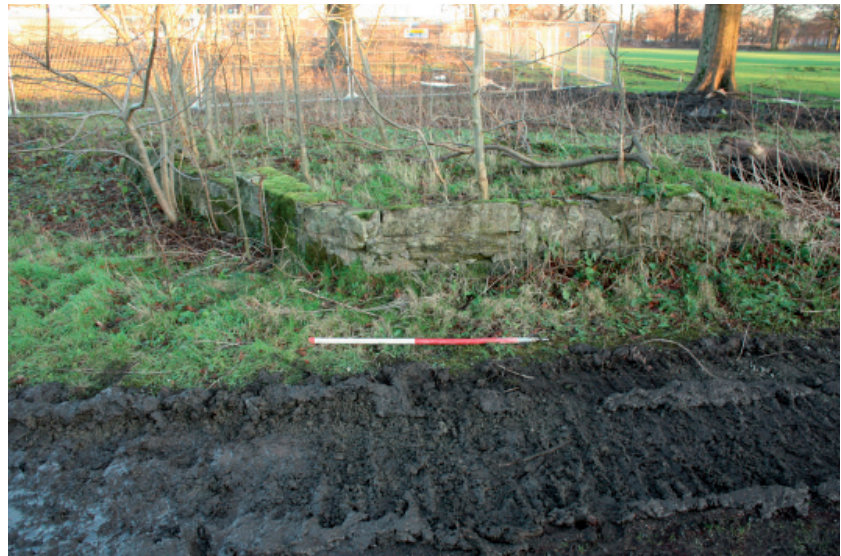
Illus 20

East facing shot of possible gateway base (photo 143)

Adjacent to the northeast corner of the walled garden, three stone piers lay either side of a track (Illus 13 and 20). Approximately triangular in plan, they were 3m in length and survived to a maximum height of 0.4m. The structures consisted of mortar-bonded, squared sandstone blocks and were heavily overgrown. The piers represent the foundations of a gateway associated with the grounds of Kerse House.

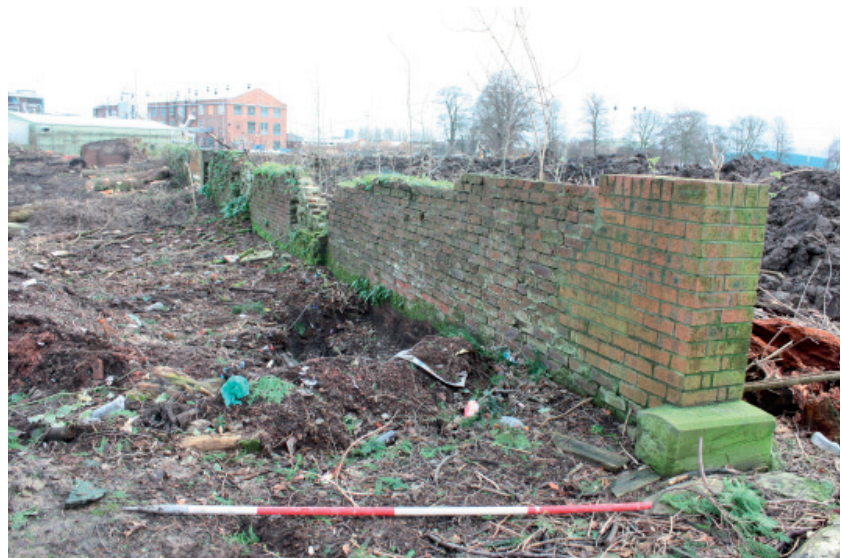
Illus 21

Southeast facing shot of garden wall section that extends to Kerse House (photo 166)

The eastern section of wall (Illus 21) sat on stepped sandstone foundations and was 0.4m wide; surviving to a maximum height of 1.7m. The wall was buttressed at approximately 10m intervals with an additional thickness of brick and later repairs/remodelling were evident at its western extent. At the eastern end, the north face had been rendered in cement and a brick-blocked entrance 0.8m wide (Illus 22) was located 8m from the east terminus. The door jambs comprised chamfered sandstone blocks. This section of wall

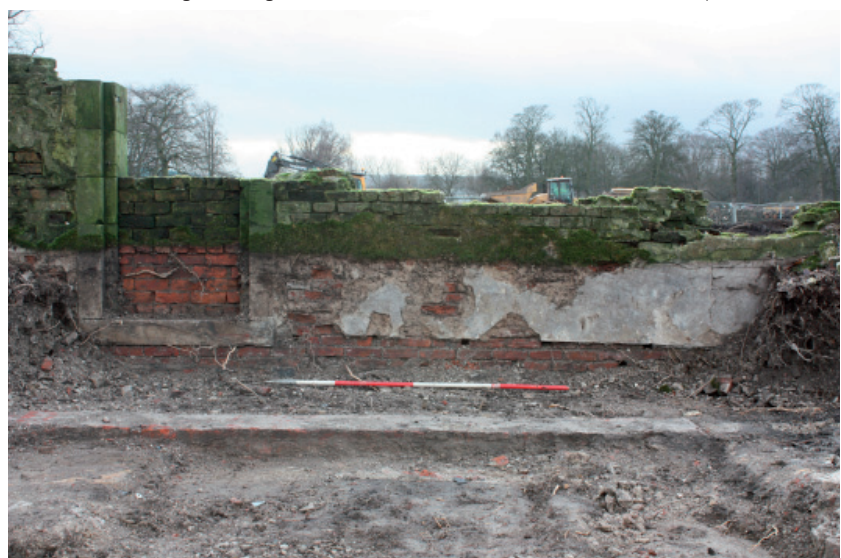
Illus 22

North facing shot of garden wall with blocked doorway into Kerse House (photo 172)

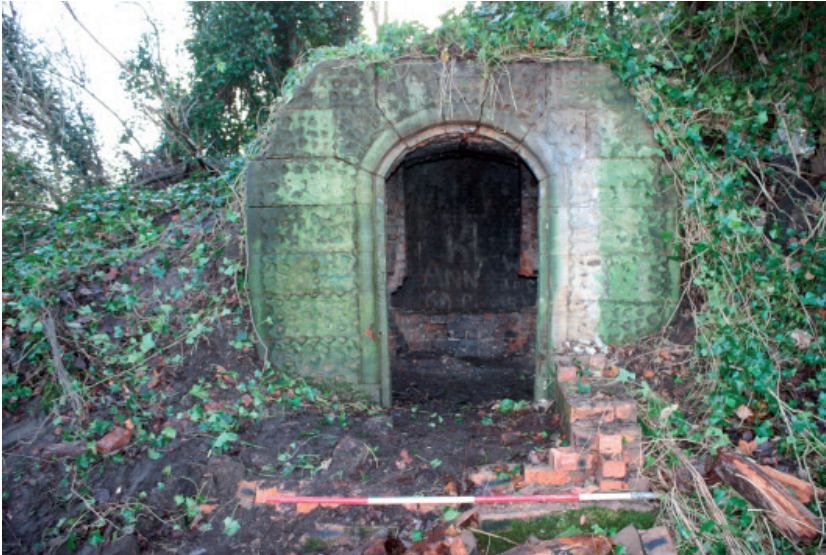
Illus 23

Ice House, north façade. Blast wall removed and prior to removal of mound (photo 006)

The porch façade consisted of an arched doorway 2m in height, with columns and head displaying rolled moulding. Holes on the inner face of the door head suggested it may have held a grate. The basal course of surrounding grey freestone displayed vertical fluting; above which the stonework was heavily rusticated, with rolled moulding continuing down either edge of the porch. The upper part of the façade had been truncated and therefore it is not clear if it too formed a full arch.

The remainder of the structure was brick-built and consisted of a cylindrical main chamber with domed roof abutted by the vaulted porch entrance. The chamber wall had an internal diameter of 3.7m and stood 1.2m high (above the ground entrance level). The bonding was English Bond (alternative coursing of header then stretcher) with grey coarse sandy cement. The abutting porch had a variant on this bonding comprising three or four stretcher courses to one header. Stone blocks 0.45m wide were located in the east and west porch brick walls, behind the façade. It is likely that their function was to hold the entrance door.

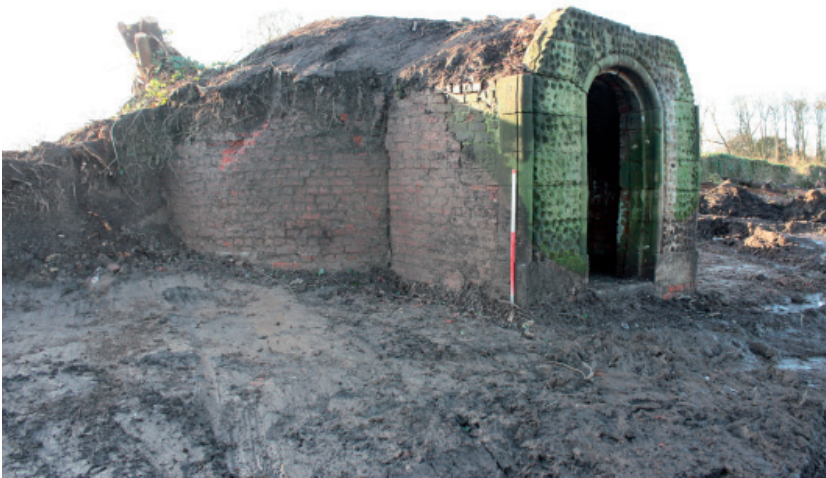
Illus 24

Southwest facing shot of exposed Ice House (photo 153)

Internally, the porch had a flagstone floor and an iron tie-bar was evident along the central axis of the vaulted roof. At the south end of the porch the main cylindrical chamber was reached through an opening raised 0.6m above the floor level. This opening had been damaged to provide easier access at a

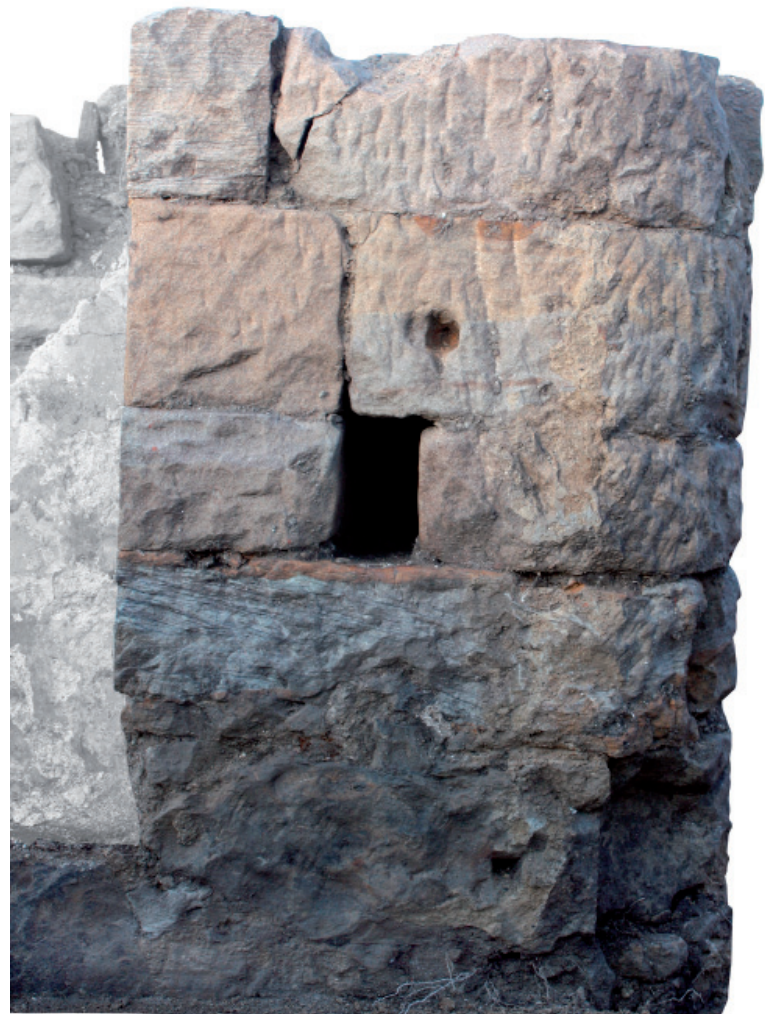
**Illus 28** ▶

Photo-rectification of wall (074) entrance

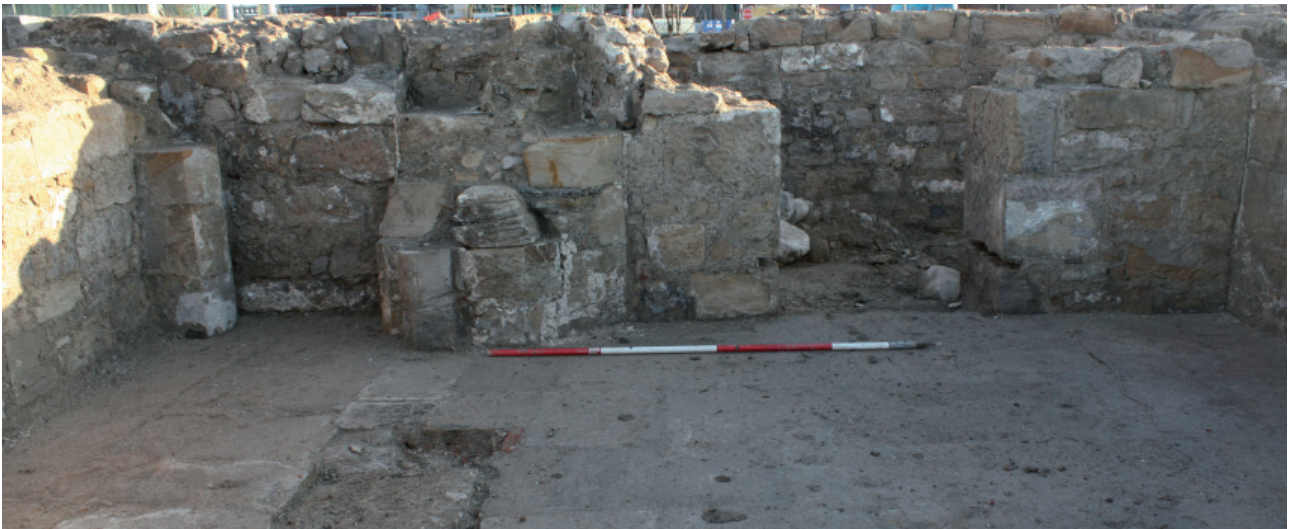
Illus 29

East facing shot of Phase 1 structure with truncated wall (171) in foreground (photo 205)

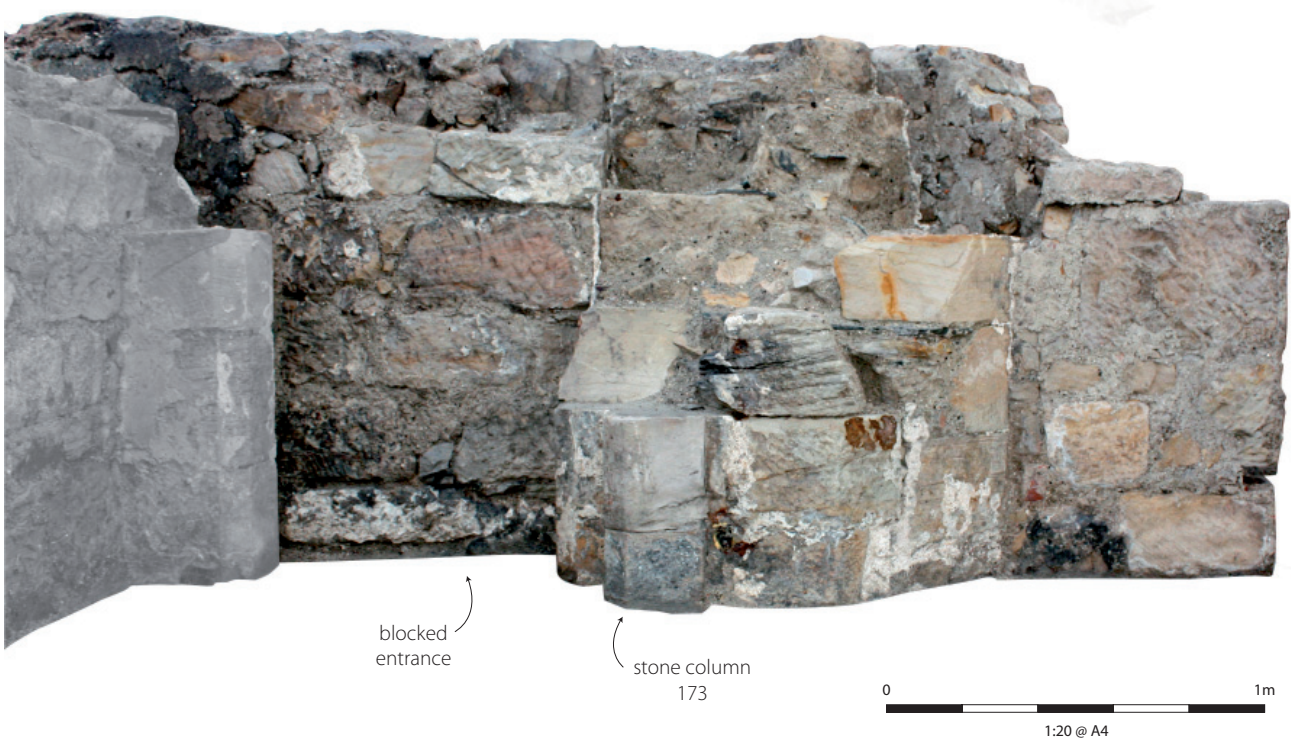
Illus 30

Photo-rectification of stone column (173) and blocked entrance

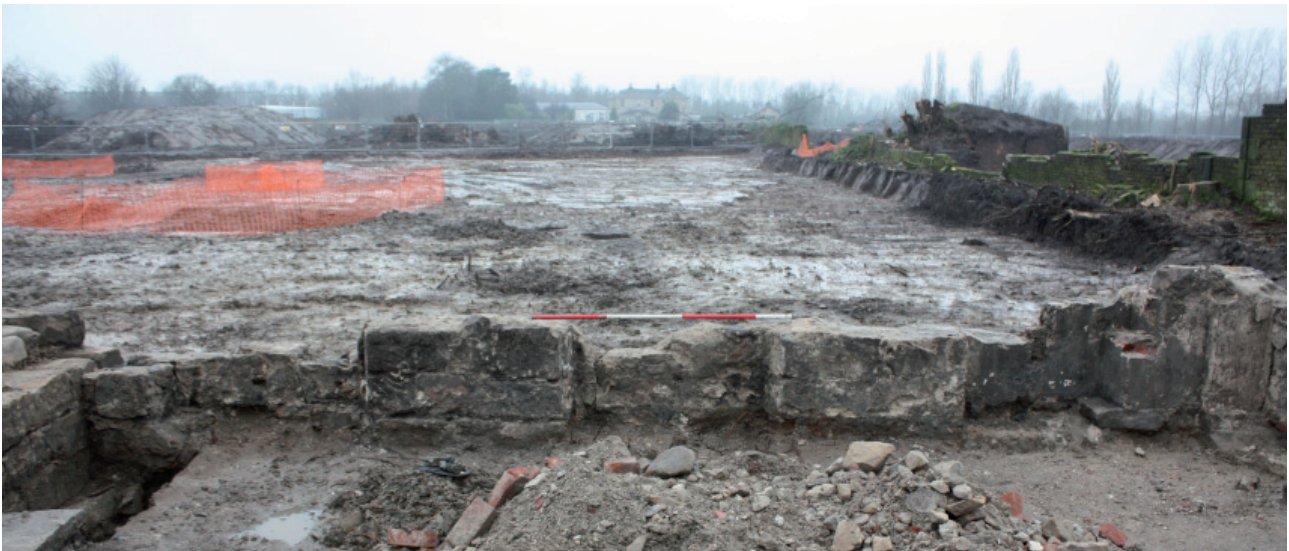
Illus 34

West facing shot of Phase 2 outer wall (056) and windows (photo 275)

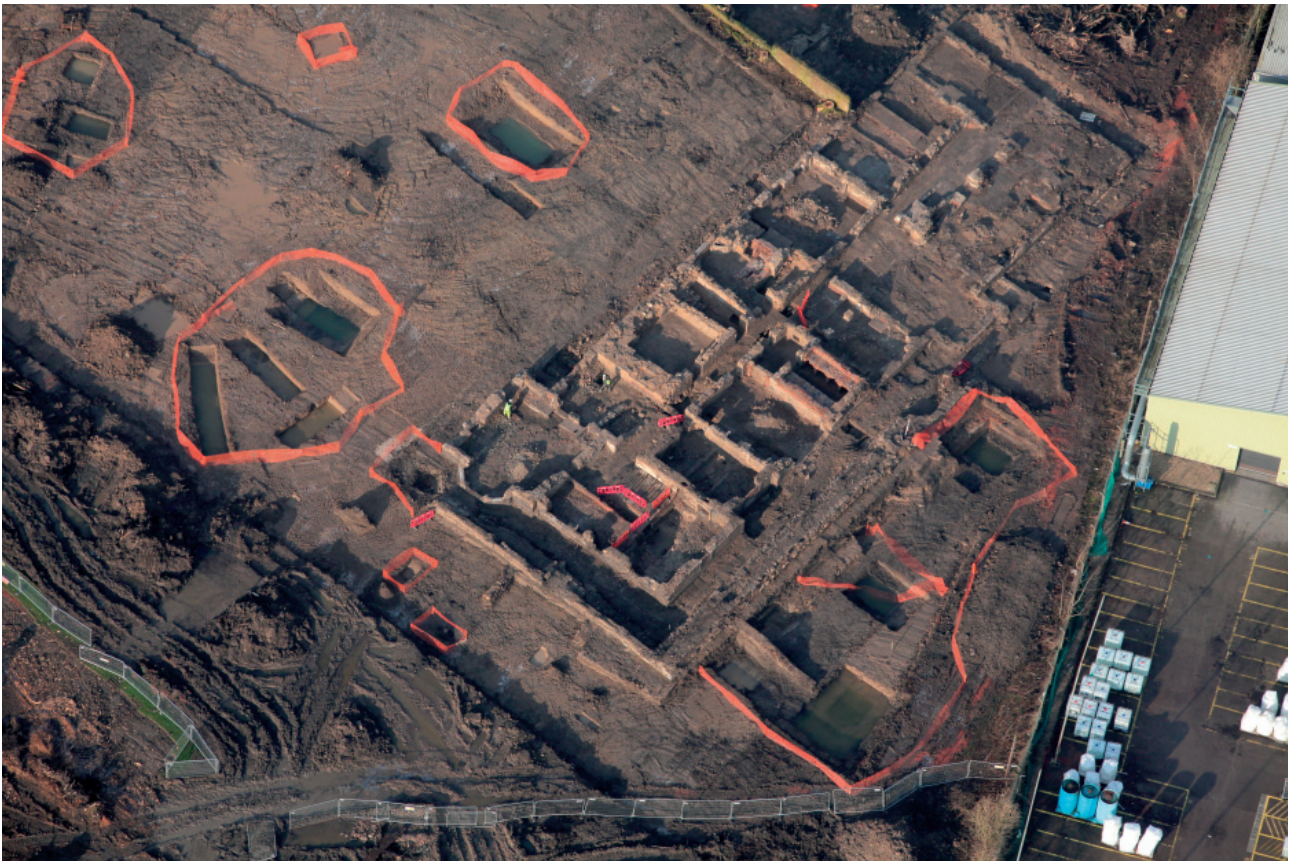
Illus 42

Aerial photo from southeast showing area excavation centred on Kerse House
Taken by Guthrie Aerial Photography

The final phase of significant alteration was undertaken in the later 19th century when the house was extended northward. The central courtyard was covered and outbuildings erected to the northwest (Illus 10 and 42). The 1876 ground floor plan and elevations (ST 1309, 1311, 105/2; Illus 10) provide a close representation of the structural remains. Appendix 1 provides a detailed room-by-room description of the surviving fabric and features.

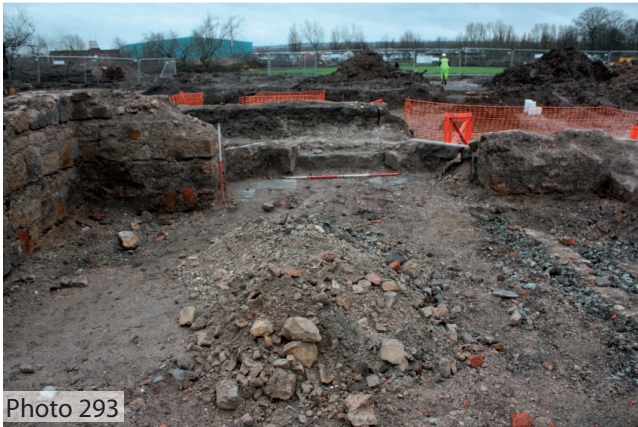
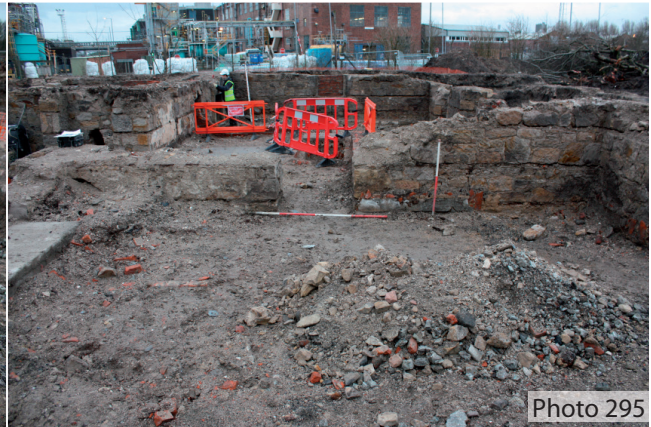
Photos 293, 295

Room 1 'Valets Room' (1876 plan) / 'Servants Room' (1830 plan)

Forming the southwest corner of the house, Room 1 comprises walls of dressed masonry blocks of varying size. The remains of a three-bay window are evident in the south wall, with the stone sills 0.6m above floor level. A further two windows with splayed opening are set into the west wall. The outer faces of the south and west walls comprise a projecting ground course of squared and dressed stones, approximately 1m in length, with chamfered tops. Subsequent coursing consists of masonry blocks around 0.5m in length. An entranceway is located midway along the east wall, which also shows evidence of plastering. The north wall is heavily truncated but a bayed recess with bricked back survives in its western half, with an apparent entrance into Room 2 adjacent. A concrete culvert abuts the north wall, while the floor comprises stone flagging overlying sand and clinker levelling.

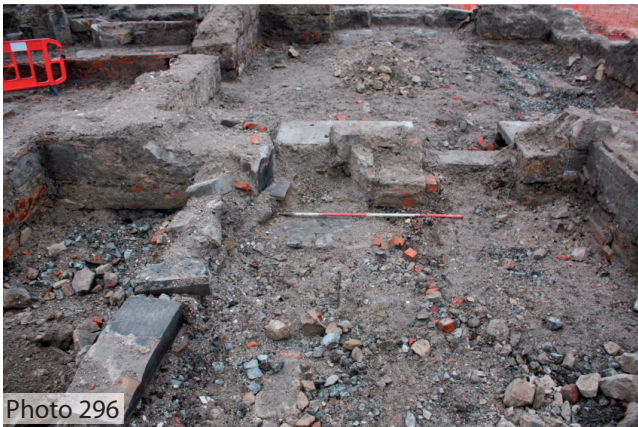
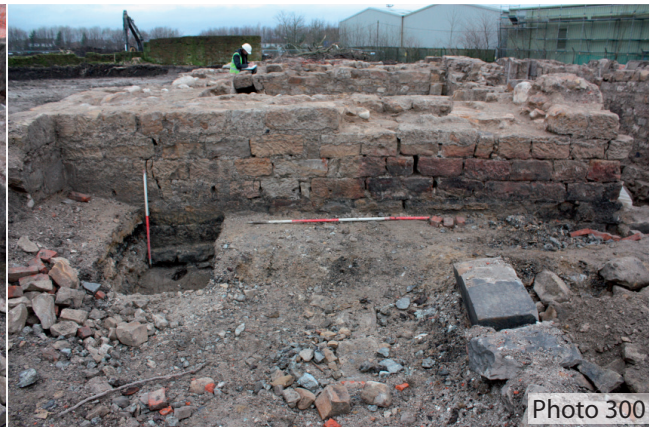
Photos 296, 300

Room 2 'Lamp Room' (1876 plan) / 'Servants Room' (1830 plan)

The east, south and west walls are approximately 0.7m thick and consist of dressed masonry blocks with cement mortar as well as occasional patches of brickwork. An entrance way is located in the northeast corner and an interior masonry wall partitions the room. The remains of a centrally placed fireplace are located in the south wall and the opening into Room 1 lies on its west side. A centrally placed window is present in the west wall with the splayed design found throughout the building, which has been latterly bricked up. The external face of the west wall also displays the projecting ground course of masonry seen in Room 1. An excavated slot reveals that the foundations step out around 0.5m from the wall face and consist of roughly hewn masonry.

The north wall is clearly abutted by the west wall and predates it. The wall comprises dressed sandstone facing with a rubble core; totalling 2m thickness. The sandstone blocks are 0.25–0.6m long by 0.3m wide and bonded by sandy lime mortar. Reddening on the south face of the north wall indicates exposure to heat from a fire, while signs of subsidence are evident from the increased spacing between a number of the blocks. No floor surface survives, but sub-floor deposits of clinker and sand are evident.

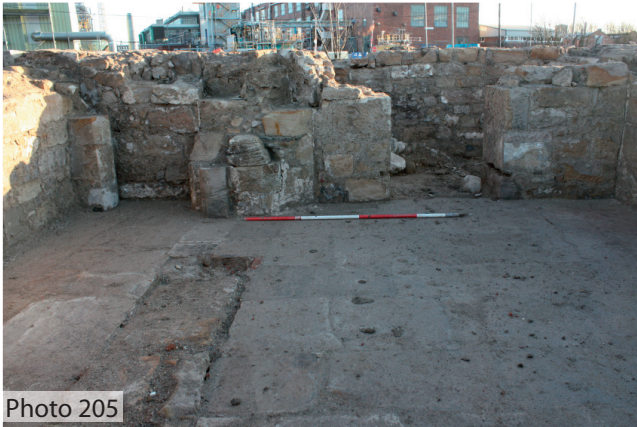
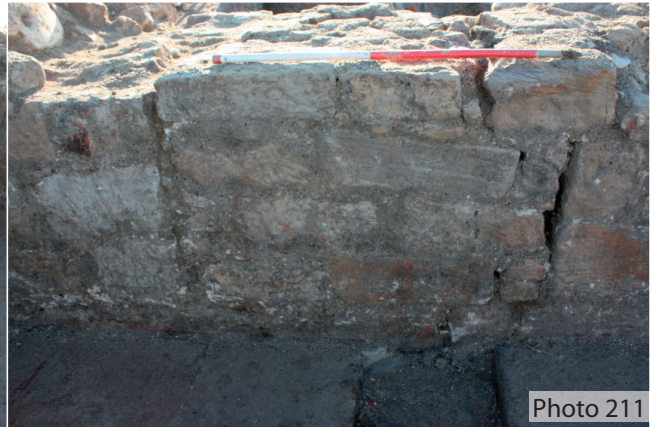
Photos 205, 211

Room 3 'Cellar' (1876 plan) / 'Cellar' (1830 plan)

At the northeast corner an original doorway has been blocked by mortared masonry. The doorway displays moulded jambs which would have held a door that opened away from the room. A second doorway may have been located between the east wall and the reduced internal wall, which shows a jamb at its east end. In the east wall, the section with door jamb is abutted on its south side by a later section of sandstone walling which contains the current entranceway. The north wall abuts the west wall and consists of coursed sandstone rubble 0.65m wide. The coursing is less regular than that of the west and south walls. Remnants of white plaster are visible on the inner faces of the walls.

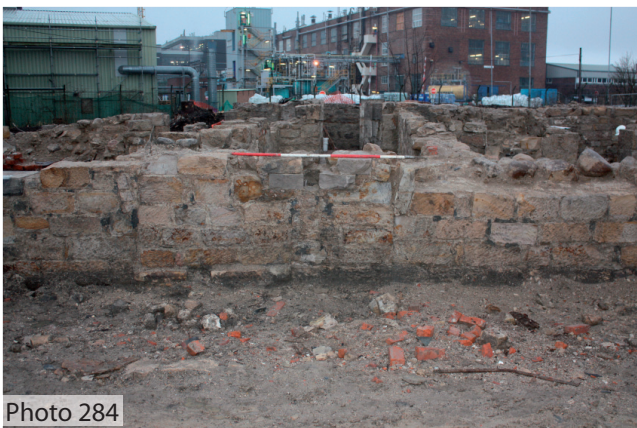
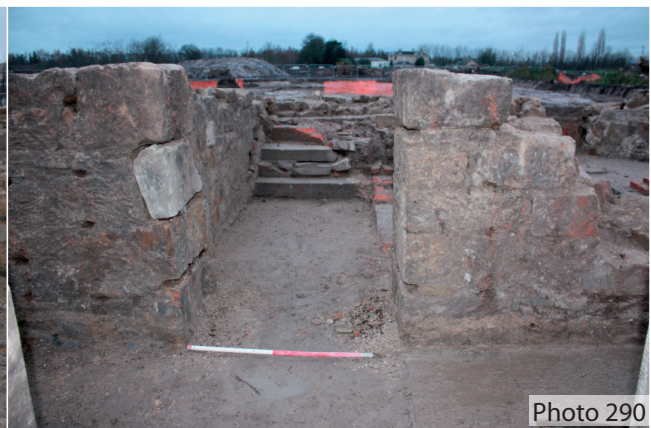
Photos 284, 290

Room 4 'Stair' (1876 plan) / 'Stair' (1830 plan)

A narrow room, entered from a doorway in the east wall which has horizontal slats for door fixings. The room is partially floored with flagstones. The west wall is the continuation of the rubble cored wall in Room 3 and is abutted by the south wall of the room (north wall, Room 2). The base of a dressed-stone, curving stair is located at the west end with one step set into the fabric of the west wall. A drain also runs down the core of the wall. On the outer face of the west wall, vertical joins and a stepped foundation make it clear that there has been a rebuild at the location of the drain and steps. A recess marked 'W.C.' is shown here on the 1830 plan. The north wall consists of two abutting lengths of coursed sandstone and mortar. A brick and cement lined chute into a cellar is located in the northeast corner, which extends under the north wall into Room 5.

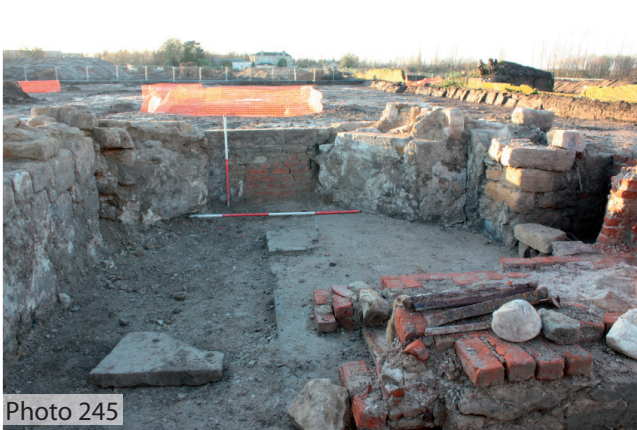
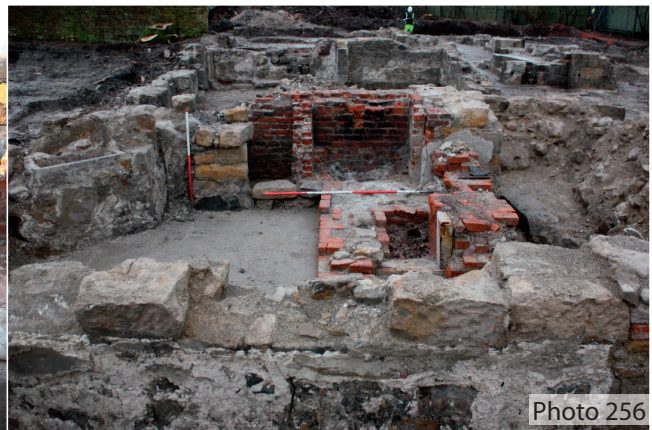
Photos 245, 256

Room 5 'Store Room' (1876 plan) / 'Servants Room' (1830 plan)

The west, north and east walls consist of rubble coring with dressed sandstone facing up to 1.8m thick. Midway along the west wall is a splayed window opening and a stone sink has been set into the northwest corner. The north wall has been truncated by a brick-built structure bonded by sandy, off-white mortar. The feature incorporates a chimney base and possible fire-box; suggesting it was a base for an oven. A sub-surface, stone lined chute which communicates with that in Room 4 lies between the brick feature and east wall of the room. On the east side of the entranceway, the east wall corner has been chamfered and rectangular and circular sockets have been cut into the wall head. It likely represents a former entranceway and the rectangular socket would have held a drawbar.

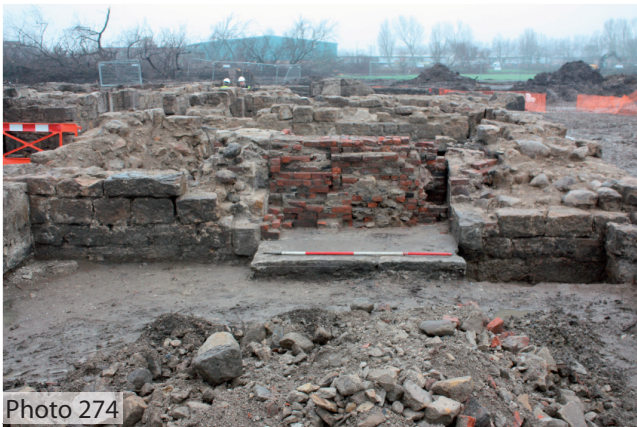
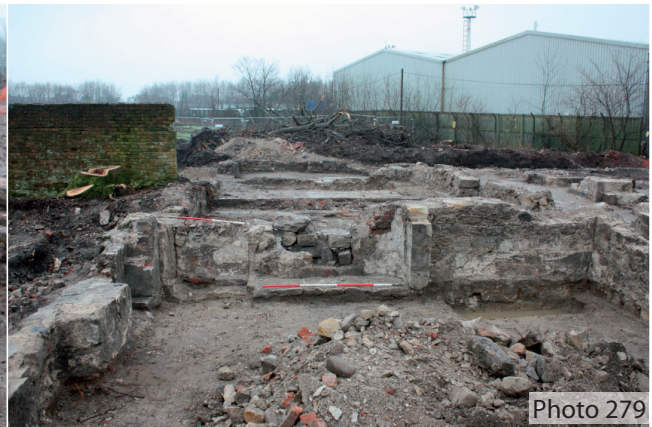
Photos 274, 279

Room 6 'Housekeeper's Room/Still Room' (1876 plan)

The room is a later extension to Room 5, evident from the abutting joints of the east and west walls to the south wall. The walls comprise randomly coursed stone of varying sizes, roughly hewn, with white mortar bonding. Three windows are located in the west wall, while in the north wall a blocked doorway with projecting jambs is in the northwest corner and a fireplace is set centrally.

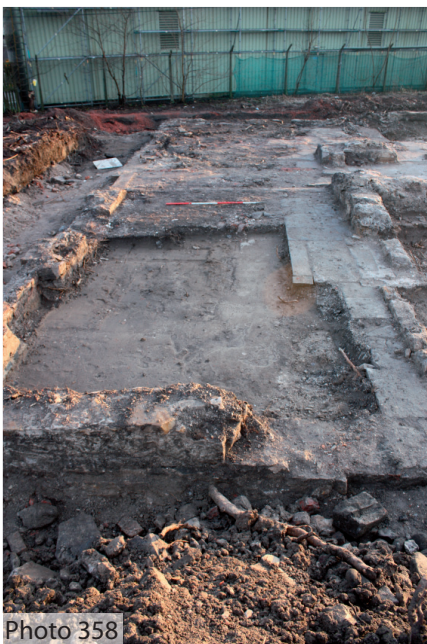
Photo 358

Room 9 'Servant's Hall' (1876 plan)

This room forms the northwest corner of the main house. The east wall is a brick-built dividing wall which abuts the north and south masonry walls. Two splayed windows are in the north wall and a fireplace is set centrally in the south wall. The west wall forms the continuation of the house's outer west wall from Room 7. Flag stone flooring survives to the south.

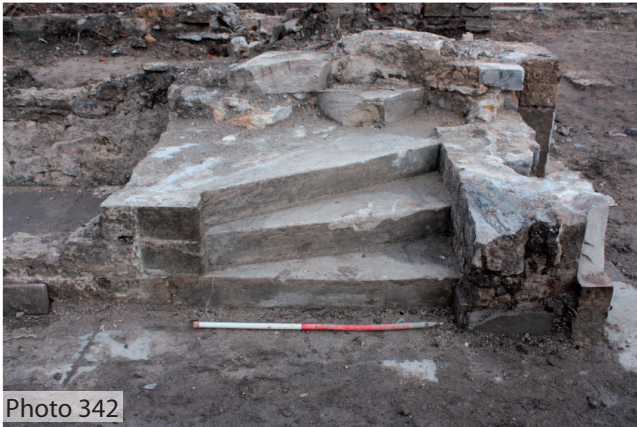
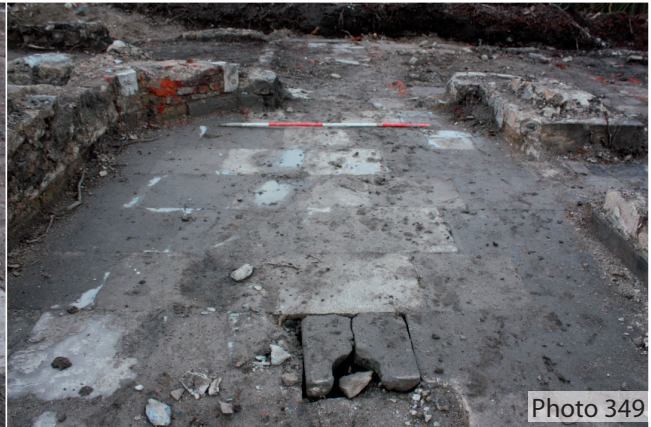
Photos 342, 349

Room 10 'Vestibule/Lobby' (1876 plan)

A cut sandstone step provides a north entrance into a lobby which is flanked by brick walls, two courses thick. To the south, this opens into a wider vestibule bordered to the east and west by sections of dressed sandstone wall. An aperture set into the west wall between the vestibule and lobby has been bricked up and may be a blocked window or fireplace. The floor consists of stone flagging with a central drain cut into one slab. To the south, a spiral staircase of cut stone standing to three steps survives. Two lengths of masonry wall extending north from the stair form a compartment. At the southern extent a doorway opens into Room 14. The west walls bordering Rooms 7 and 8 appear to be older than the walls and stair to the east.

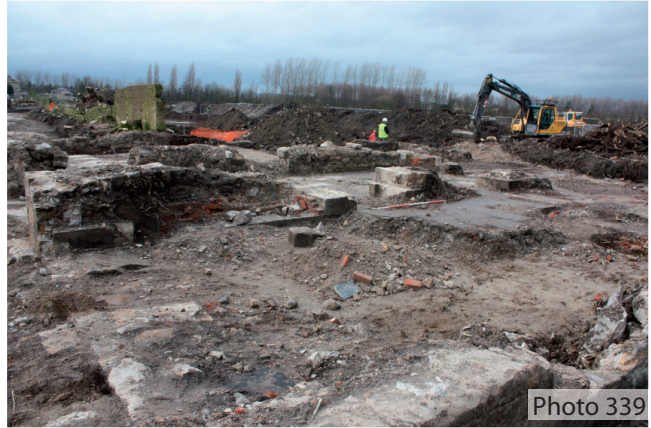
Photo 339

The walls in this area are heavily truncated. The east outer wall stands three courses high and is the continuation of the east outer wall of Room 12. On the west side of the room two columns of cut and dressed stone form two entrances into Room 10. At the southeast corner, a brick-lined recess is located in the wall adjacent to the spiral staircase. An entrance in the south wall leads into Room 14.

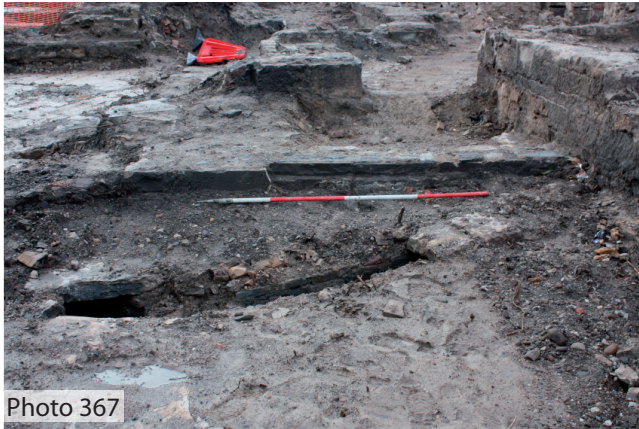
Photo 367

Room 14 'Entrance Hall' (1876 plan)

To the east, a porch of dressed stone provides entry into the room from outside; abutting the outer east wall. There are no remains of flooring, however two rectangular stone bases are set into the mixed loam levelling. The south wall in the room is heavily truncated but comprises randomly coursed, dressed stone bonded by lime mortar.

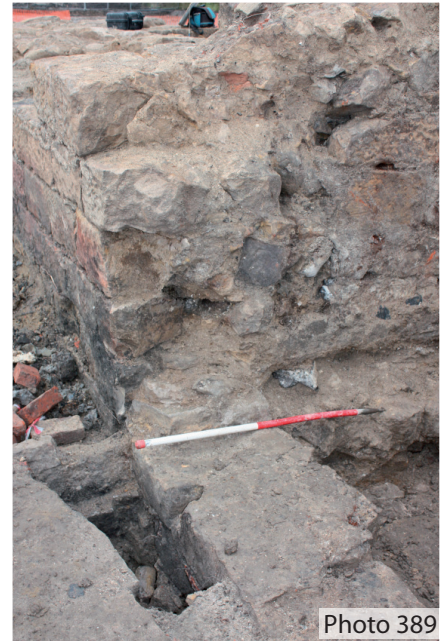
Photo 389

The corridor runs up the centre of the house, narrowing at Room 15. It is clear the rubble-cored south wall of Room 3 originally extended into the corridor space but has been cut back. An abutting joint in the entranceway to Room 20 may show its original extent eastwards. The flooring of the passage is stone flags. The other room descriptions provide details of associated walls.

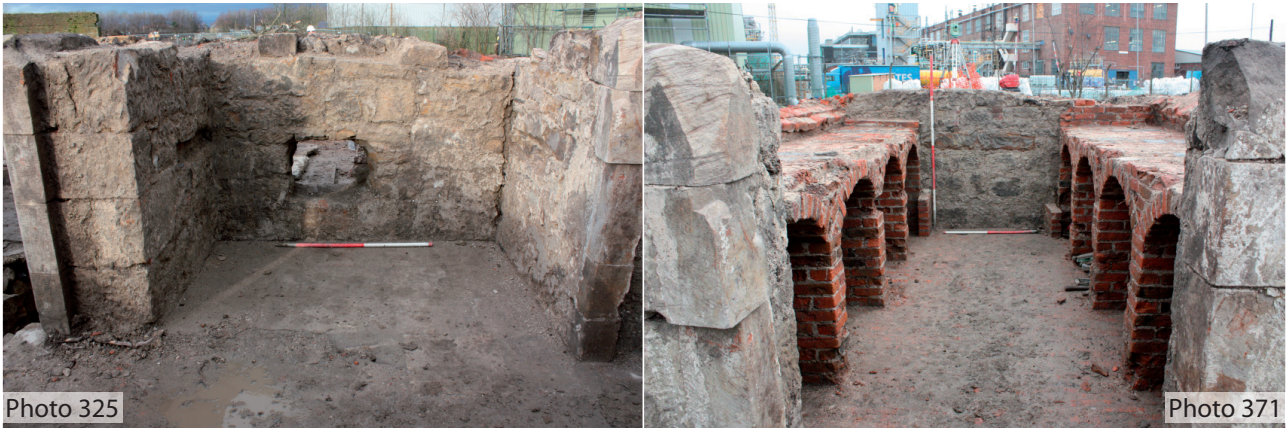
Photos 325, 371

Comprises two rooms entered from the passageway to the west. In the first room off the passageway the walls are randomly coursed, roughly hewn sandstone blocks with neatly dressed door jambs. The south wall abuts the east and west walls, possibly representing blocking of a previous opening. In the north wall, a rough hole 0.5m in diameter has been cut through. The floor is stone flagging. An entrance in the east wall leads to the second room, which contains two rows of vaulted brick recesses.

There are four brick recesses lining each of the north and south walls, bonded by compact lime mortar. Each is 0.9m wide and 1.1m in height, with arched head. The spacing between the vault tops has been bricked to provide a flat surface over the structures. Remnants of brick vaulting are mortared onto the surface, suggesting the room itself also had a vaulted roof. The east wall is the outer wall of the building and the continuation of that in Room 15. The floor is also completed in brick.

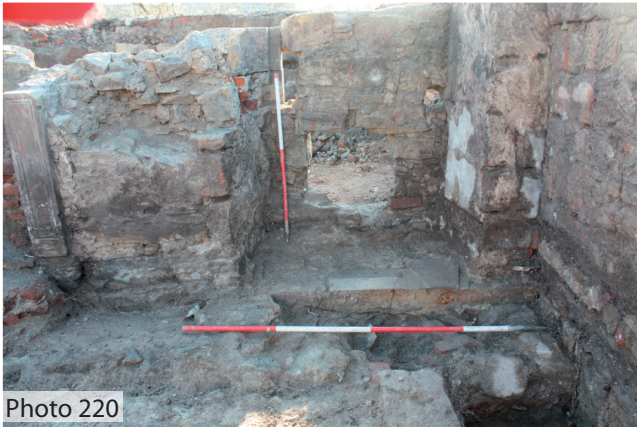
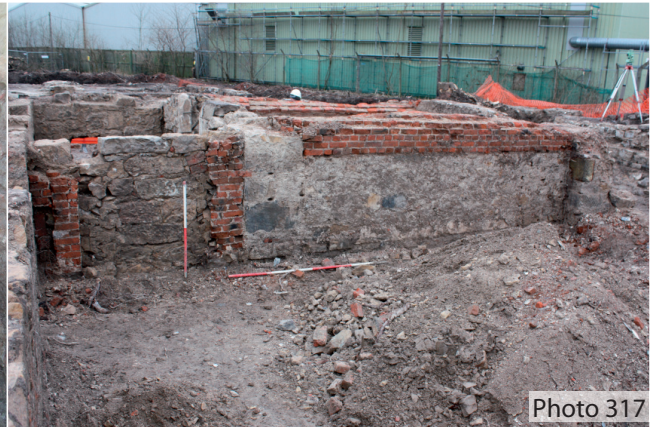
Photos 220, 317

Room 19 'Stewards Room' (1876 plan) / 'Stewards Room' (1830 plan)

The south wall consists of lime mortared, coursed sandstone with a centrally placed fireplace, flanked either side by rubble-blocked window recesses. The hearth comprises brick and mortared sandstone, with the uprights displaying flush bead moulding in a simple rectangular pattern. At the base of the window in the southwest corner it is evident that a keystone lintel has been reused in the foundation course.

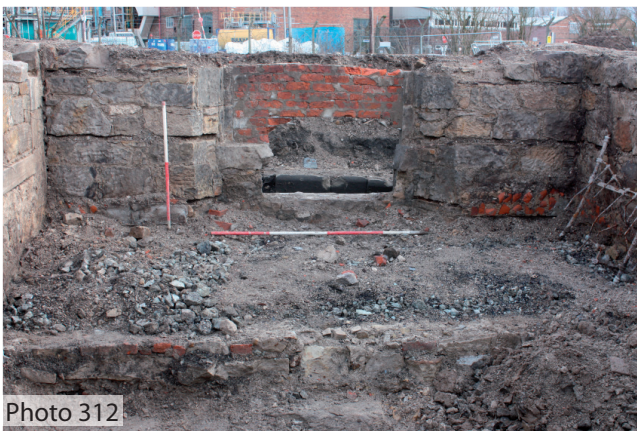
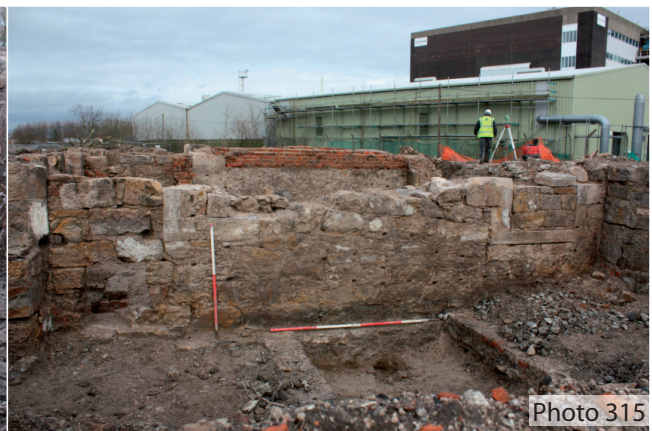
Photos 312, 315

Room 20 'Housemaid's Room' (1876 plan) / 'Servants Room' (1830 plan)

A cut stone pier abutting the north wall forms the north side of the entranceway. Horizontal slots with wood remains represent door fixings in the pier. A join in the western part of the north wall is taken as a possible earlier eastern extent of the thick walls that form the oldest part of the house. Also in the north wall details of the blocked windows of Room 19 are more evident. The east window displays dressed jambs and sill flush with the outer face. The west window is similar but the sill is missing. Holes in the wall face may be plaster fixing points.

The east (outer) wall abuts the east wall of Rooms 15, 18 and 19 and appears to represent a later extension to the house. Constructed in randomly coursed stone blocks, the build is similar to the earlier phase however the ground course lacks chamfered tops. Midway along the east wall is a splayed window recess, blocked up with brick. Horizontal slats in the bay walls infer fixings for shelving or a bench beneath the window. The south wall is a continuation of the west wall and contains a fireplace set midway along it. The hearth is brick with cement mortar while the uprights and lintel are constructed of simple dressed stone with no mouldings. At ground level, two rough sandstone and brick footings extend north-south across the room and the sub-floor make up consists of clinker and slag.

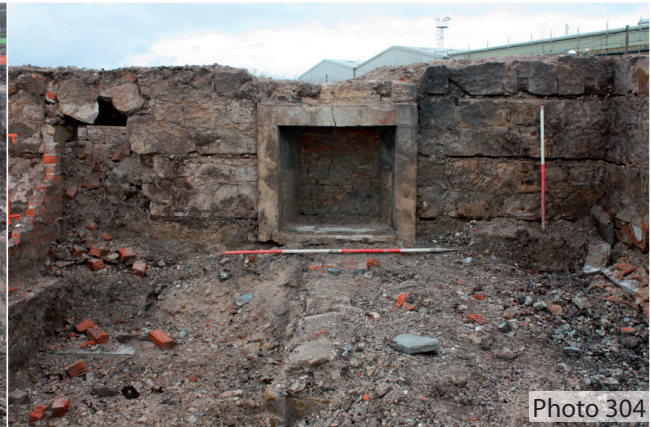
Photo 304

Room 21 'Room' (1876 plan) / 'Servants Room' (1830 plan)

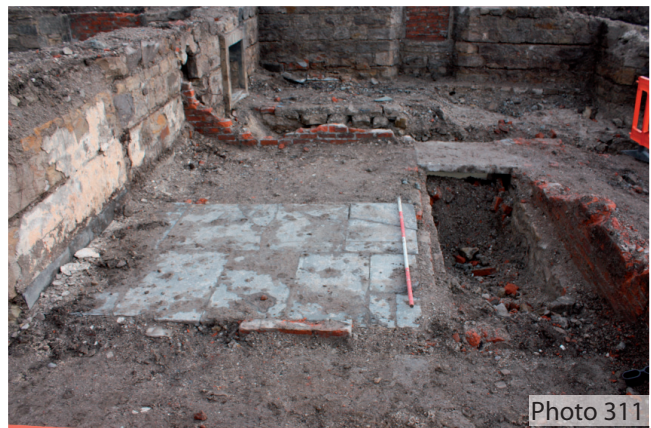
Photo 311

The north wall is a continuation of the sandstone wall in Room 21, while the west wall is a thin brick partition; a single course thick. The west side of the floor has slate flagging which is edged by bonded bricks. To the south a concrete capped culvert extends into Room 21.

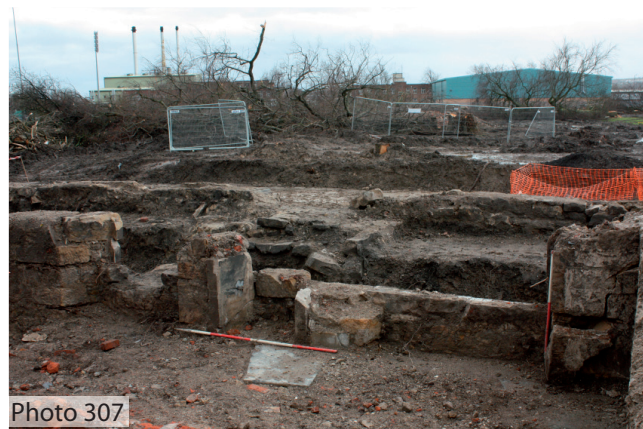
Photo 307

Room 23 'Room' (1876 plan) / 'Bed Closet' (1830 plan)

The south (outer) wall has a fireplace with sandstone uprights, flanked by two windows. The window to the west is wider (1.7m) than that to the east (1.4m). The west wall is dressed sandstone with white plaster on the interior face. A number of loose flagstones indicate the flooring medium.
