EARLS GATE PARK, GRANGEMOUTH

*Desk Based Assessment, Archaeological Excavation
& Historic Building Recording*

for Bericote (Ryton) Ltd

March 2012

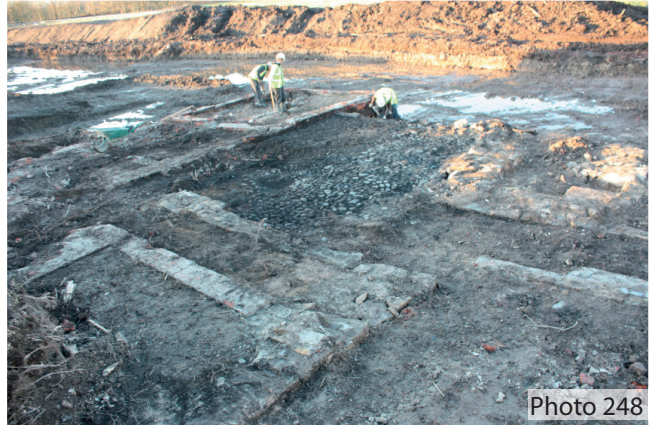
Photo 248

In the northwest extension, only the footings of structures survived and comprised of both mortared brick and sandstone. A cobbled yard area was located centrally. A number of stone lined culverts ran beneath the structures.

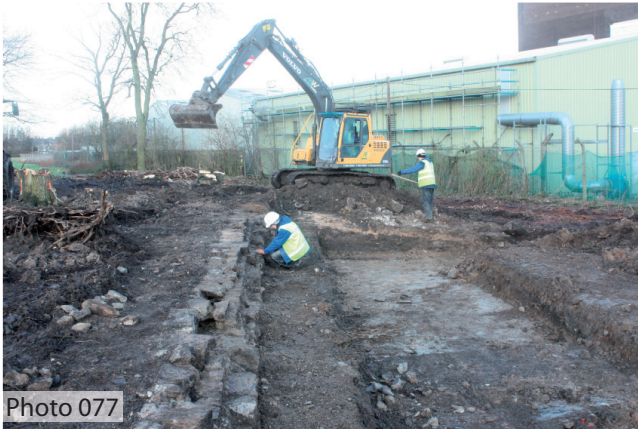
Photo 077

Ballustraded Embankment
