THE RESULTS OF AN HISTORIC BUILDING SURVEY (LEVEL 2)
AT THE STAR AND GARTER HOTEL,
HIGH STREET, LINLITHGOW

for Ross Wilkie

0770/FUL/12

December 2012

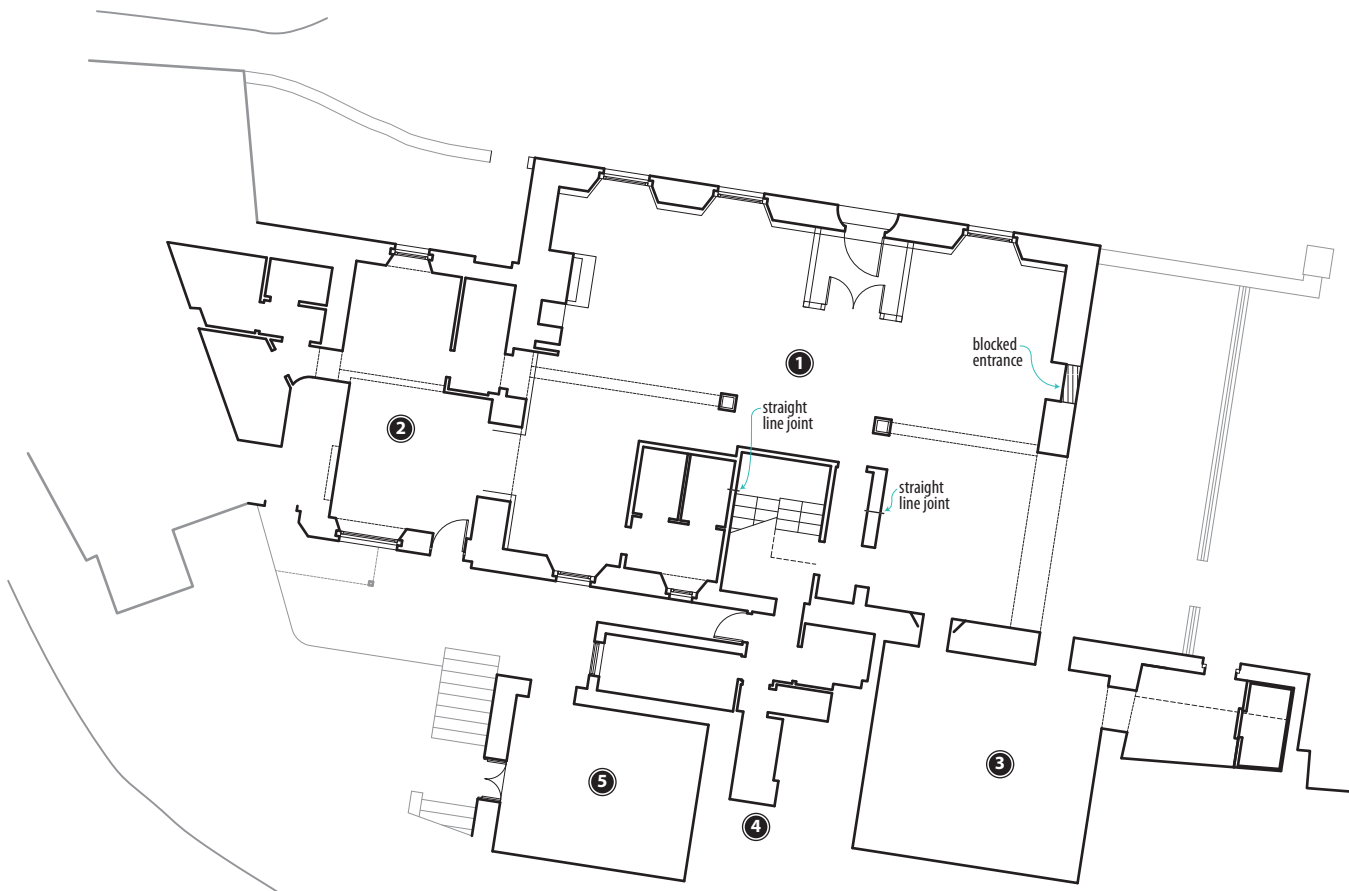
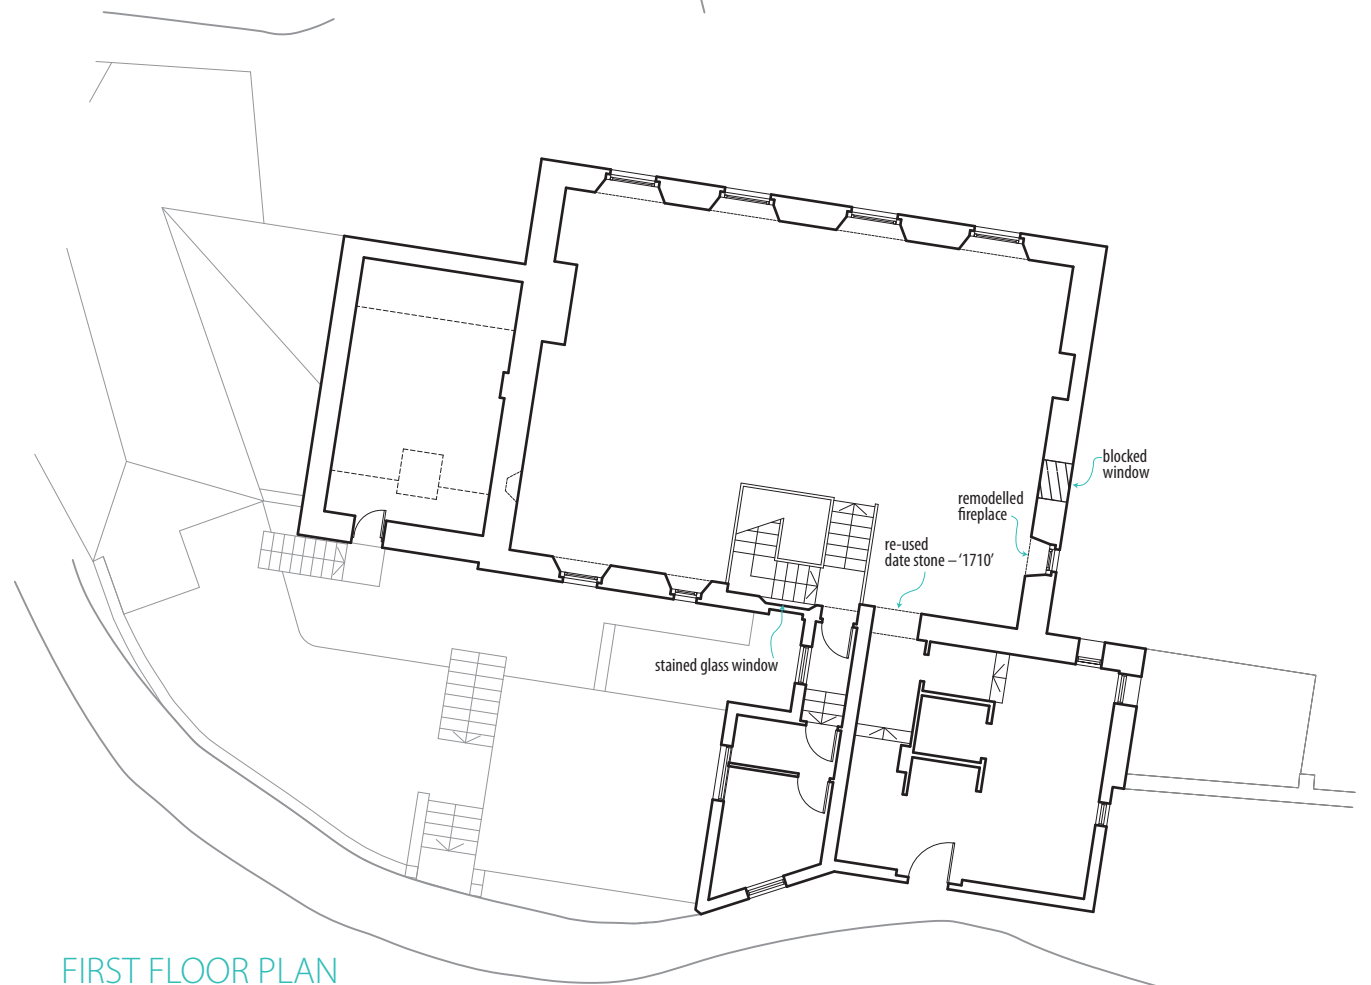
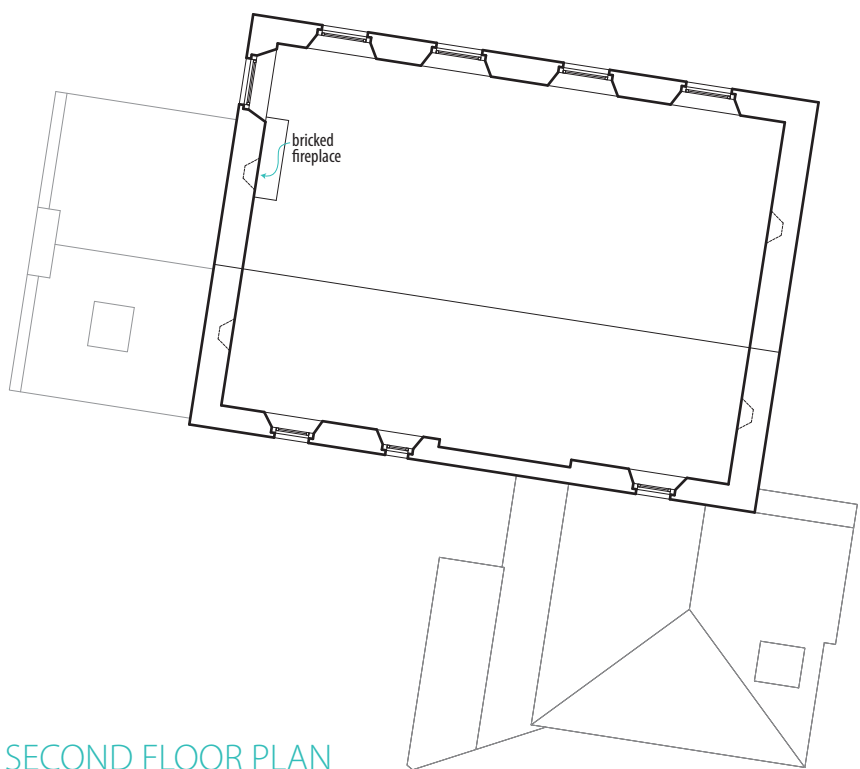
GROUND FLOOR PLAN

FIRST FLOOR PLAN

SECOND FLOOR PLAN

Principal Building (1) (Illus 3)

The building is a three-storey, four-bay rectangular structure which has been harled and painted. As part of the renovation works, it has been re-roofed with a pitched grey slate roof to match the previous construction. The exposed masonry shows the wall faces to be built of randomly-sized rubble with squared stone quoins. Internally, all windows are set in splayed recesses that extend from floor to lintel height; despite varying window sizes. The window margins comprise dressed stone blocks in contrast to the rubble build of the walls. In its current form the lintels of all windows have been reinforced with concrete slabs.

West wing (Building 2) (Illus 3 & 12)

A west extension to the principal building is formed by a two-storey harled building with piended slate roof. Small areas of exposed masonry suggest the walls consist of coursed sandstone of varying sizes. On the north elevation at ground level a blocked doorway is positioned to the east and 12-pane recessed window to the west. The west elevation connects to a single storey extension (Building 6), aligned almost at right angles. The south (rear) elevation has a wide recessed window to the west and doorway to the east at ground level. At first floor level, a doorway to the west links to a fire escape. The interior is modern, with Wainscott panelling on the walls and plastered ceiling.

Rear extensions (Buildings 3-5) (Illus 3 & 13)

A single storey wing projects from the south side of the principal building's rear elevation (3) at first floor level. The structure is harled with piended slate

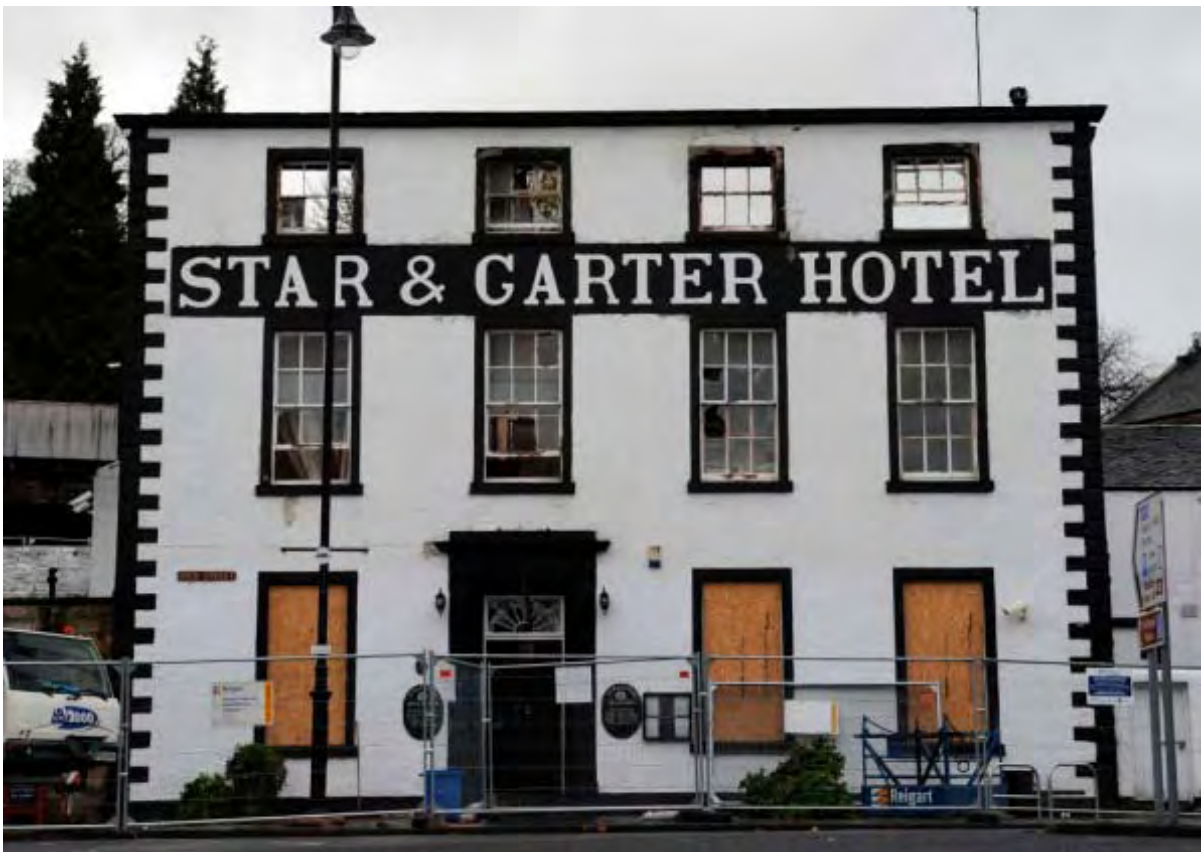
Illus 6

S-facing shot of principal (N) elevation taken in November 2010
©Linlithgow Gazette

North (entrance) elevation (Illus 6)

There are four symmetrical bays. At ground floor, a doorway with decorative fanlight is located off-centre to the east, with one window to the east and two to the west. At first and second floor levels there is regular fenestration. The ground and first floor windows are 12-pane sash and case while the smaller windows to the second storey are six-pane. All margins are painted black, in contrast to the white harling.

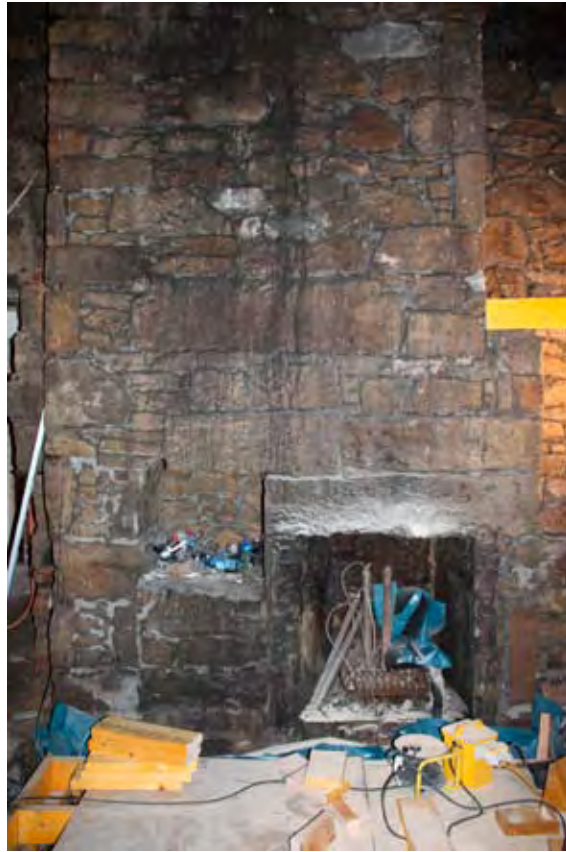
Illus 7

W-facing shot of Ground Floor fireplace

At ground floor, a centrally located entrance with dressed stone margins and wood lintel leads into the west wing (Building 2). To the south is a fireplace with simple stone block surround and adjacent square recess (Illus 7), while to the north a second wider entrance also leads into the west wing. The entrance has brick margins and concrete slab lintel.

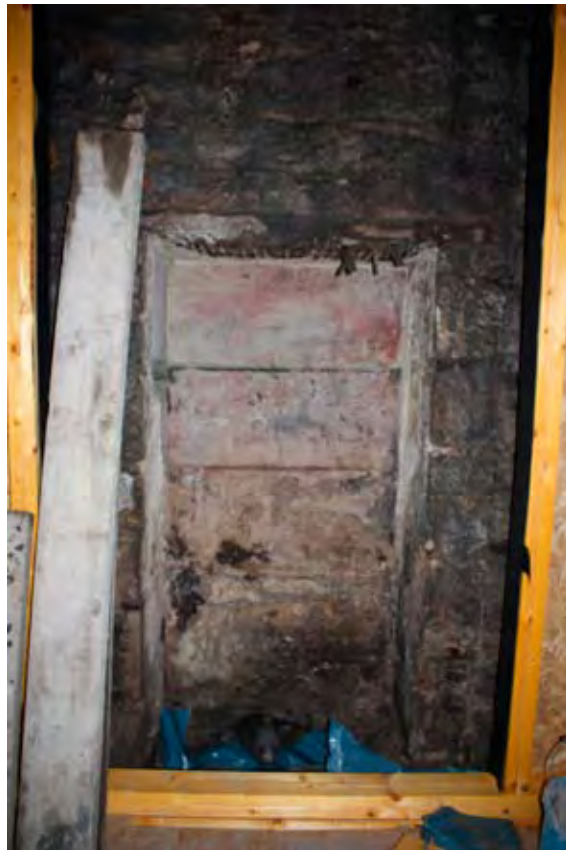
Illus 8

E-facing shot of blocked entrance in E elevation

At ground floor level, an opening left by the demolition of an extension spans half the width of the building. A steel joist provides the lintel and wooden partitioning forms two doorways which would have opened into an extension now removed. An earlier doorway, now blocked with stone slabs was visible from the interior (Illus 8). At first floor level, there is a central window, blocked by stone slabs, with fireplace to the north and window to the south. The window has brick and concrete margins and appears to have been inserted at the location of a former fireplace. On the second storey are two further fireplaces.

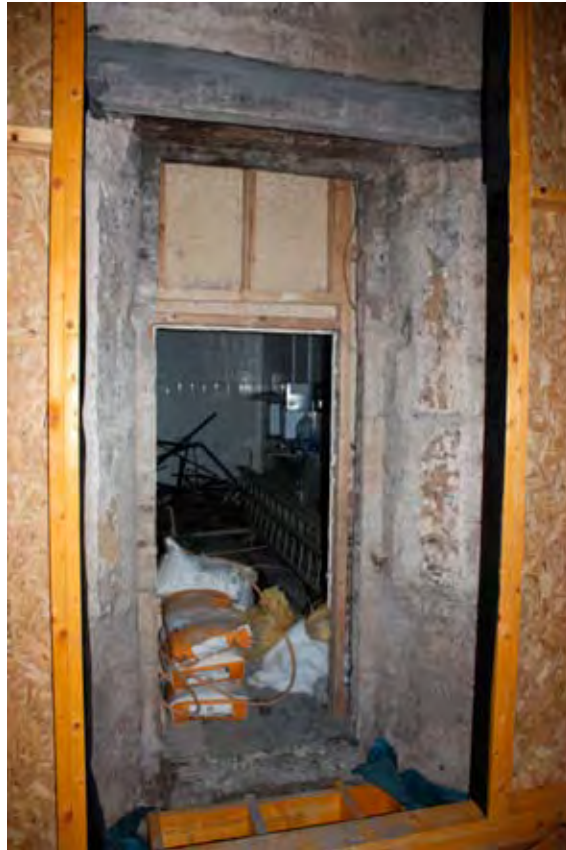
Illus 9

S-facing shot of splayed entrance into south extension

At ground floor level there are two windows to the west, with that to the centre being narrower. To the east are two entrances into rear extensions (Buildings 3 and 4). Internally, one entrance sits with a splayed embrasure indicating that it may previously been a window. Internally, a staircase rises

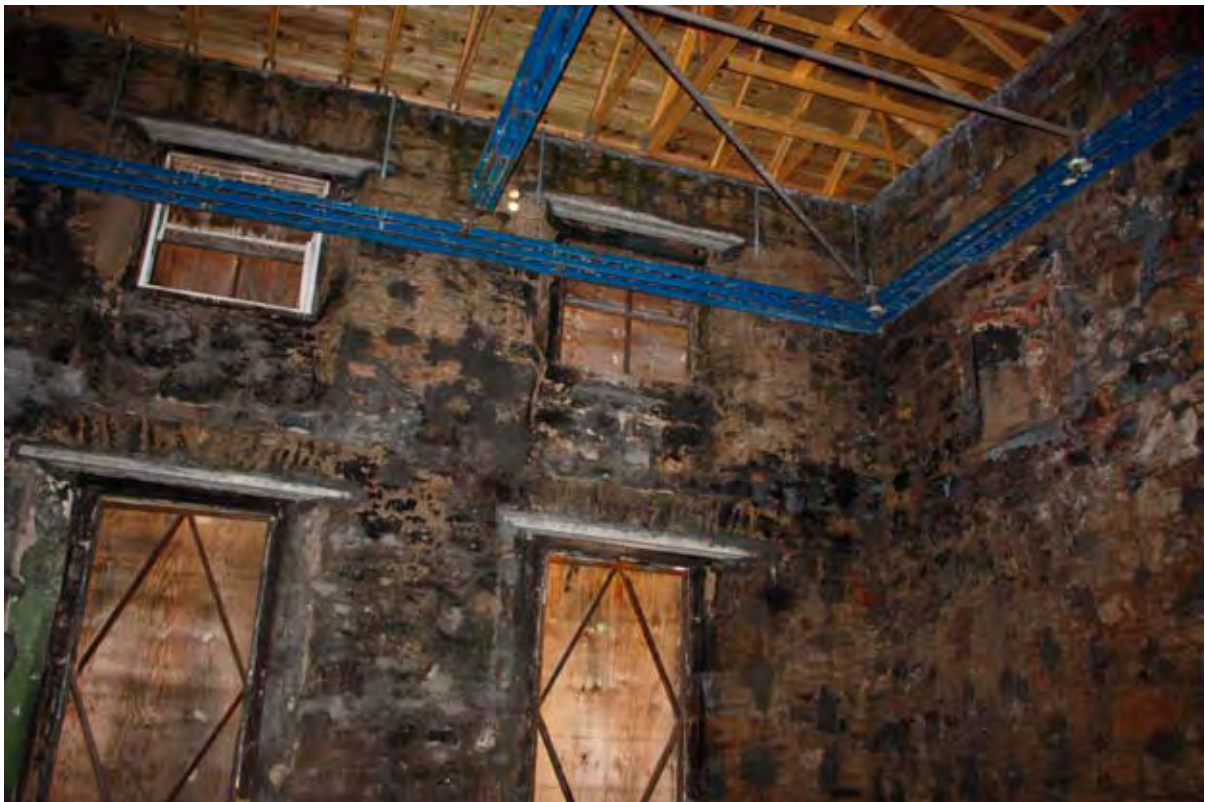
Illus 10

N-facing shot of internal N elevation

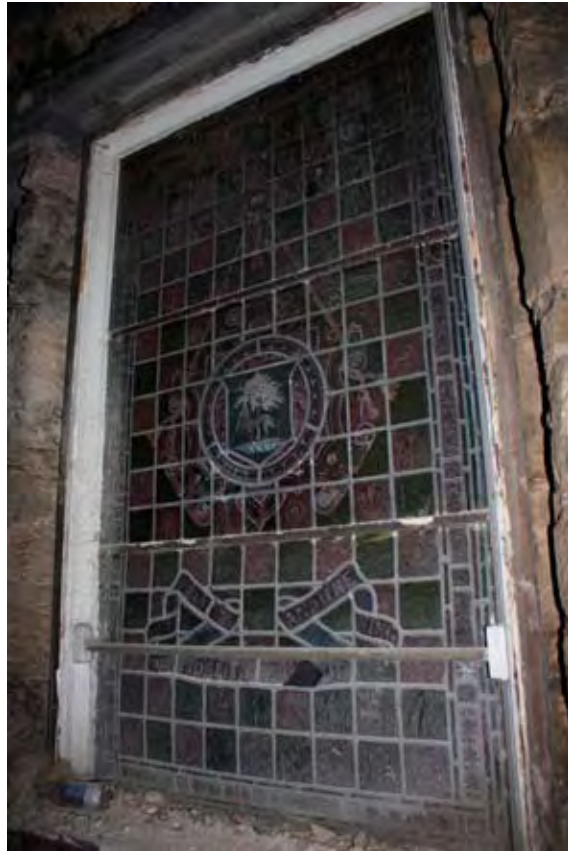
Illus 11

SE-facing shot of stained glass window in S elevation, first floor

At first floor level, there are two windows to the west and an off-centre entranceway. The entranceway has been blocked externally with steel shuttering and internally a stained glass window has been fitted to the jamb (Illus 11). Adjacent to that is a doorway with brick margins and concrete lintel leading into a rear extension (4). A date stone appearing to be marked '1710' sits over the concrete lintel and this appears to have been re-used from elsewhere. At second floor level, two windows are positioned to the west and one to the east.

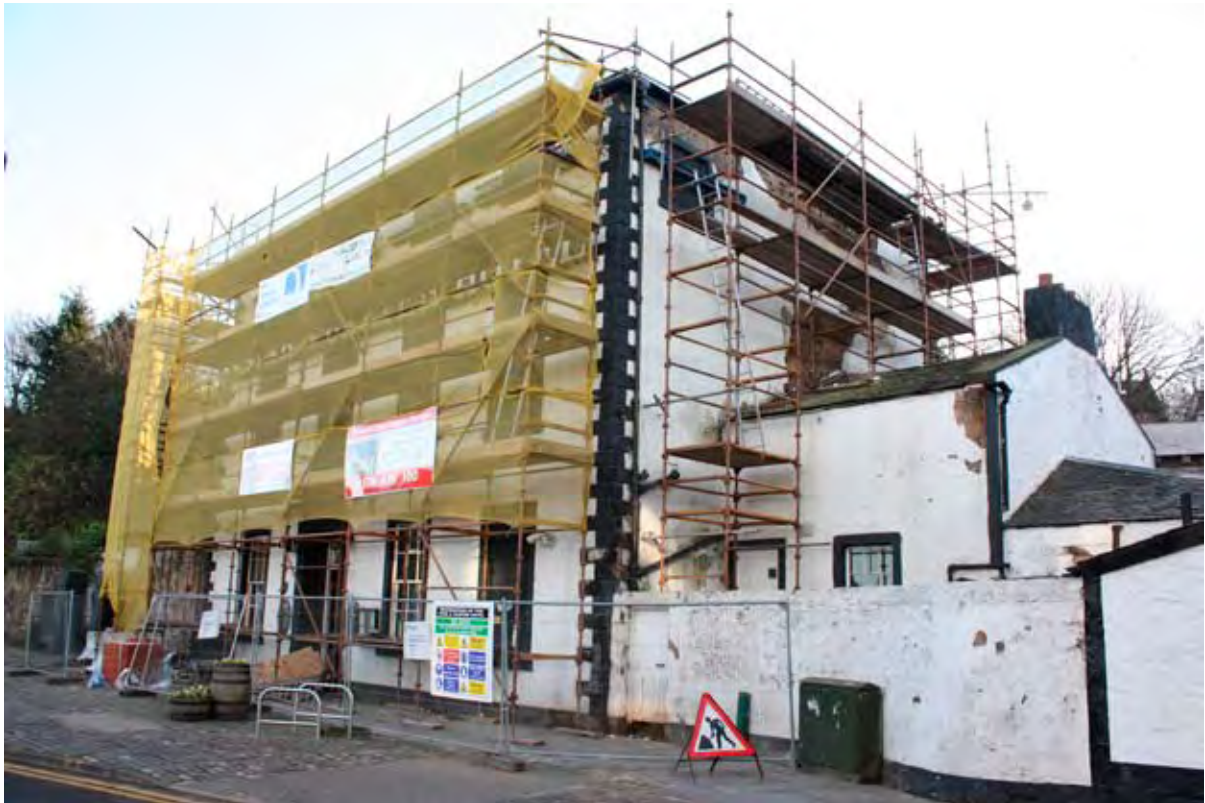
Illus 12

SE-facing shot of main building with western extensions (2+6)

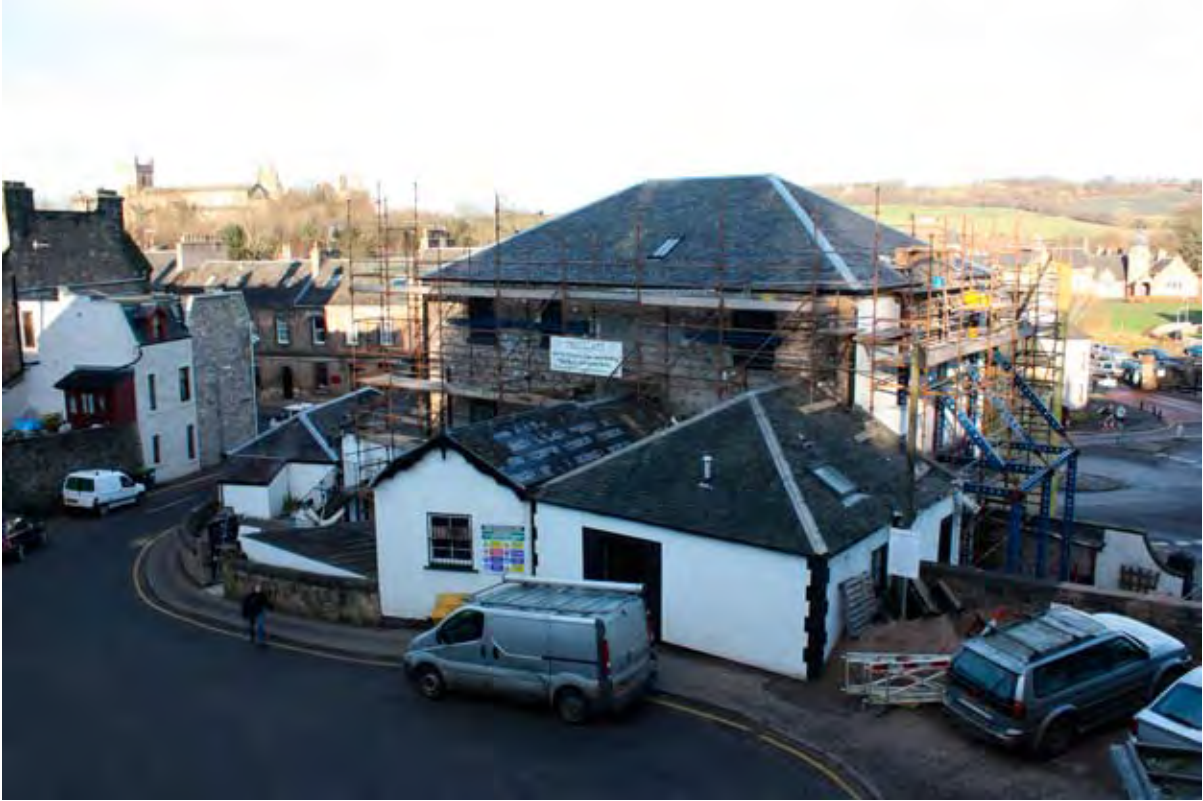
Illus 13

NW-facing shot showing rear (S) elevation and extensions (3-5)

roof. Two flush windows are on the east elevation and one on the east side of the north elevation. An external doorway is located on the south elevation.

Adjoining this is a further extension (Building 4) with gabled slate roof that also connects to the principal building. The south elevation at least comprises harled wooden boarding. A centrally placed, flush window is also on this elevation. A further window is on the west elevation. Both buildings most recently functioned as the customer toilets.

Building 5 is mainly constructed in coursed sandstone blocks of varying size; however the upper courses are brick and the sloped roof made of corrugated iron. A flush window is set centrally in the west elevation and the walls have been white-washed.

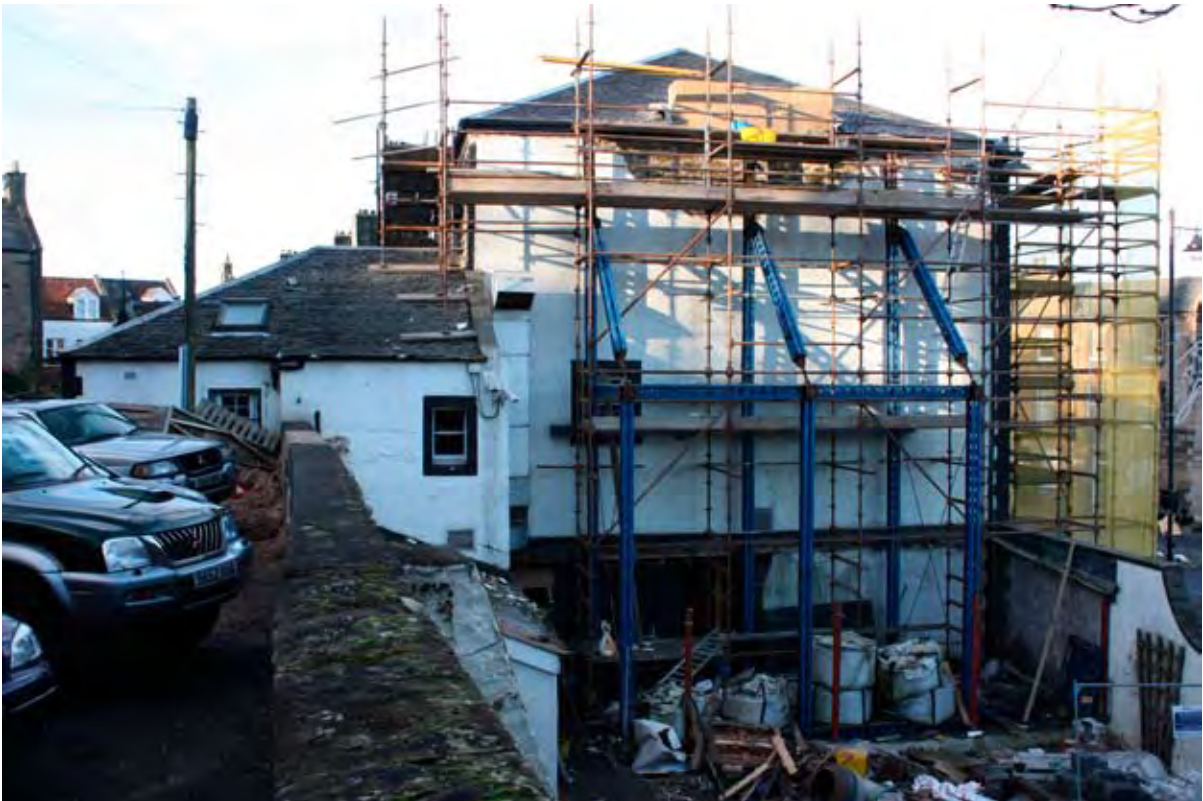
Illus 14

W-facing shot of E elevation of main building

More recent alterations include the opening of the east elevation (with structural support from a steel joist) and associated extension; which was completely removed at the time of the structure survey. The hotel suffered a serious fire in October 2010, which resulted in the collapse of the pitched roof and the second floor. The building was subsequently braced in order to stabilise it (Buildings at Risk register for Scotland).

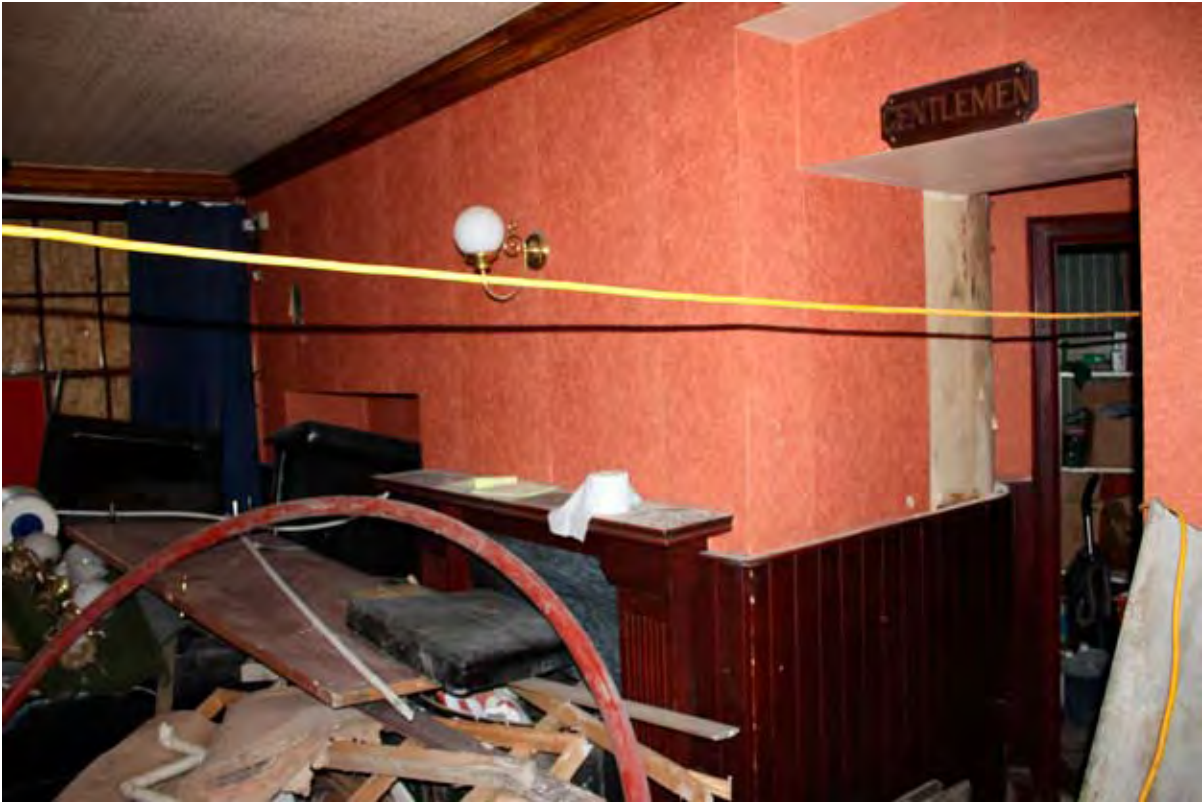
Illus 15

SW-facing shot of interior of Building 2

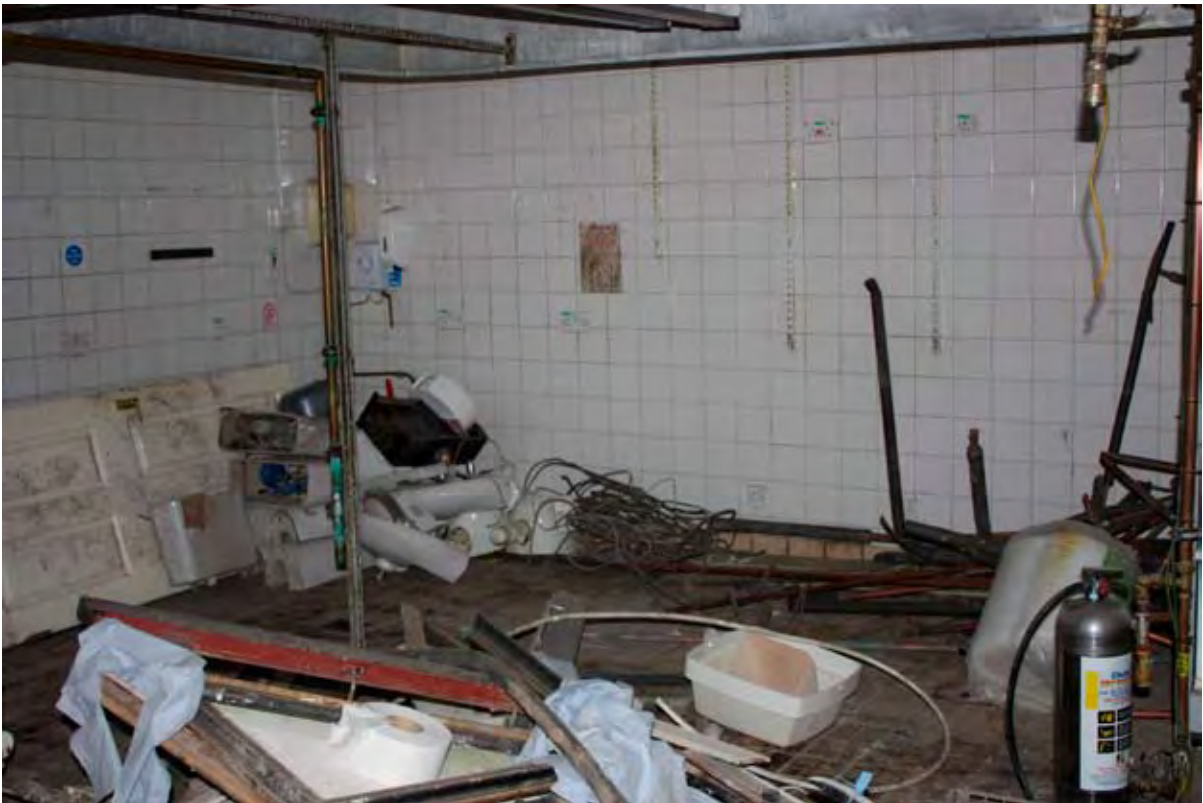
Illus 16

SE-facing shot of interior of Building 3
