Project Code: PPJ04
Planning application reference number:
Date of report: 5th March 2008
Client: Morgan Ashurst, on behalf of Scottish Prison Service

Archaeological Evaluation at HMP Perth

The evaluation was carried out adjacent to the B-Listed hospital block, scheduled for demolition as part of the Phase III works. The archaeological evaluation consisted of a single trench, excavated in the Estates Yard and revealed both the probable remains of the 1811 perimeter wall and a further, stone and concrete, structure of 20th century date.

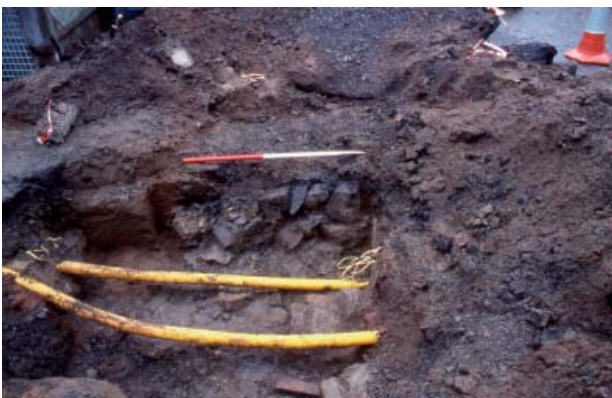
Plate 2

Rubble core of 1811 perimeter wall

The heavily truncated whinstone structure (018) identified at the south-western end of the trench was similar in nature and dimensions to that described in previous archaeological investigations, as the remains of the 1811 perimeter wall of the prison (Hatherley 2006). The structure appears to represent the remains of the rubble core of the wall, minus its dressed facing blocks. This interpretation is further supported by the position of the feature, directly reflecting the projected line of the former boundary. Whilst the trenching has allowed for the position of the former boundary wall to be established, it also suggests that the level of preservation of this section is quite poor.

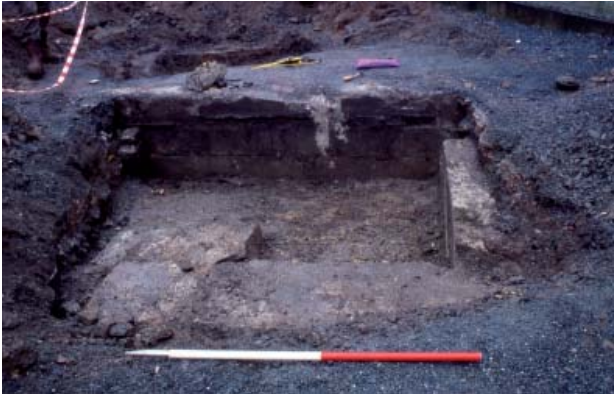
Plate 3

20th century sandstone and concrete structures

Sandstone wall (003) was identified as the probable remains of a section of wall shown on the 1947 plan of the site but absent from the previous plan of 1857. It appears that wall (003) formed a 90° angle with the surviving portion of the 1811 perimeter wall, which appears to have been demolished to its south-west.

Wall (004) was almost certainly contemporary with wall (003). Whilst it was constructed as an abutting structure as opposed to bonded into wall (003), the foundation and all other aspects of its construct

The two course brick structure (007) was interpreted as the remains of a duct which passed through wall (003) by means of an aperture with an iron support lintel. It was thought likely that the duct was constructed to feed services through to the former Hospital block. Modern services, truncating the western portion of the trench, appeared to have been inserted into the structure.
