## KILDRUMMY WIND FARM, ABERDEENSHIRE

*Archaeological Works*

*for RENERCO*

*September 2012*

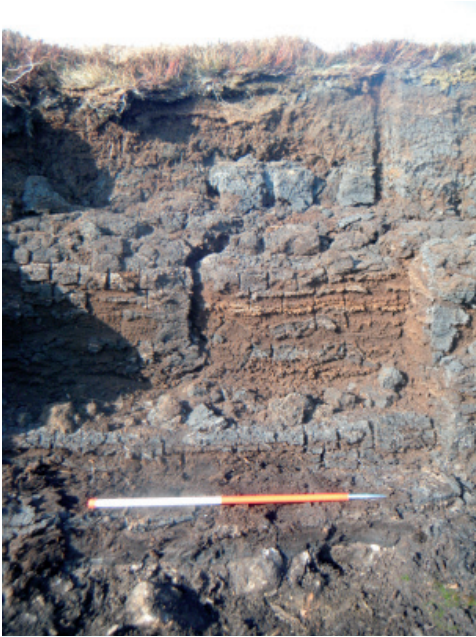
◀ **Illus 2**

*Cleaned section through exposed peat face*

The peat cuttings in the area of turbine 2 covered an area of 130m by 110m, a cleaned section of the exposed face of the peat cutting at the northern edge of the area (*Illus 2*) showed that 1.62m of mid to dark brown humic peat with some gnarled branches and many thin laminations overlay a dark brown silty clay which in turn sat upon the glacial deposits of gray gritty / sandy silt with frequent large stones.

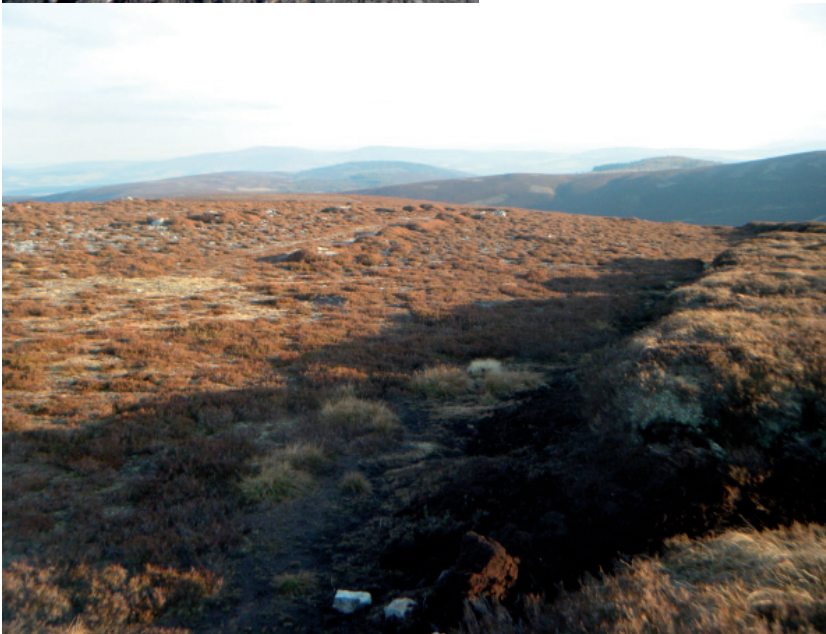
◀ **Illus 3**

*S facing view of former peat cuttings showing 'cairns' adjacent to access tracks*

A total of 85 'cairns' were surveyed in the area of the former peat cuttings (*Illus 3*). These 'cairns' were sub-rounded to sub-oval in shape measuring between 2m and 3.5m in diameter and surviving up to 0.6m high. The cairns formed north south lines, some either side of the visible tracks. They were confined to the area of the hillside that had been cleared of peat, leaving the glacial deposits exposed. Some modern surface finds were observed in the area of the peat cutting, these comprised primarily metal blades, possibly tools relating to peat cutting and bottle glass.

The archaeological features identified and recorded at Kildrummy wind farm relate to the post-medieval agricultural use of the landscape. The most interesting aspect of this are the rows of 'cairns' associated with the areas of former peat workings. These rows of 'cairns' appear to have two possible interpretations, firstly that they are stances for drying peat before it is transported down the hill; or that they are simply piles of stone cleared to form the tracks leading into the peat cutting. Structures for drying of peat have been identified at Ben Lawers, in Perthshire and are known from the Western Isles (Boyle 2002). These long narrow structures, whilst still small, are more substantial than the small cairns seen at Kildrummy. It is possible that these small cairns are a local development and used for drying peat, however it is more likely that these structures are the result of stone clearance in order to form the tracks running to the face of the peat cuttings.

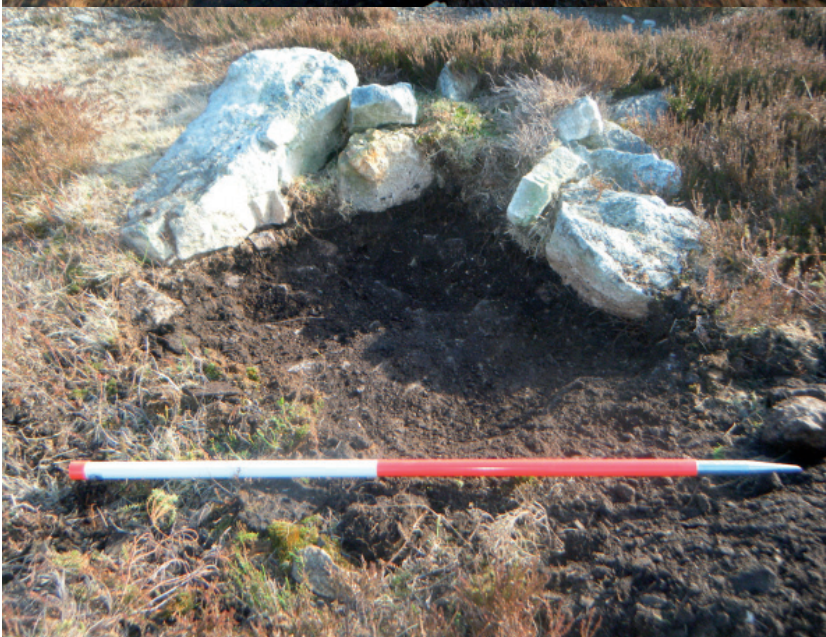
◀ **Illus 4**

*N facing view of excavated quadrant of one of the 'cairns'*

A quadrant of two of the 'cairns' was excavated with the aim of identifying their date and function. The excavated quadrants of the cairns showed that they were constructed of medium to large angular stones (up to 0.8 by 0.4 by 0.2m) in a dark brown humic gritty silt matrix laid directly upon the glacial material (*Illus 4*).

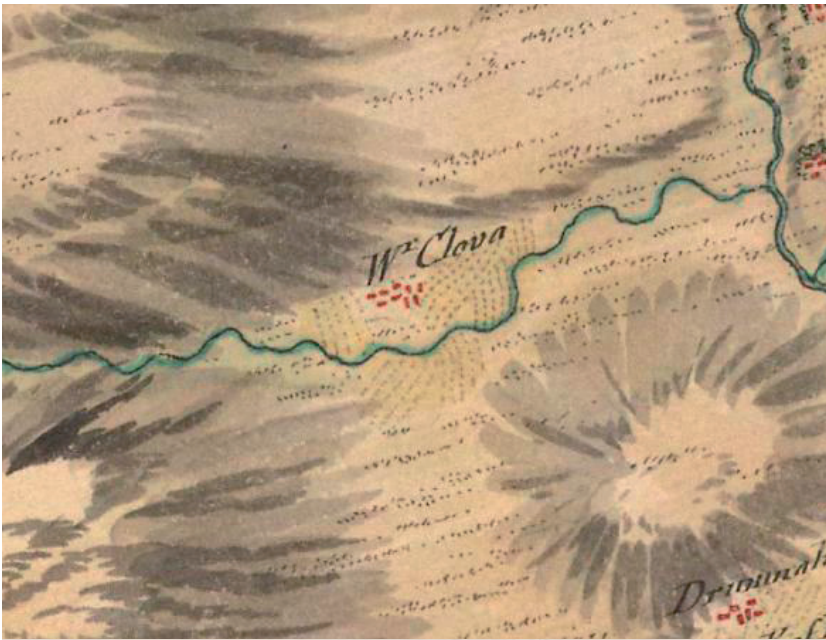
◀ **Illus 5**

The historic map evidence suggests that the farm building at Wester Clova was built between surveys of 1755 and 1822. The original Wester Clova as depicted on Roy's map in c.1750 (*Illus 5*) is located on the northern side of the Mossat Burn and is depicted as a cluster of houses surrounded by rig. By the time of James

Roy's map of 1747–52 showing Wester Clova on the north side of the Mossat burn

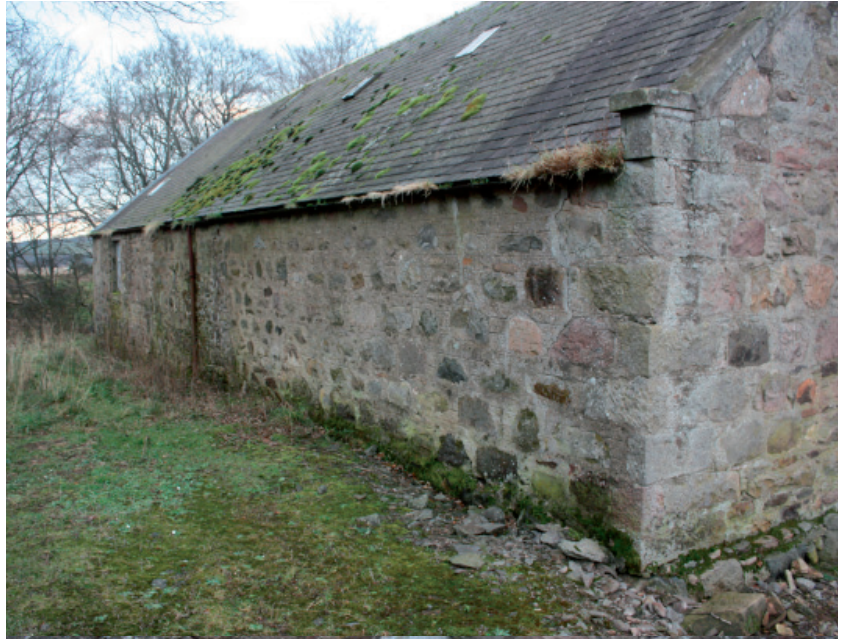
**Illus 8** ▶

*N-W elevation of N-W block of outbuilding at  
Wester Clova*

In terms of building fabric, the earliest part of the building is the north western (*Illus 8*) and north eastern wall of the north westerly block, which corresponds to part of the elongated T shaped building depicted on the 1st edition OS mapping. Later render and plaster covered much of the walls of this building hindering its interpretation, however this part of the structure contained several blocked windows showing that it was part of an older structure later modified. Modernisation and renovation of the building can be dated to 1900 by a date stone in the middle gable end (*Illus 9*). This phase of construction appears to have utilized part of the elongated T shape building, widening it and incorporating it into the current layout (*Illus 10*). The other building depicted on the OS 1st edition appears to have been removed completely. Later editions of the Ordnance Survey mapping show that the 1900 phase of construction is the latest major alterations to take place.

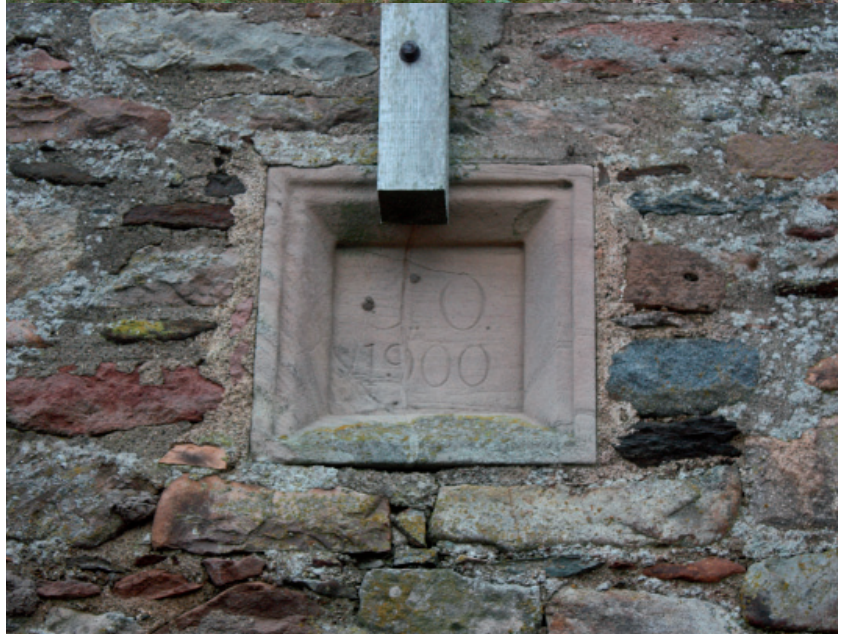
**Illus 9** ▶

*Detail of date stone in central gable end*

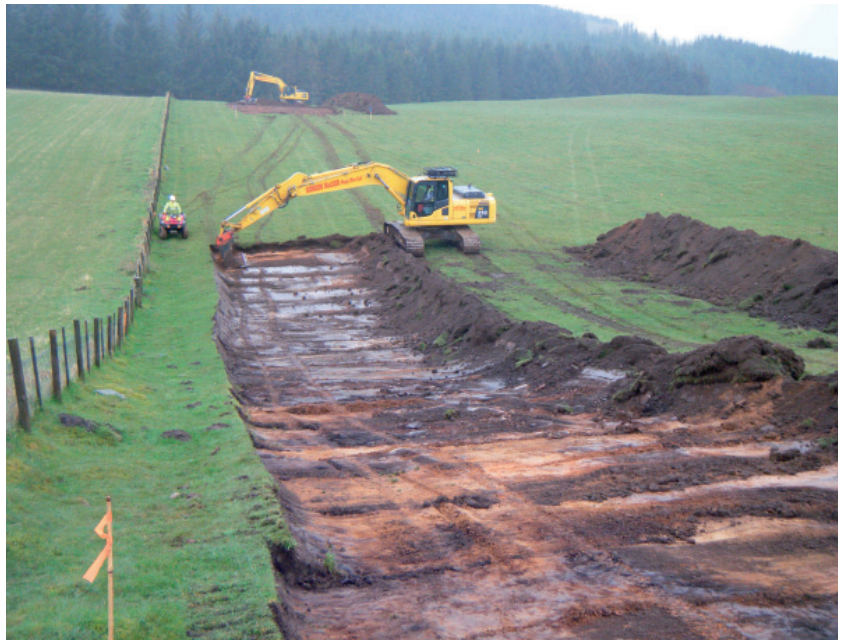
**Illus 11** ▶

Archaeological monitoring was carried out on construction of the main access route to the west of Wester Clova, where a new road was constructed to bypass the farmhouses and on the area of the site compound (*Illus 11*). The access track was between 10m and 20m wide and extended for 1.1km, the compound covered an area of 70m by 60m. The track ran through rough pasture fields and dense conifer plantation on a normally gentle, but with occasionally steep, east-facing slope between 245m and 270m OD. The soil profile across the excavated area was uniform with up to 0.5m of clayey topsoil was excavated to reveal a glacial till into which the noted archaeological features were cut.

*General view of topsoil removal, facing W*

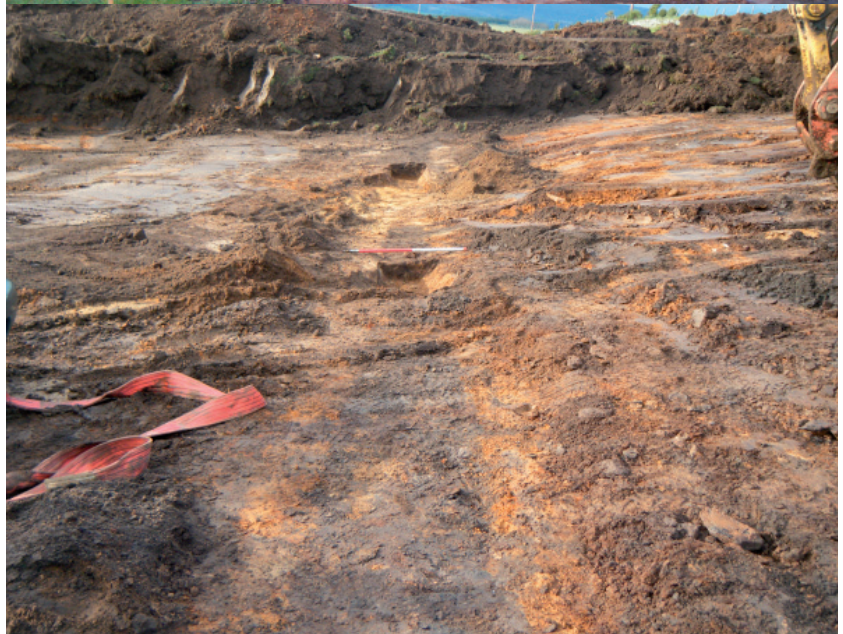
**Illus 12** ▶

Ditch [001] was a narrow (0.69m wide) and shallow (0.4m deep) ditch with steep sides and a flat base (*Illus 12*). The primary fill (002) of this ditch was a silting deposit of pale brown silty sand, overlying this deposit was a dark brown sandy silt (003) that was very similar in composition to the overlying topsoil, suggesting that this deposit is of recent origin.

*Ditch [001], facing S*

The ditches revealed during the archaeological monitoring appear to be of post-medieval date, the smaller of these features, ditch [001] was probably a small open drainage ditch located in a low lying area of a field. The larger more substantial ditch [004] is a former field boundary. This boundary relates to a previous arrangement of the landscape and predates the OS first edition mapping of 1870.

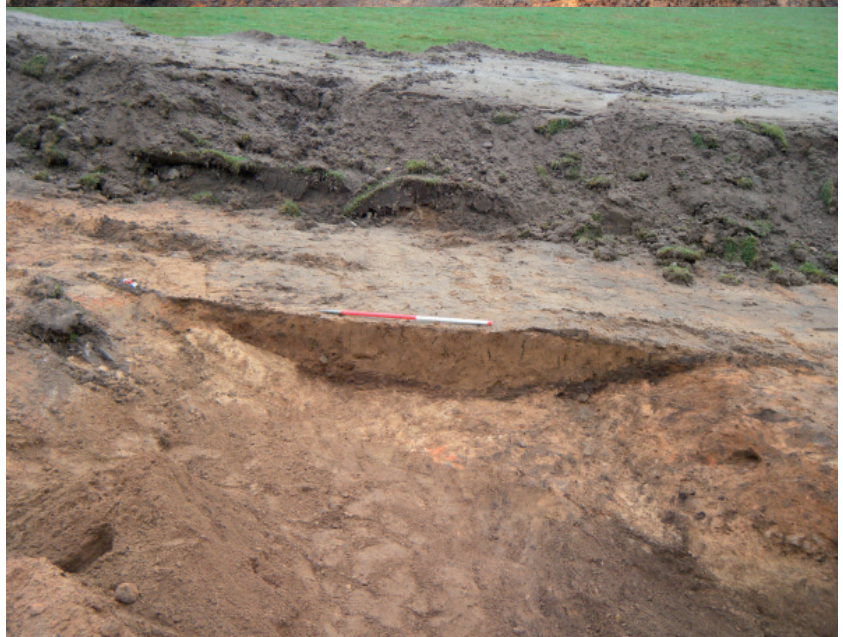
**Illus 13** ▶

Ditch [004] was a larger ditch, 4.85m wide by 0.70m deep that ran across the full width of the trench (*Illus 13*). Ditch [004] had gently sloping sides and a flat base. The basal fill of [004] was a brownish black humic sandy silt (009) that was a buried topsoil, overlying this was a loose yellowish brown silty sand (008) this deposit was derived from the natural glacial deposits excavated to form the ditch and probably formed a bank on the uphill side of the ditch that was deliberately backfilled into ditch [004] after it fell out of use. Overlying deposit (008) was the dark brown sandy silt topsoil (007).

*Ditch [004], facing N*
