Archaeology InSites

Hume Castle, Church and Village - Hume, Scottish Borders

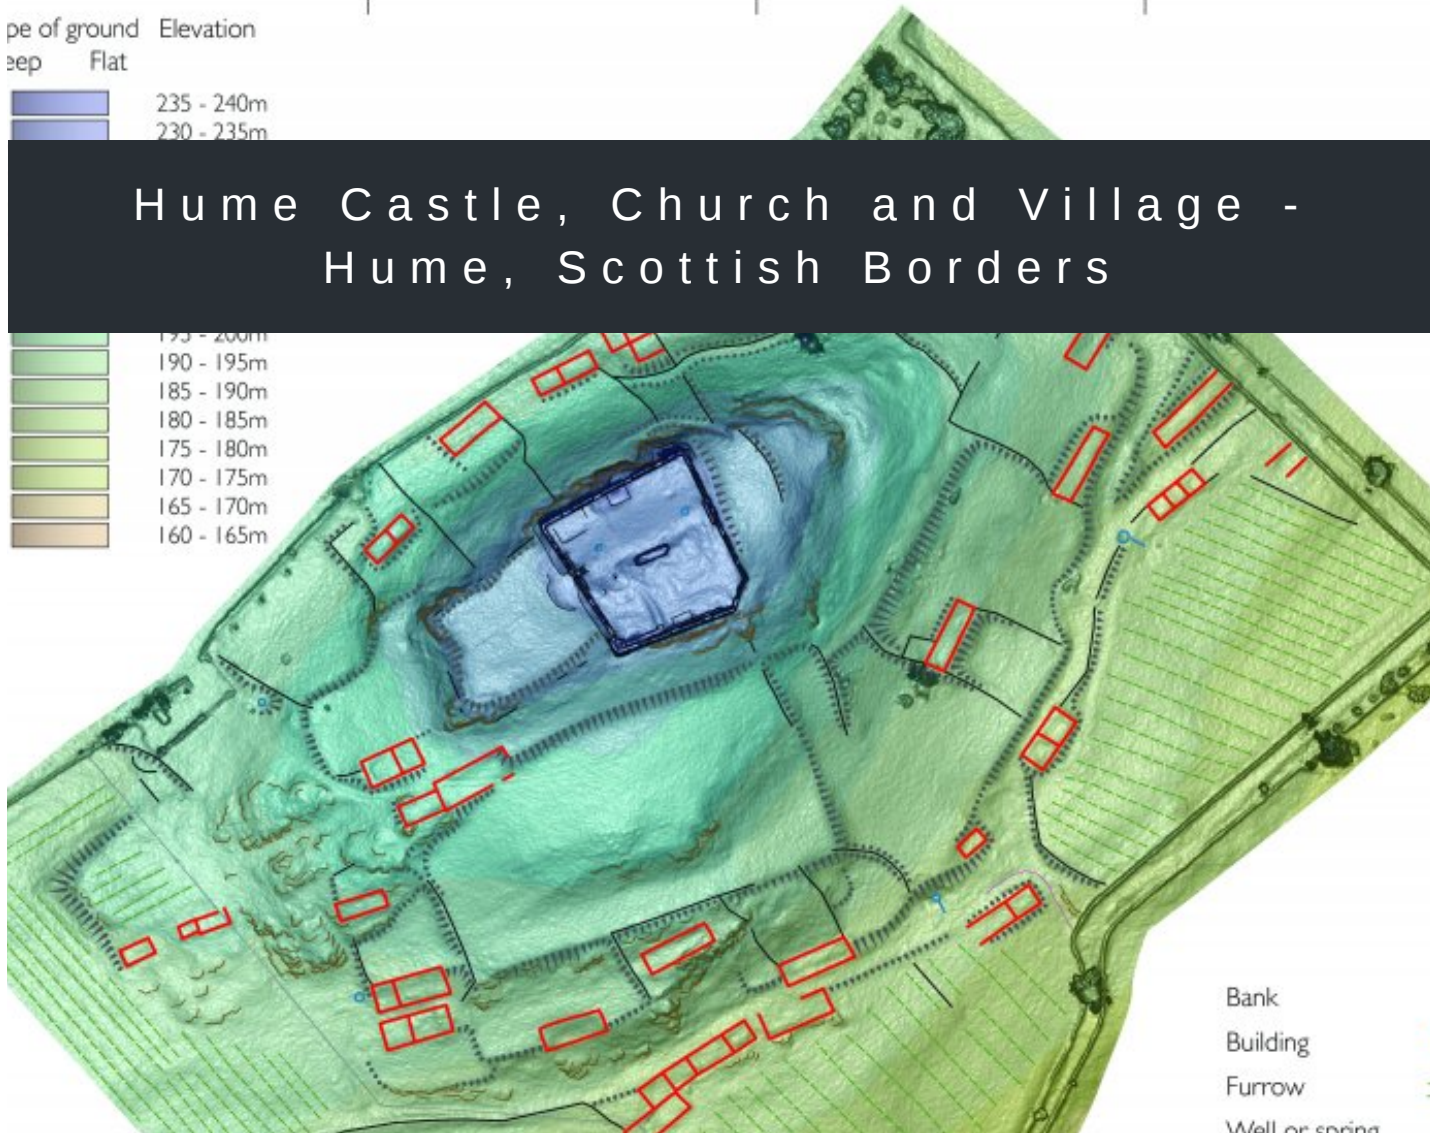
Type of ground Elevation
Deep Flat

235 - 240m
230 - 235m

195 - 200m
190 - 195m
185 - 190m
180 - 185m
175 - 180m
170 - 175m
165 - 170m
160 - 165m

Bank
Building
Furrow
Well or spring

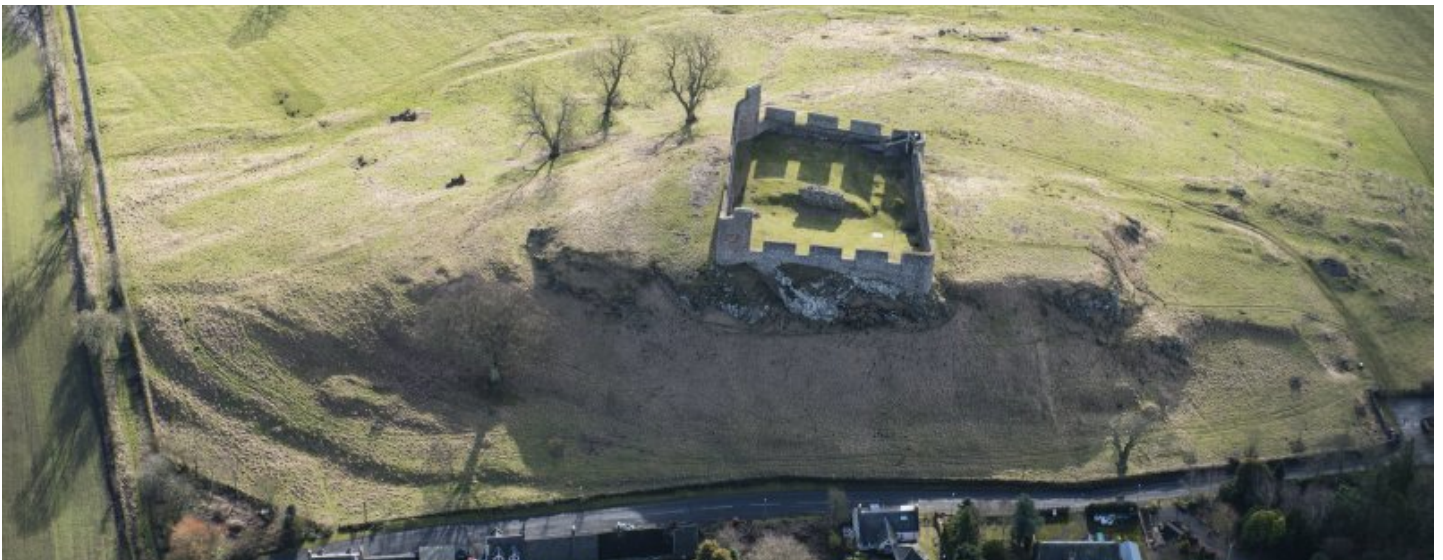
The size of the settlement was revealed in a survey by Piers Dixon and a local team of young people in 1987. The sites of many houses and ridge and furrow cultivation was mapped that stretched from modern village for half a mile to the west on either side of the loaning that leads to the churchyard of the former parish church of St Nicholas. The church itself has been robbed of stone and can only be traced as a platform surrounded by gravestones. The village houses that were located did not stand to any great height and the walls were mostly reduced to footings or robber trenches, suggesting that the superstructure of the walls may have been of perishable material, such as clay, on a stone base.

The 1987 survey lay dormant in the local records for almost 30 years until the Hume Castle Preservation Trust acquired the site. Royal Commission on the Ancient and Historical Monuments of Scotland answered a request for help from them to interpret the site that led to a resurvey of the castle and surrounding field using a low level aerial survey by UAV in 2015 (including a video). A 3D model of the ground surface was produced from which a plan of the castle and surrounding part of the village was mapped. Within the field in which the castle stood some 25 houses and yards alone were located forming rows of properties along the hollow ways of the village streets to north and south of the castle rock. However, this is only about one third of the late 17th century village, the rest of which still lies, further to the west. On the slopes to the south of the village, two phases of ridge and furrow were revealed, with straight narrow, Improvement period ridges over curving broad ridges of medieval origin, hitherto unnoticed.

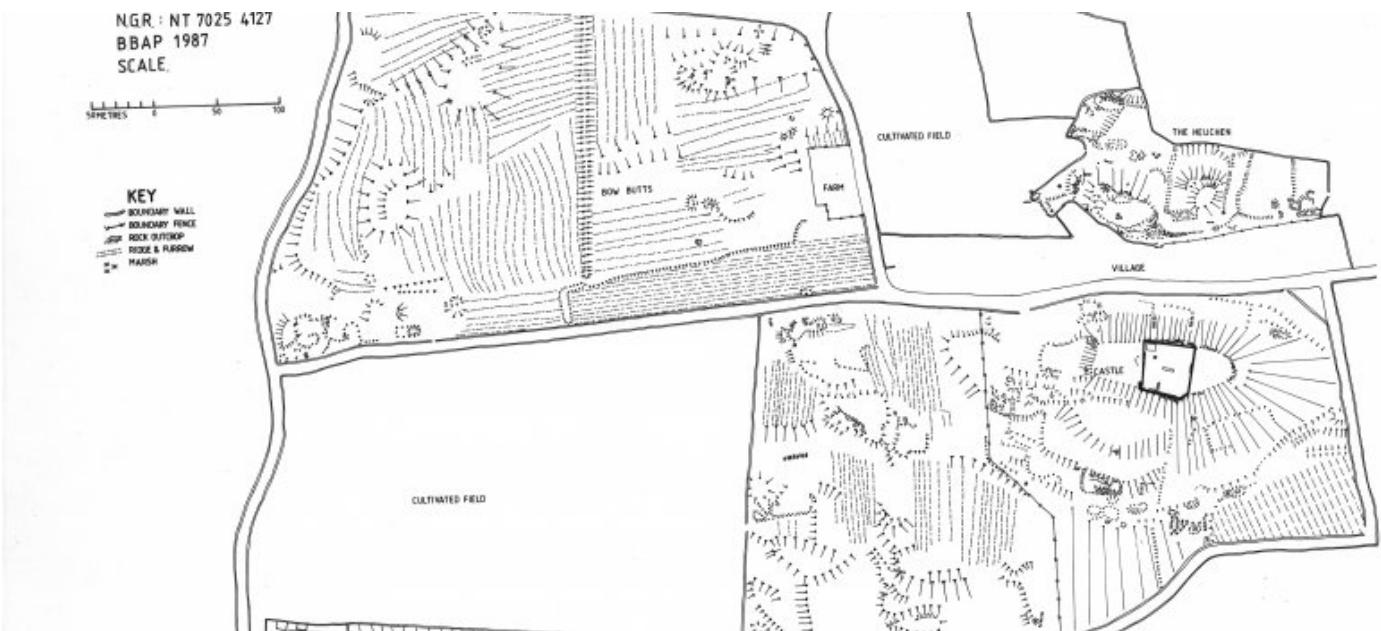
The 3D model also showed that there was a rampart on the east end of the castle rock outside the stone walls of the folly suggesting there might have been an earthwork and timber castle here, possibly dating to the 13th century. There was also an outwork of the castle on the west which can be traced from the stone footings around the squared shape of the outcrop at this end. Further indications of the early castle were shown clearly by the 3D survey to include an earlier wall outside the present west wall which included a round tower immediately in front of the present entrance and another round tower on an outcrop outside the north wall which had been invisible until the UAV survey. This evidence suggested an enclosure castle replaced the earlier earthwork in the 13th or 14th centuries, which was in turn replaced by a large tower and artillery defences in the 15th and 16th centuries, when the Homes acquired baronial status. Part of the tower still stands as a ruin inside the folly, a 15th century dumbbell gun-loop is built into the west wall and the sloping artillery defence of the south wall is of late 16th or 17th century date. The outer approach to the castle was via a ramp from the west between two robbed-out buildings, with a large terraced garden on the south, which gives a more pleasurable aspect to the castle than hitherto appreciated.
